# AUTO ELECTRIC CORNER — Drive Doctor, Corrosion Issues and HID Headlights

## Drives...and Ford Diesel Starters...!

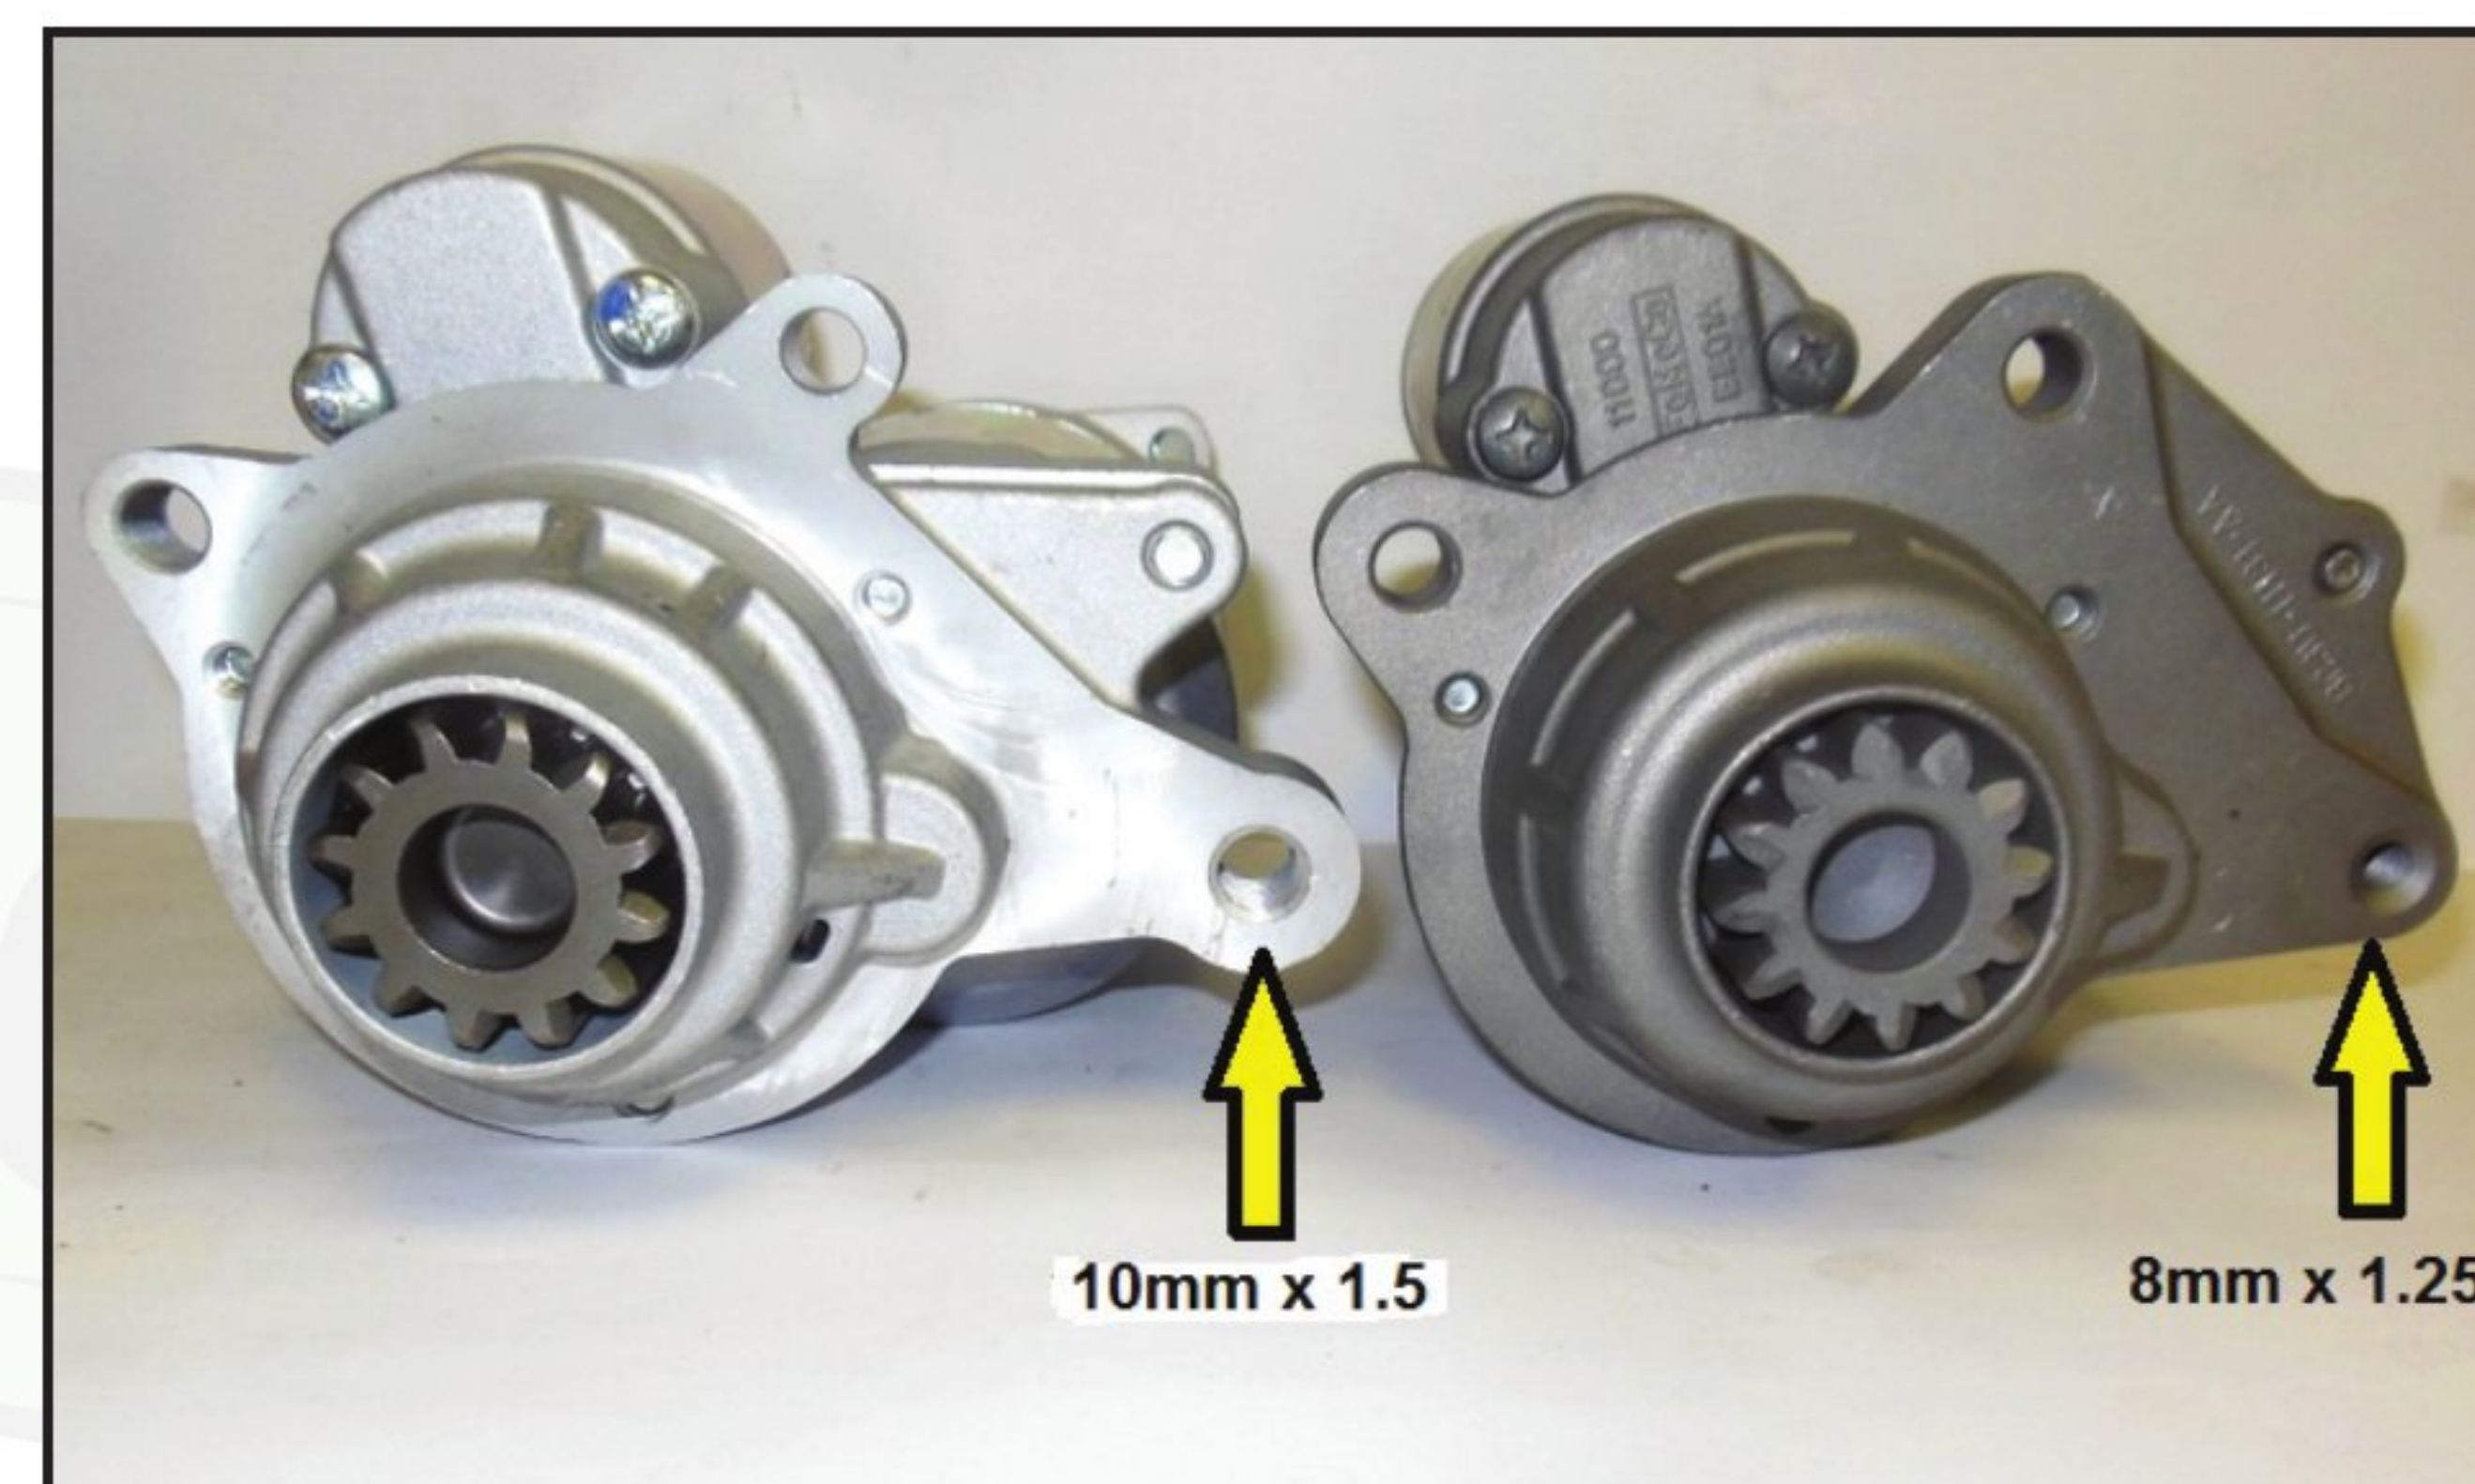
Figure-2 shows the 6675 and 6696 starter side by side. Notice the third mounting hole of the 6675 has a 10mm x 1.5 thread, whereas the 6696 starter has an 8mm x 1.25 thread, but otherwise they look similar.

Figure 2 – 6675 and 6696 starters and their threaded mounting hole difference

experiment with them to see if they interchange with the use of appropriate hardware, thus I only warn you of the differences of their mounting bolts.

These two starters use very similar drive assemblies. The replacement drives are listed and available for the 6675 but none is listed for the 6696. I do not know the reason, but to be on the safe side, I had ours rebuilt as I mentioned above.

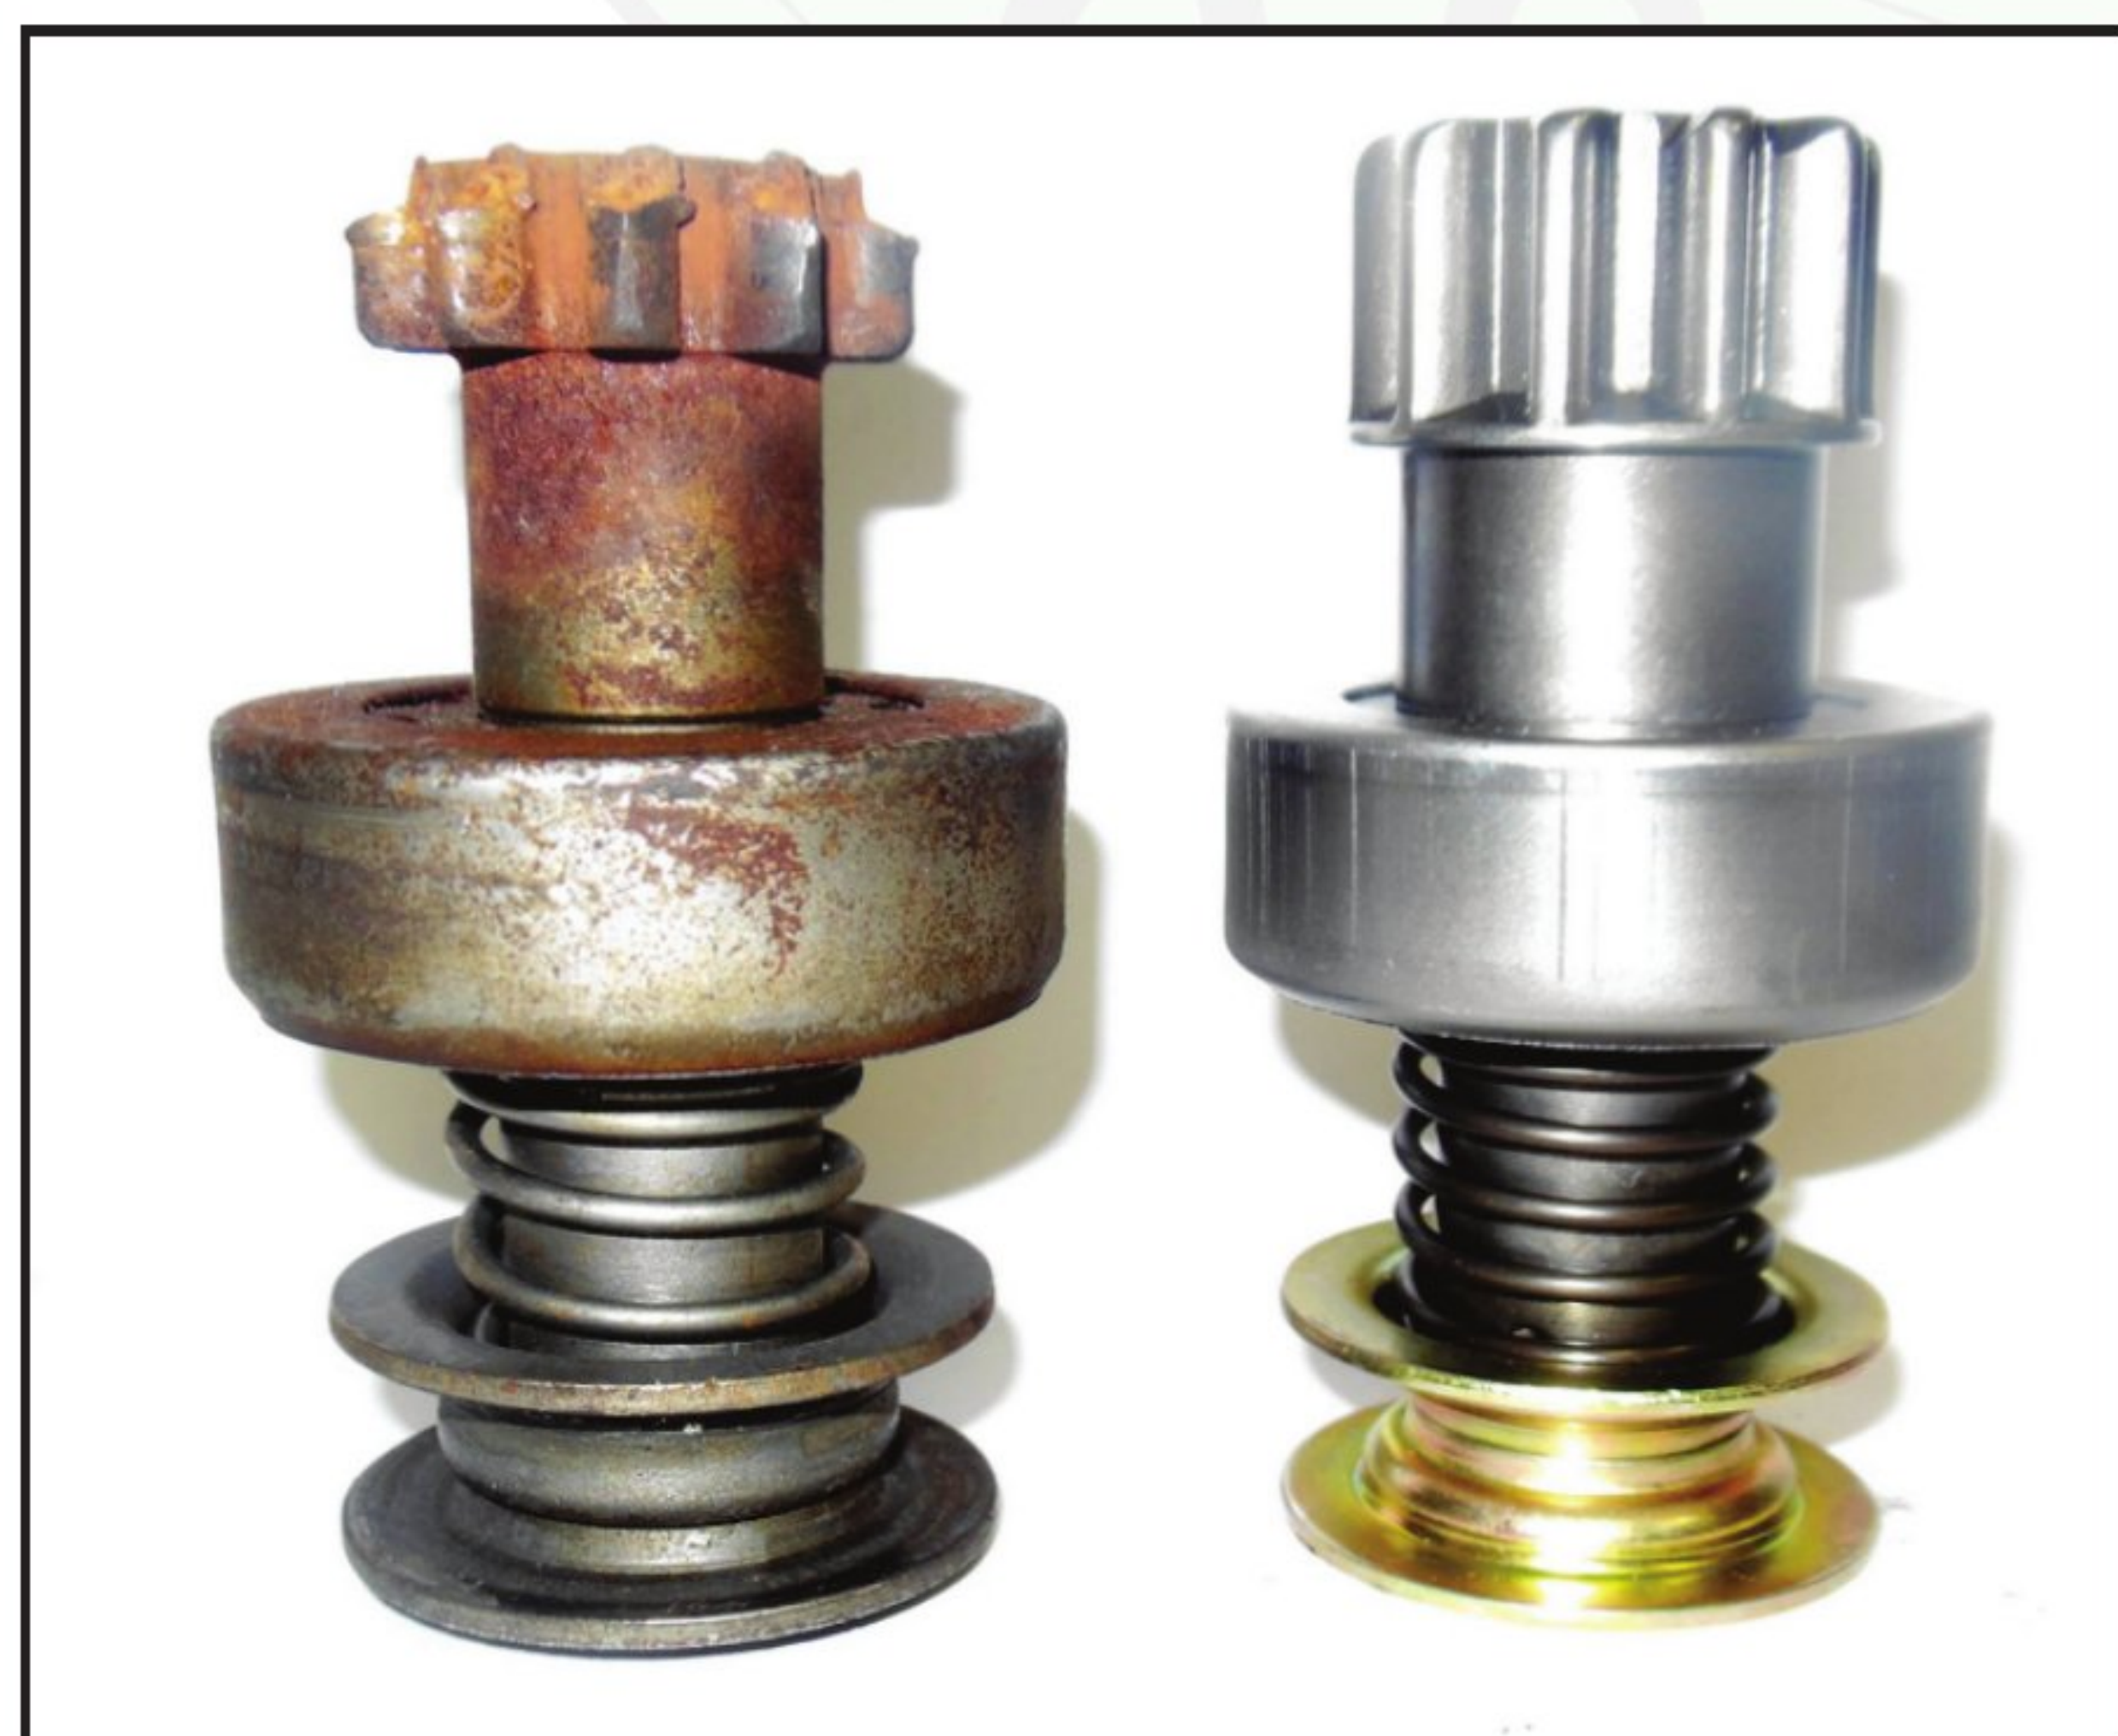
One example is an older Onan stand-by generator that was equipped with the Prestolite MEO-6003 starter for which we needed a drive. Going with the more economical version of the drive, The Drive Doctor shipped us this very reasonably priced new P1818 starter drive that worked out just fine (Figure-1).

Figure 1 – The old Prestolite drive and the replacement from "The Drive Doctor"

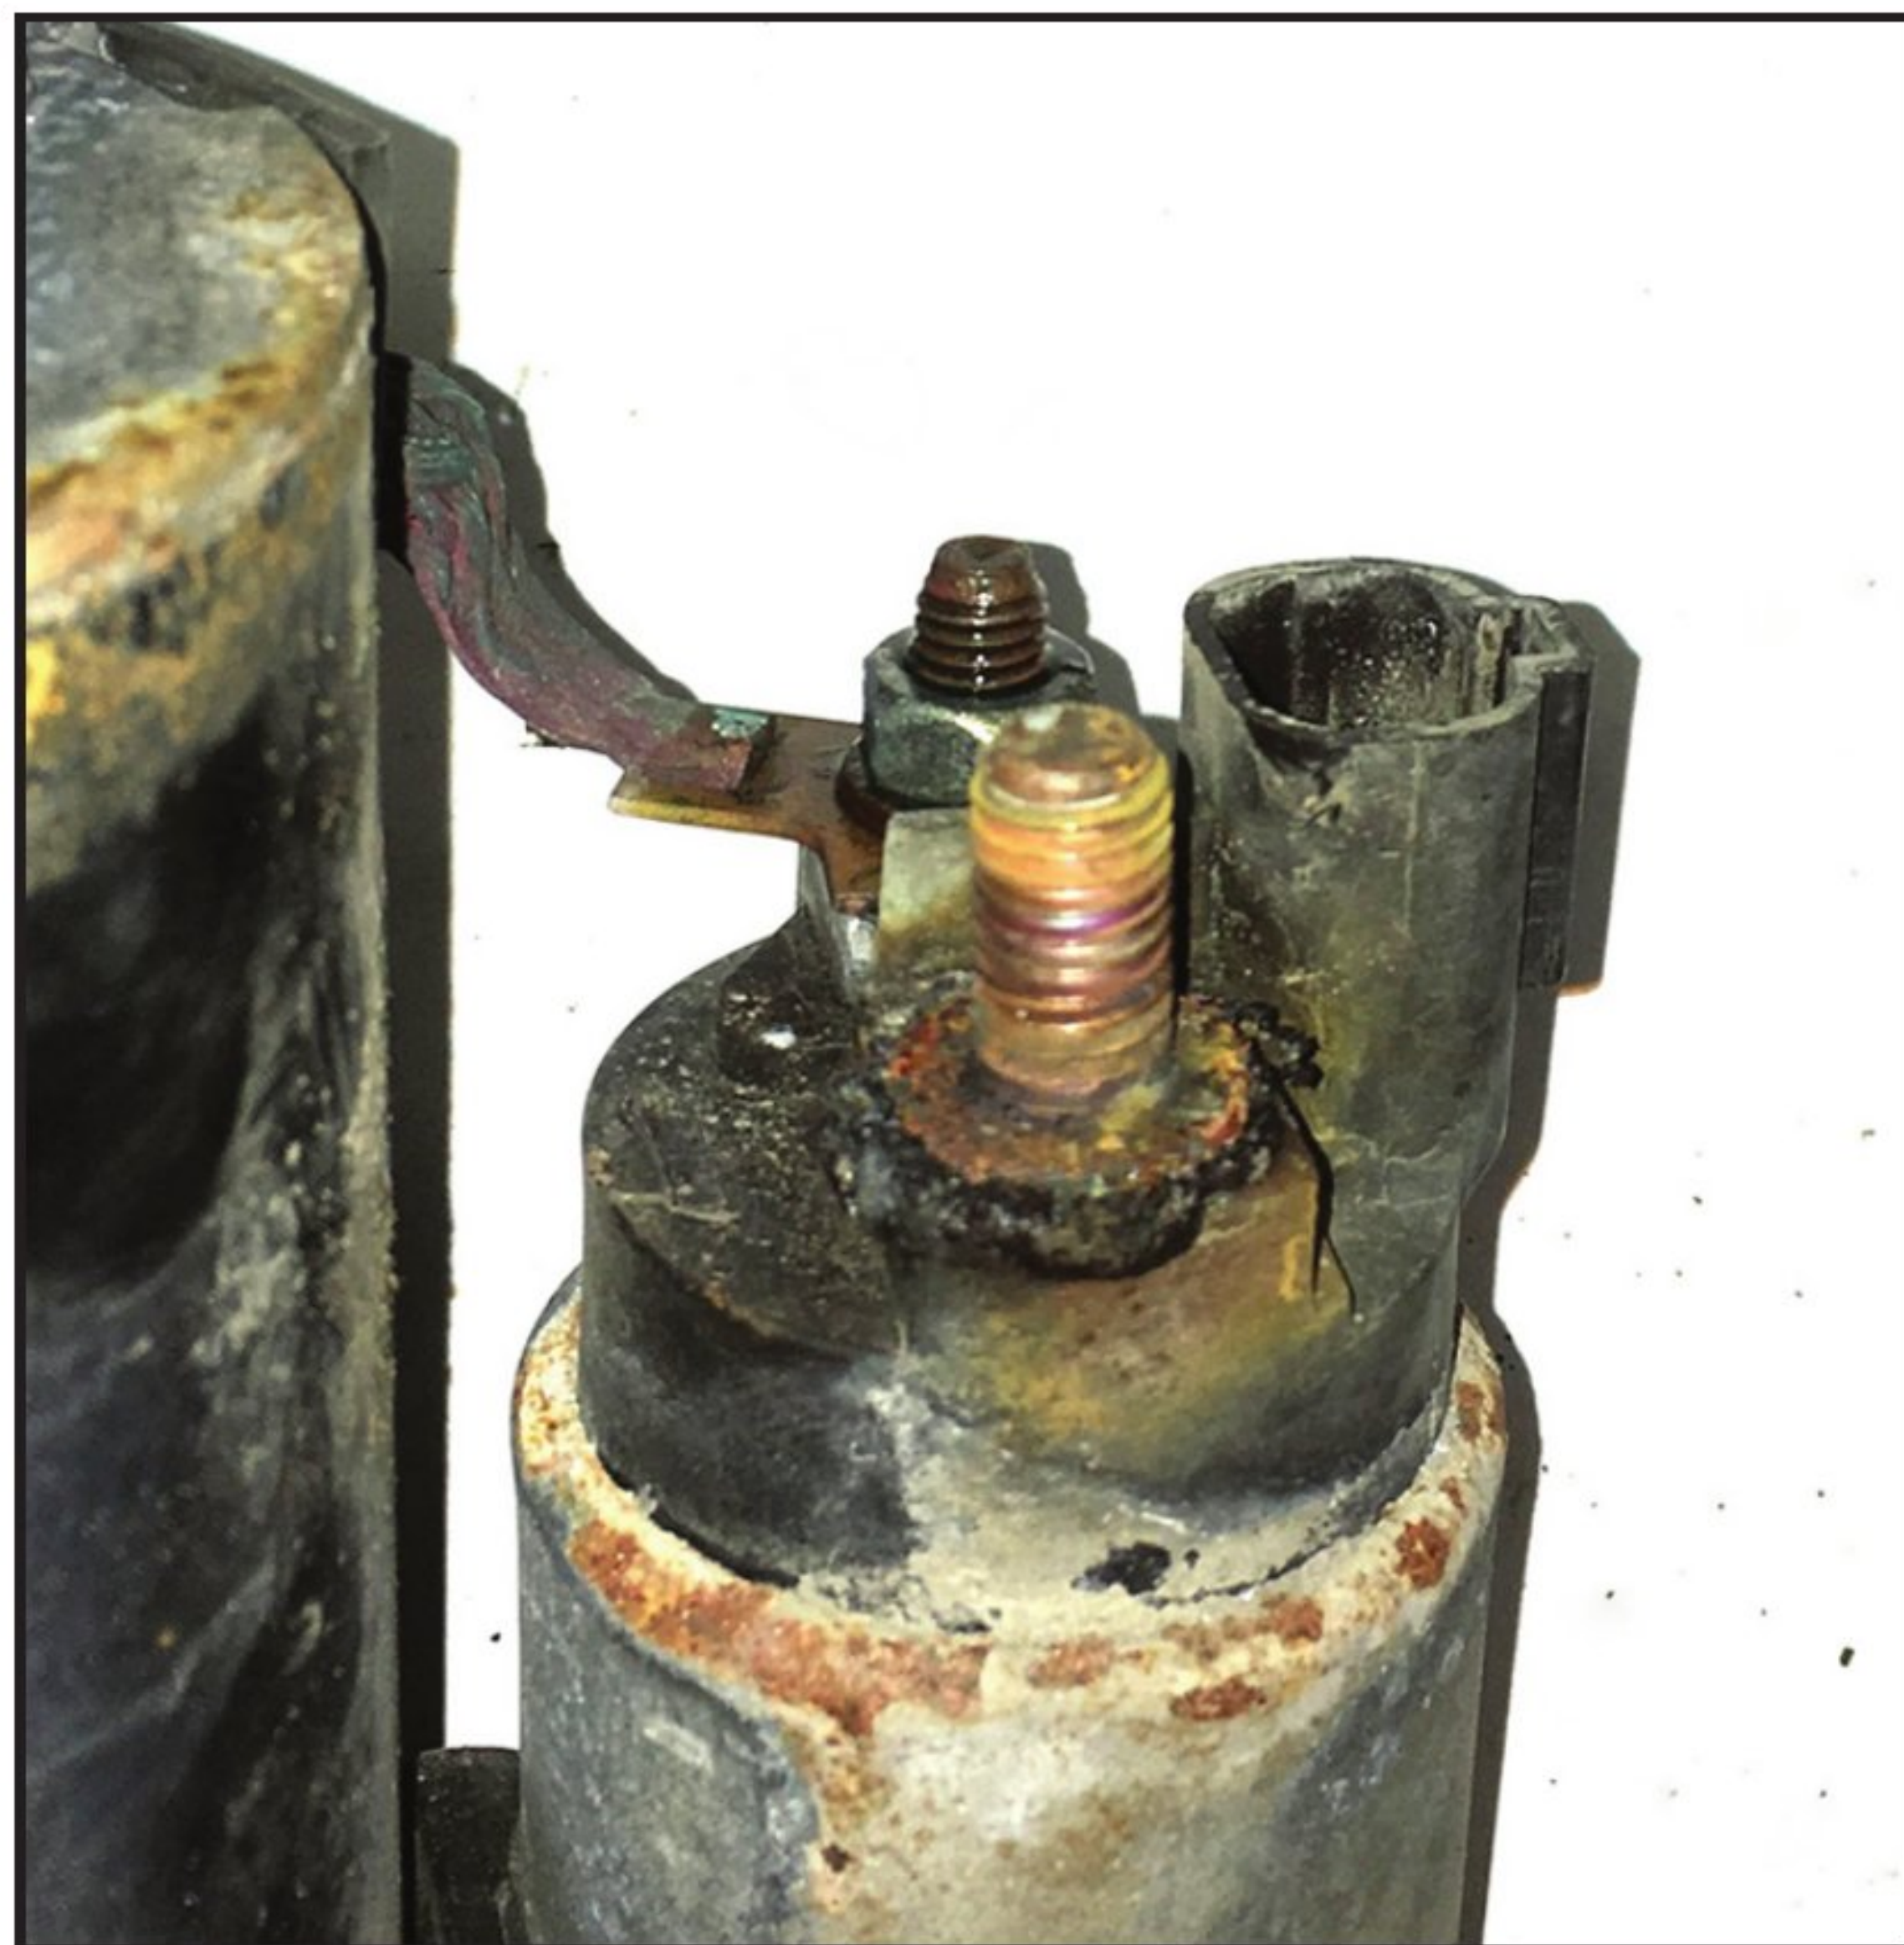
There are many examples but a recurrent one, much to my surprise, is the little 17593 Valeo starter that is mostly used on later models Kia Souls and Hyundai Accent with 1.6L engine. These are not very common cars but since we still supply a few repair shops, we do get calls for them. Their problem is usually a poor and rusted connection on the battery and motor posts of the solenoid. Excessive build-up of corrosion completely insulates it. (Figure-3).

Figure 3 – Deteriorated 17935 starter post due to corrosion and poor connection

The solenoid is just too small and unique to be rebuilt, but luckily replacements (WAI 66-9464 and J&N's 245-40029) are available at minimal prices. I have added a complete starter to my stock for quick turn-around for the next time. Most part stores do not have one in their inventory.

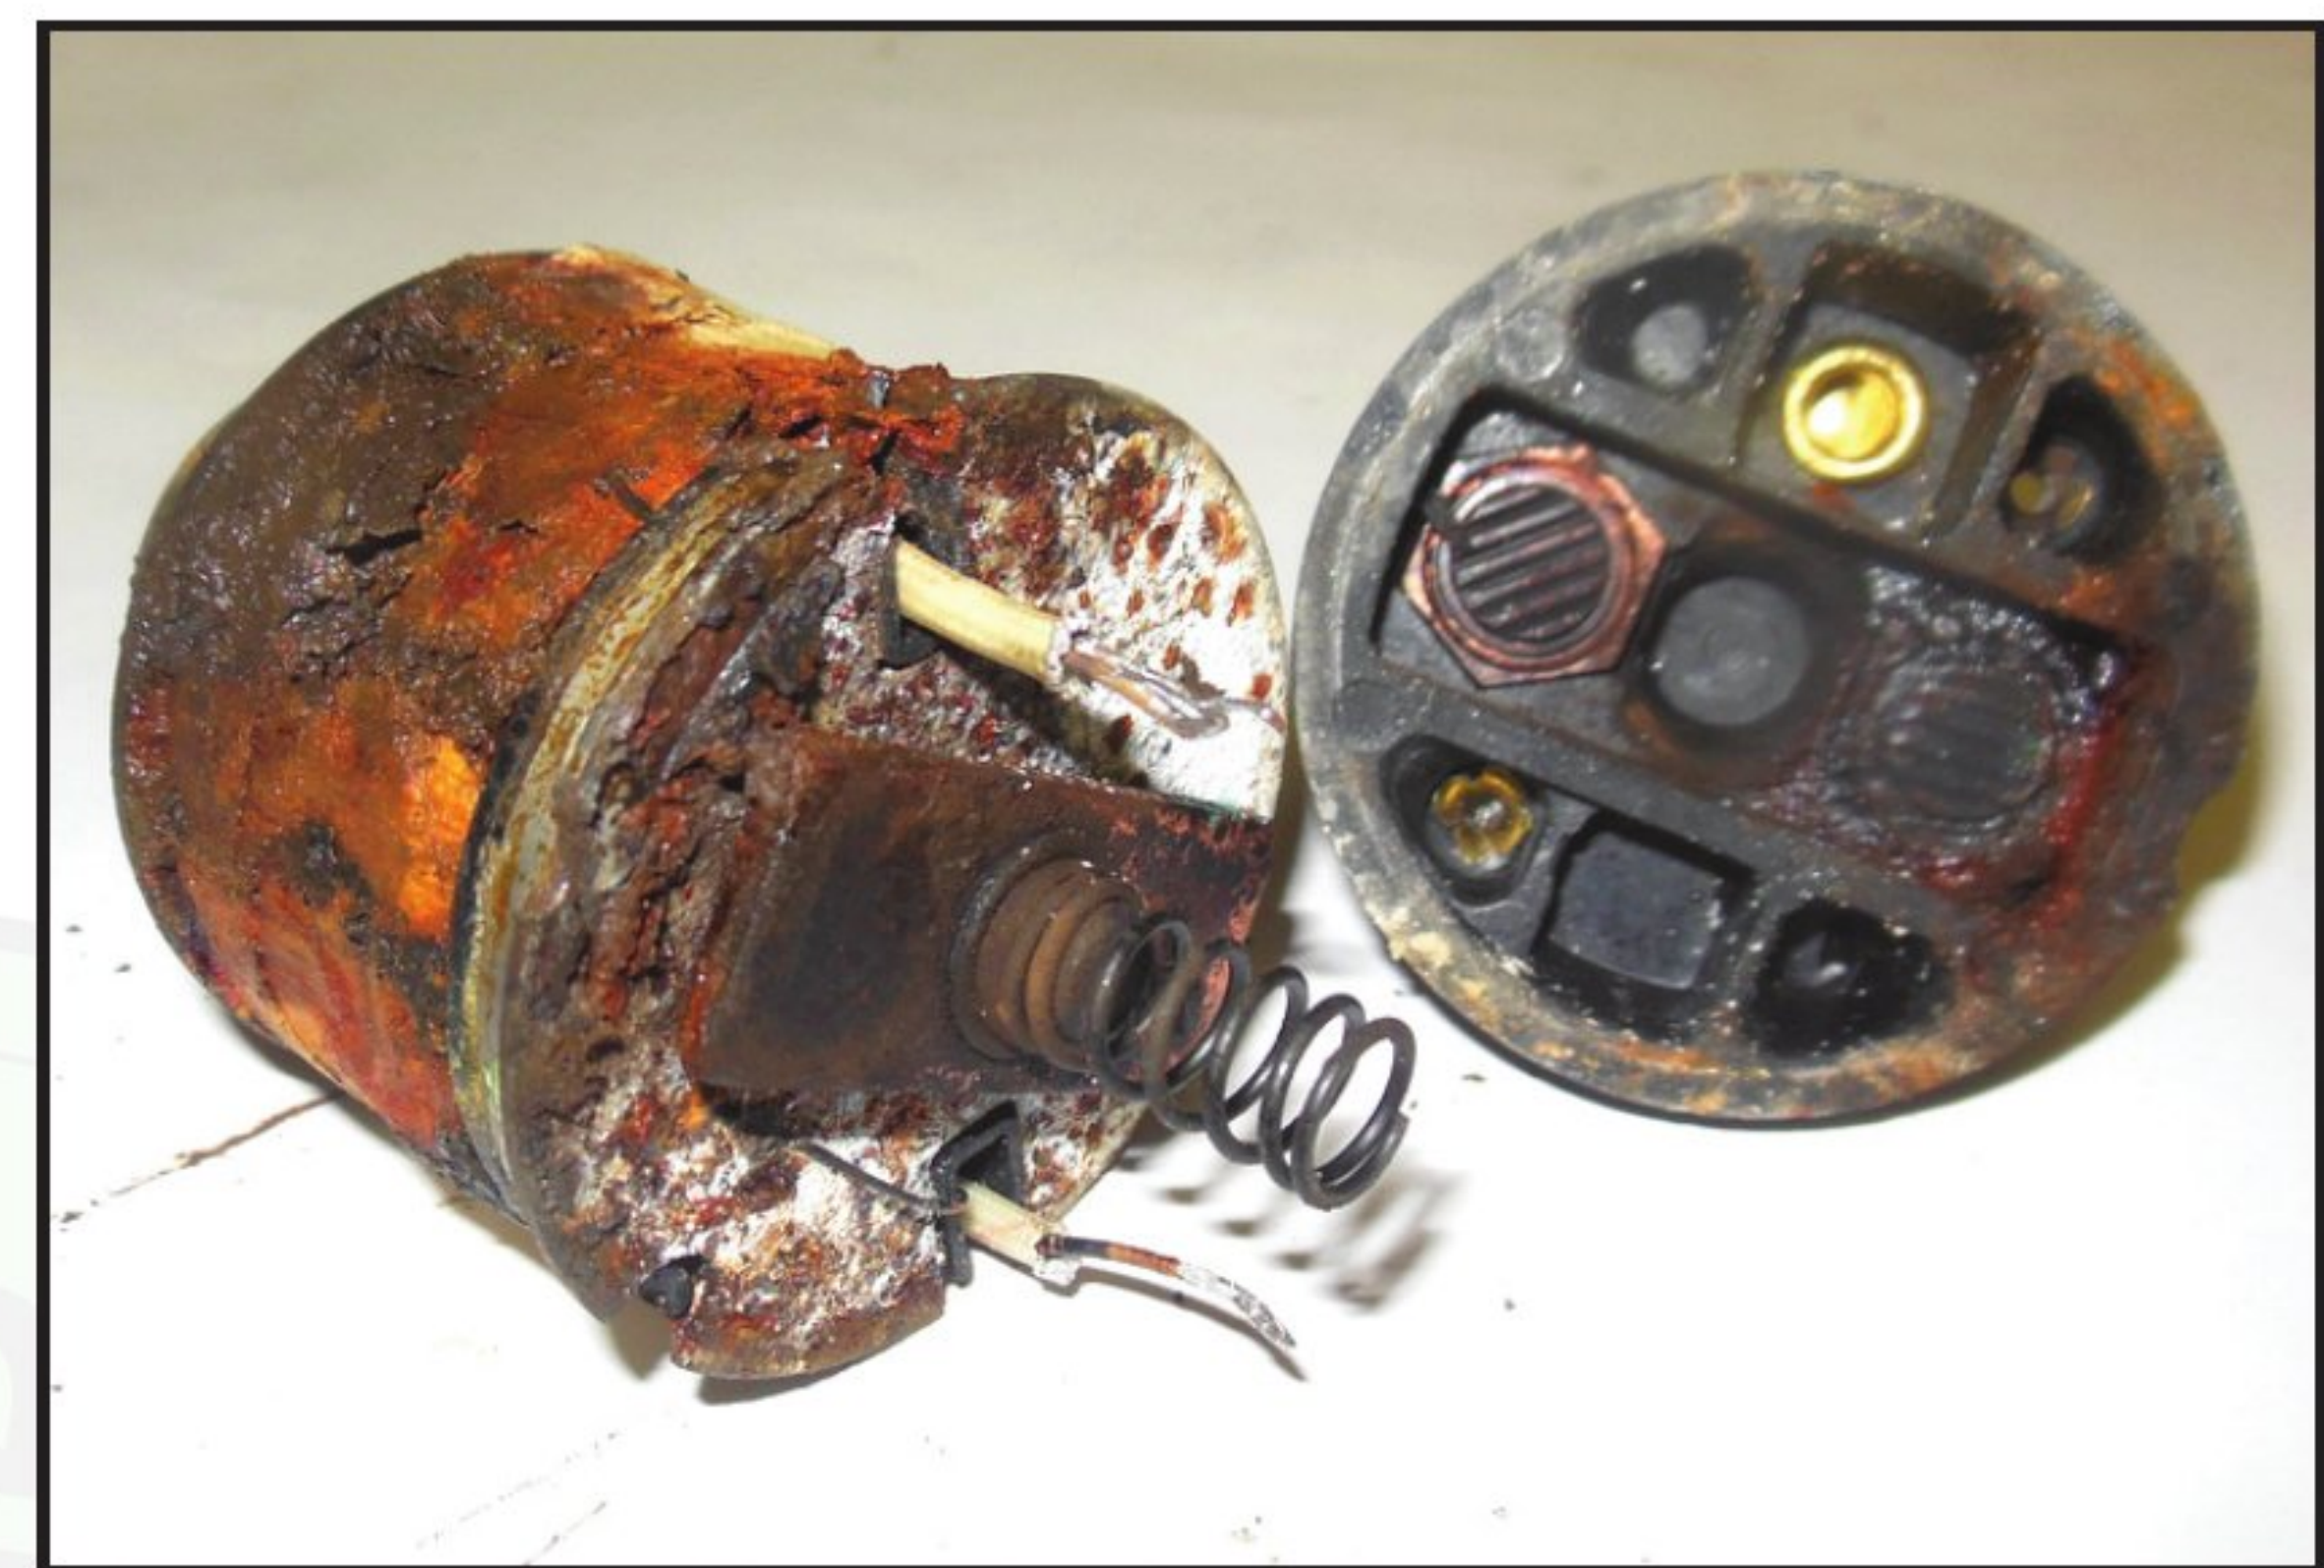
to open the solenoid and take a look inside for any issues. As you can see on Figure-4, I am glad that I did. The amount of rust and build-up was extreme. I have no idea how a clean starter and solenoid could have deteriorated to that extent. I learned another lesson to not assume a clean unit is also pristine inside!

Figure 4 – Inside of a Bosch solenoid that looked very clean on the outside
