# “STUFF” HAPPENS

## True Quality Takes Time

BY BOB THOMAS

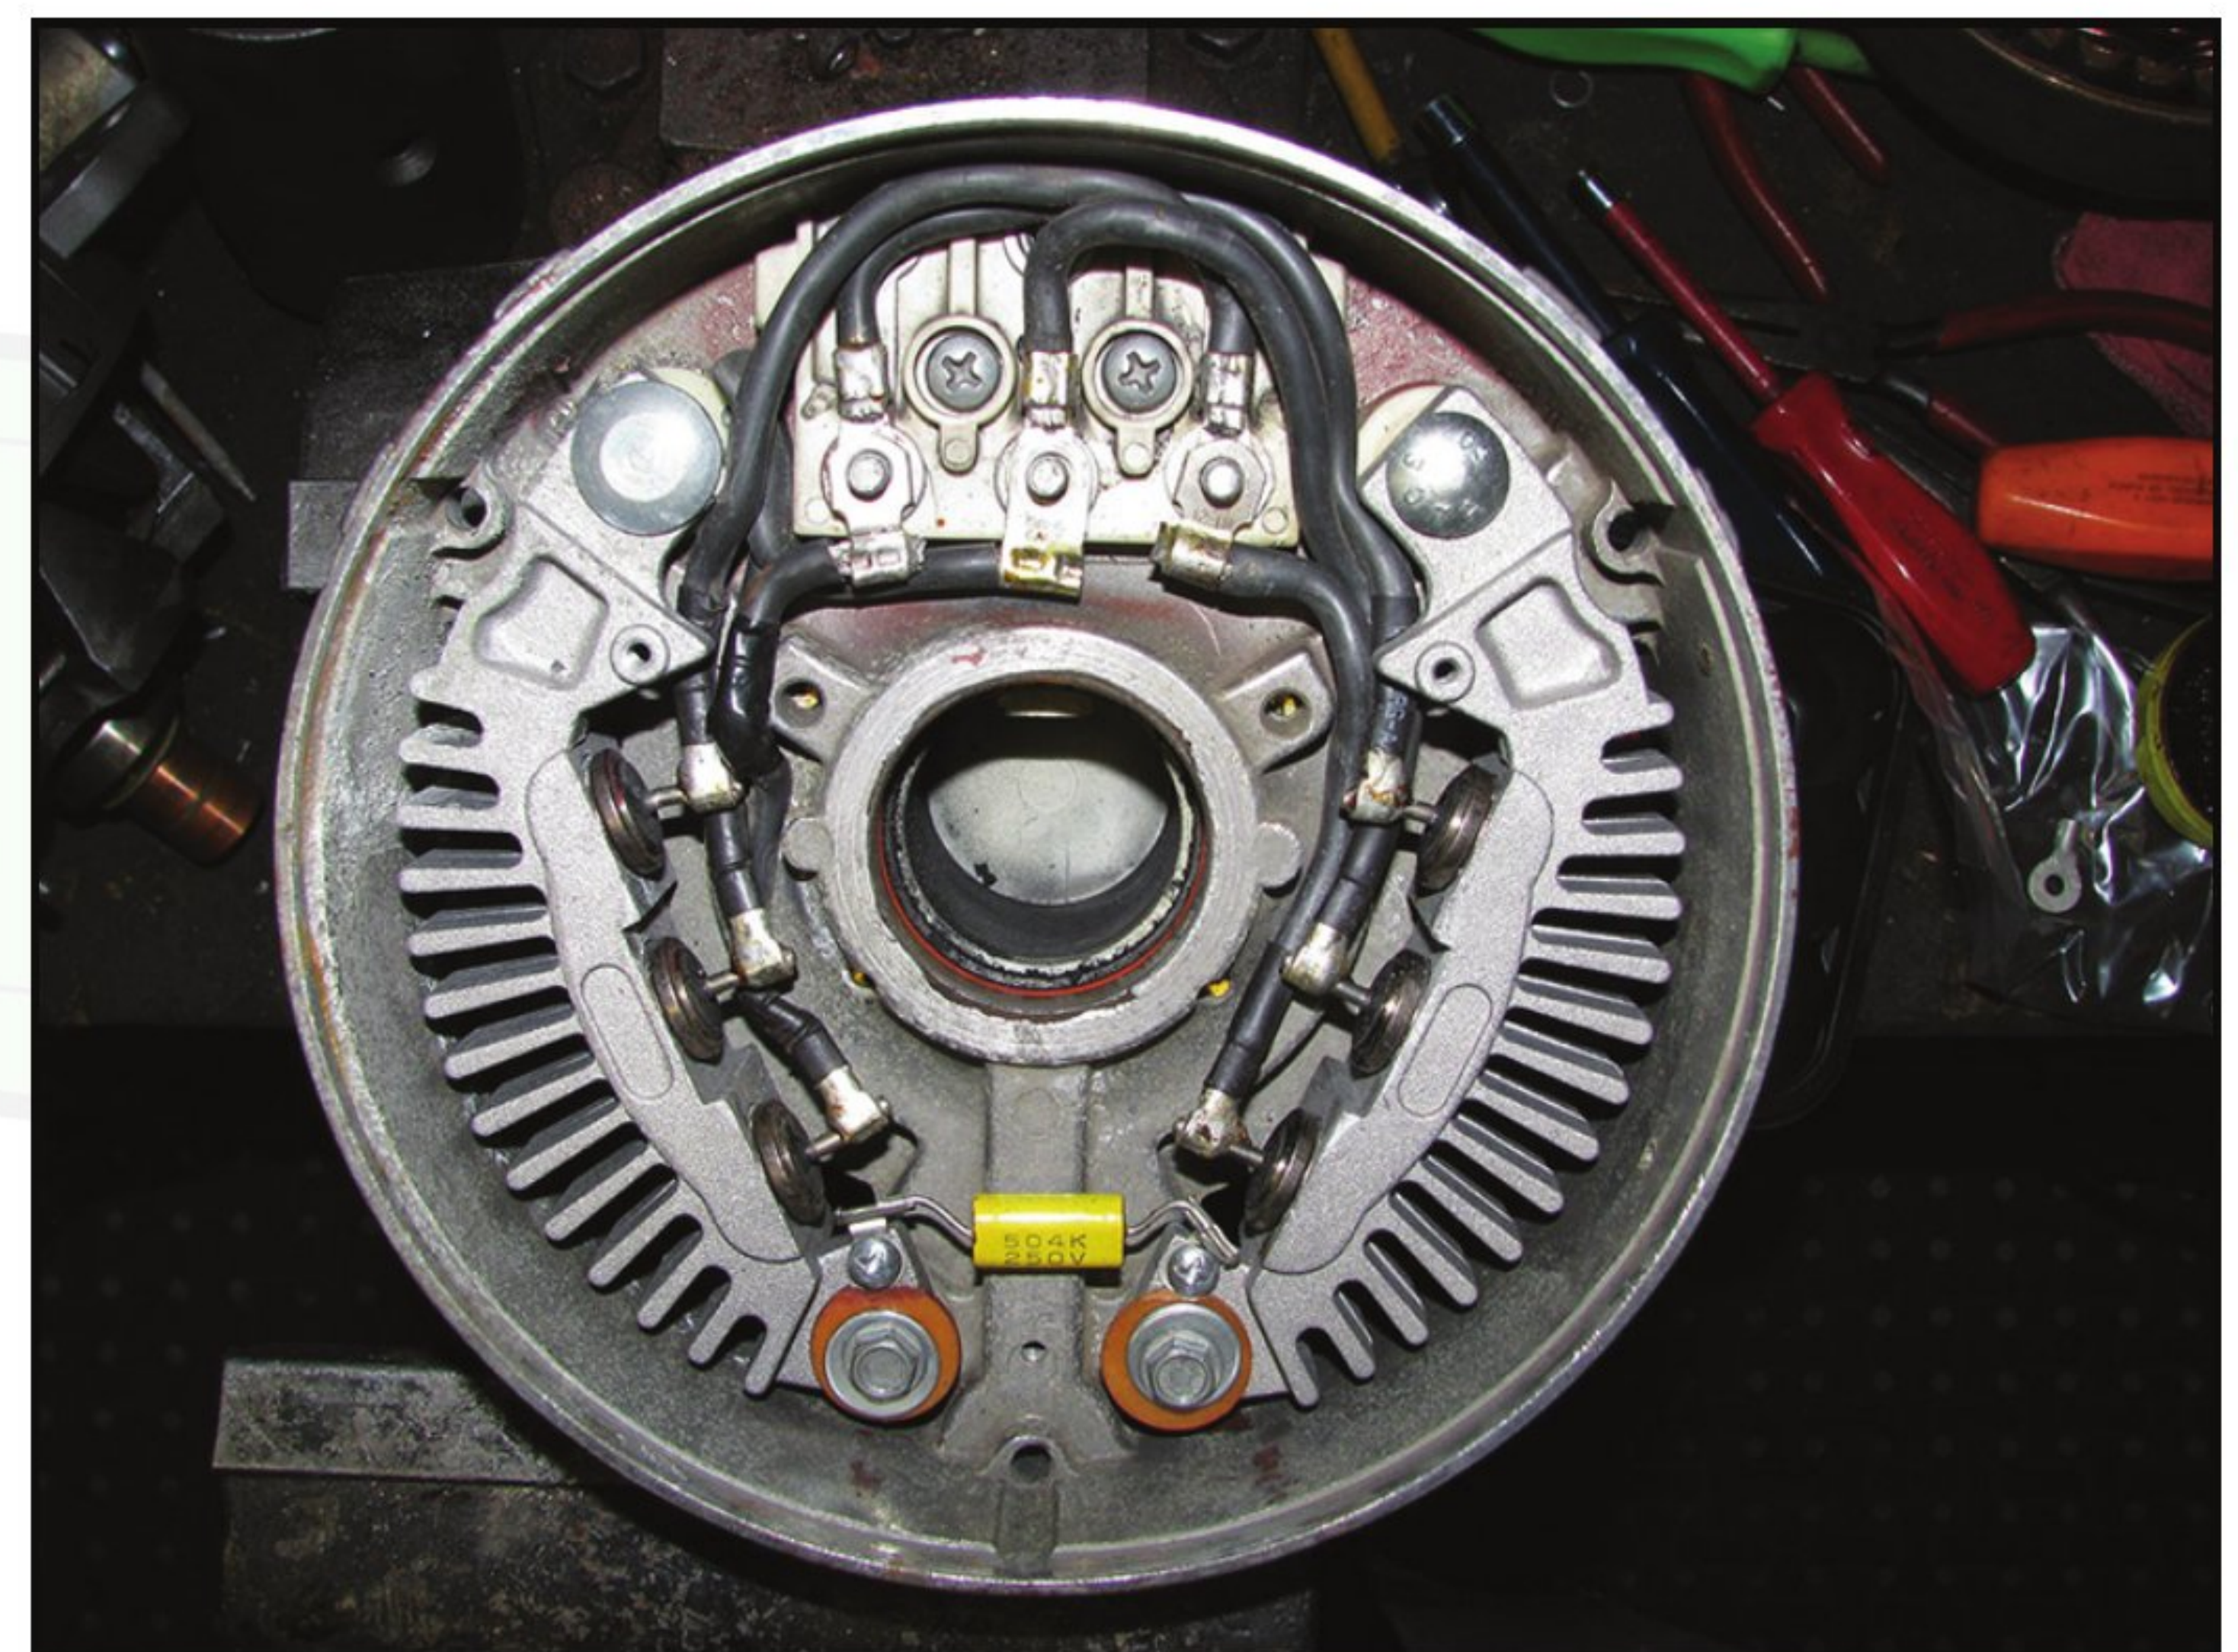
*Figure 1 – This photo shows the Leece Neville slip ring end housing assembly once the repairs were made.*

what bothers me most is that it was tested at least three times, once by the remanufacturer and twice by the local shop. It was passed as being OK three times. Here is one more hint for you (see Figure 1). That photo was taken after the repair was made.

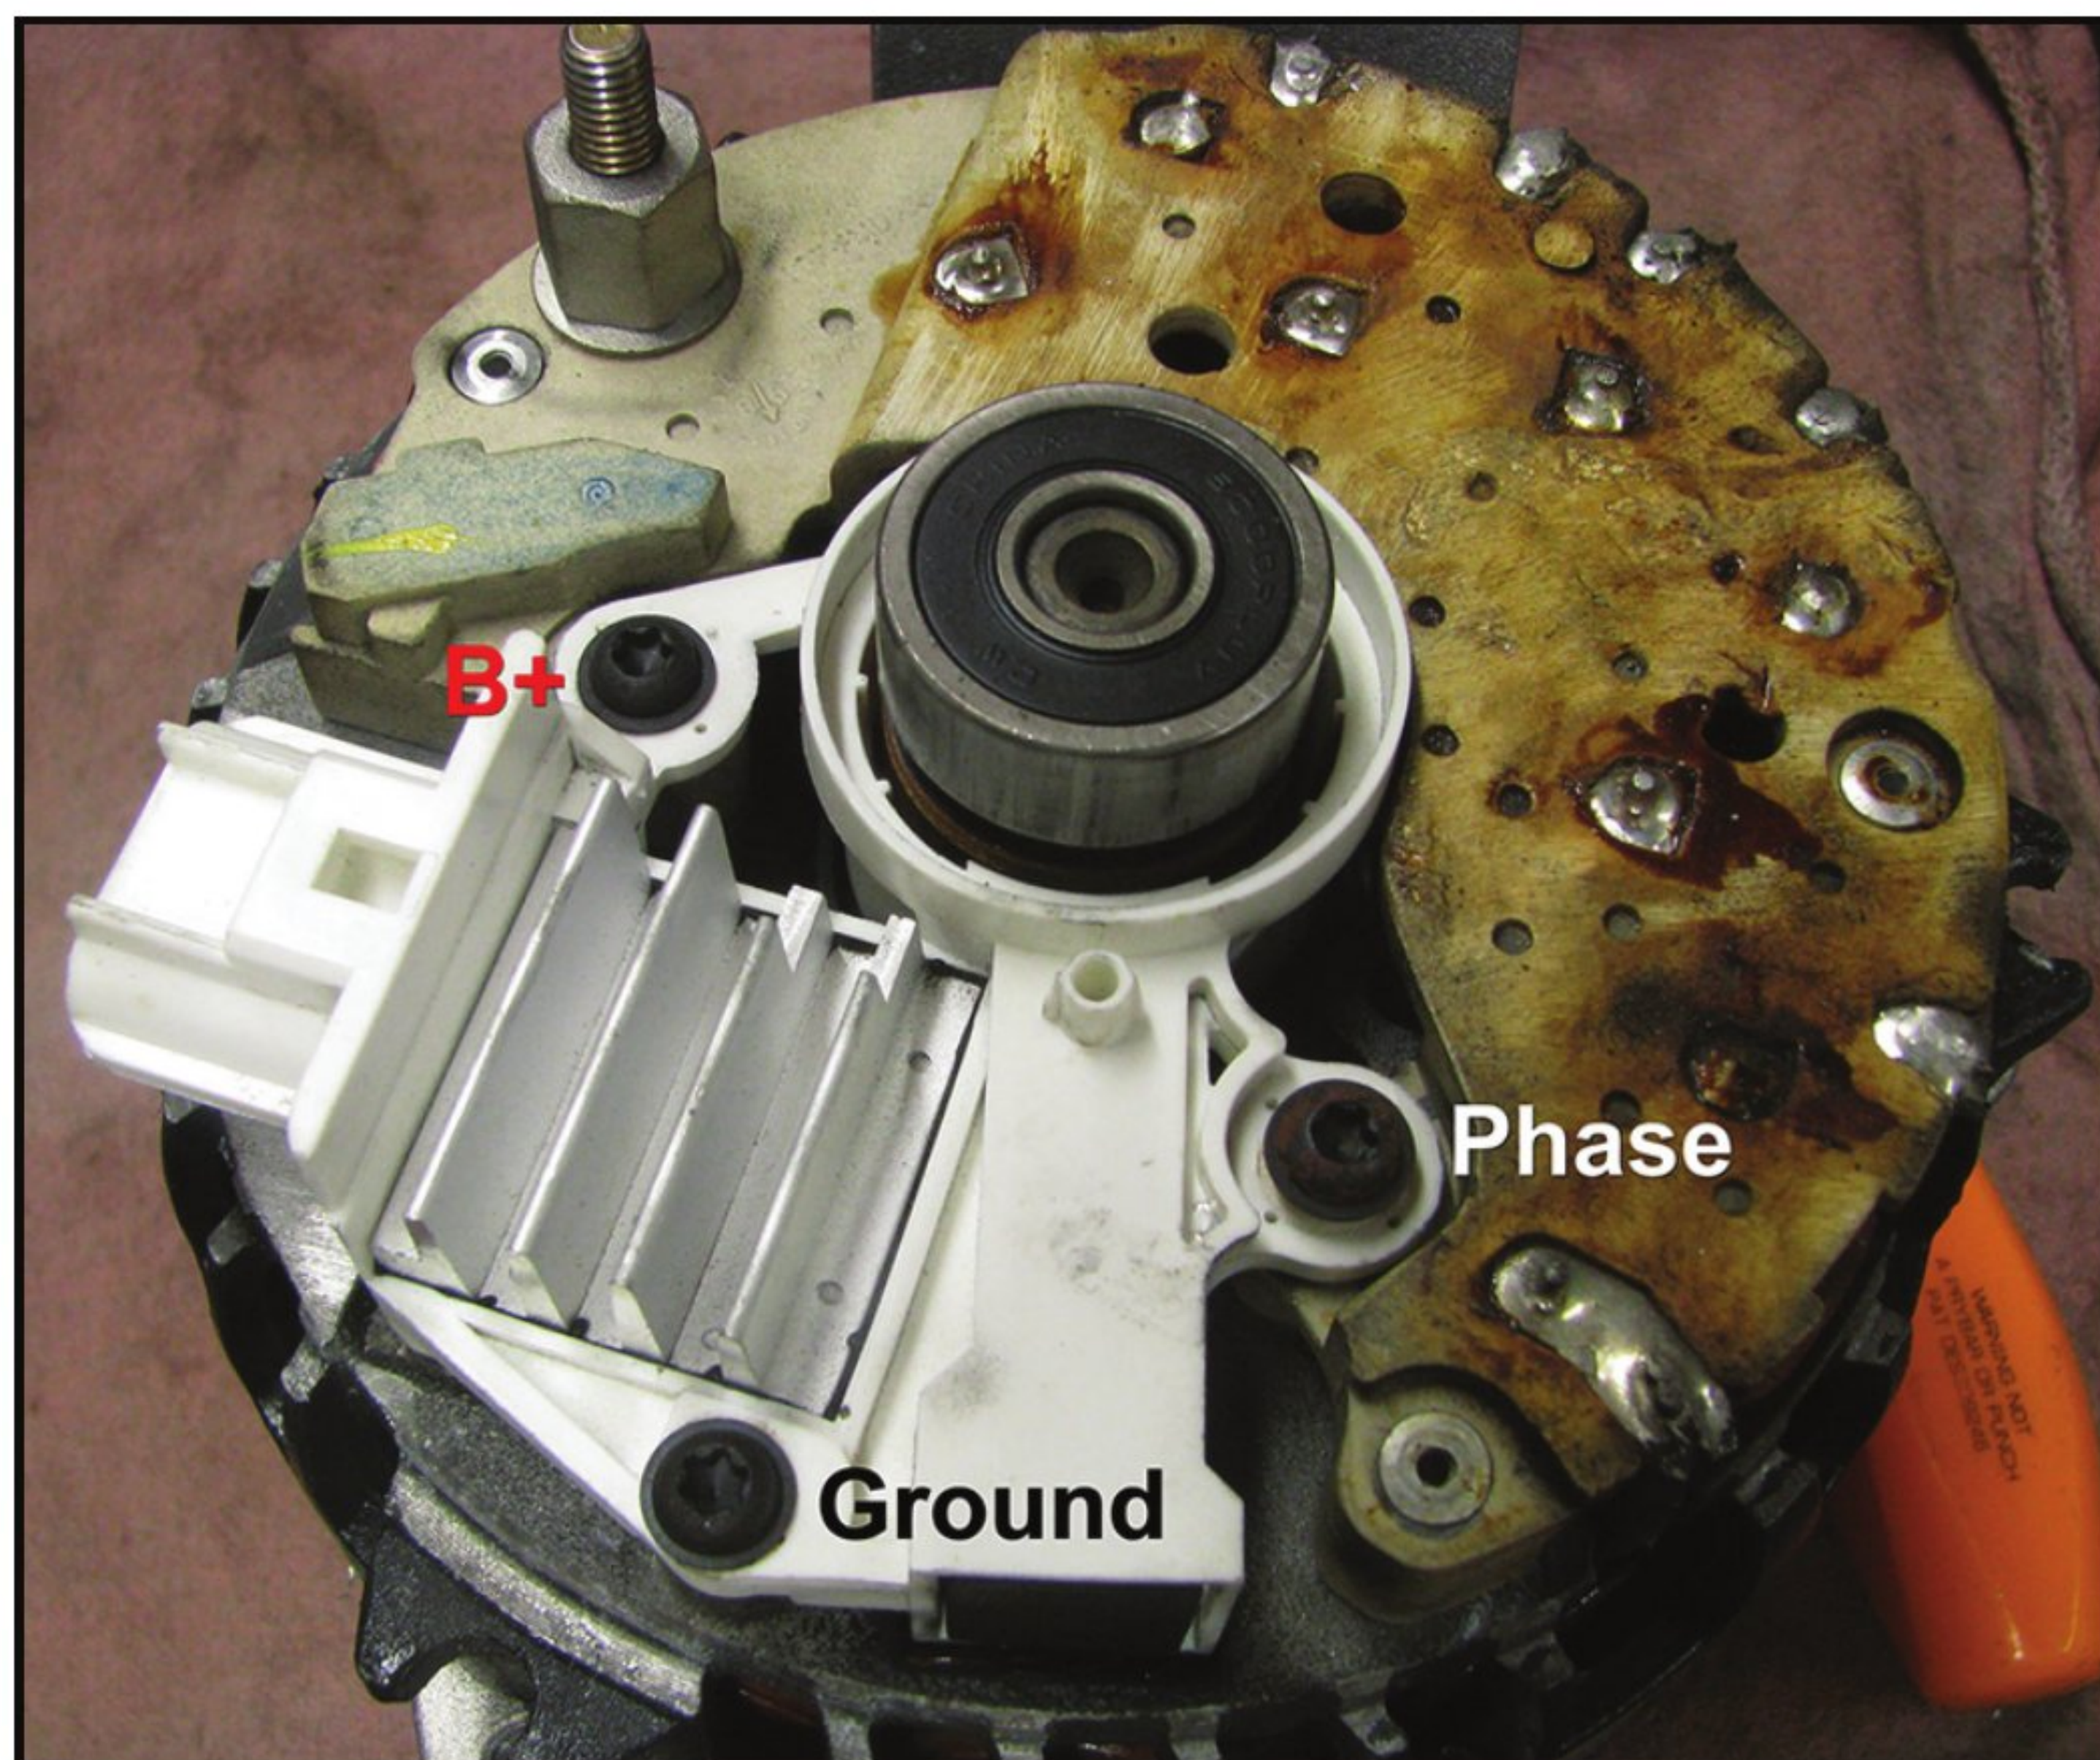
The question was now coming down down to finding the cause. Unlike the tech, I never suspected the regulator although I knew that anything was indeed possible. As you know, Ford's 6G regulator is attached to the rectifier with three 4mm torx-head screws (see Figure 2). One of them is regulator ground. Another is regulator B+ and the third is the phase (stator output) connection. The topic of these screws becoming loose has been covered previously in print publications, the ERA Website Forums and several seminars. But evidently it is still a problem. The ground screw in particular can become

Figure 2 – This is the remanufactured Ford 6G with the rear housing removed. It was on the Focus one week.

Once inside, I found several problems that included a loose ground. For the record, this alternator was on the car for just one week before being brought back by the owner.

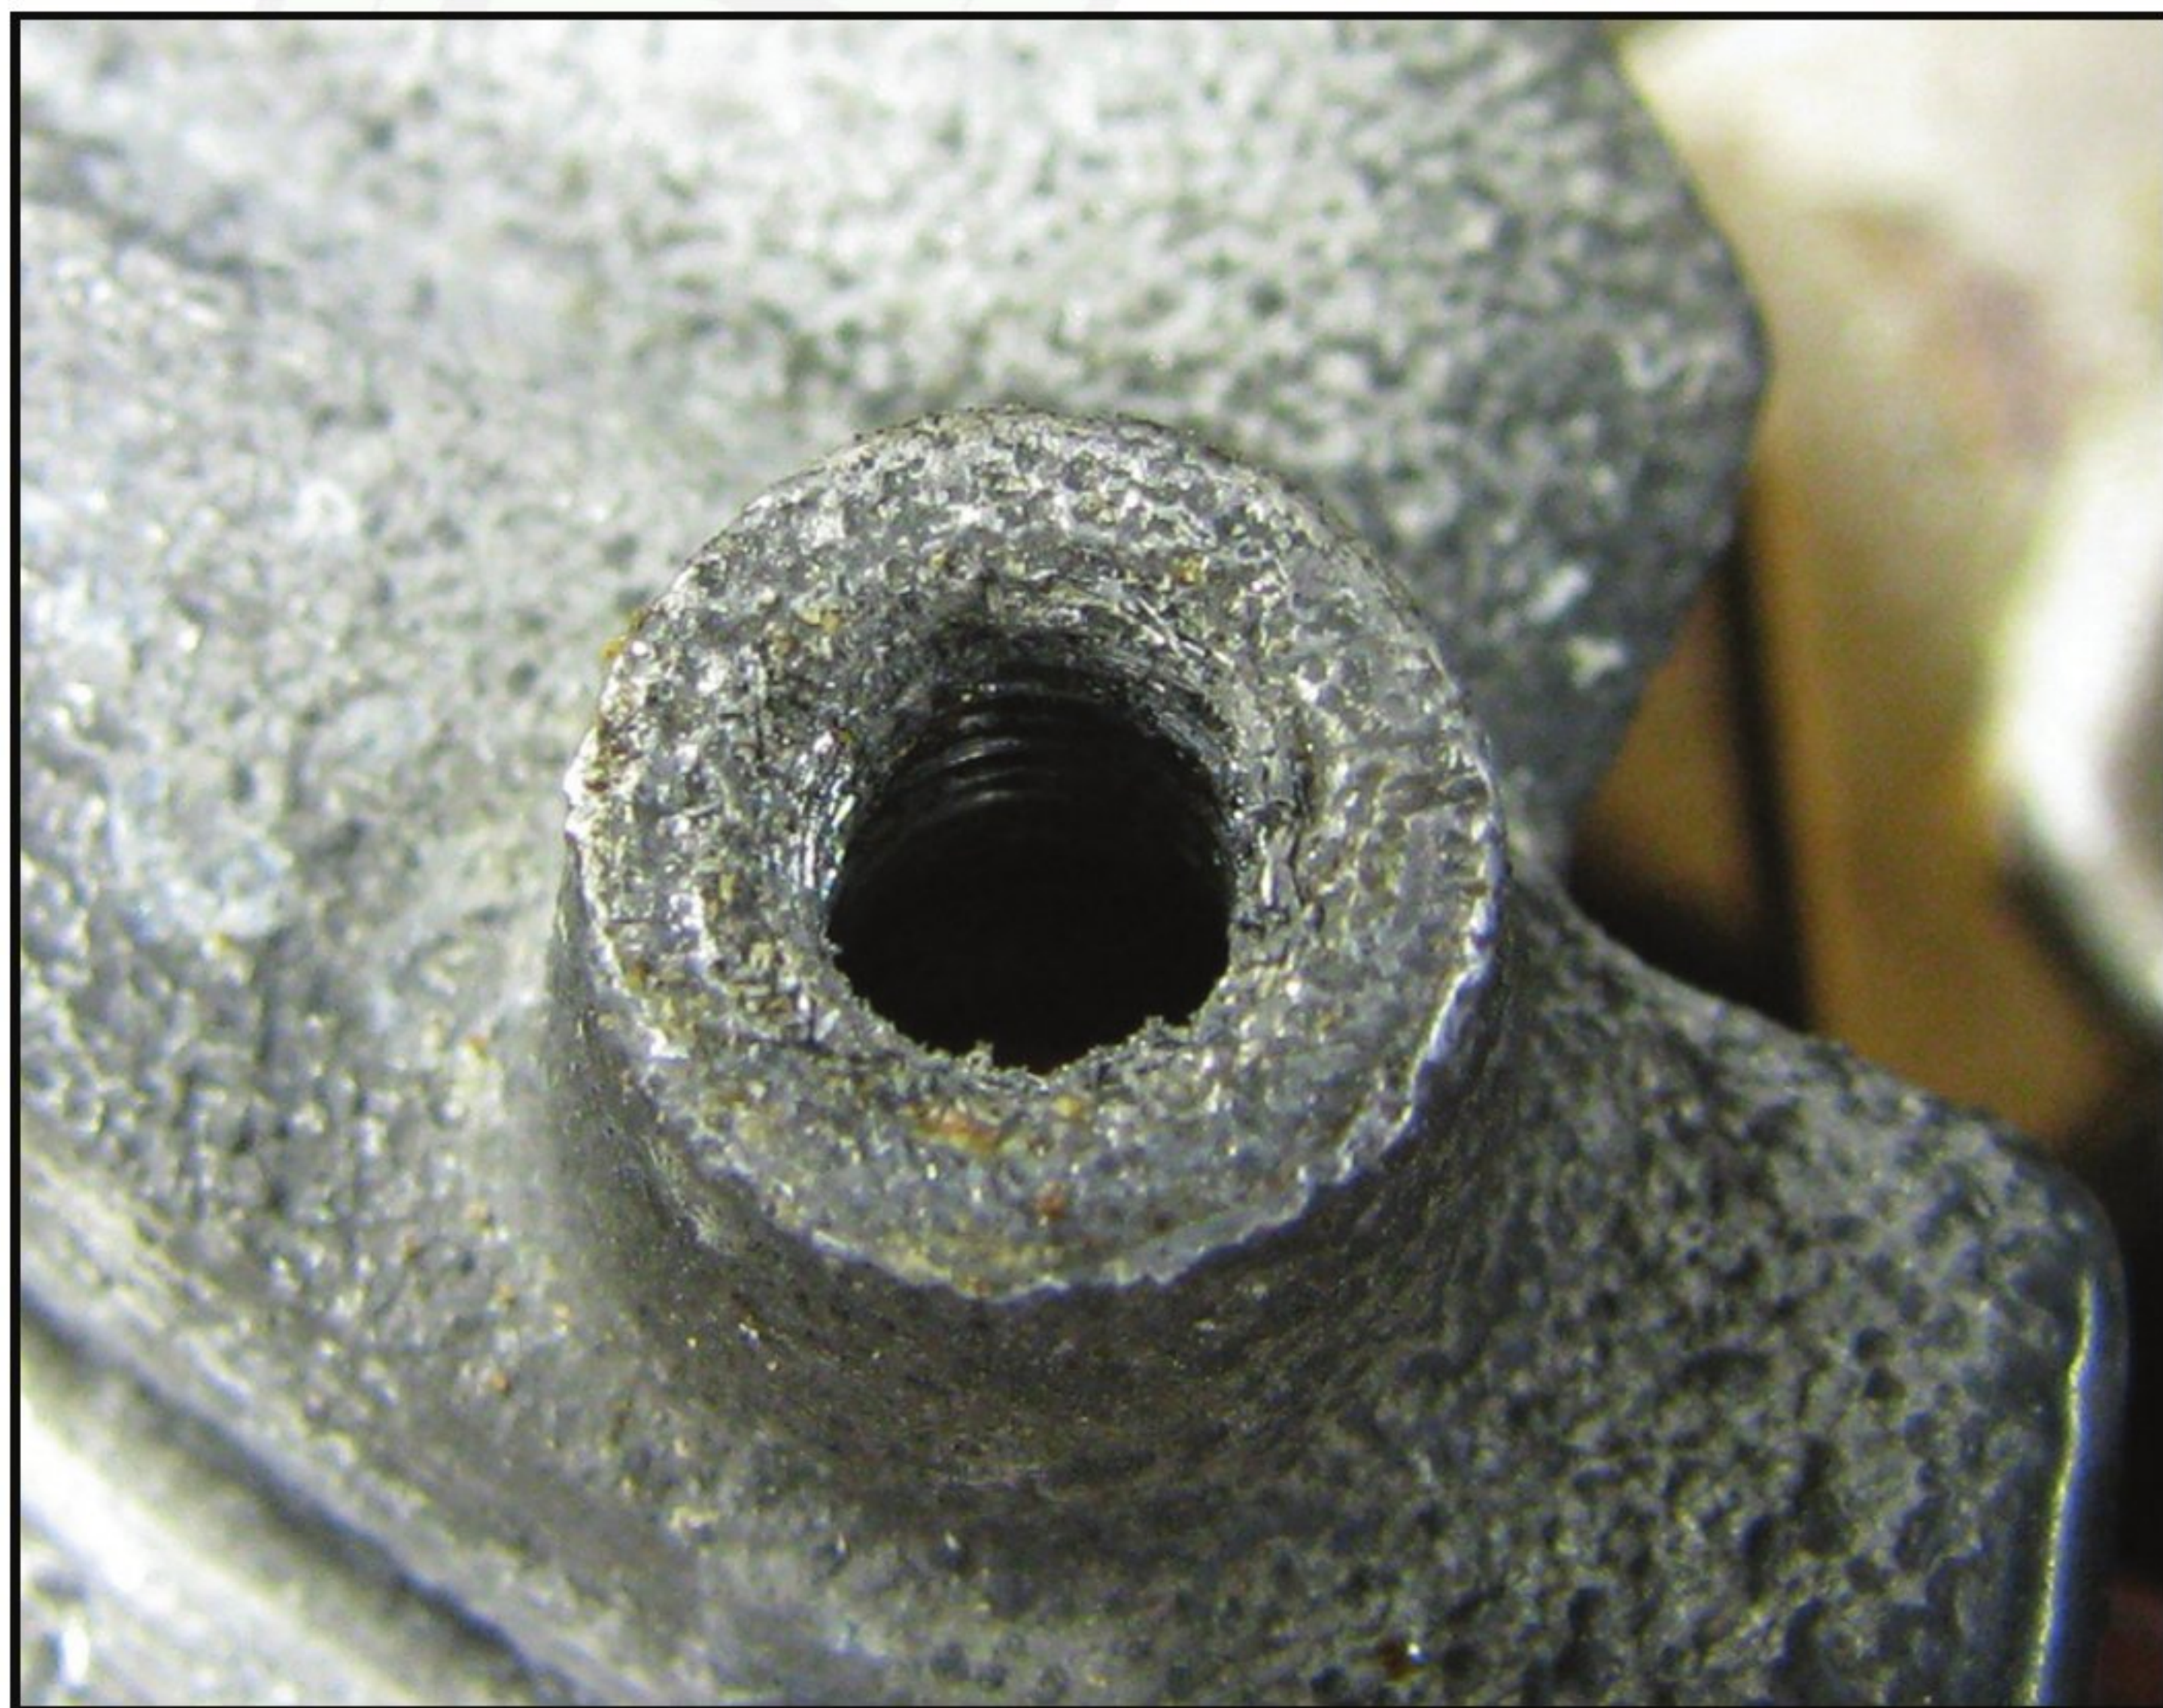
Figure 3 – This is a close up photo of the pitting on the surface of the regulator's ground side mounting post.

The first thing that I noticed was that the reclaimed rectifier was dirty and pitted. Though not the cause of the pulsing voltage, this short cut did reflect back on the quality control of the remanufacturer. When removing the regulator hold-down screws I noticed that the ground was loose and B+ was not as tight as it should have been either. Once the regulator was out of the way, I took a close look at the regulator's ground pad on the rectifier (see Figure 3). Obviously, this level of pitting took a lot longer than a week to develop. A close look at the regulator's

The sad fact here is that this rectifier was fully functional and could have been reclaimed successfully with a proper cleaning and resurfacing of the regulator's ground pad. While I can excuse the parts store for not operating this alternator under load long enough to get the problem to arise, I would be embarrassed if this alternator had been a product of my business.

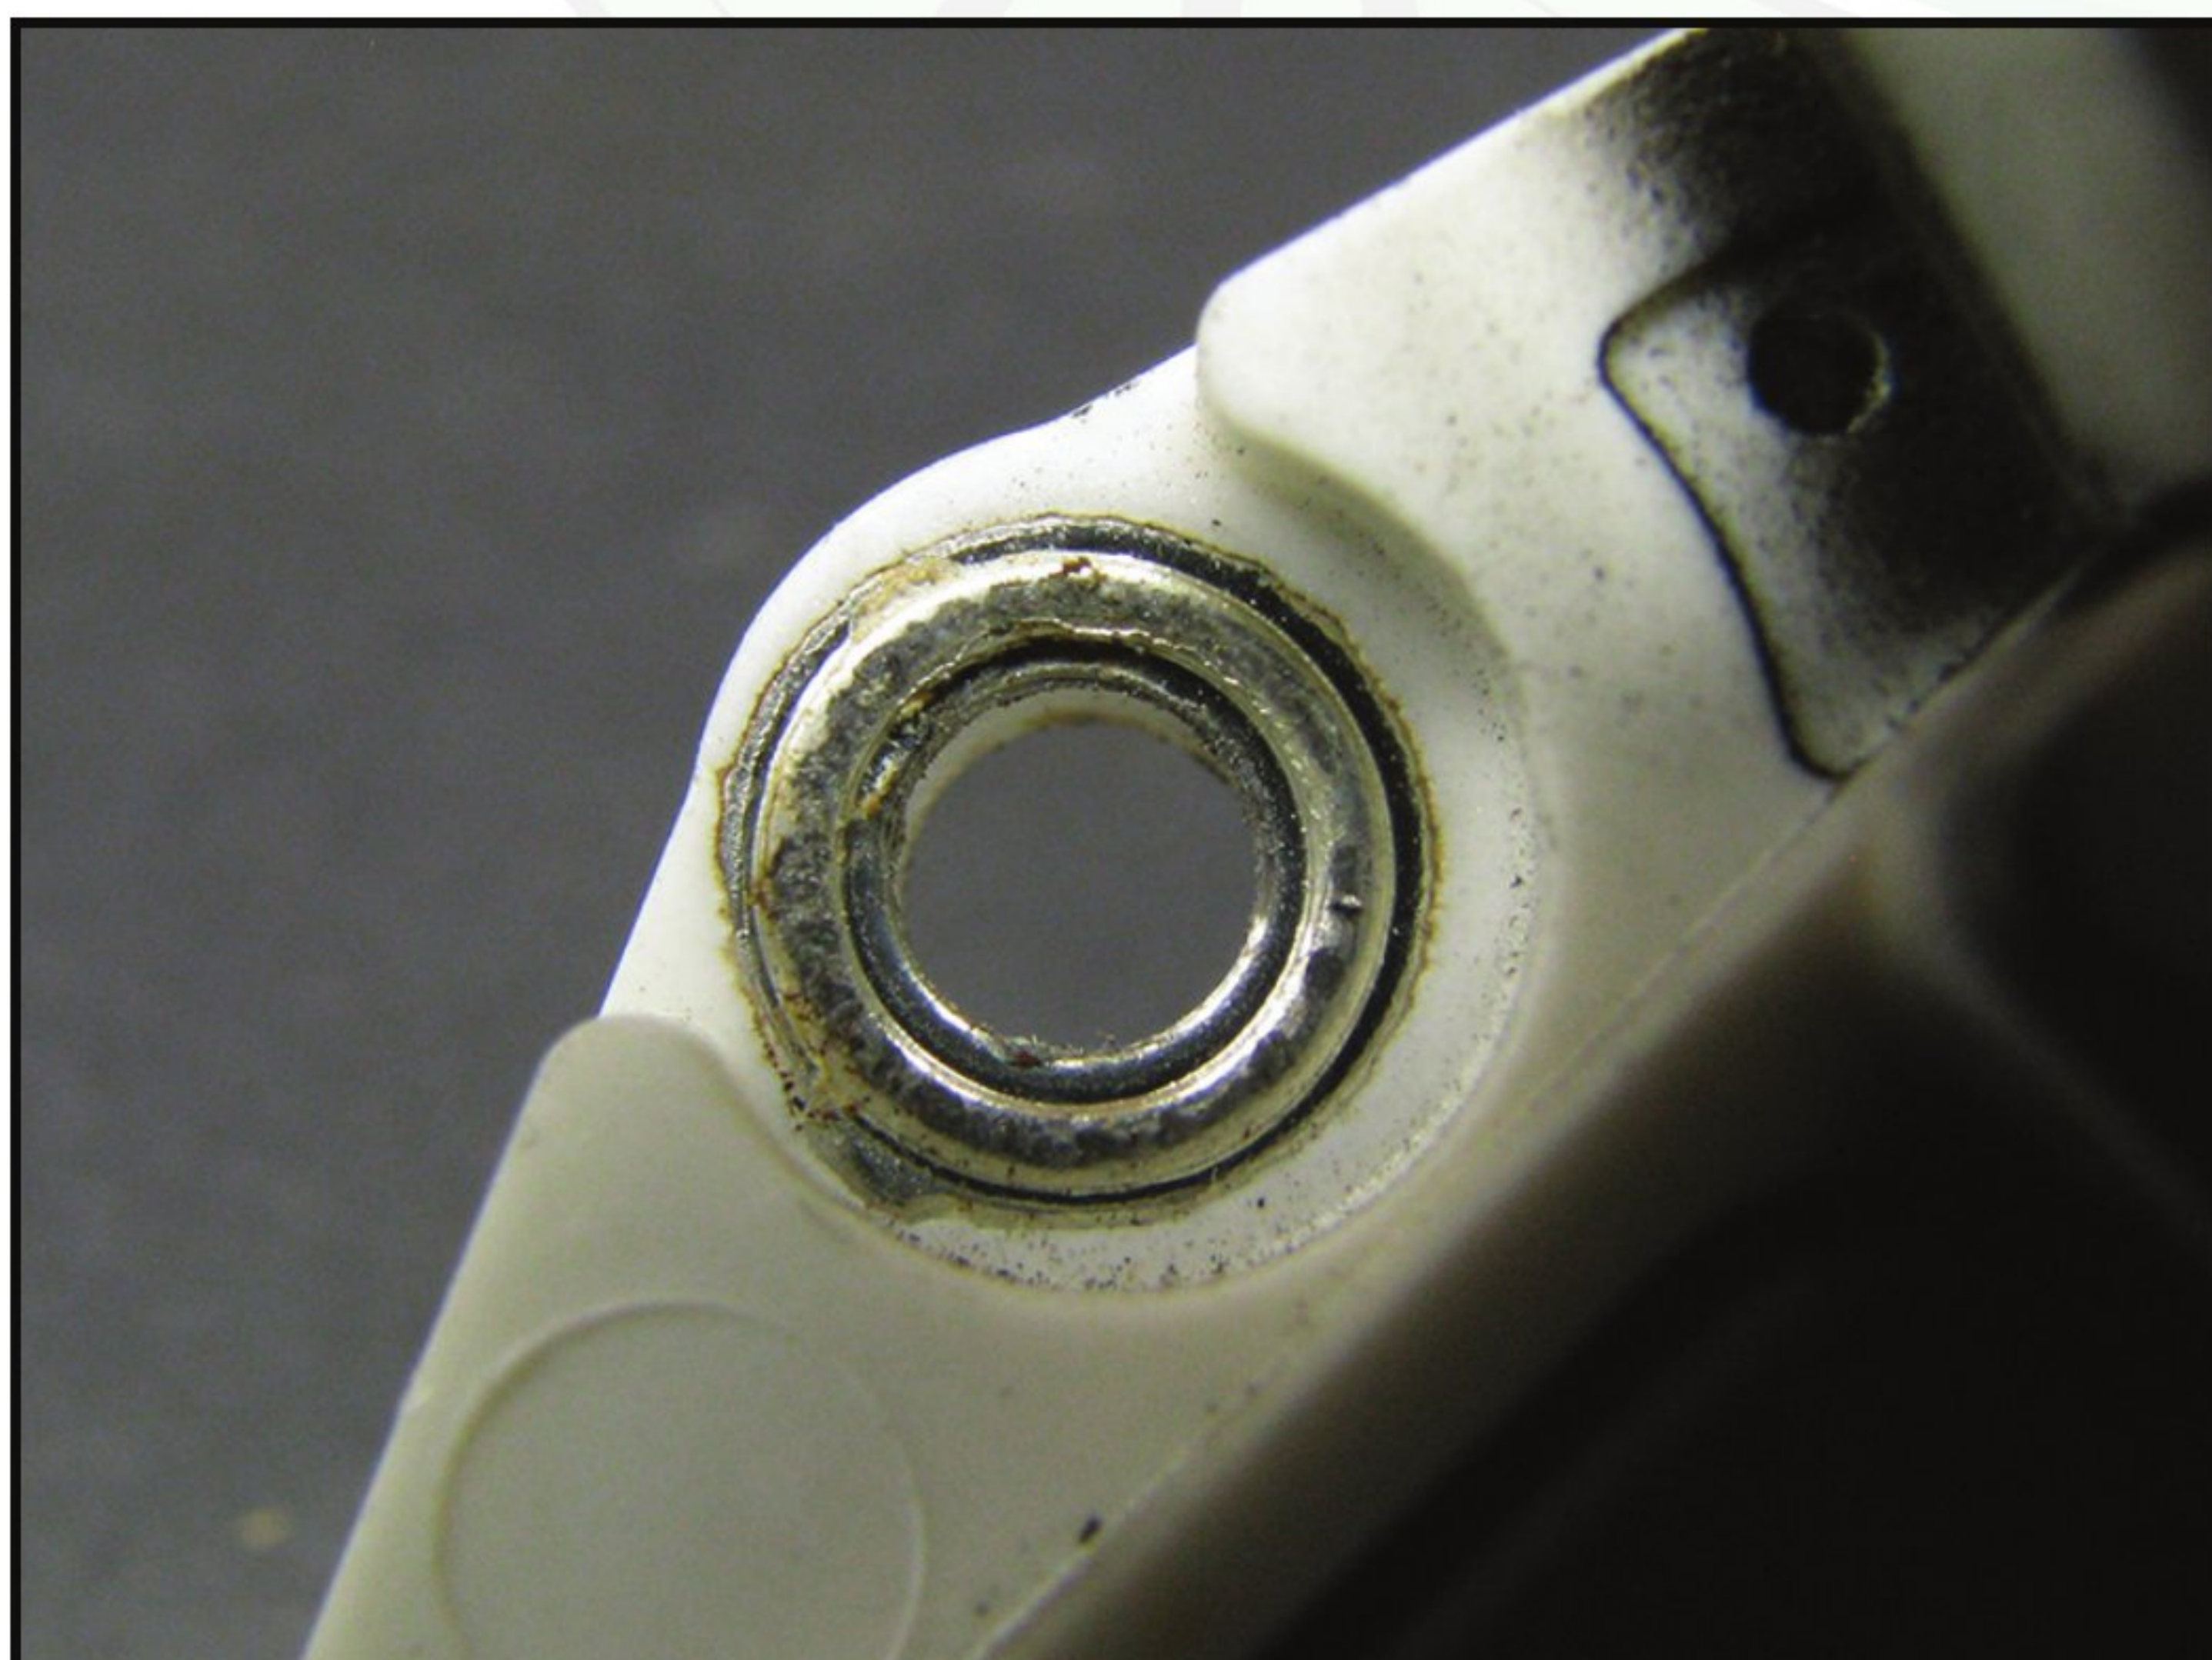
Figure 4 – Here you can clearly see arcing on the regulator's ground tab, caused by a loose mounting screw.

loose or the plastic regulator housing may relax enough under high heat to allow it to become loose. Since this is an A-circuit regulator, that ground connection must carry the full load of the rotor. So under full electrical load at low speed in particular, you are talking about passing 6 to 8 amps through a loose ground.

This regulator also depends upon that ground to sense output voltage directly from the rectifier. So resistance on that ground connection under load will fool the regulator into sensing voltage that is lower than the rectifier's actual output voltage. When that happens, the regulator will compensate, which results in momentary overcharging. Once the regulator eventually senses the target voltage it cuts back, which cause voltage to drop and the cycle starts all over again. What led me to suspect that? It was overcharging once the pulsing started, even at the low point of the cycle.

ground tab revealed some arcing had been taking place at that connection (see Figure 4). While the loose ground screw was the primary cause of the customer's complaint, the pitted ground pad on the rectifier invited further corrosion that would have occurred eventually, even if the screws had been tightened properly.

A few simple lessons can be learned from all of this. Do not take shortcuts when reclaiming good used parts. Clean and tighten all electrical connections using dielectric grease to block out air and moisture. And when bench testing an alternator that is being returned, allow enough time. Test it long and hard enough to insure that no connection points are breaking down under loads. Keep in mind that good regulators can be tricked into doing bad things and most important of all - we all make mistakes.

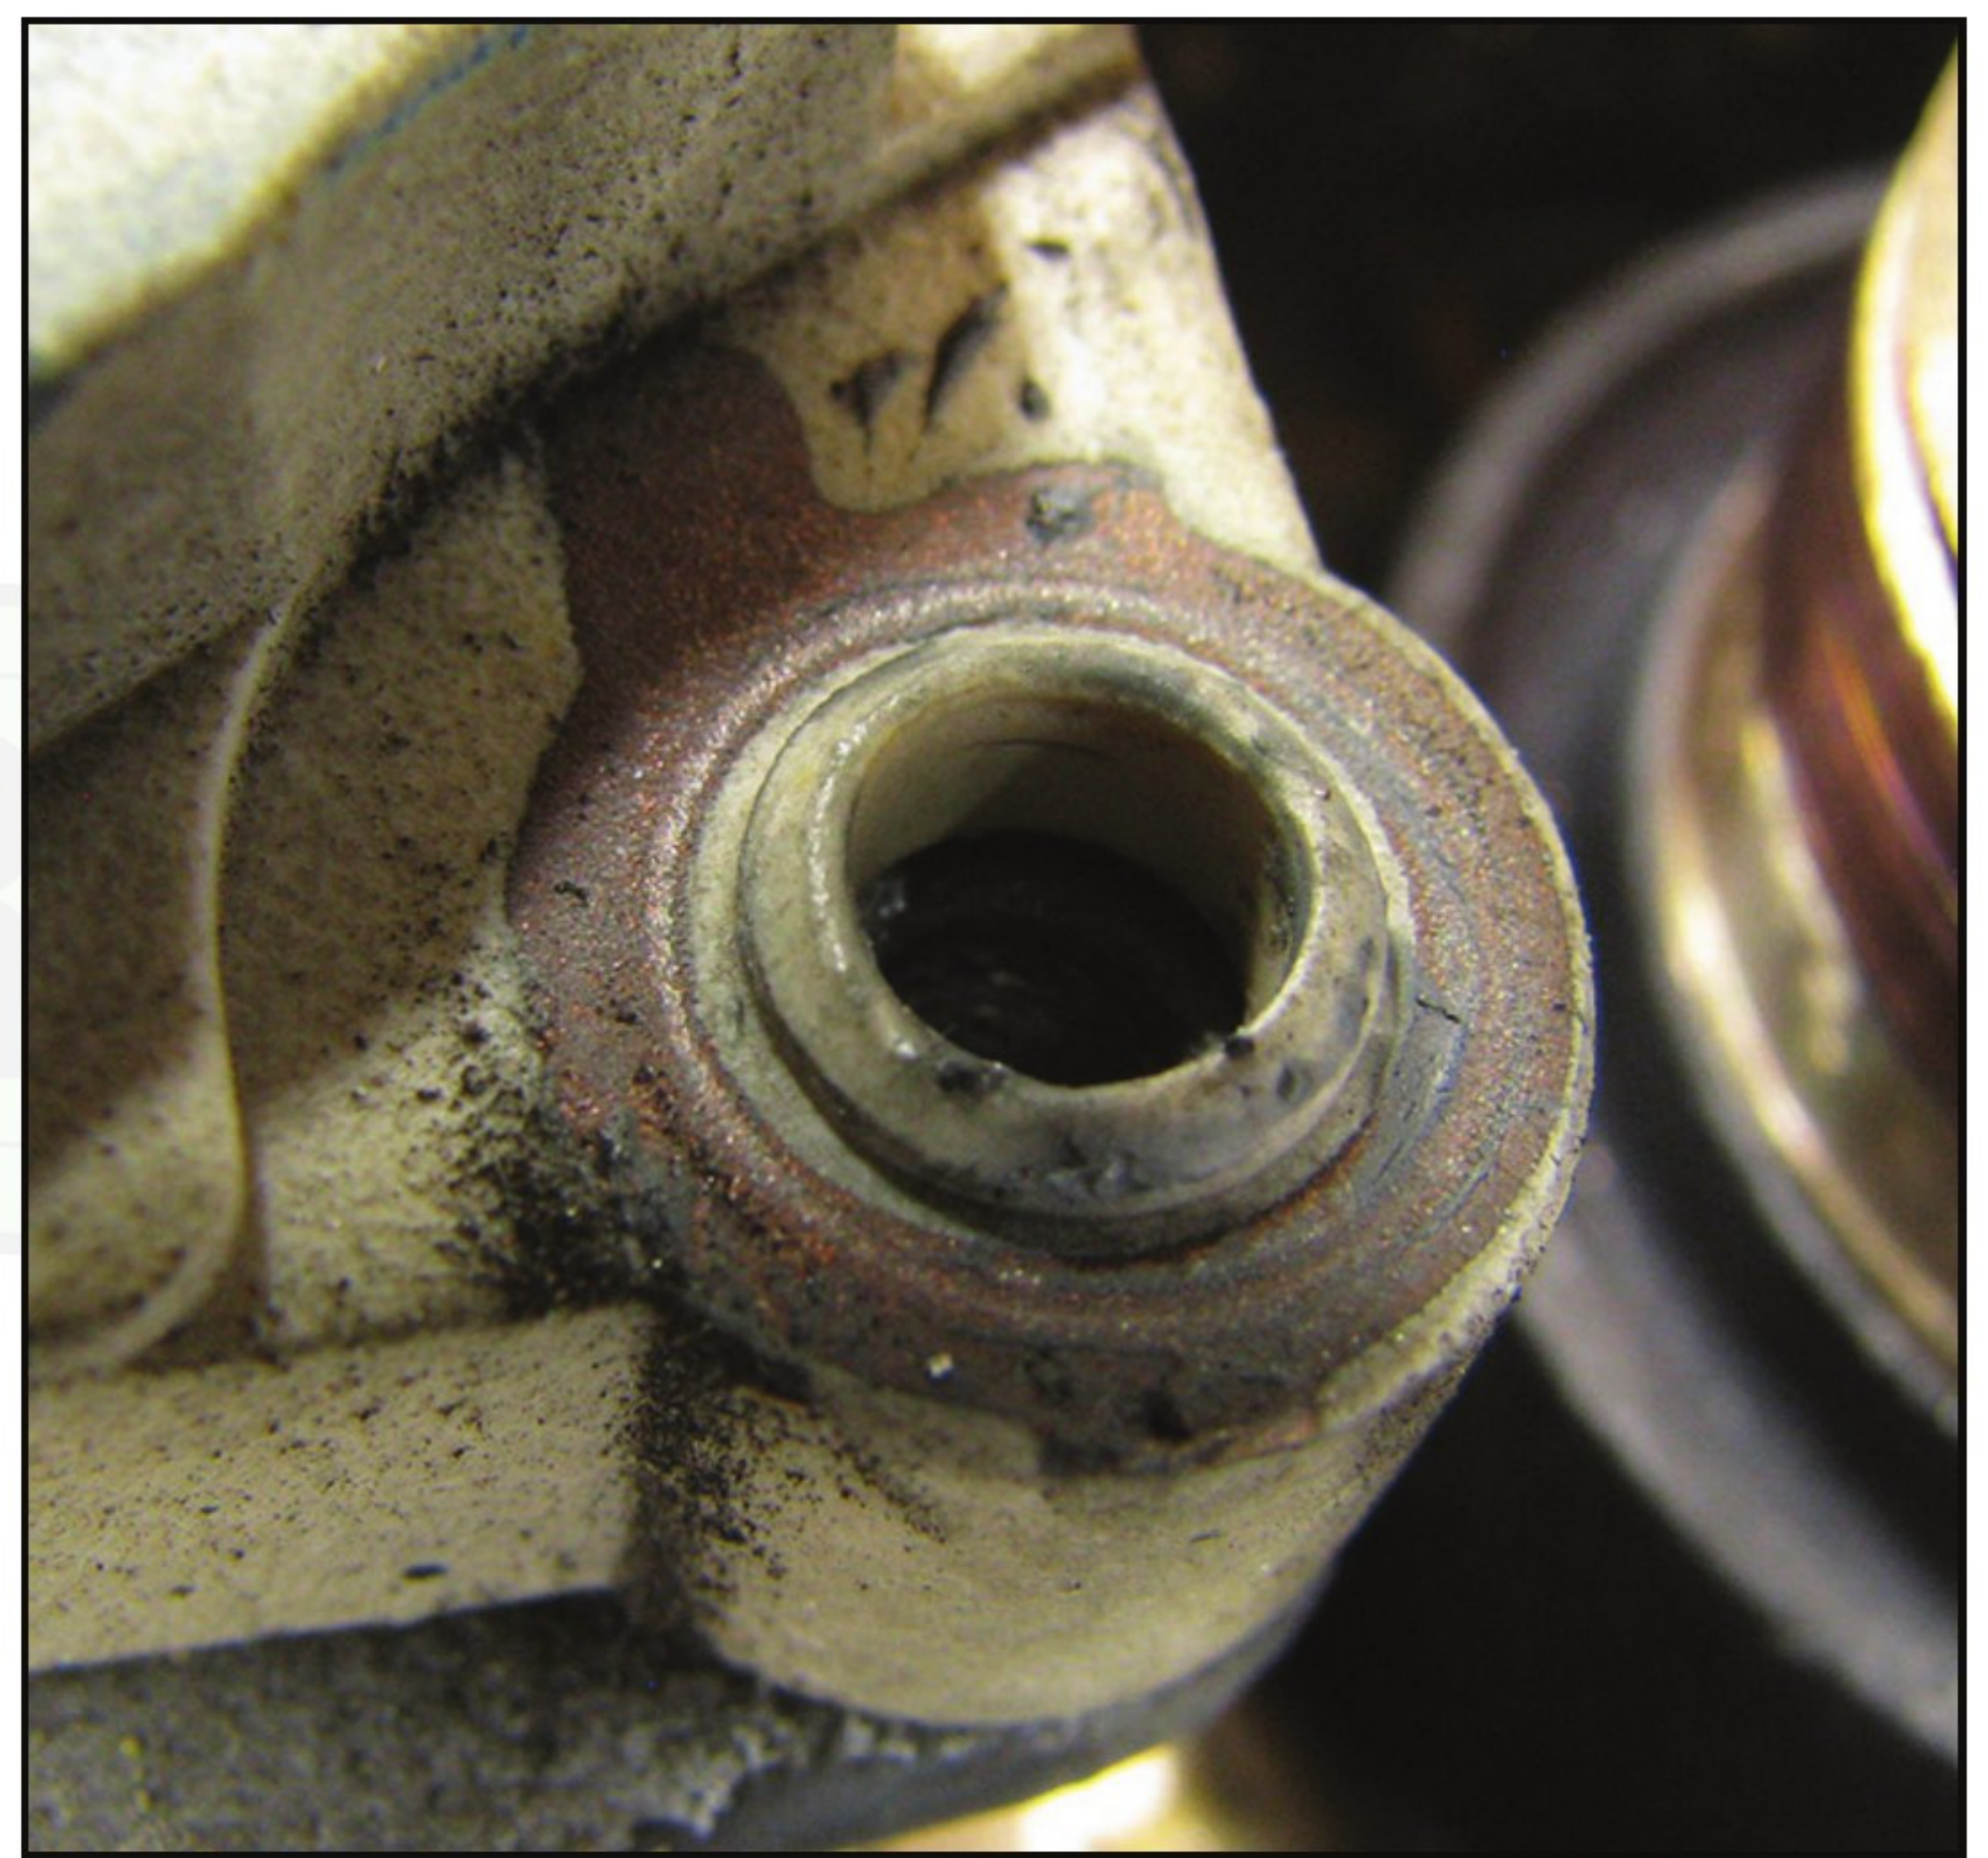
Figure 5 – The corrosion on the regulator's B+ contact on the rectifier indicates that it was never cleaned properly.

Upon checking the B+ pad on the rectifier (see Figure 5), I noticed that it too was corroded, so much so that it was likely never cleaned at all. There was dirt and corrosion debris on the new regulator's B+ tab (see Figure 6), although there were no signs of arcing there. This B+ connection on a 6G is the source of field current, so it too must also be capable of carrying that 6 to 8 amps of potential rotor current.
