# “STUFF” HAPPENS

## True Quality Takes Time

BY BOB THOMAS

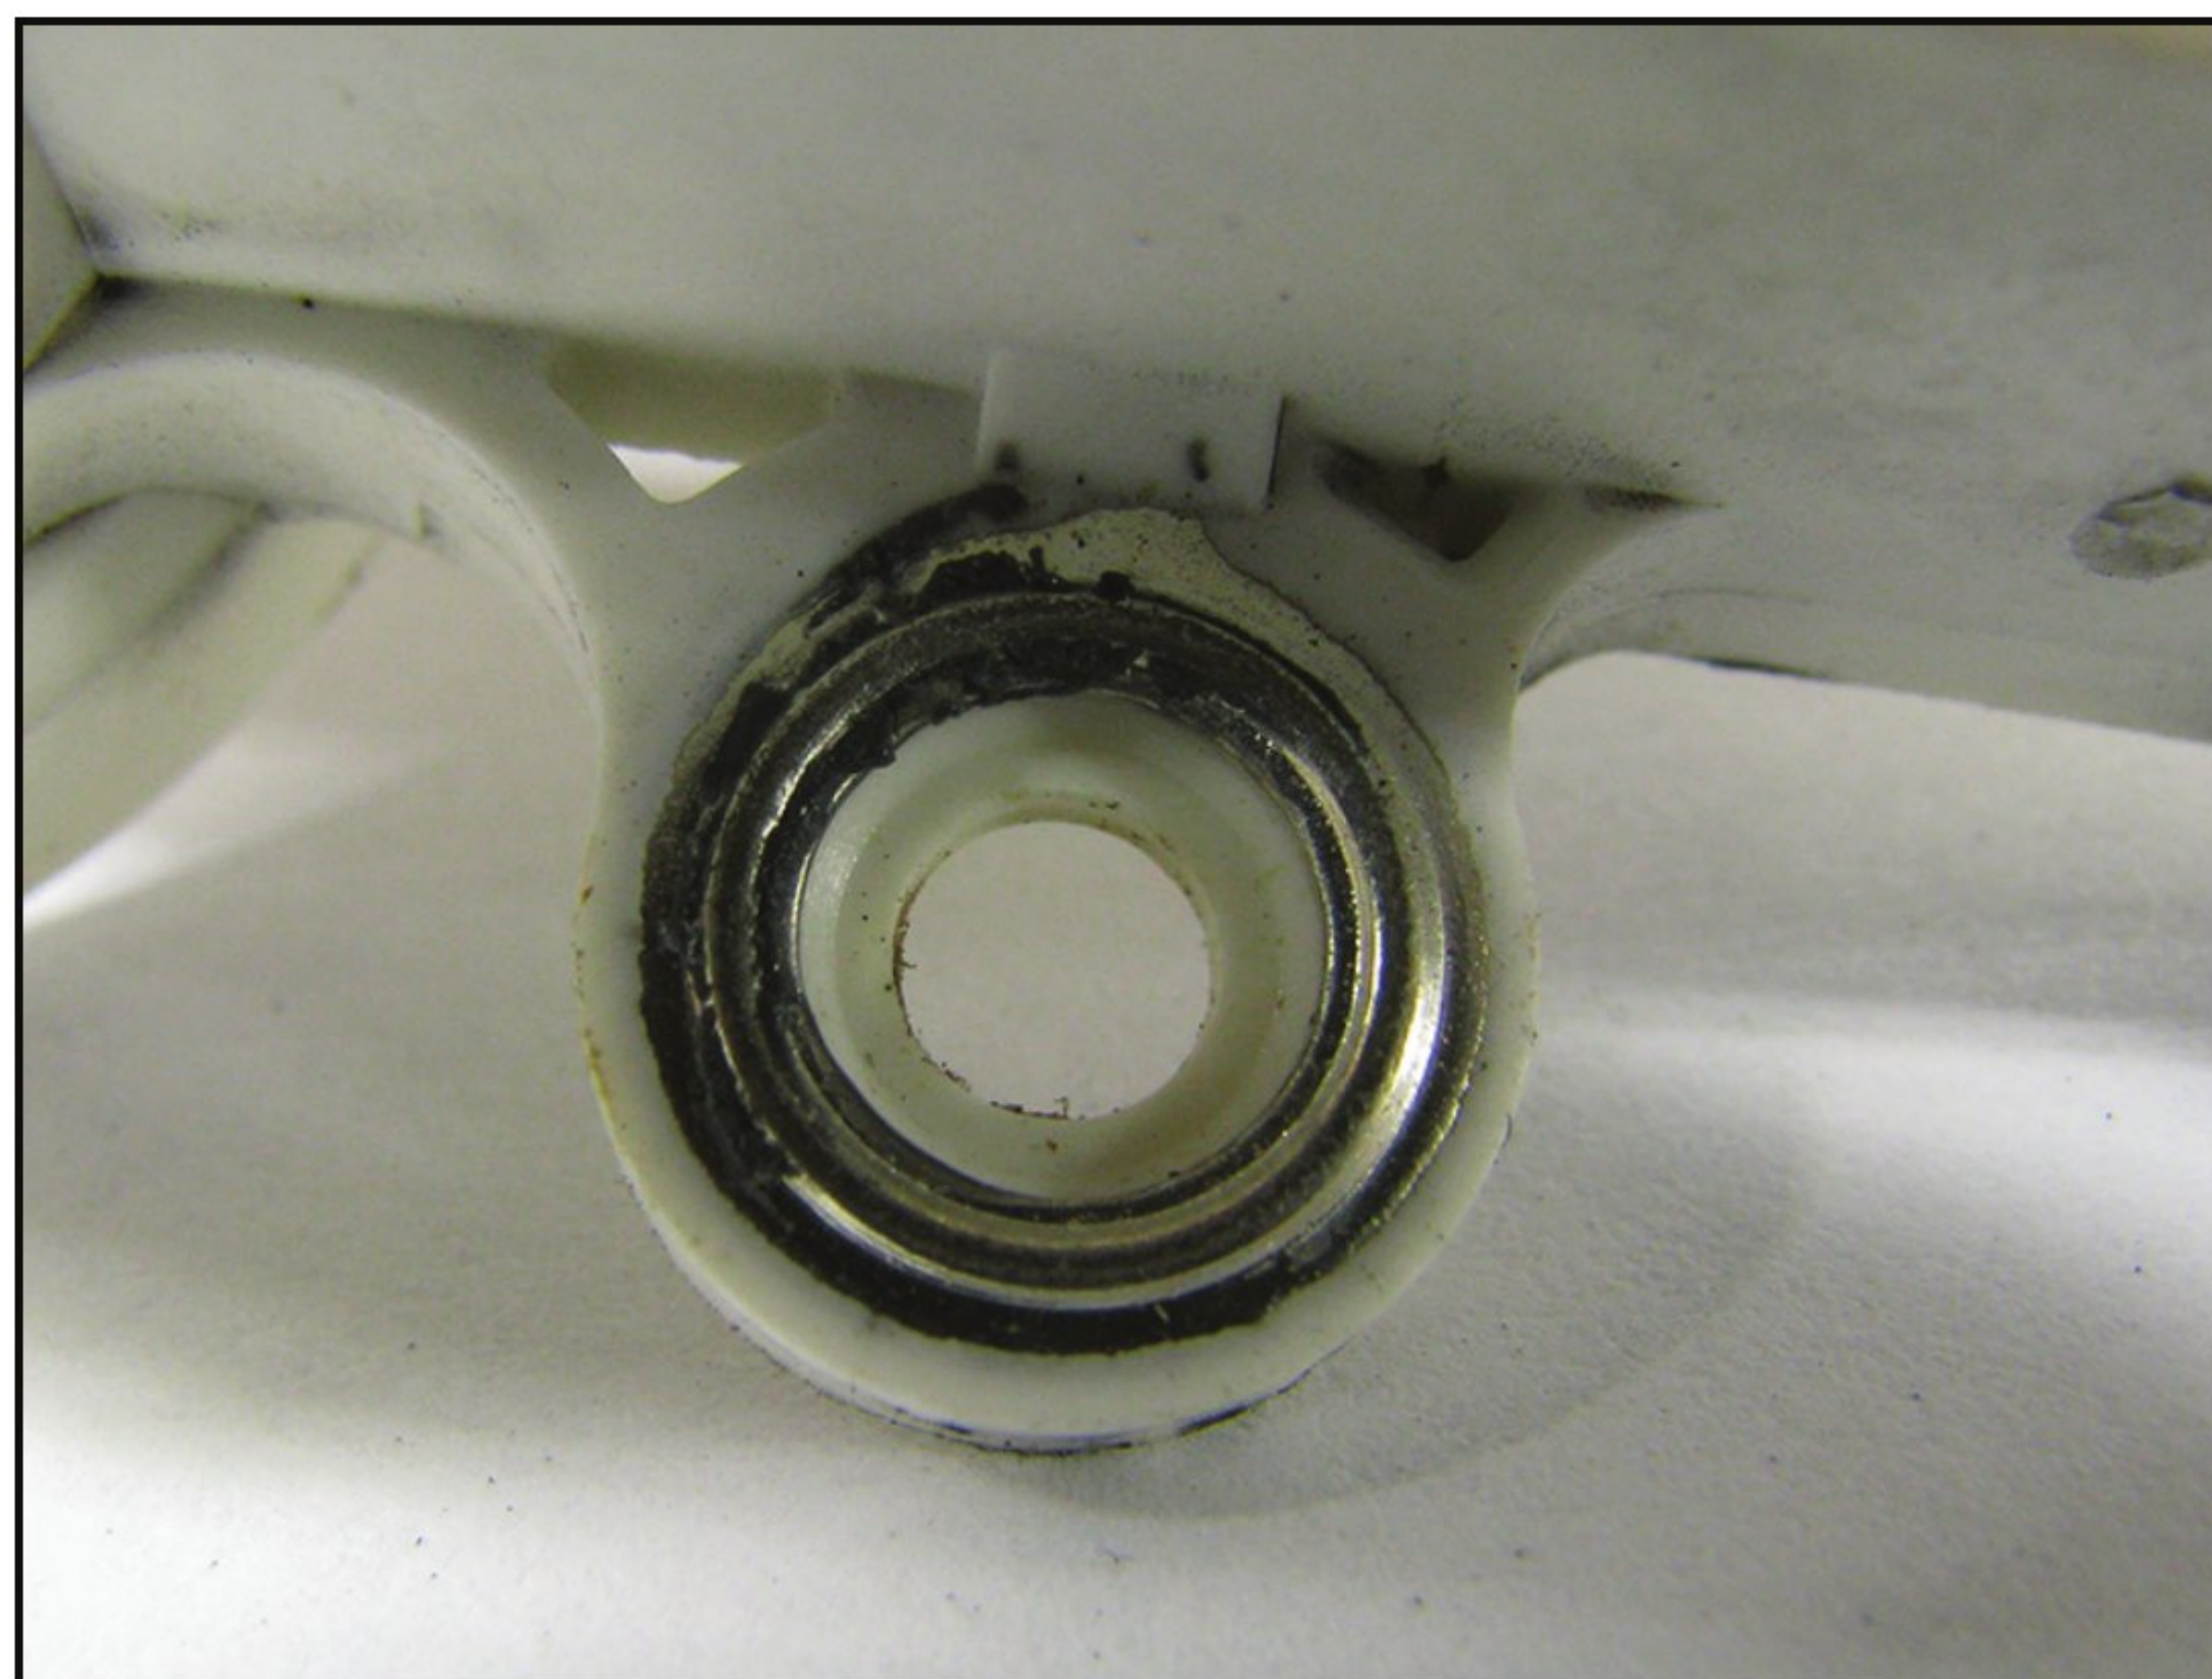
*Figure 6 – Here you can see residue from the rectifier contact on the regulator's B+ tab. Note that there are no signs of arcing.*

Upon checking the B+ pad on the rectifier (see Figure 5), I noticed that it too was corroded, so much so that it was likely never cleaned at all. There was dirt and corrosion debris on the new regulator's B+ tab (see Figure 6), although there were no signs of arcing there. This B+ connection on a 6G is the source of field current, so it too must also be capable of carrying that 6 to 8 amps of potential rotor current.
