# THE GHOST STARTER

BY NATHAN UNGER

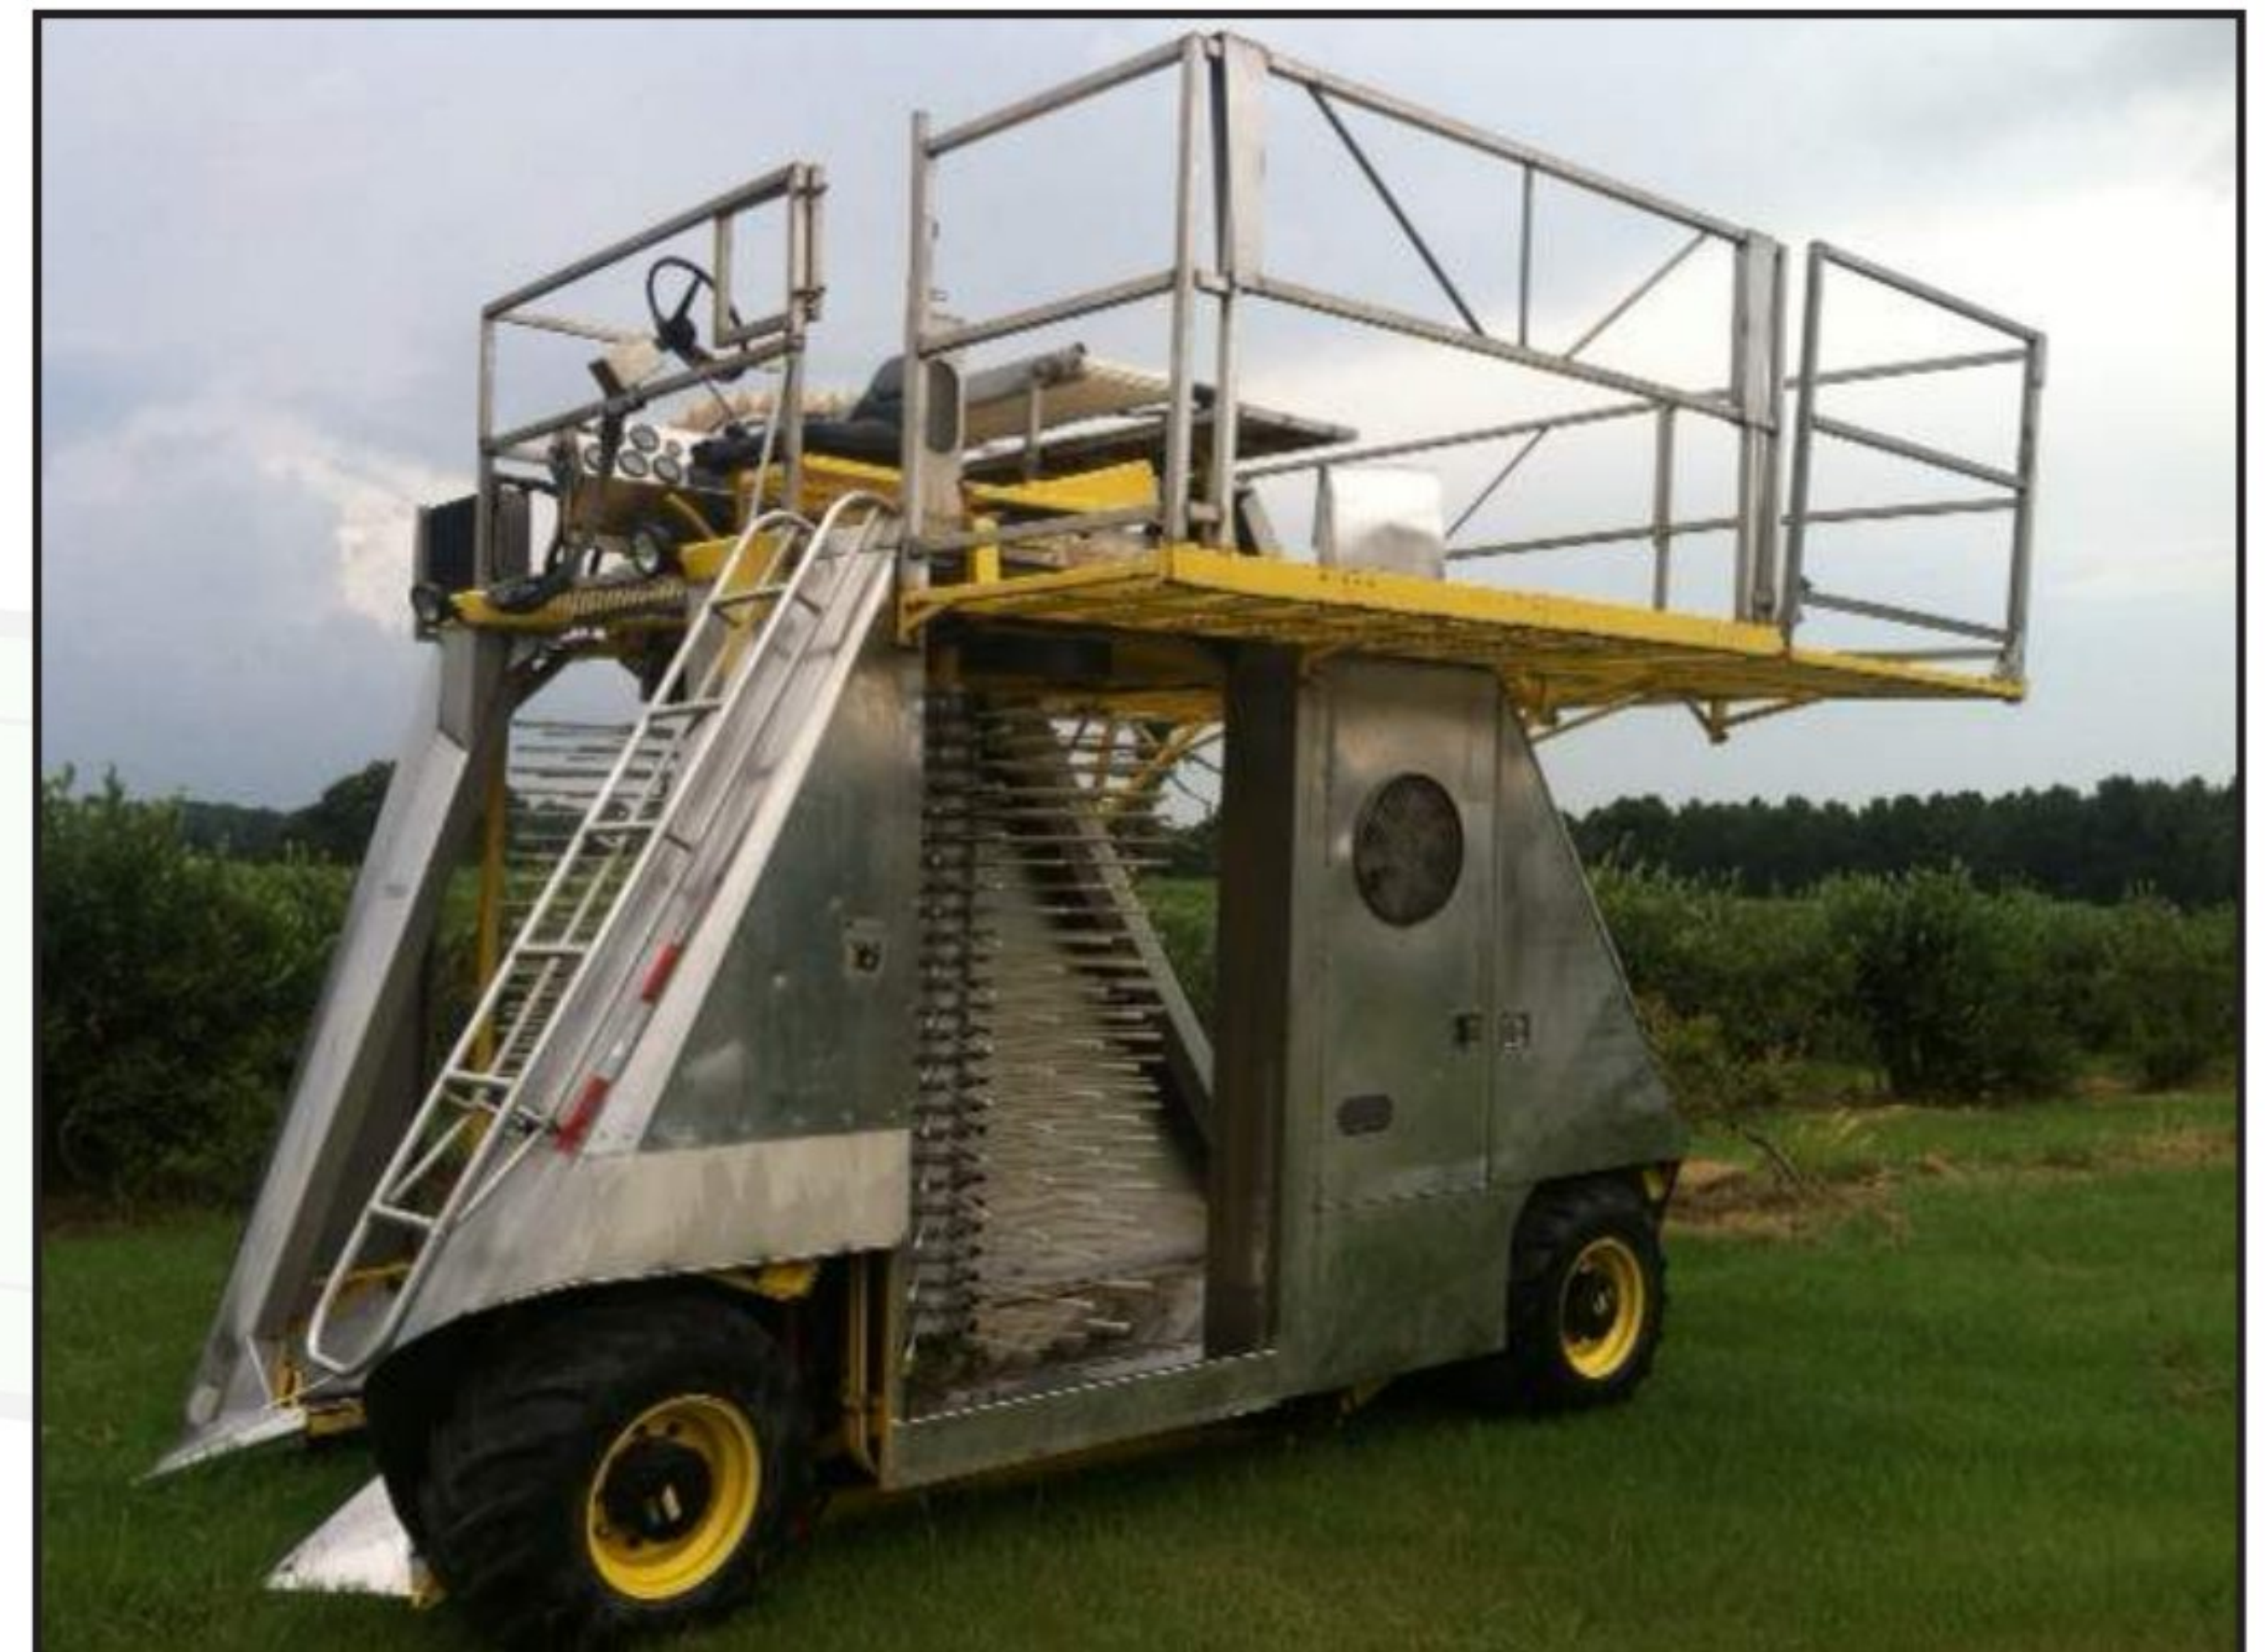
Figure 1 – The Littau Berry Harvester has a Cummins engine and Denso starter.

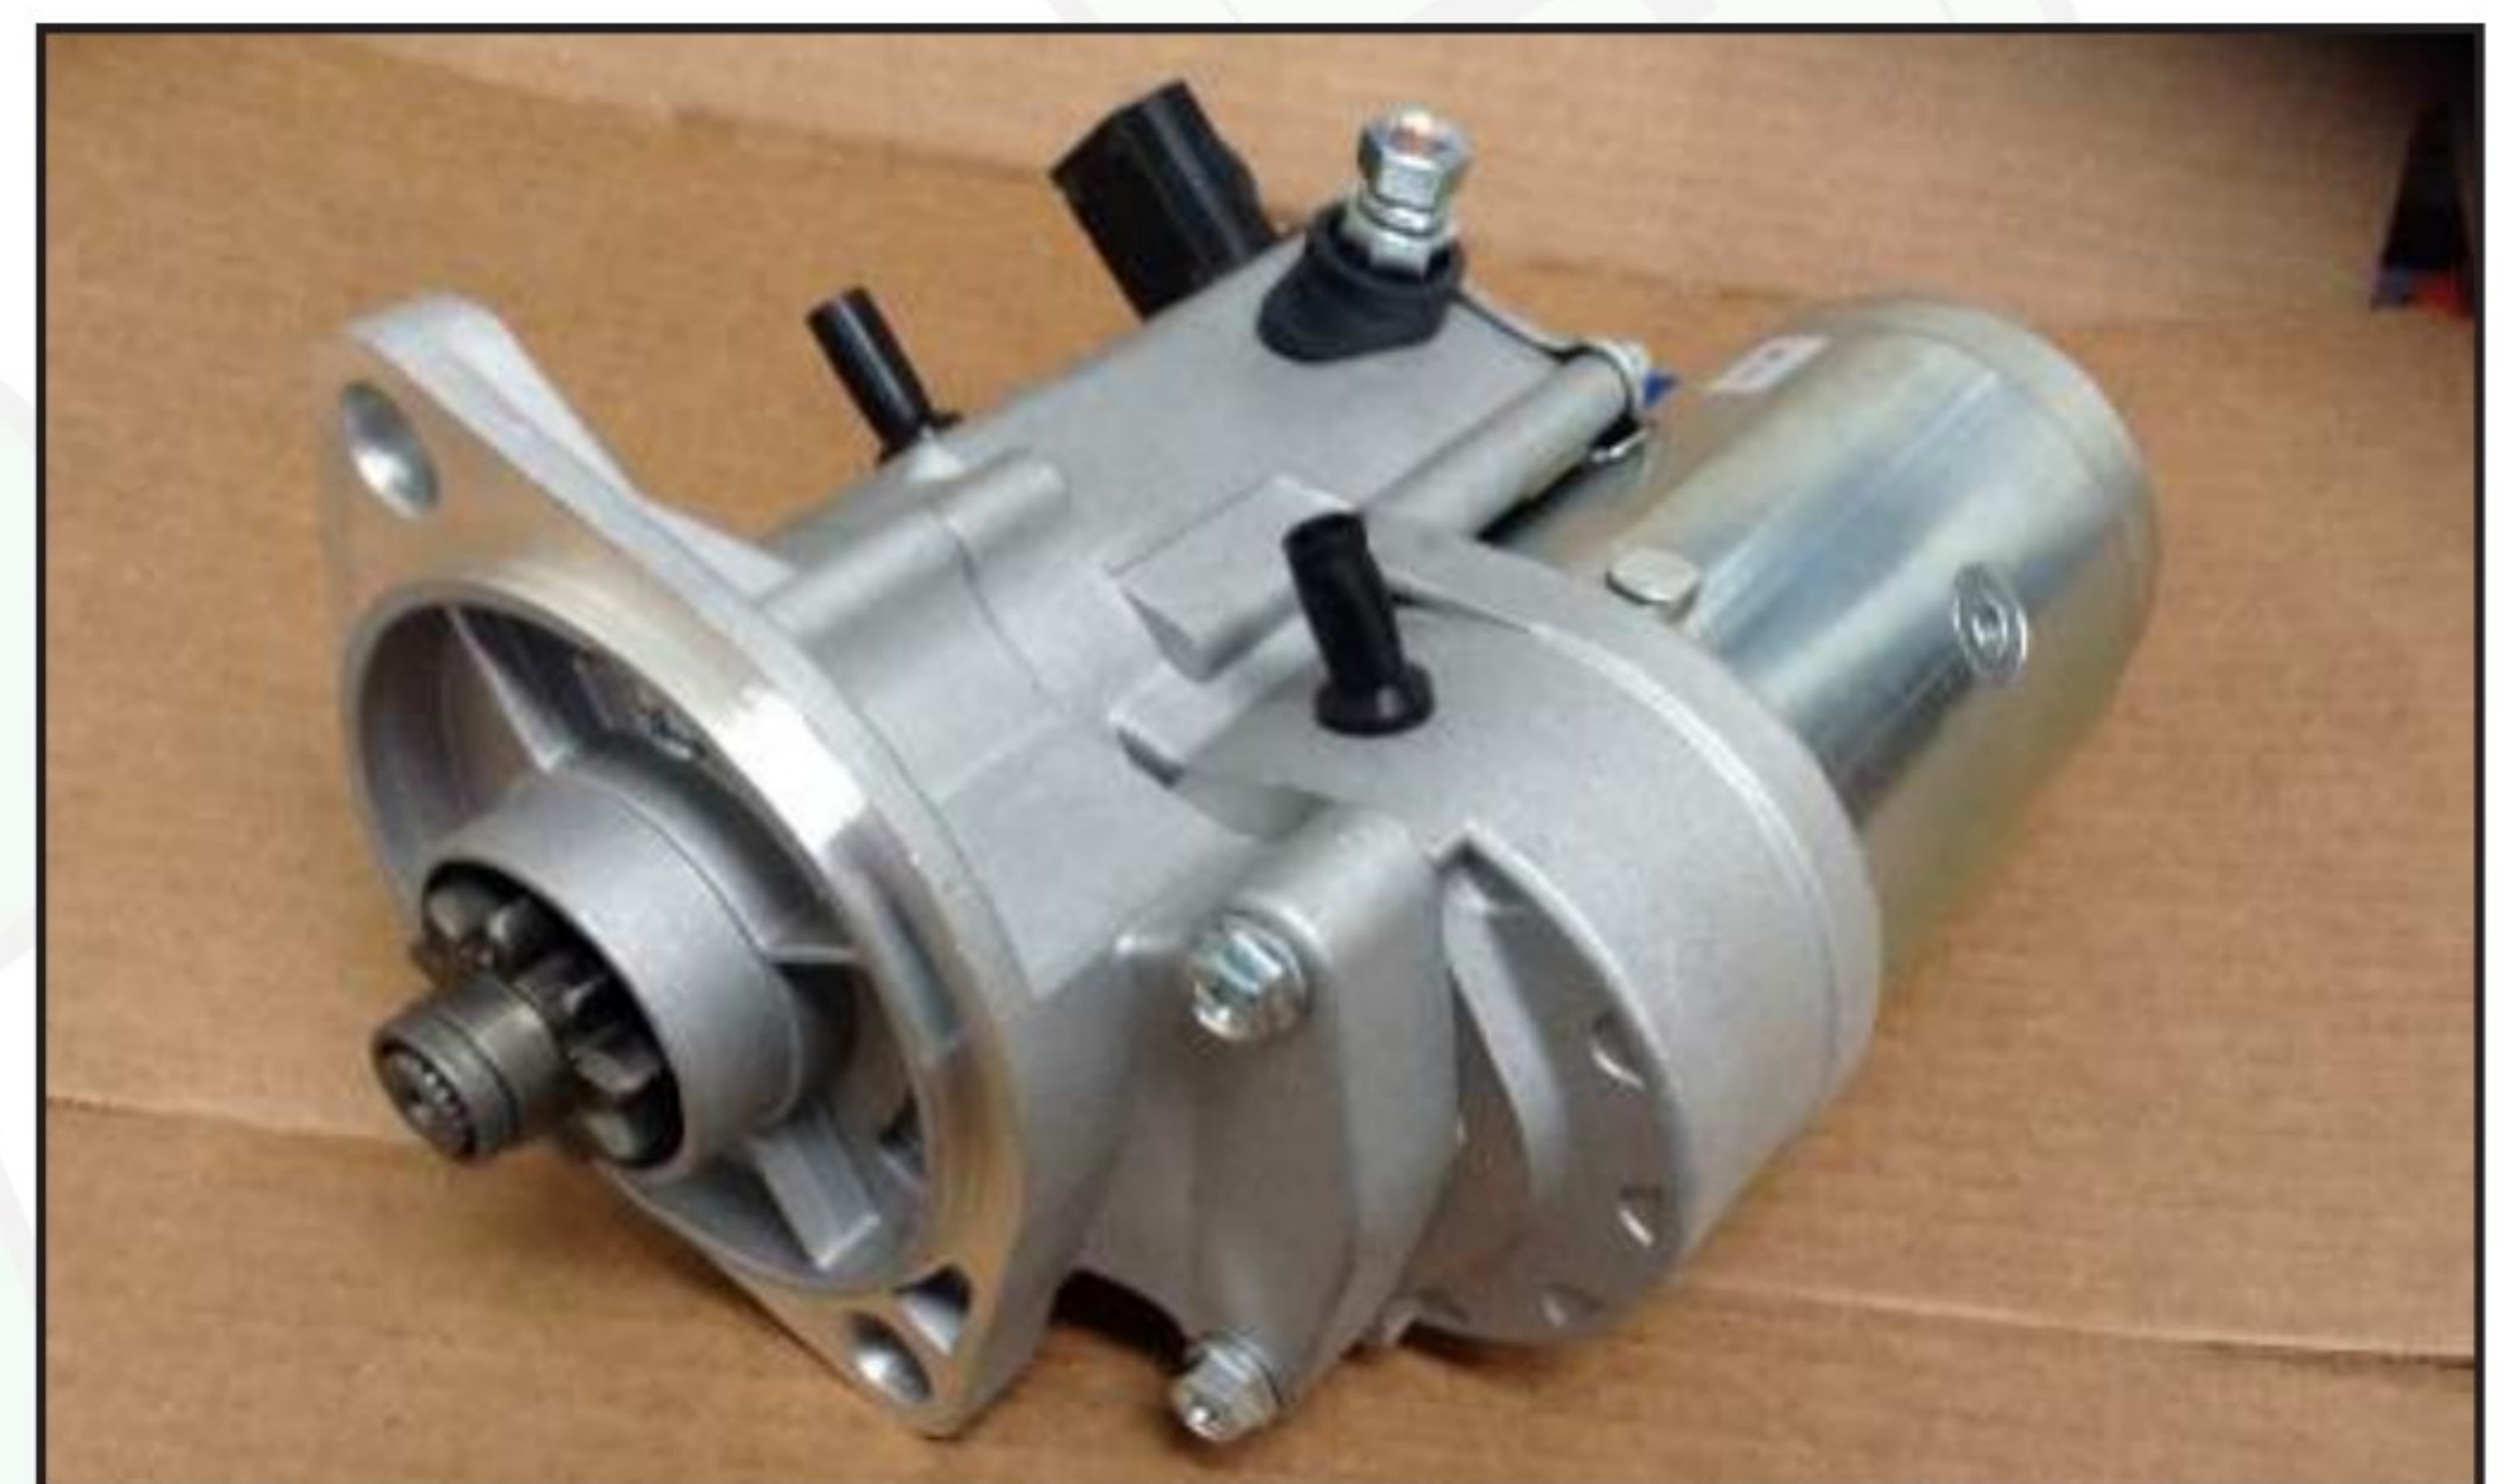
Figure 2 – 2.2kW Denso starter number 228000-9010.

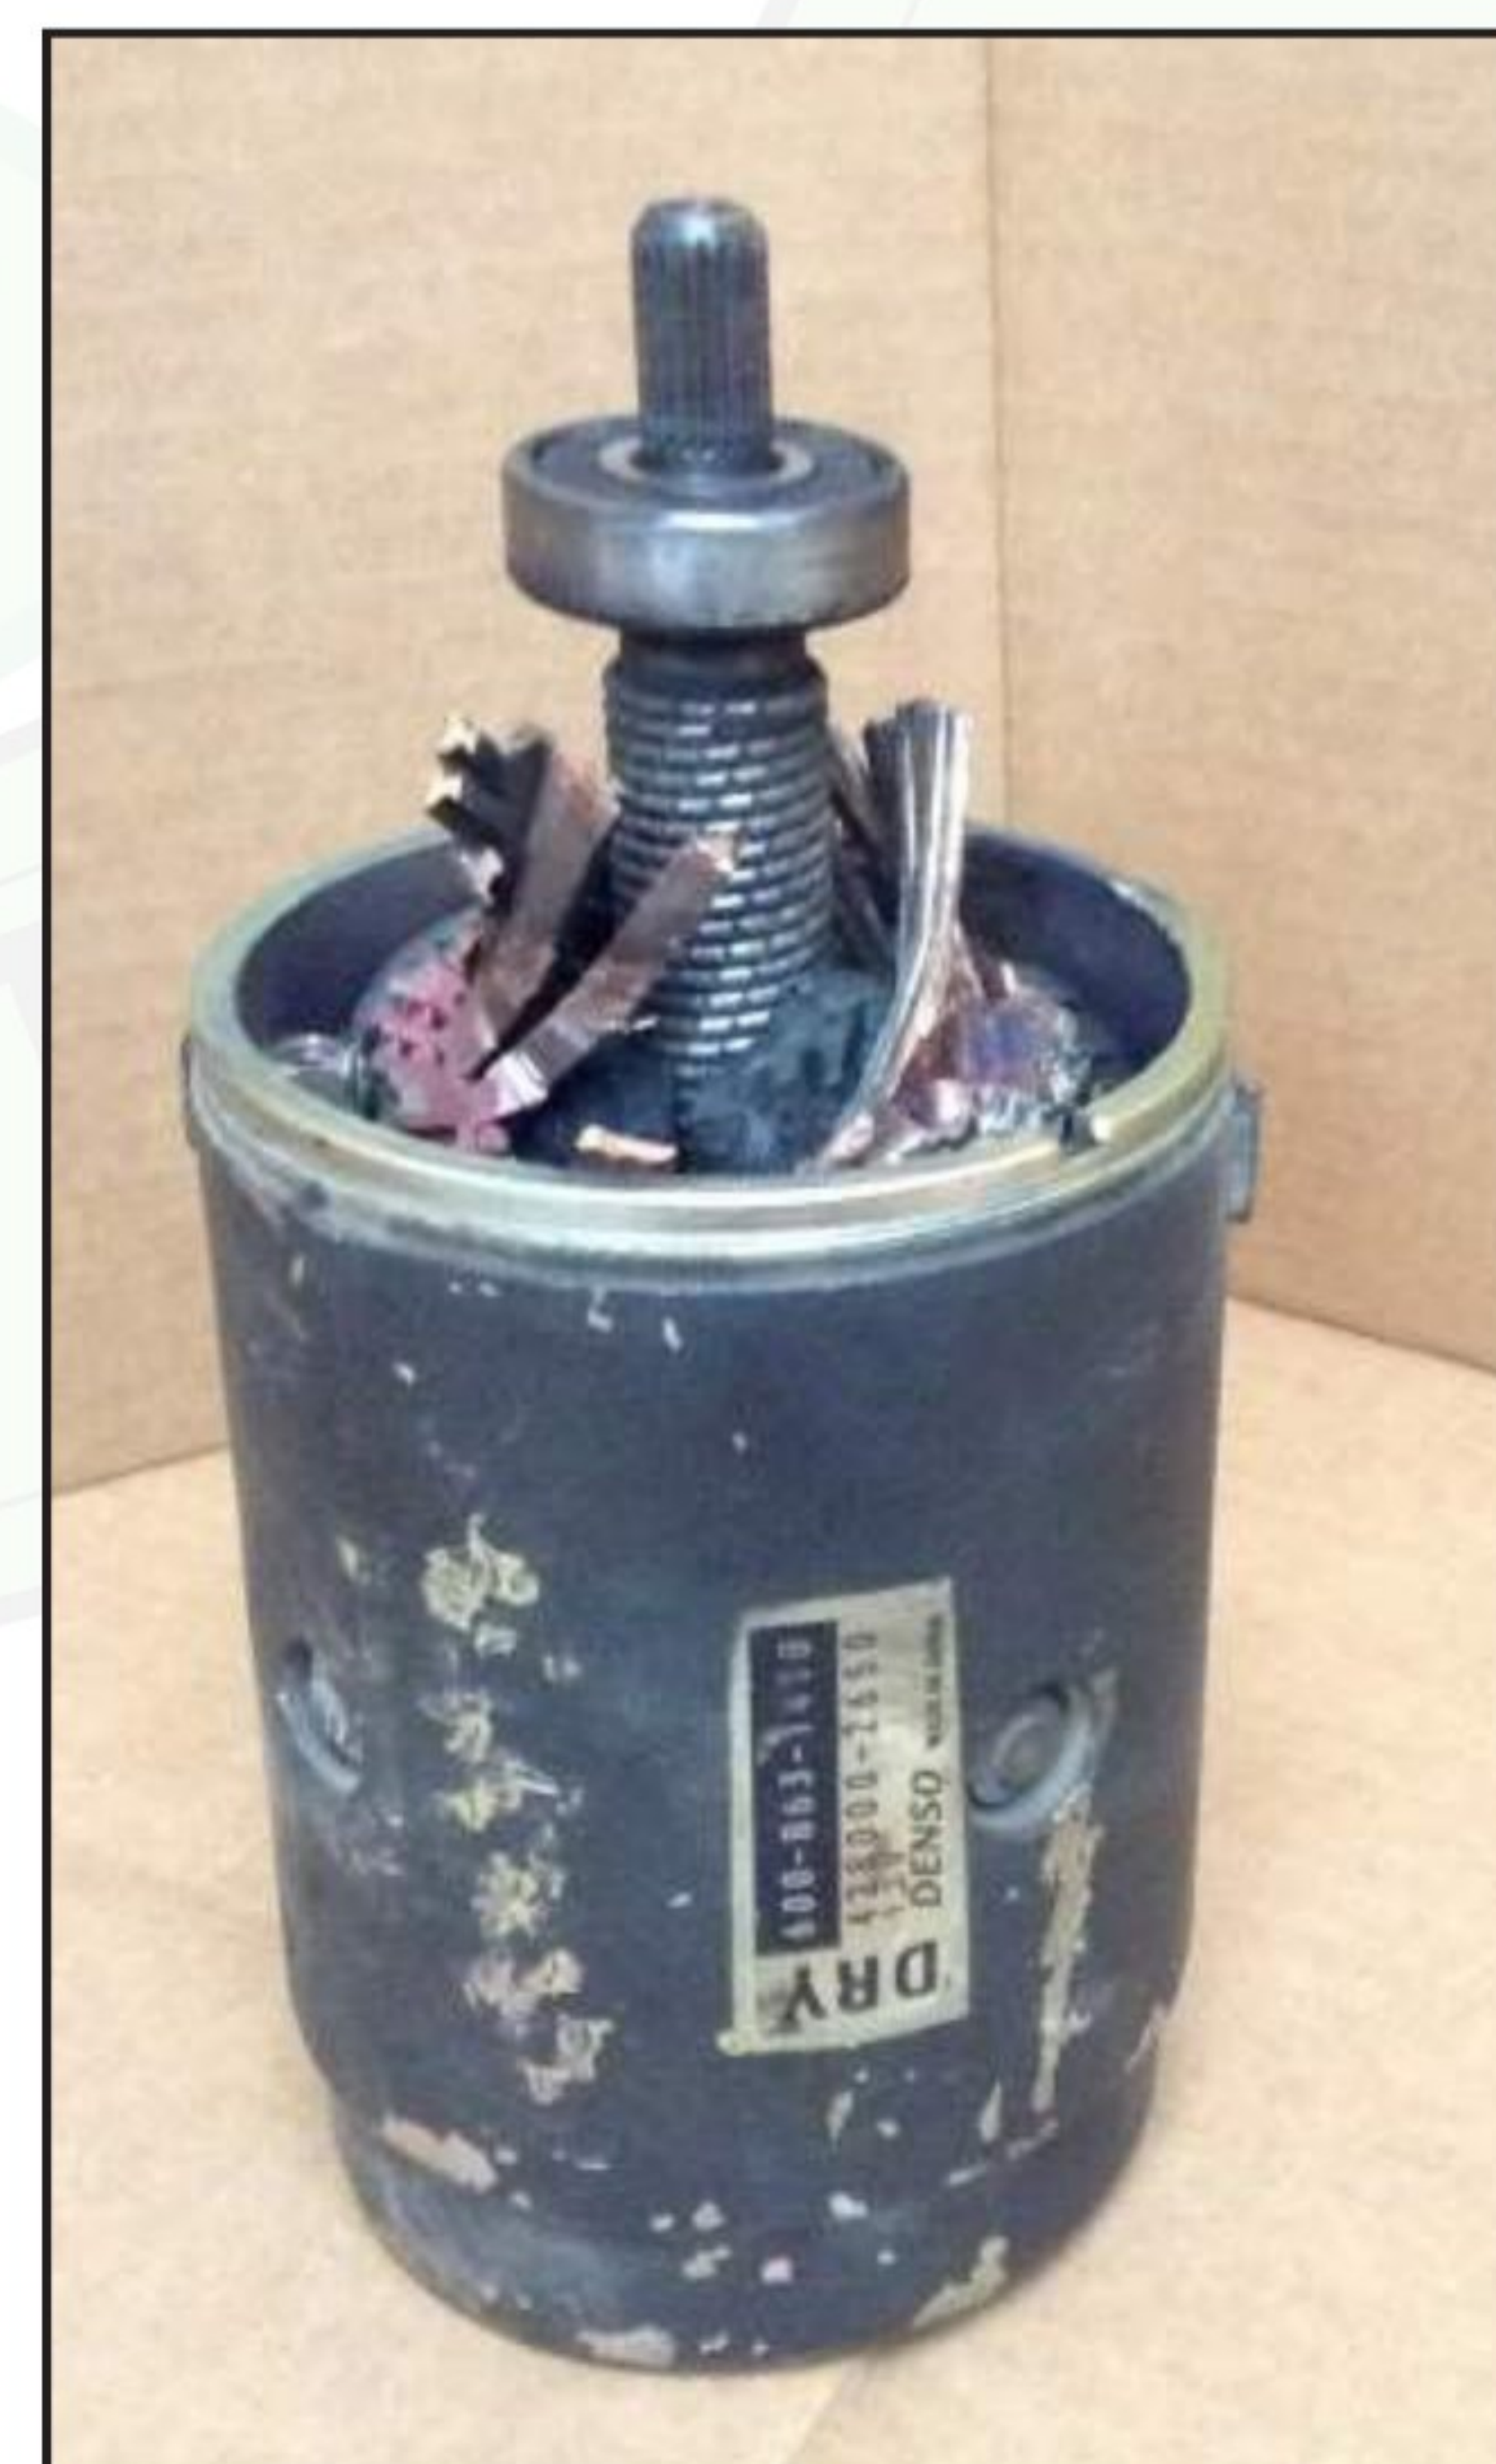
I took each component apart and did a full "autopsy". The starter had exploded due to excessive centrifugal force (see Figure 3), and also the solenoid coils had been overheated (see Figure 4), indicating that they had been powered up from an external source. There is a condition where the starter can stay engaged because its contacts are welded together, but then the solenoid coils will usually not have been burned up. This damage was not due to sticking contacts.

Figure 3 – Exploded commutator is convincing proof that this starter was engaged with engine running.

If the ring gear to starter pinion ratio is, say, 15:1, then the starter could theoretically rev up to a whopping 27,000 RPM. That's why the commutators would always blow up, taking out the brush holder and field coils as well.

Of course, an inexperienced operator might not even hear that sound over the roar of the machine, so the starter would keep trying to crank even though the engine was already running and the operator had released the key. The engine would thus be propelling the starter. With the large ring gear turning at (let's say) 1800 rpm, this would then be why the armature was exploded and the solenoid hold coil was cooked. By the way, the fact that the auxiliary relay coil had no kickback diode means that it would send a high-voltage spark into the leftover sludge, which would definitely not help the situation.

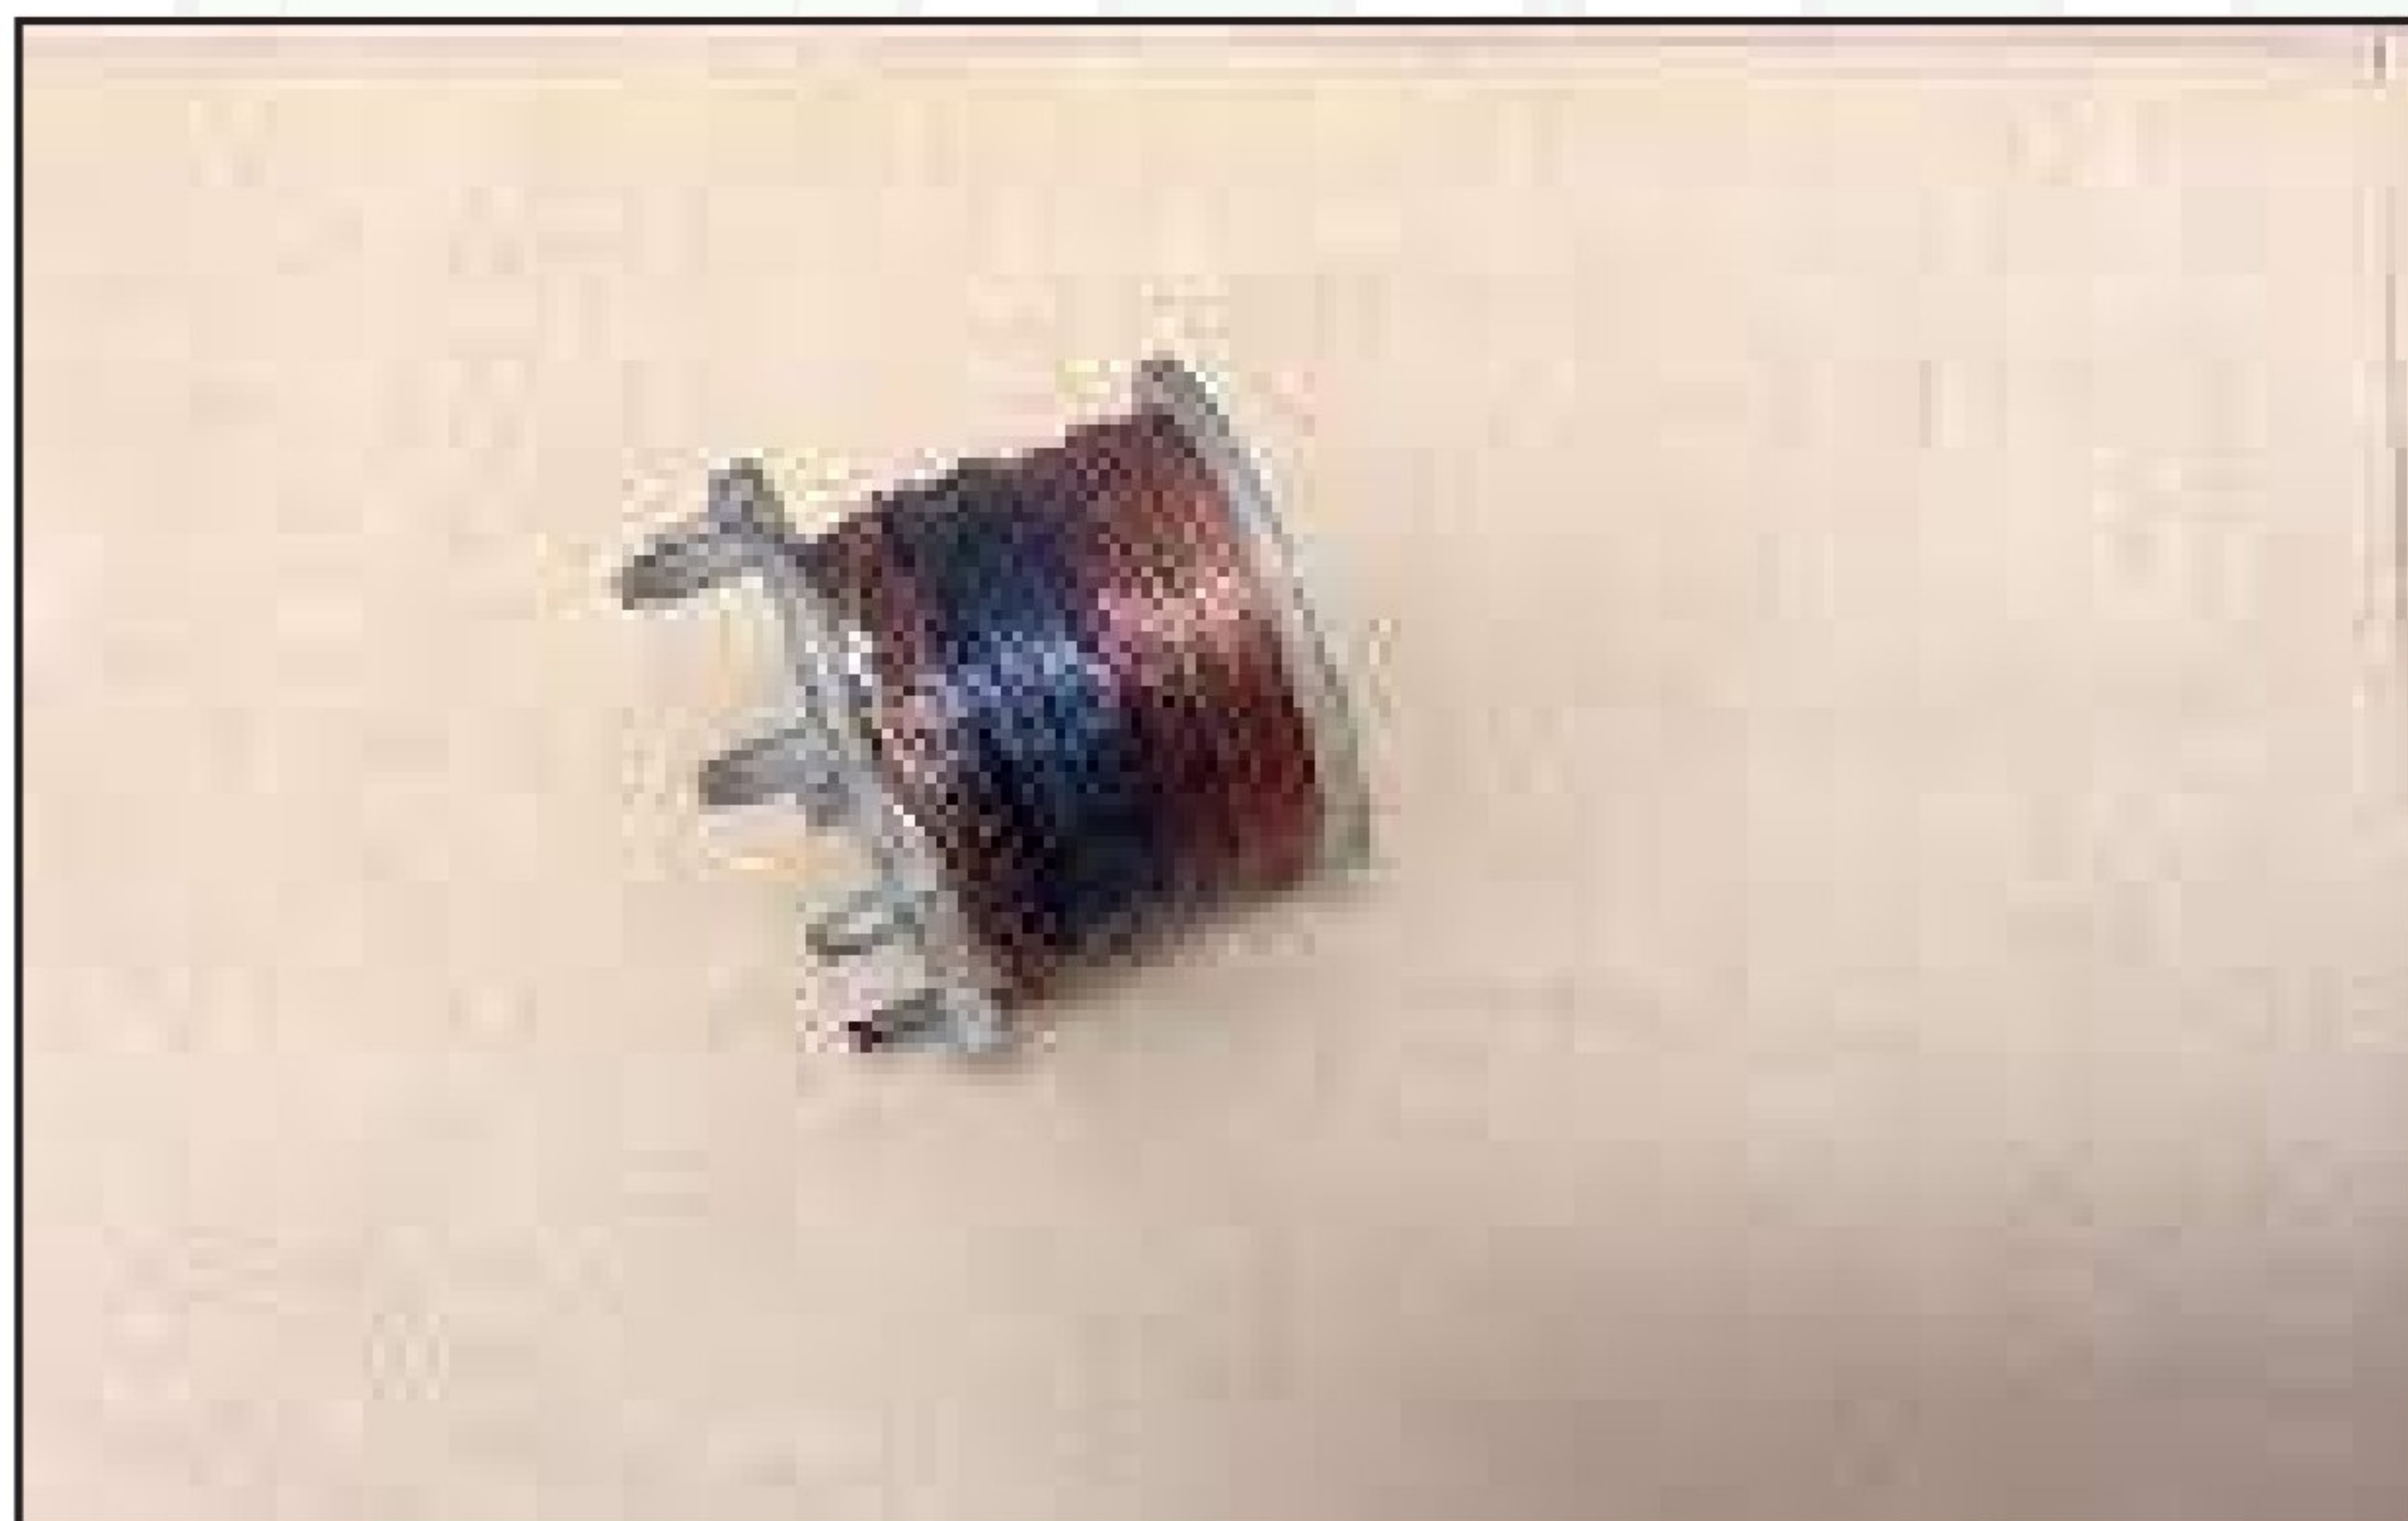
I was not required to cover the warranty on any of the rebuilt starters from that machine because they had burned solenoid hold coils, proving that they had been held engaged because of issues external to the starter.

*Figure 4 – The burned solenoid coil indicates the switch terminal was powered for an excessive amount of time.*

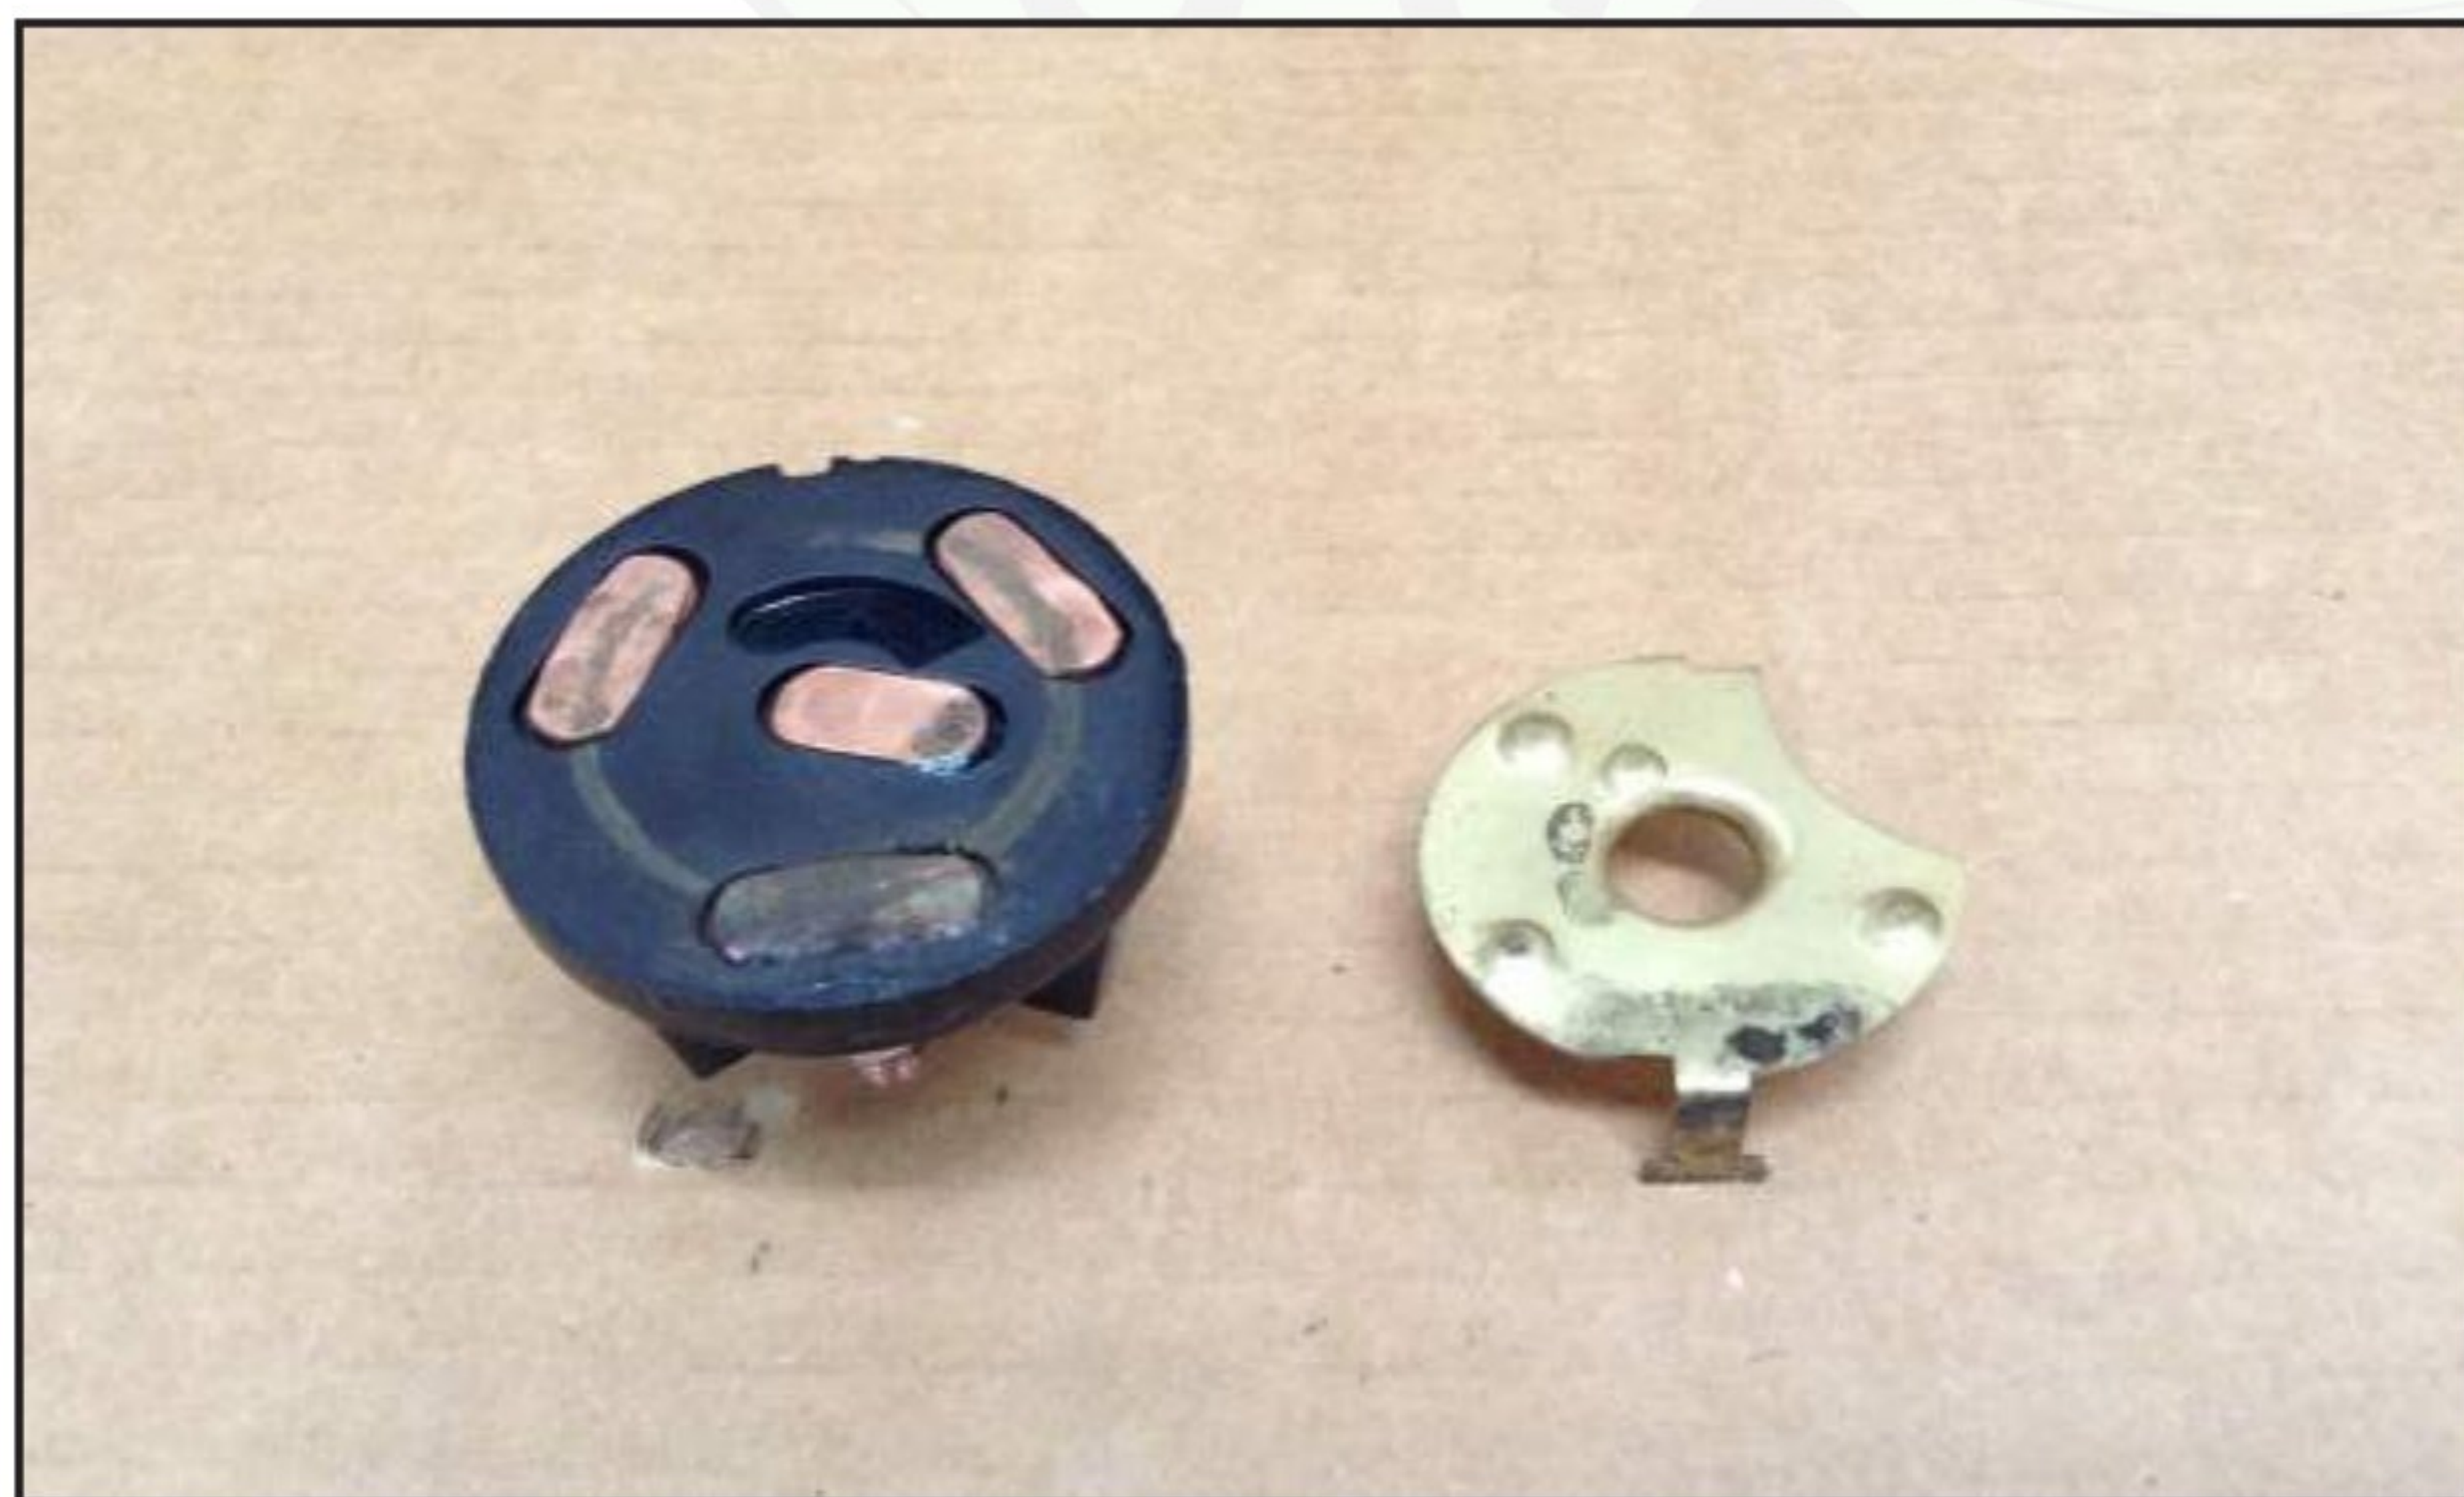
Then I got to the ignition switch. Corrosion, signs of electrolysis, and muddy watermarks were in evidence on all of the brass, copper, and aluminum components (see Figure 5).

So to unravel all the evidence, I inquired about anyone washing the machine. It seems this farmer likes to keep his tractors nice and clean. Every day after harvesting, the farmer would have one of his boys pressure-wash the machine. But the ignition switch was not protected nor sealed, and it was cheaply made besides. The muddy water that splashed into it would corrode the copper and aluminum inside, and would begin to become a conductive solution itself. That's why each newly replaced ignition switch would develop the same trouble.

Whenever they would start the machine, the ignition switch would activate the relay, and the relay would activate the starter. But once the muddy water and corrosion would build up inside the ignition switch, there would be enough conduction due to the dissolved minerals in the water to keep the relay closed even after the ignition switch was released. Remember, it only takes 0.04 amps to hold the relay closed. I was actually able to simulate this on the test bench, immersing the contacts in a plastic container of water and then stirring in a little soil from behind the shop.

*Figure 5 - Corrosion and conductive sludge inside the ignition switch caused the intermittent self cranking.*

The service technician addressed the problem by installing a separate push button start switch. I hope it was a weather sealed type.
