# Technical Update 22

## Preventing Defective Return Problems on Delco 27SI and 21SI Units

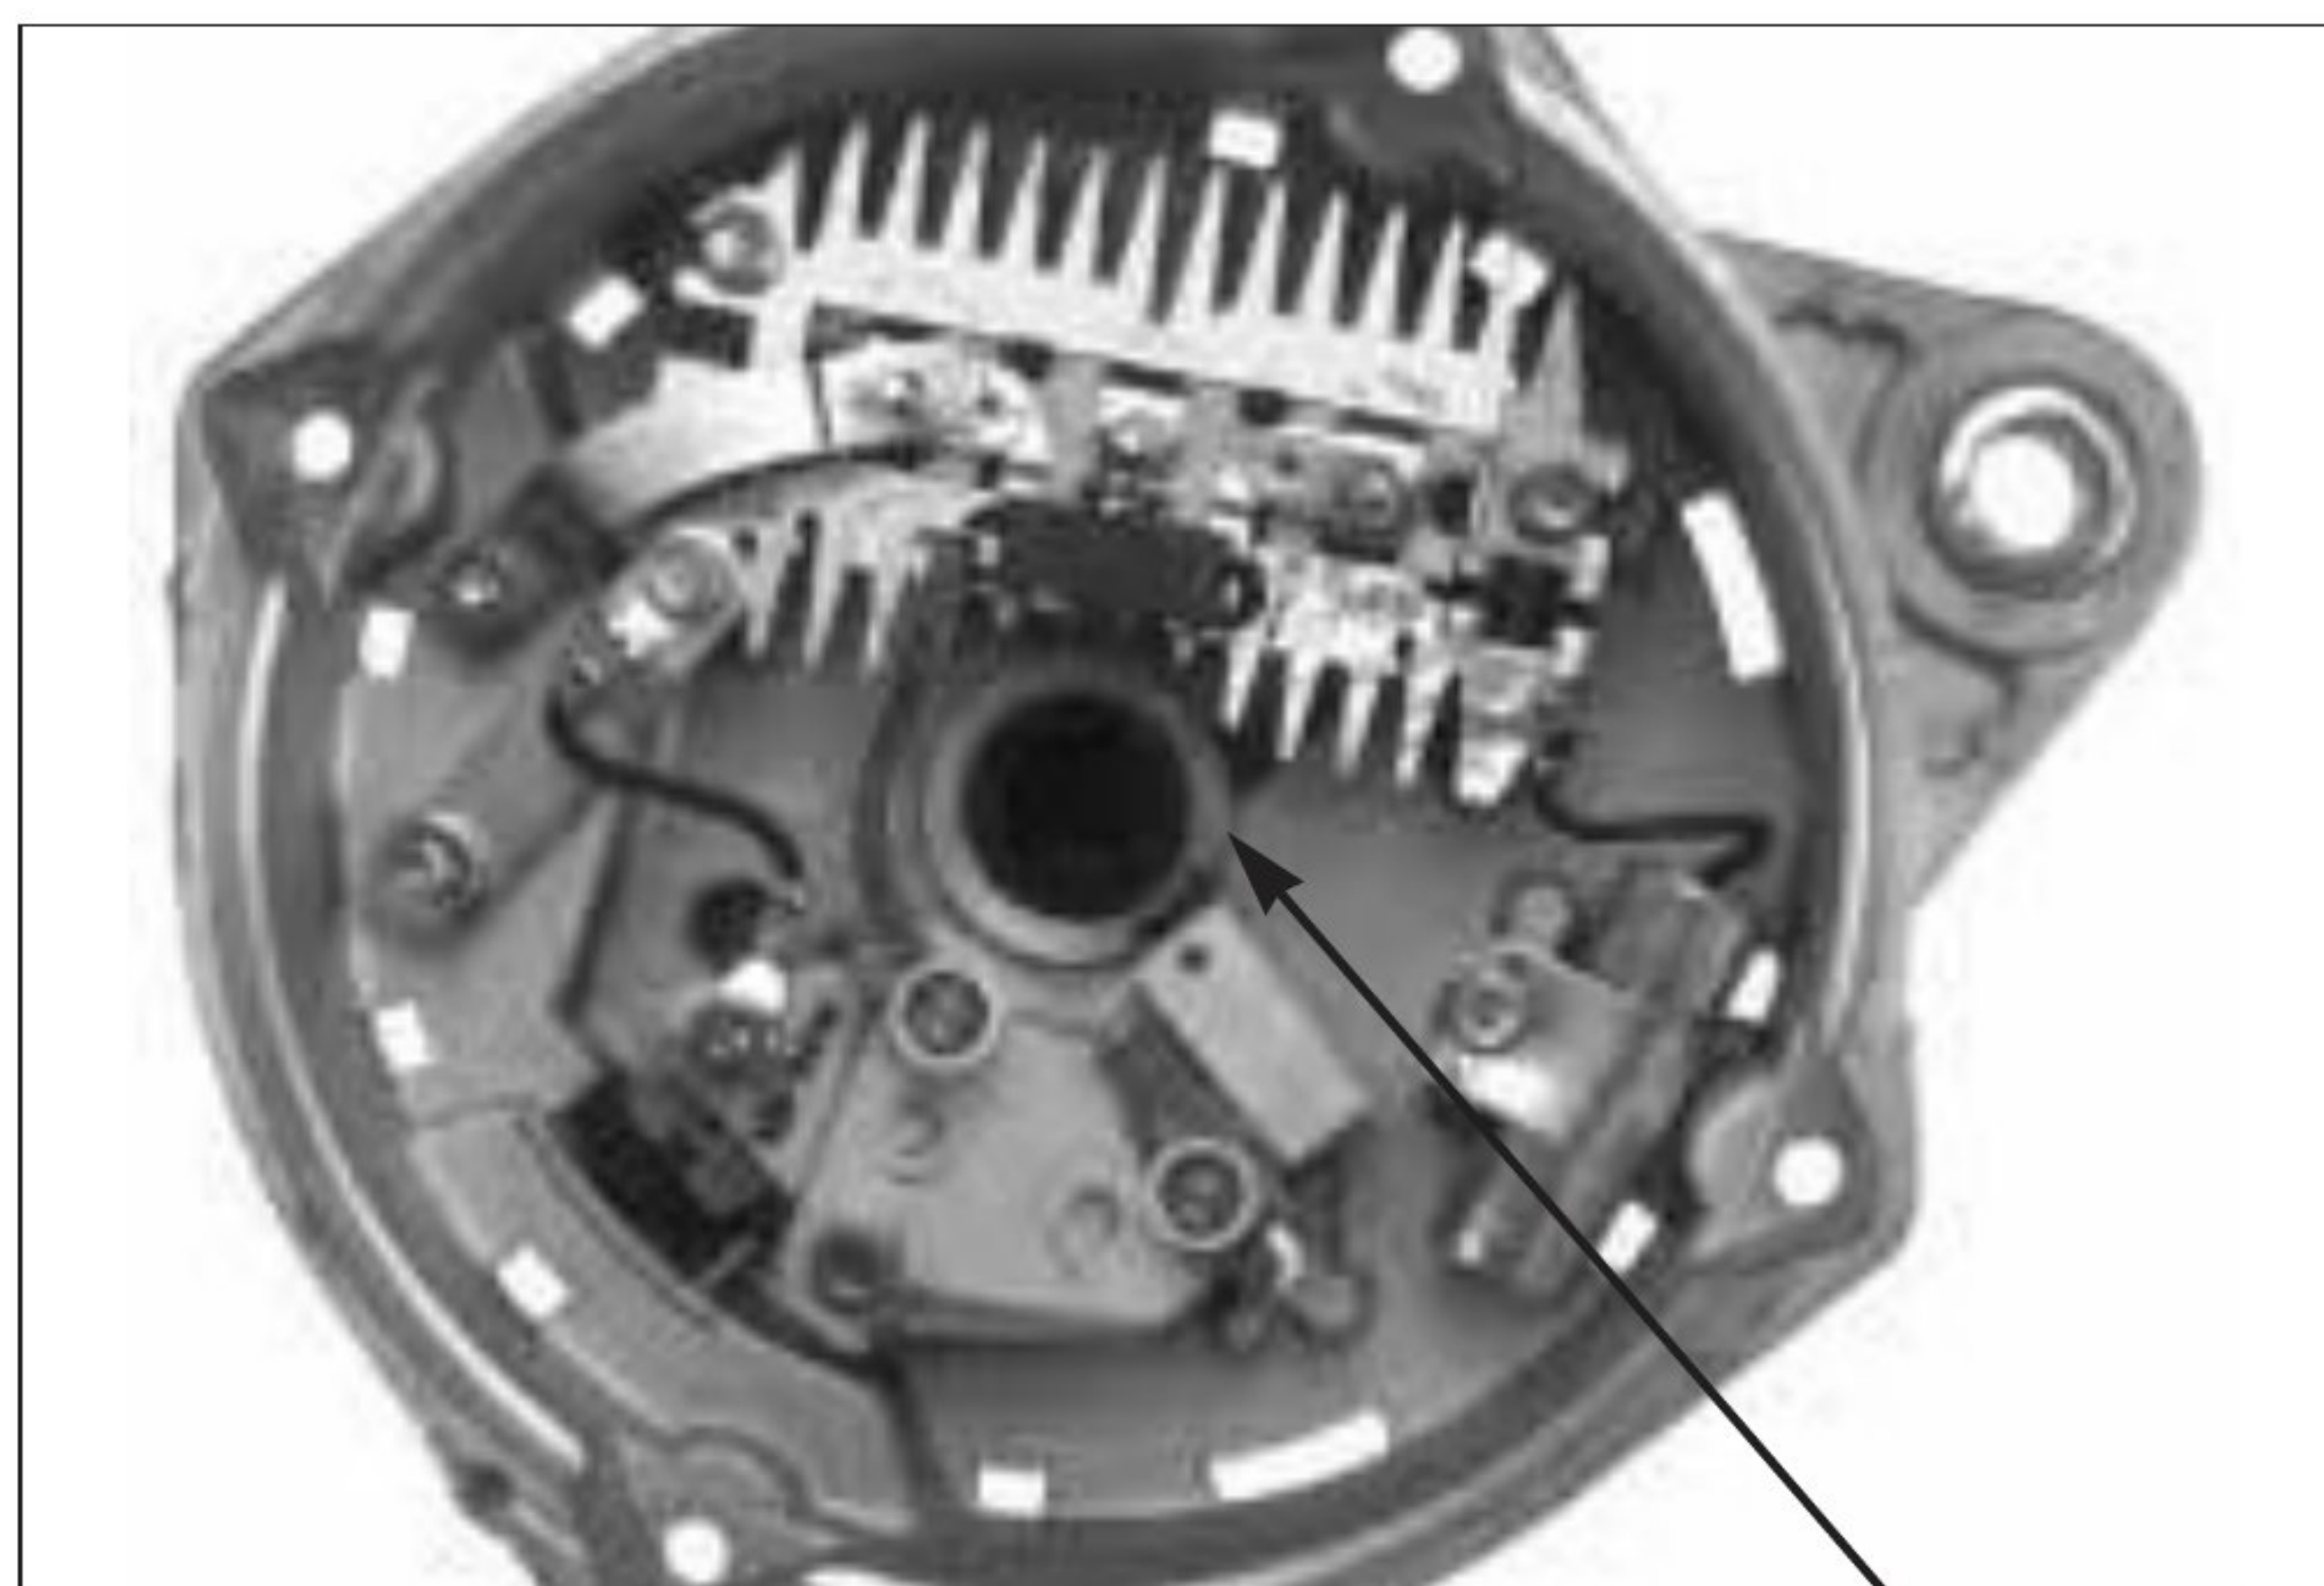
In most cases that we have seen, this condition usually occurs when the alternator does not have a pulley installed. This leaves the rotor free to move and allows the slip ring to contact the SRE frame. (See Figure 1.) If the slip ring is against the SRE frame, it only takes a slight amount of pressure to push it back along the rotor shaft and ground it out

**Figure 1.** When the rotor is able to move, the slip ring on the 27SI contacts the SRE frame at the machined area around the SRE bearing

on the rotor. This pressure often occurs during shipment of the unit or installation of the pulley. Also keep in mind that varnish on the rotor pole piece may prevent this grounding from happening immediately.

Therefore, to prevent grounding the rotor on these units, we strongly recommend that, if you are shipping them without pulleys, you install a cardboard sleeve (WAI #89-900) and a nut on the rotor to prevent it from moving. To be completely safe, it's also a good idea to install a sleeve during normal handling through the shop.

To prevent rotor movement during pulley installation, we recommend keeping the unit in a horizontal position -- with the rotor shaft horizontal to the workbench -- and sliding the pulley on by hand. If the pulley needs to be pressed on, you will have to take the alternator apart and support the SRE end of the shaft as the pulley is pressed on.

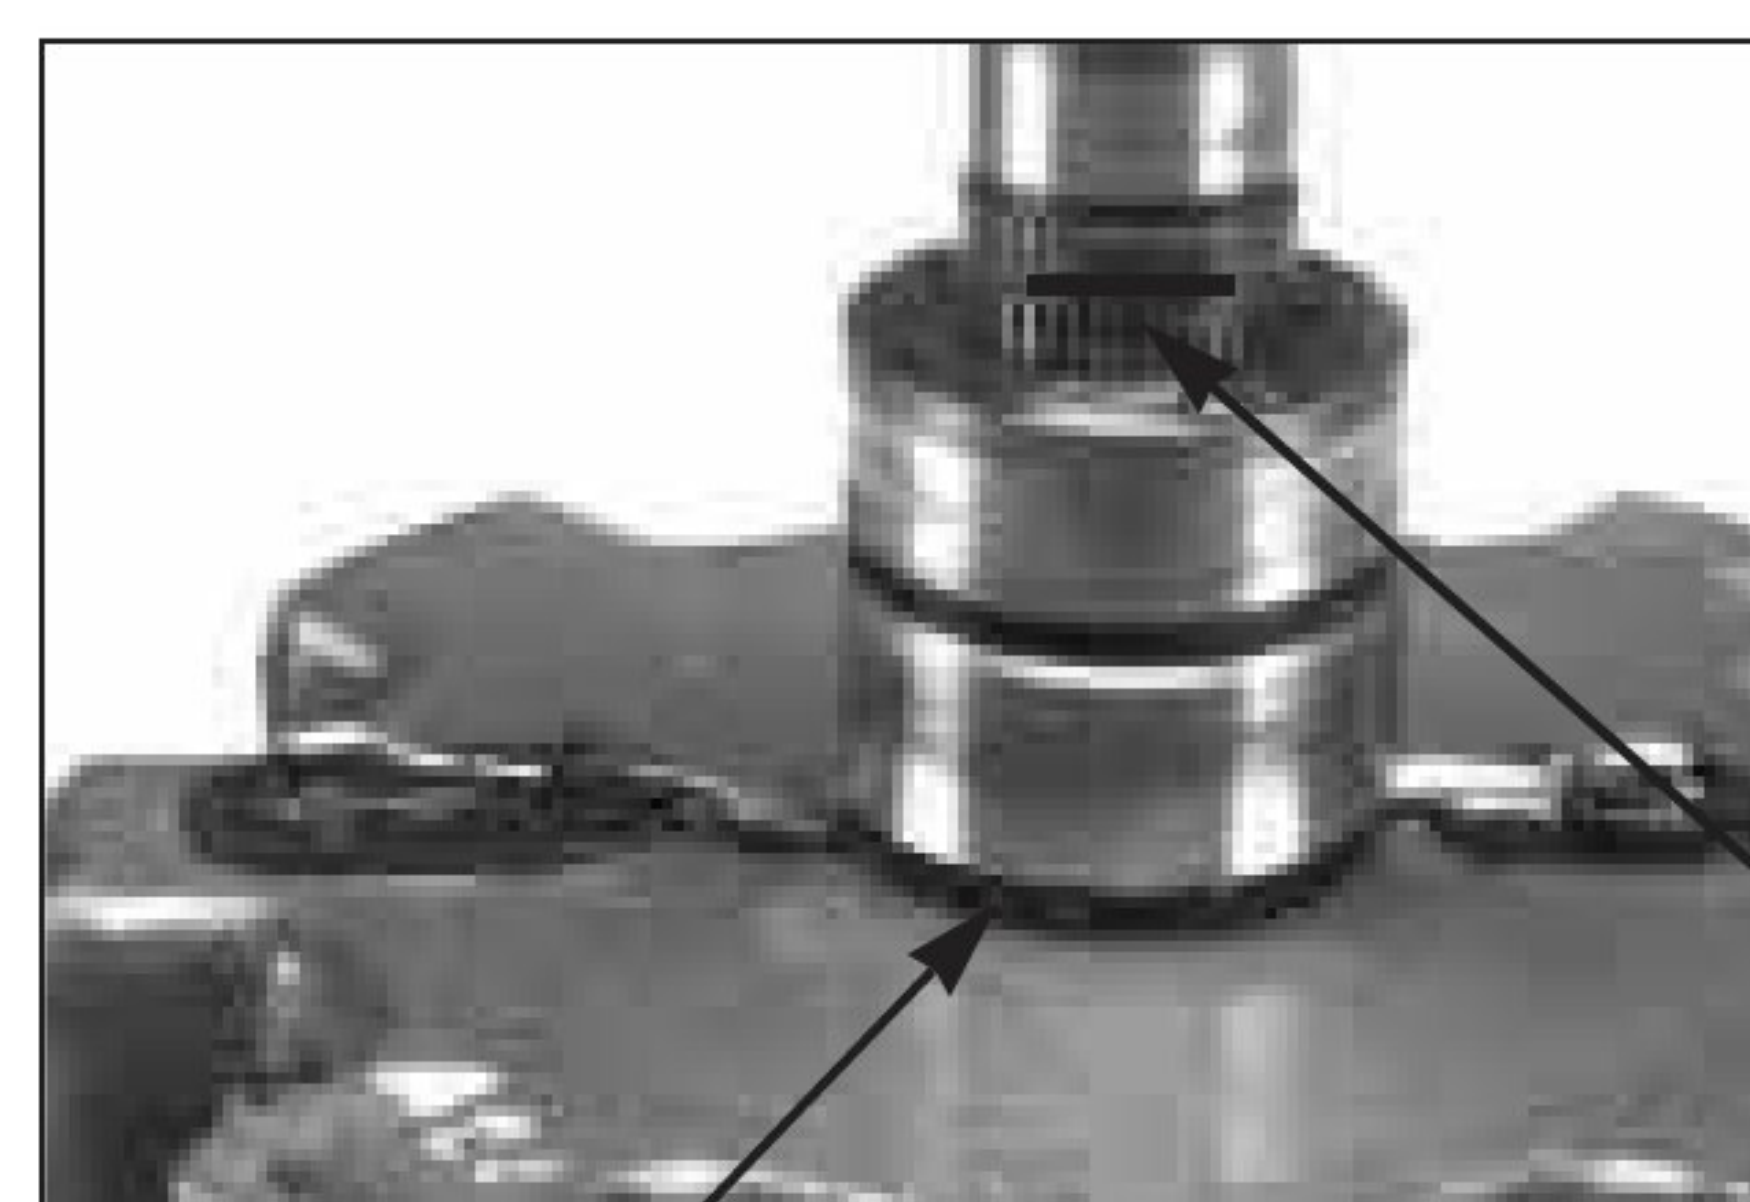
In Figure 2 note the grounded slip ring, which has moved approximately 3 mm on the rotor shaft. Also be

**Figure 2.** The slip ring on this 27SI has been grounded out against the rotor pole piece.

aware that even if the slip ring does not move far enough to ground out, any movement along the rotor shaft will cause misalignment of the brushes on the slip ring.

If these units are being sold over the counter you might want to attach a caution tag that warns the installer of this potential problem. This small effort could keep an installer from accidentally destroying your rebuilt unit.

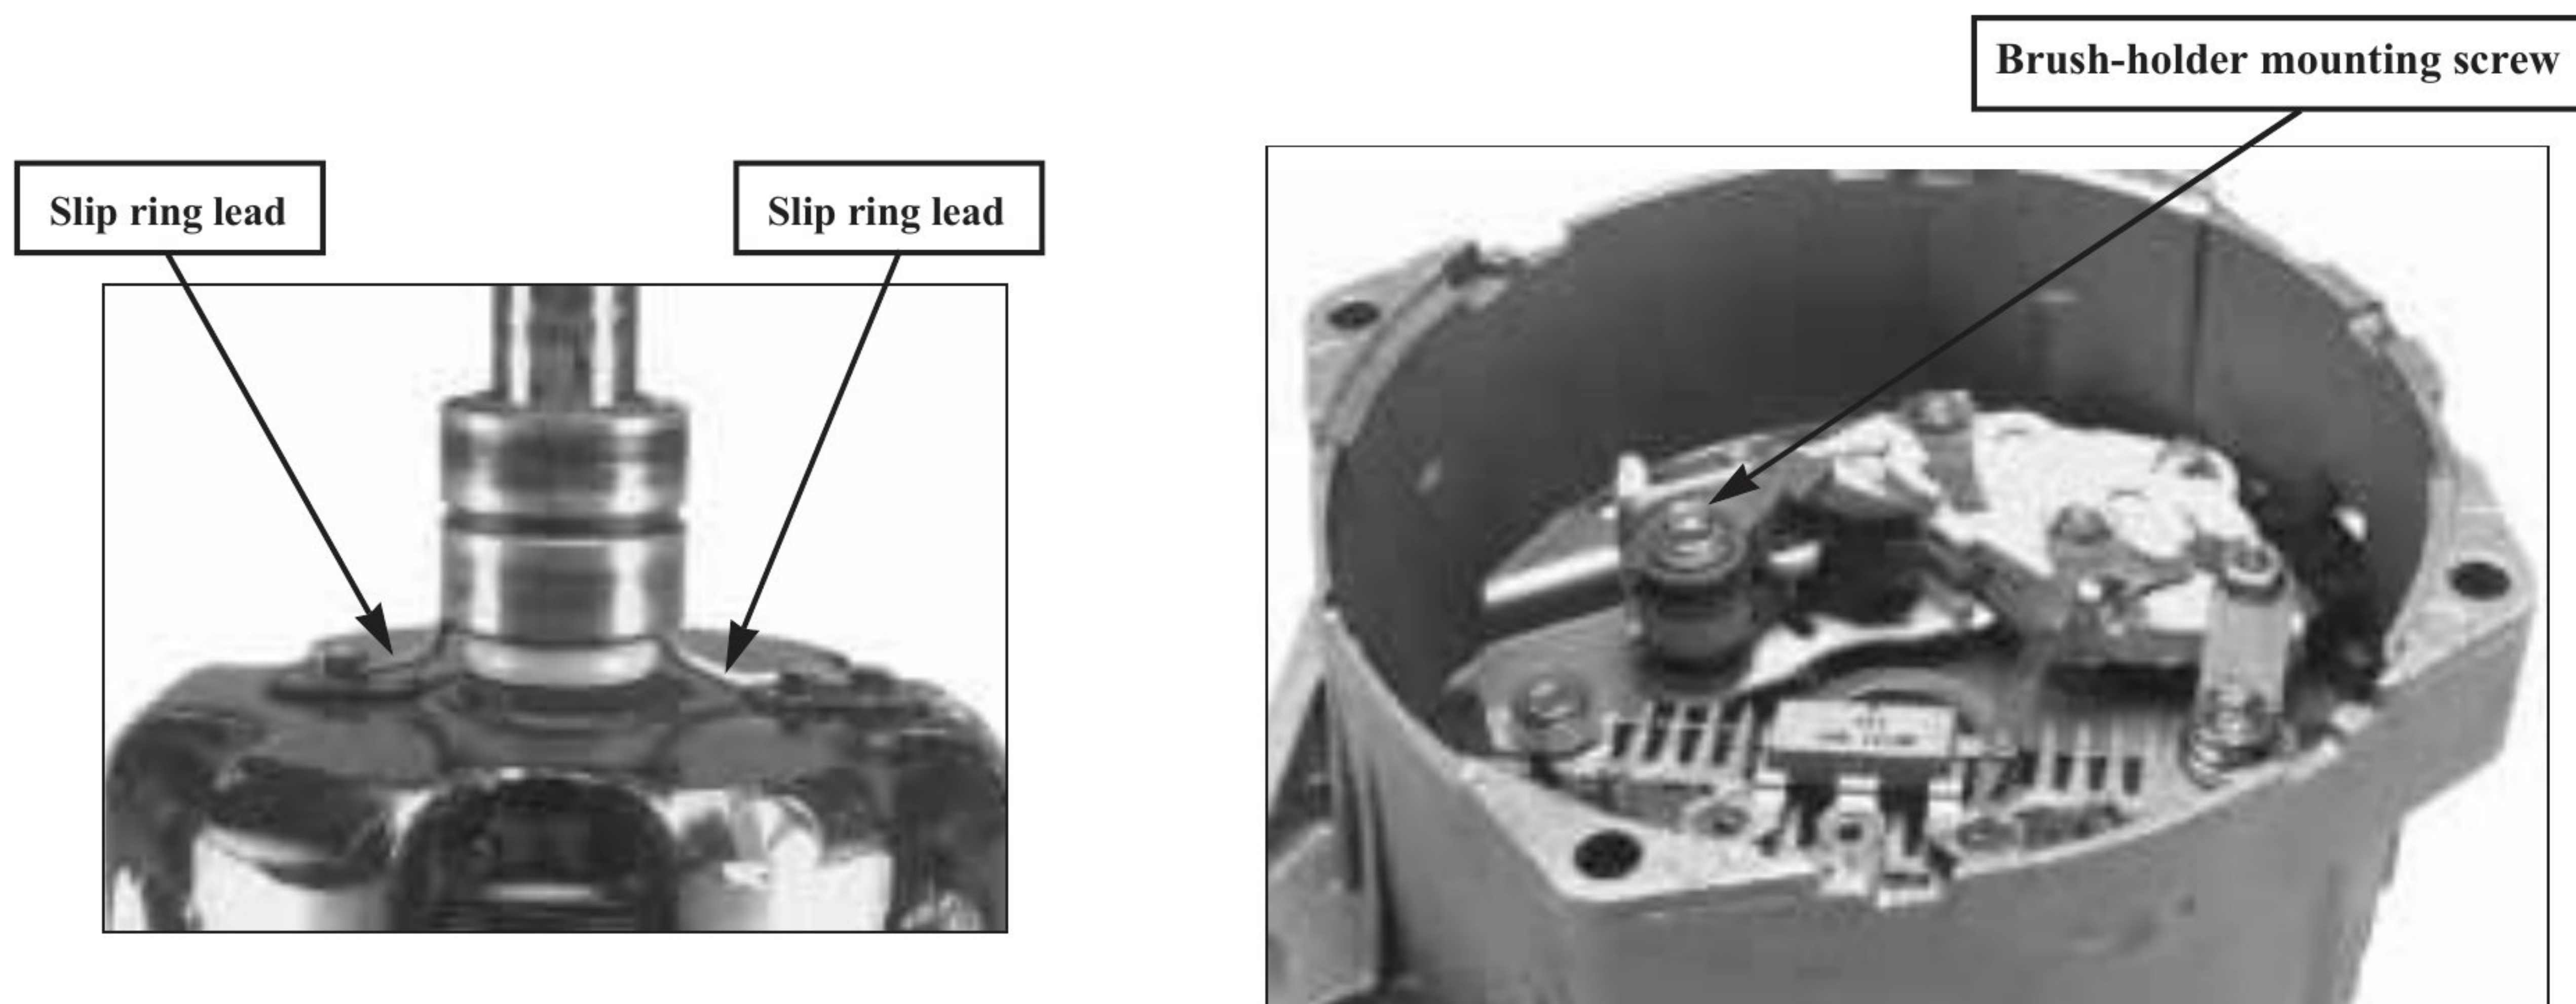
The reason for this problem is similar to the one we just discussed for the 27SI. When the unit is shipped or handled with the pulley removed, the rotor is free to move in and out. But in this case the rotor pole piece bottoms out on the brush-holder mounting screw. Any rotation of the rotor then causes the slip-ring leads to come in contact with this screw, and any further rotation will damage the screw, slip-ring leads and brush holder.

**Figure 3. On the 21SI, the rotor can move inward, causing damage to the slip ring leads, the brush-holder mounting screw and brush holder.**

To prevent this problem be very careful when you are removing or installing the pulley that the impact wrench does not spin the rotor when it is in the inward position. In addition, as with the 27SI, when you are shipping these units or

moving them through the shop without pulleys, we recommend installing a cardboard sleeve (WAI #89-900) and a nut on the rotor to prevent the slip-ring lead from coming in contact with the brush holder. (See Figure 3.)
