# TECH TIPS

**Applications:** Various Coach Applications

# WHY MOTORCOACHES MAY BURN

(A MECHANICAL ANALYSIS)

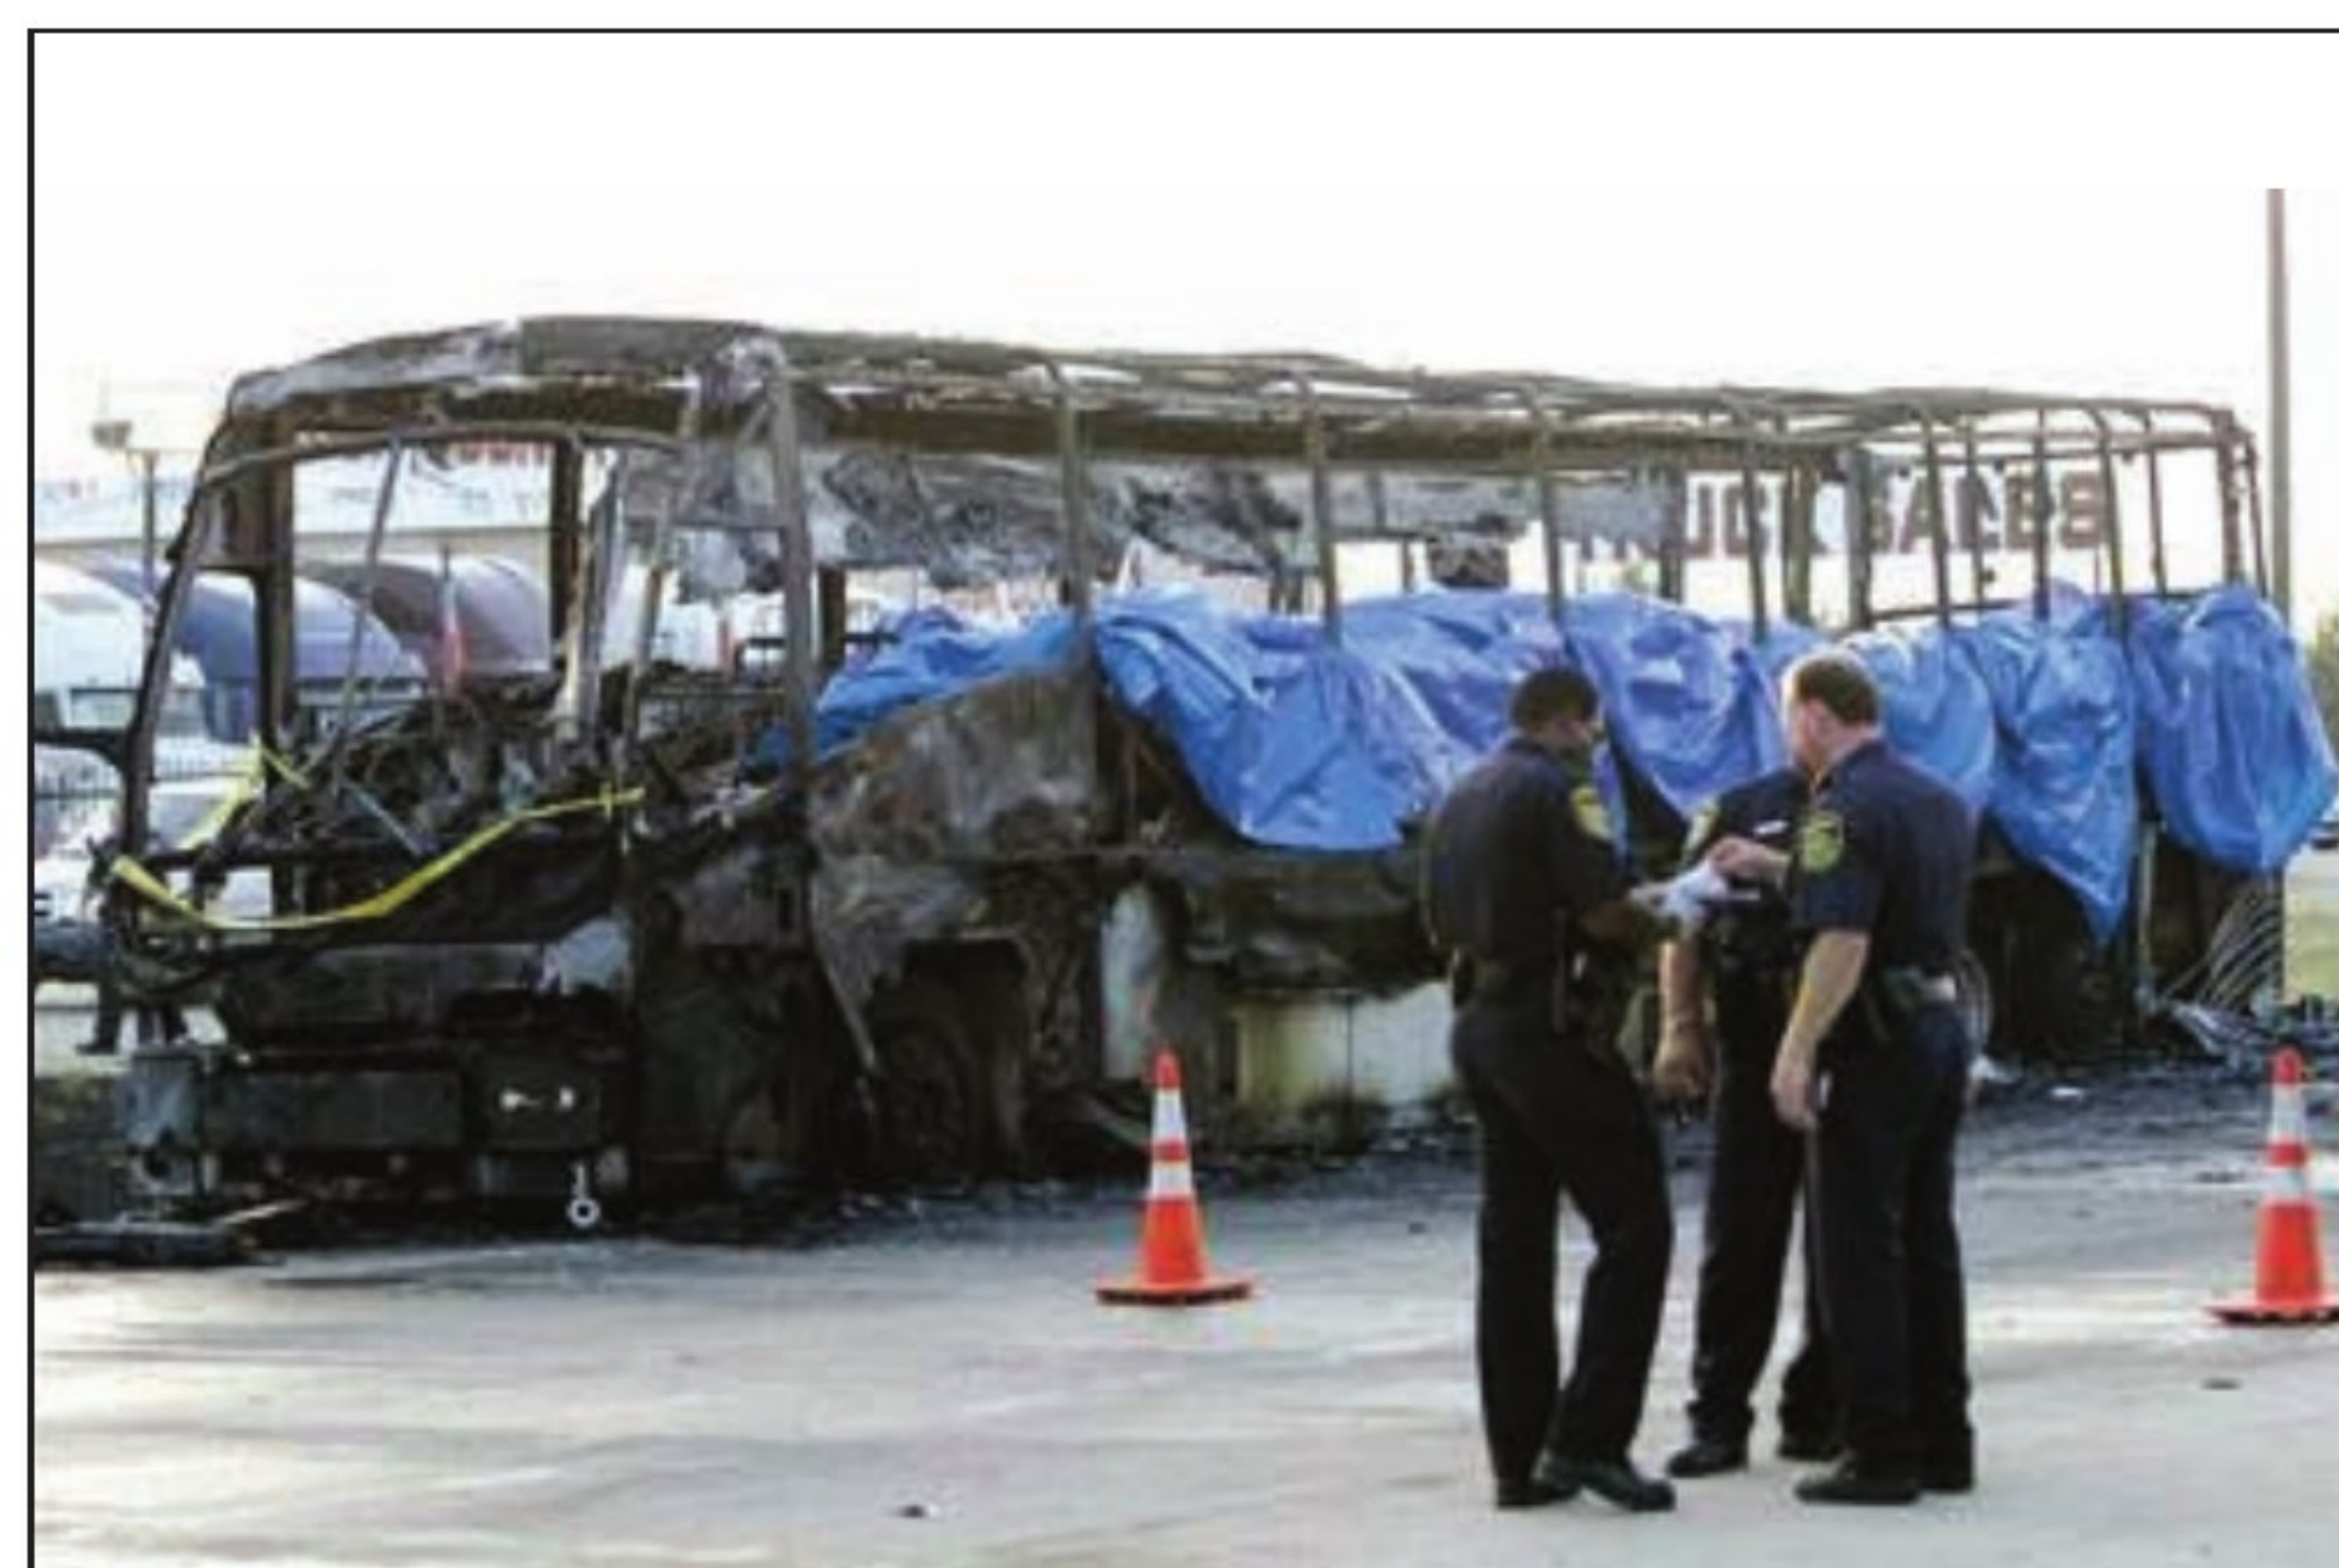
As simple as it appears, if the vehicle is in motion certain items are valid as possible causes. Likewise, if the vehicle is stationary with the engine on or off other items become potential causes. In either case, the situation is dangerous and costly in both human life and property (Photo 1).

Photo 1: Motorcoach involved in fire during Hurricane Rita evacuation (September 24th 2005)

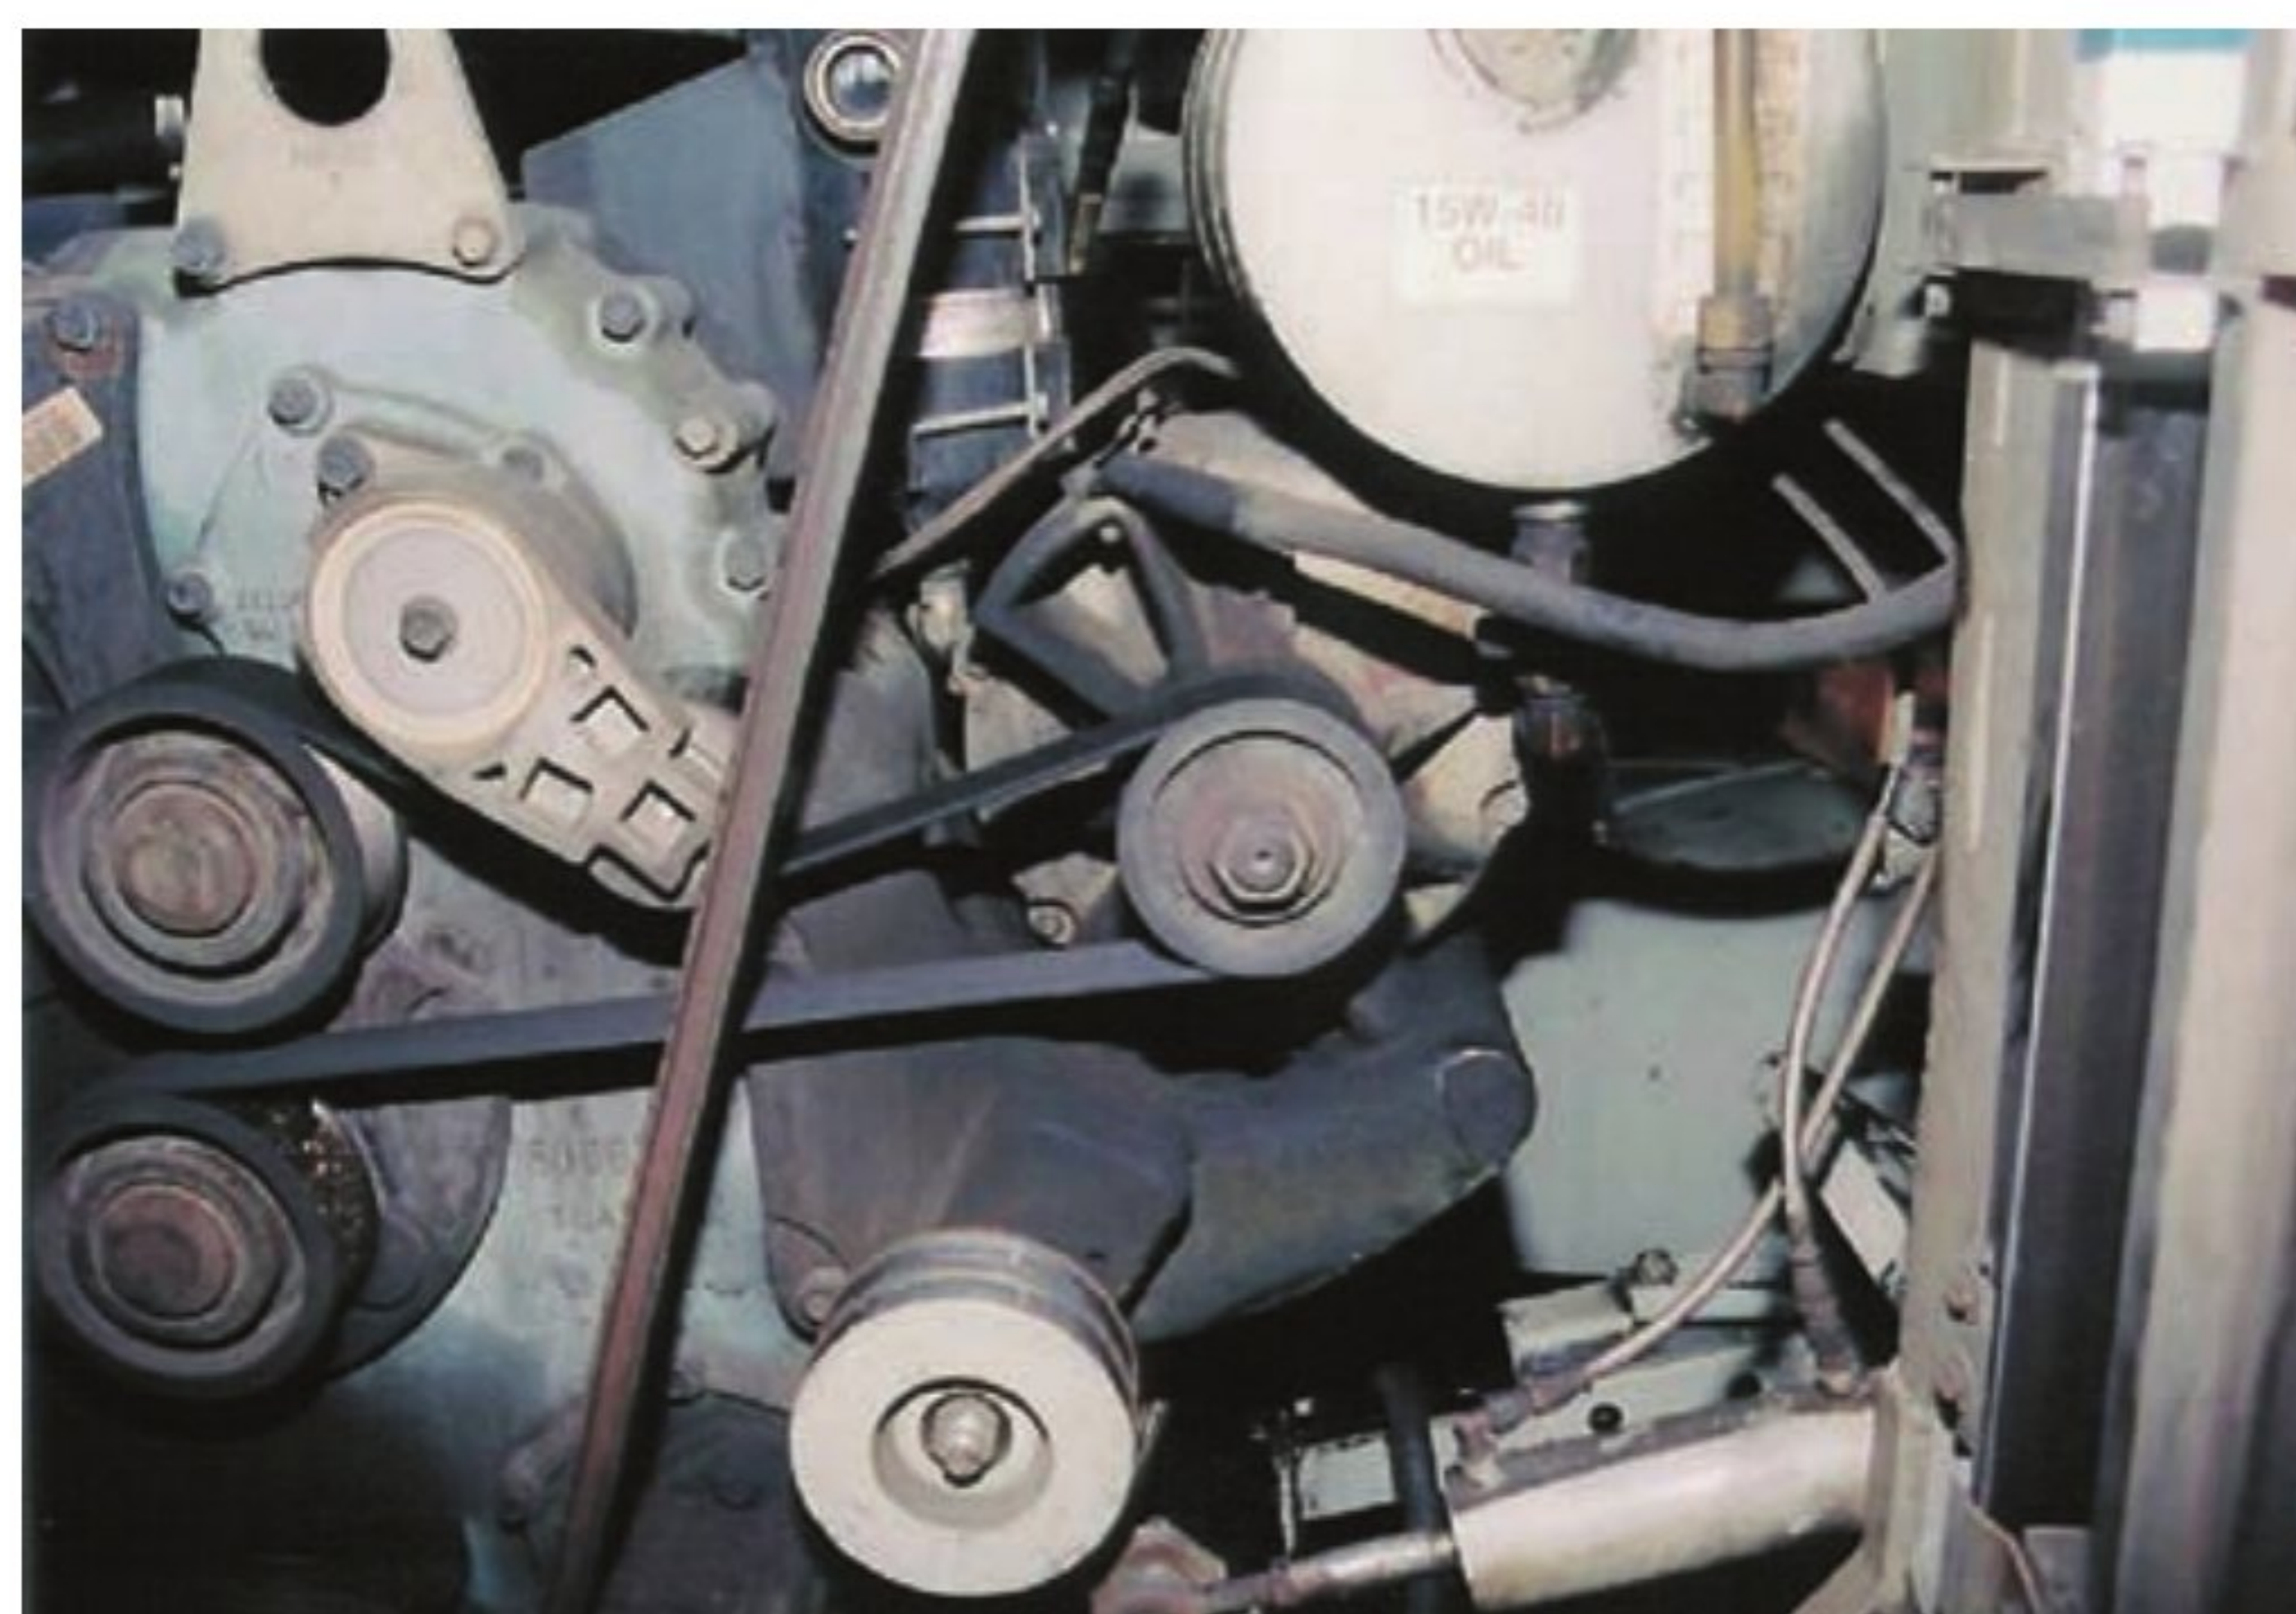
Photo 3A: 50-DN, Series 60

nator similar to an automotive application; but larger. The typical varieties are a Delco 50-DN (Photo 3a) or an air cooled dual Bosch T1 (Photo 3b) configuration. The author must stress that these manufacturers are not being singled out for any particular reason; however, they are the most commonly found units within this type of vehicle. For most applications, the charging system for the motorcoach produces 275 amperes or more — as much amperage as a typical single family home may have. With this, the alternator (and system) carries great potential as an ignition source.

Typically with a 50-DN installation (Photos 3a & 3c), the B+ (direct battery feed) cable is routed to a large stud on the back of the alternator. This in turn is held in place with a nut (to the stud) along with various clamping methods to secure the cable end from any movement (Photo 4).

These connections must be quality checked after the alternator has been installed and inspected periodically as

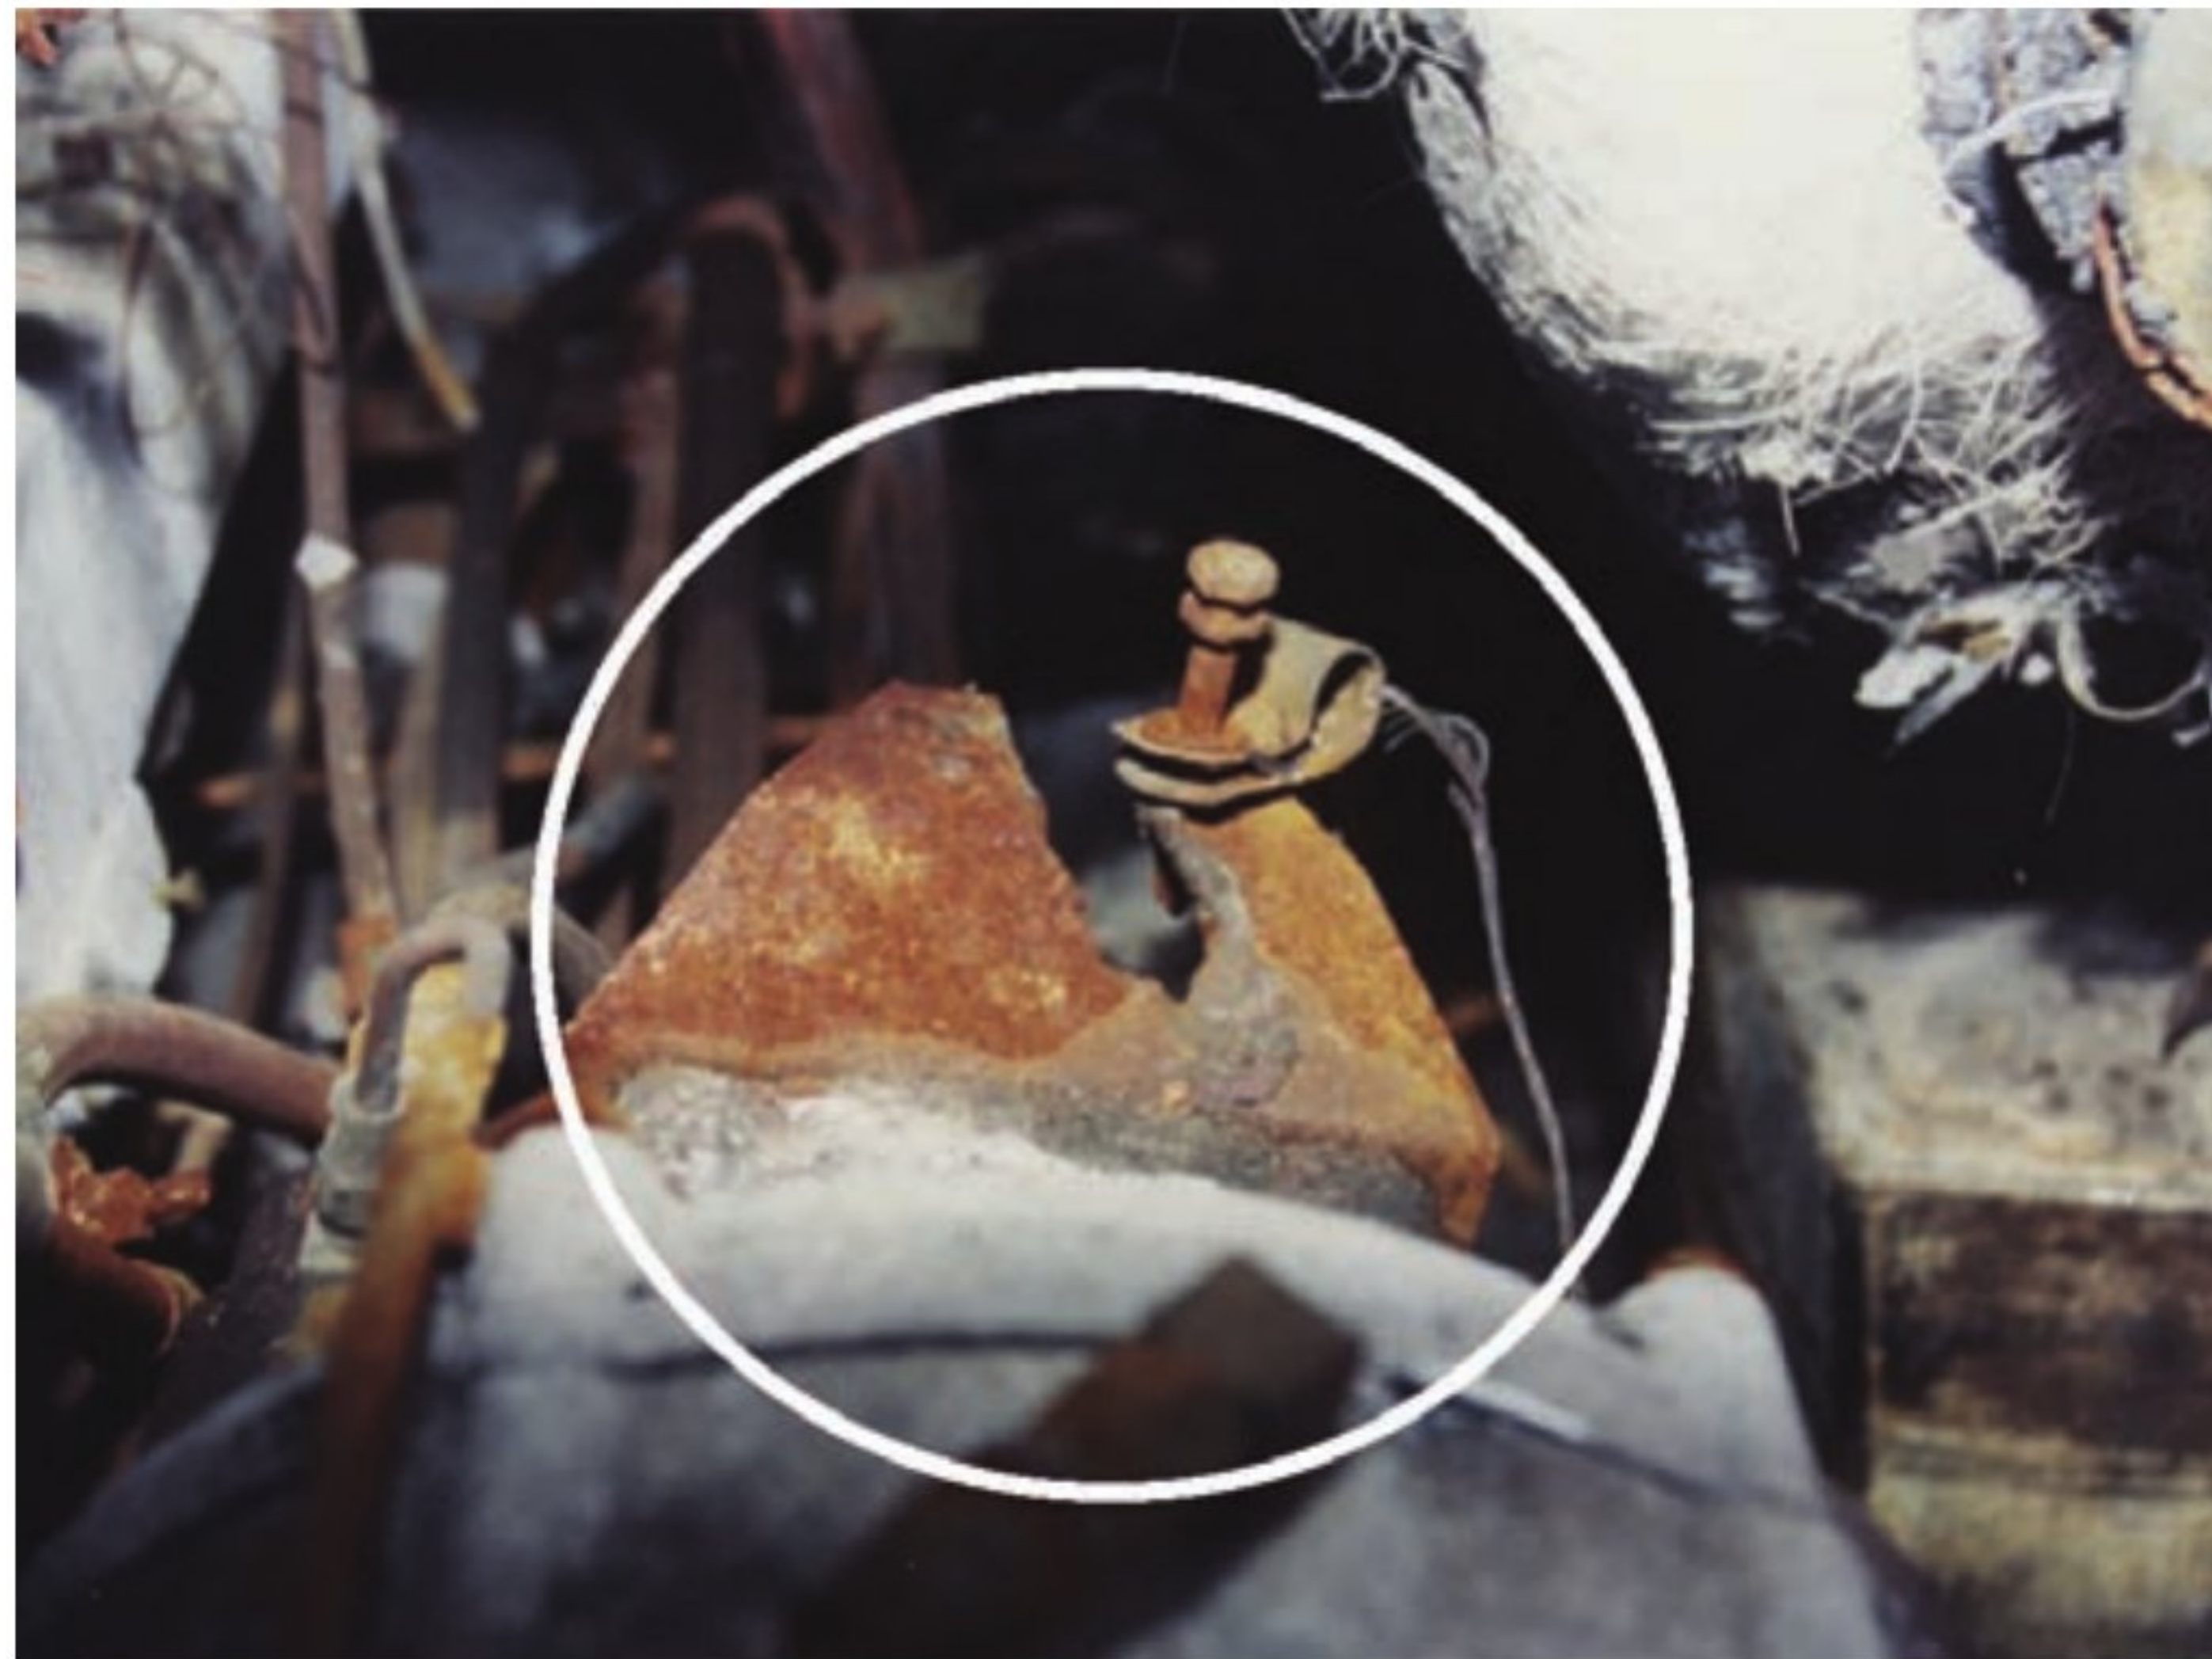
Photo 5: 50-DN, B+ Bracket, Series 60

lator material surrounding the stud at its base, internal to the alternator, or wear through the cable insulation locally and make unwanted contact with the support bracket. When this occurs the cable can act similarly to an arc welding machine and cut its way through the bracket (Photo 5).

Once the B+ cable end is free, the cable can drop, making contact with a ground source, resulting in a sustained duration spark. This is exceptionally critical in that with some engine applications the alternator is installed above and on the fuel side of the engine.

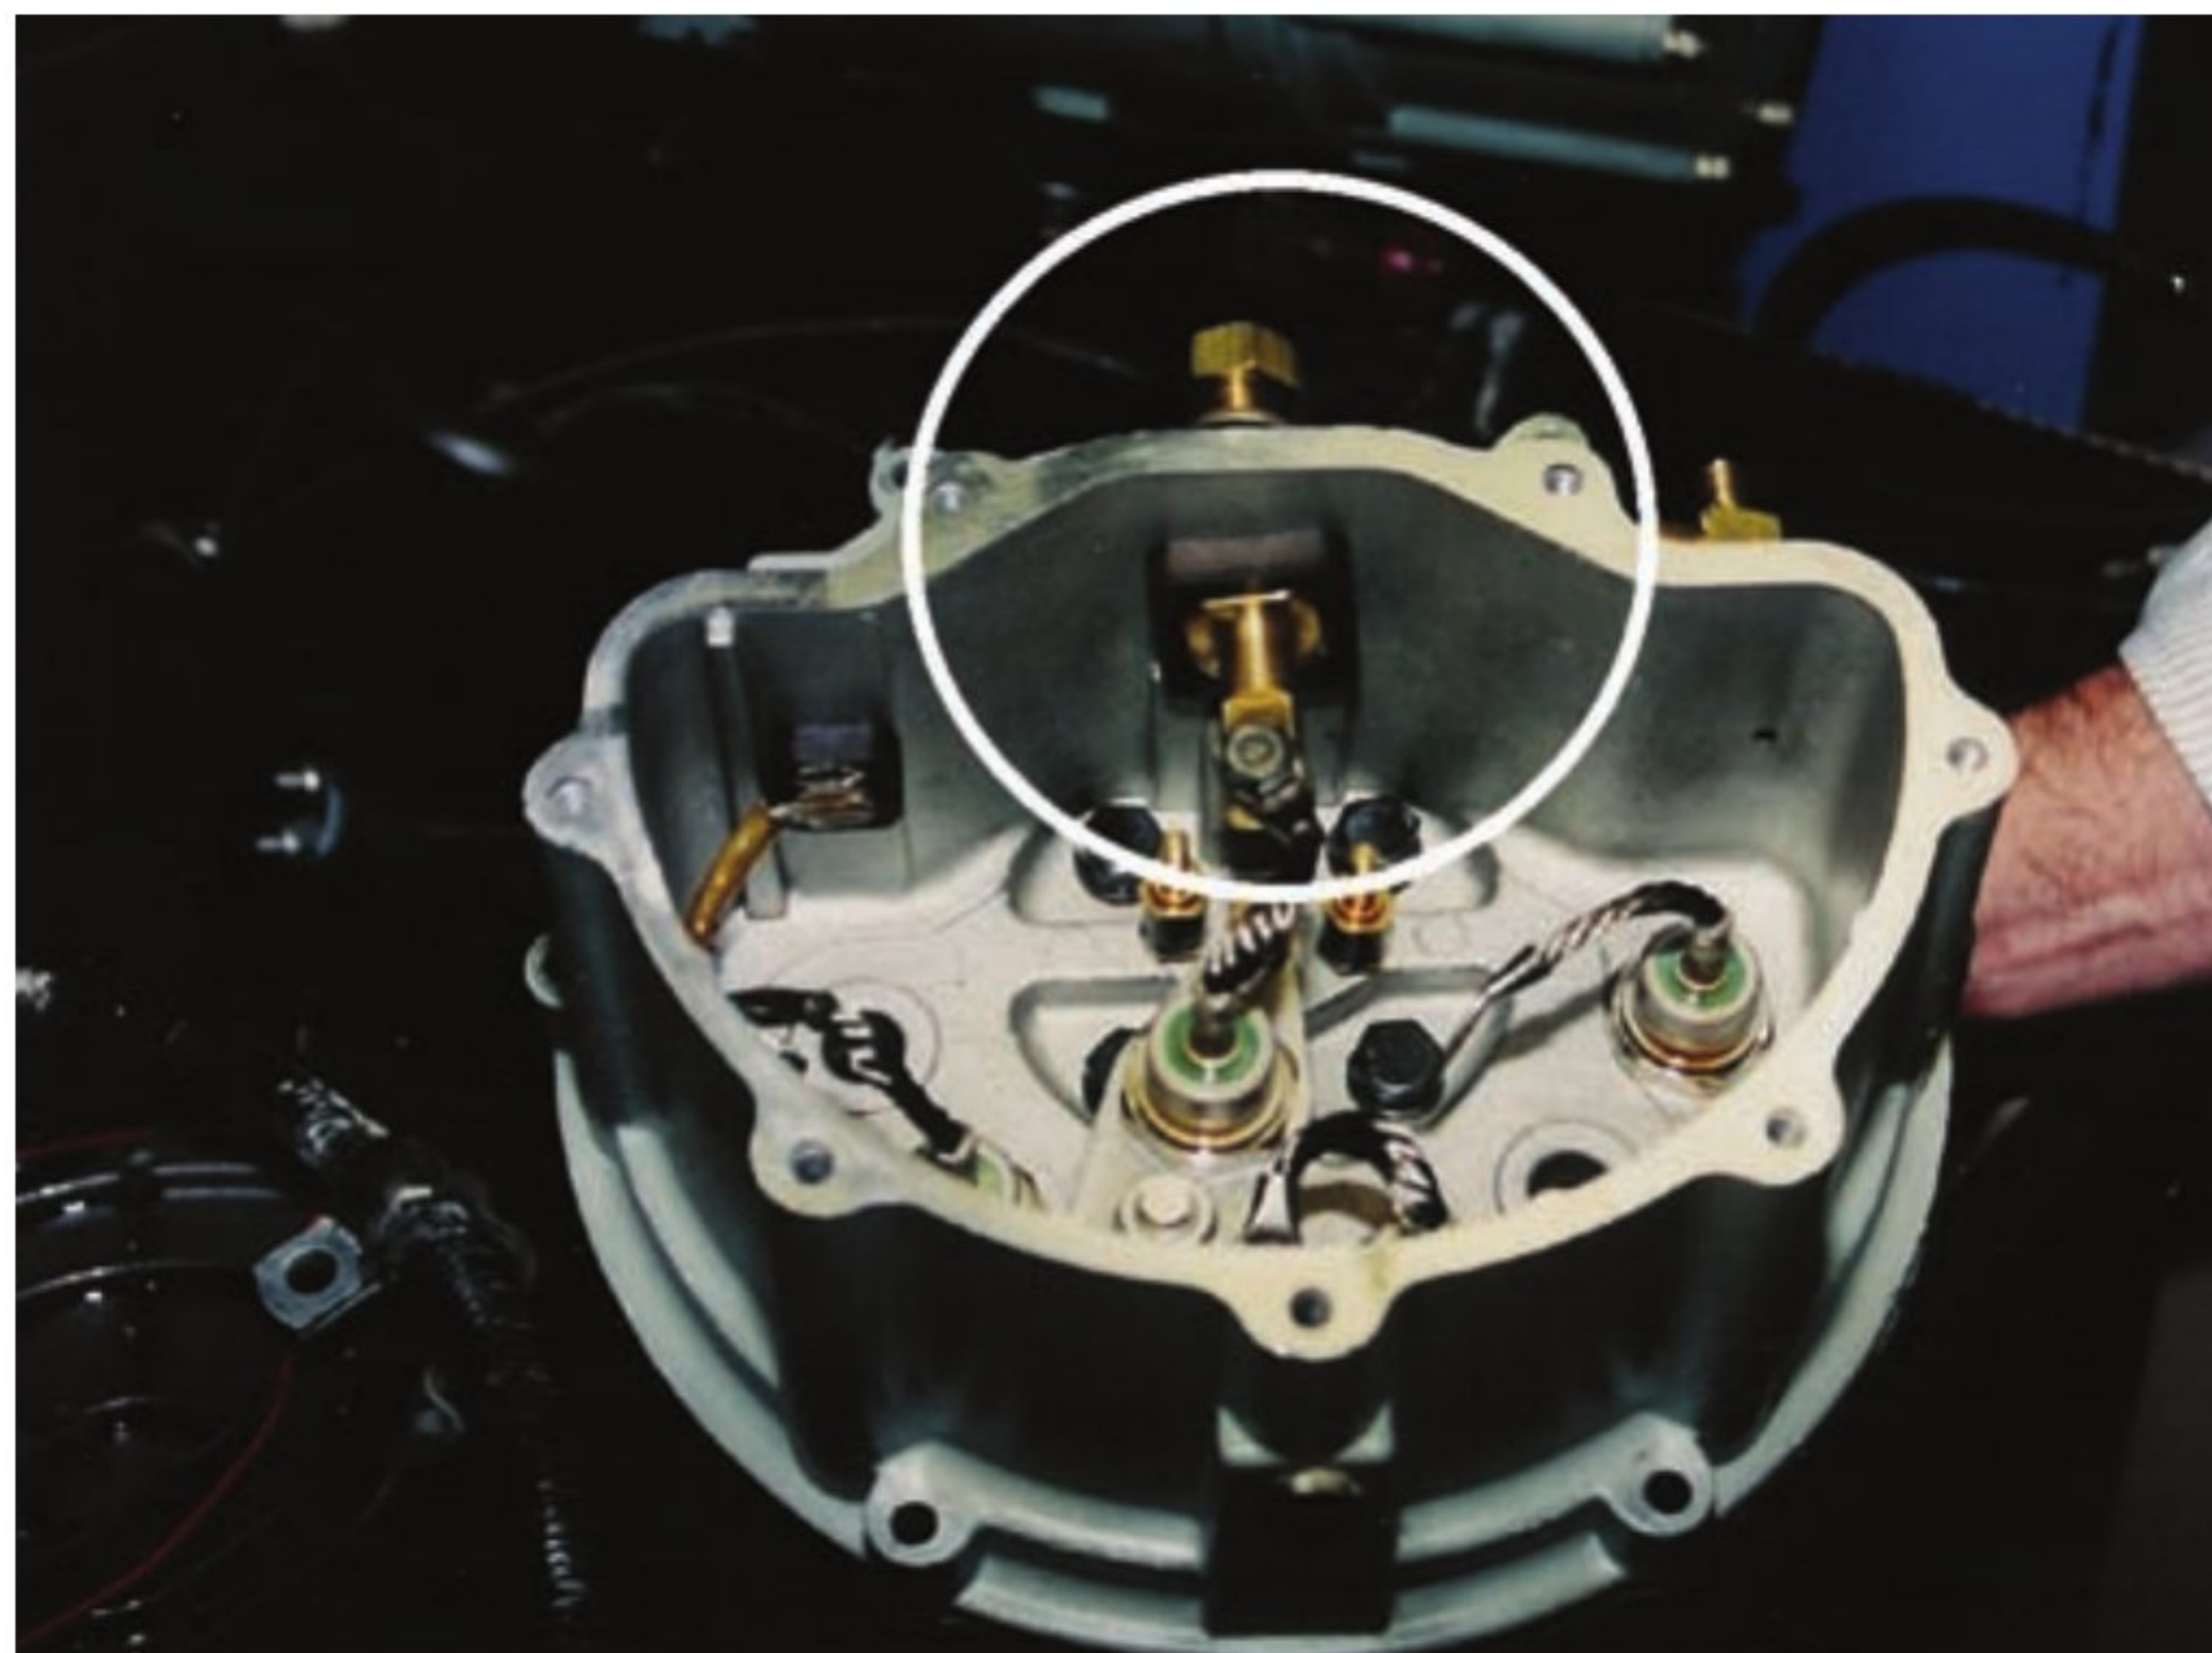
Photo 6A: 50-DN, B+ Stud Insulator

In addition to the cable and its' mounting system there is another potential fire hazard. When installing the B+ cable to the stud (50-DN) the proper torque must be used to ensure that the plastic material (internal insulator) is not broken or compromised in any way (Photo 6a). If this nut is over-torqued, or otherwise installed incorrectly, it could lead to a loose stud subsequently leading to an ignition source and fire (Photo 6b).

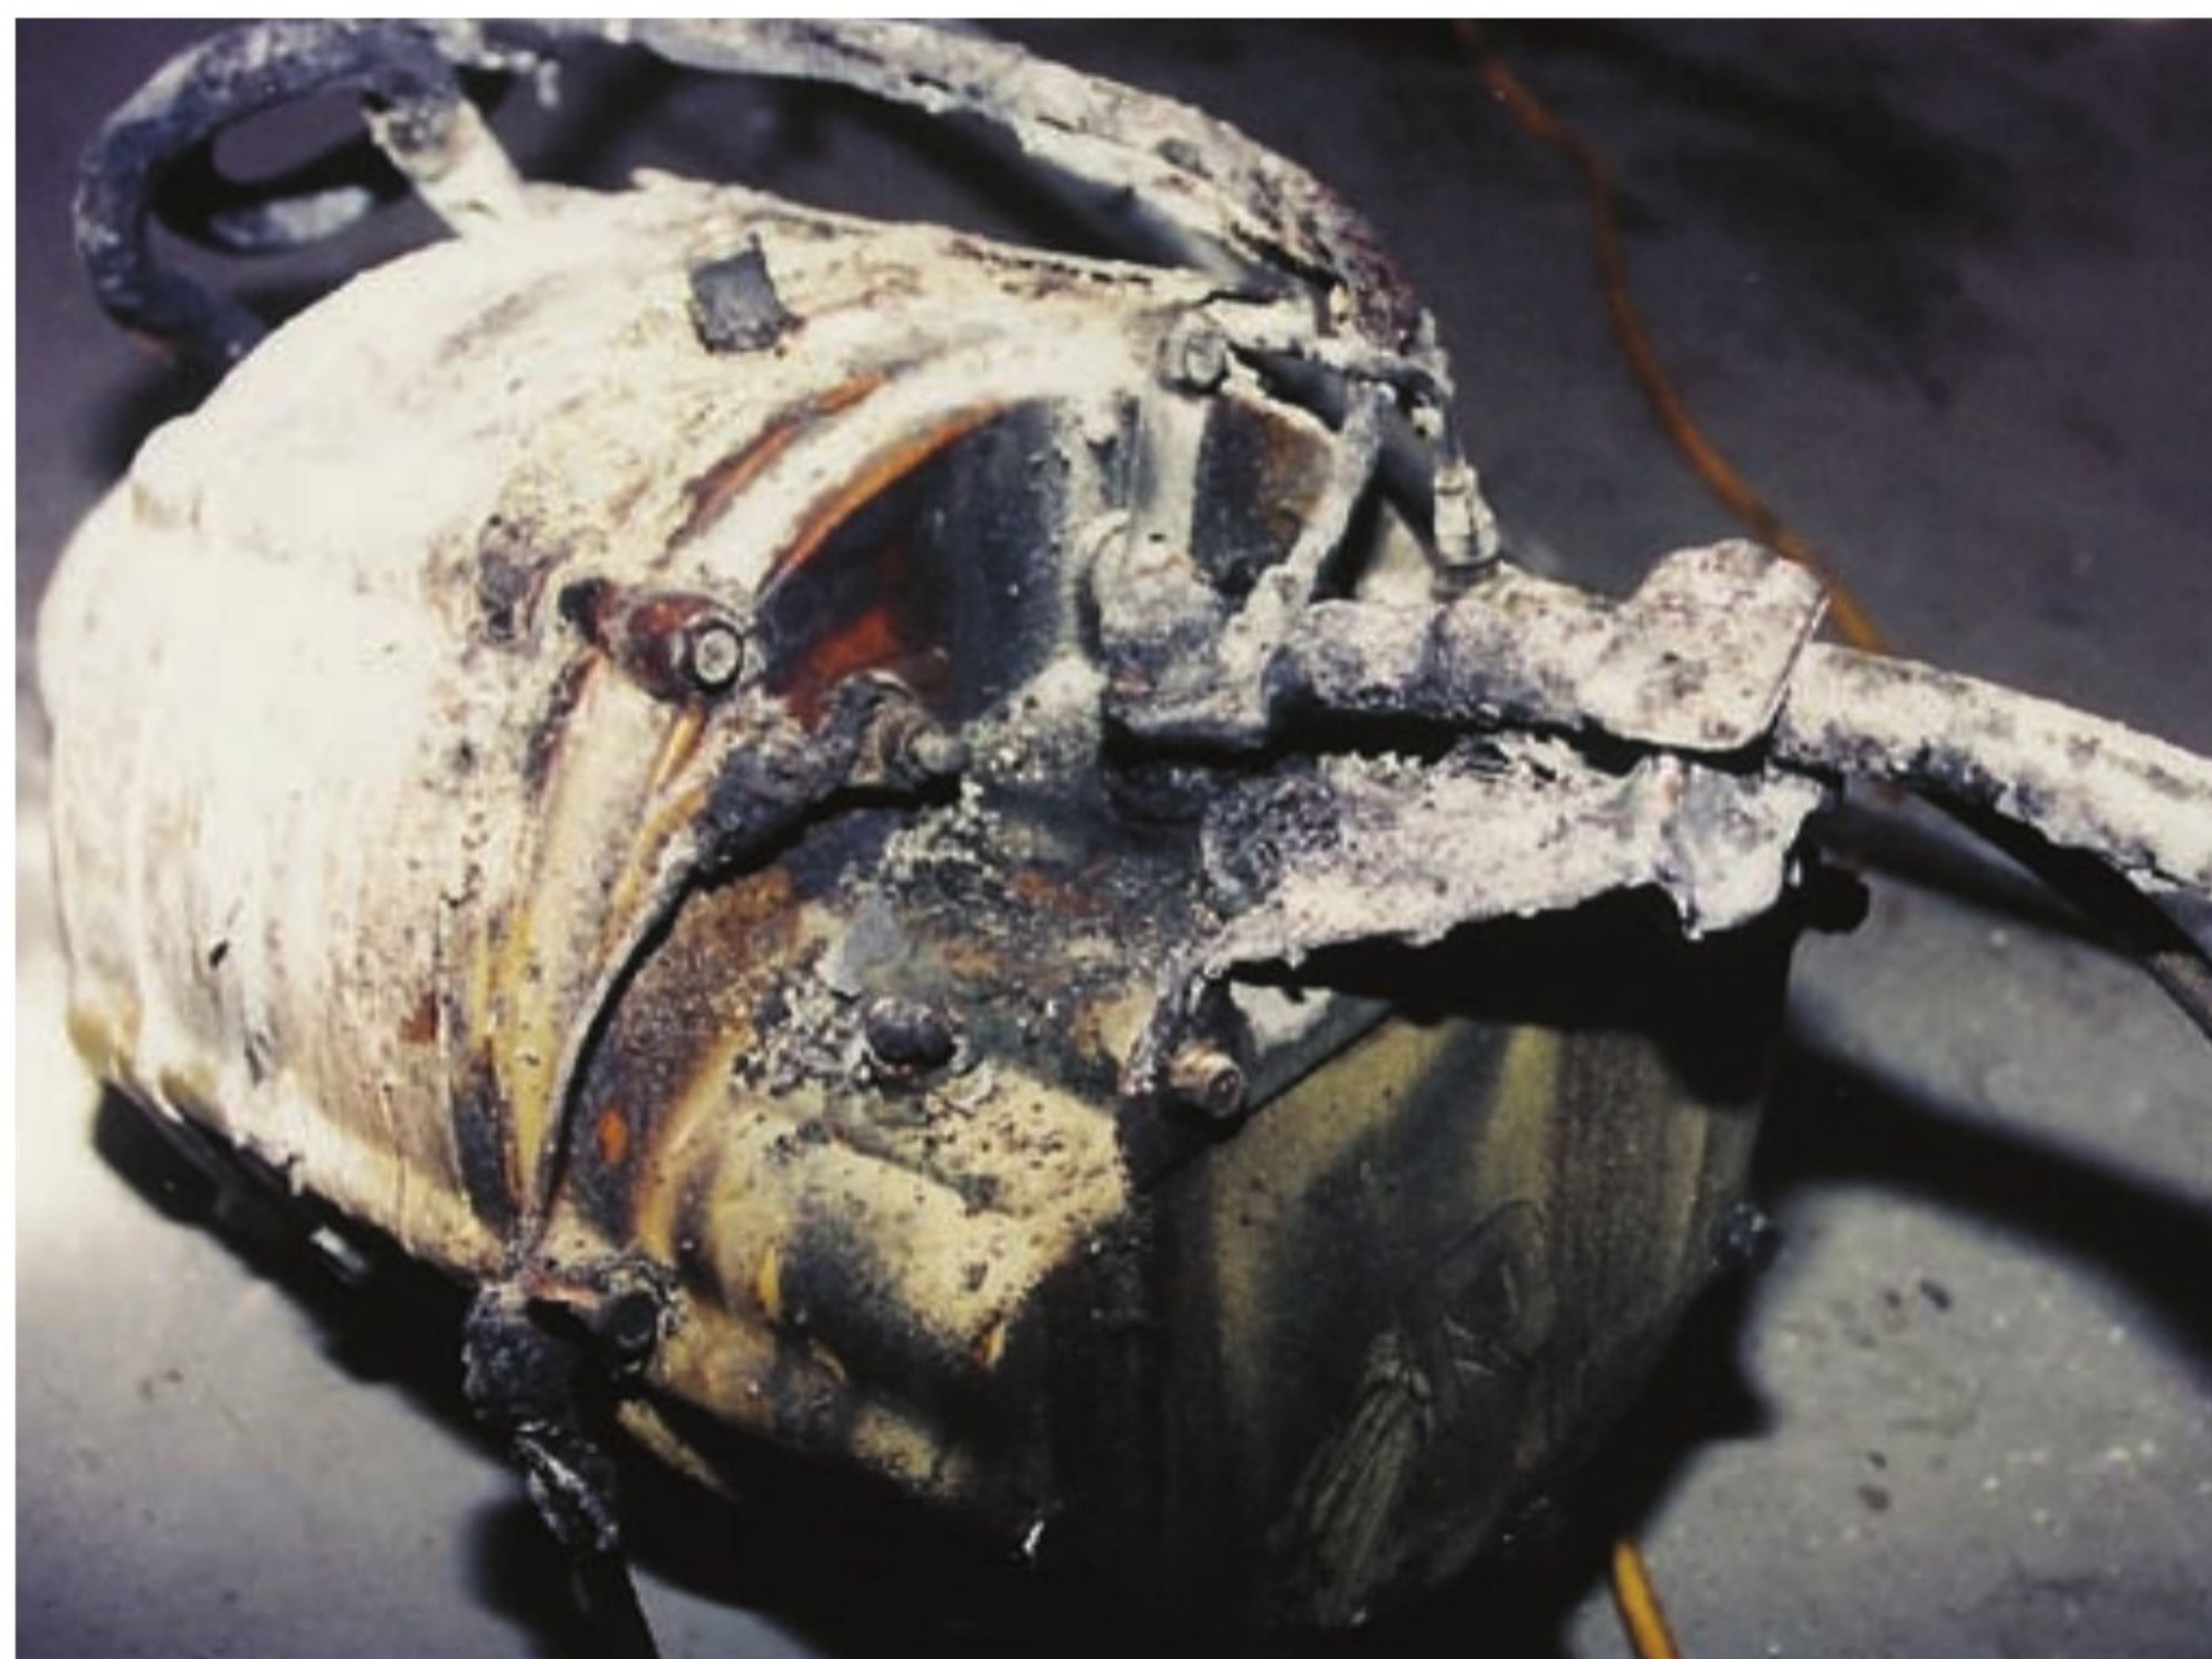
Photo 6B: 50-DN, Result of Failed B+ Stud Insulator

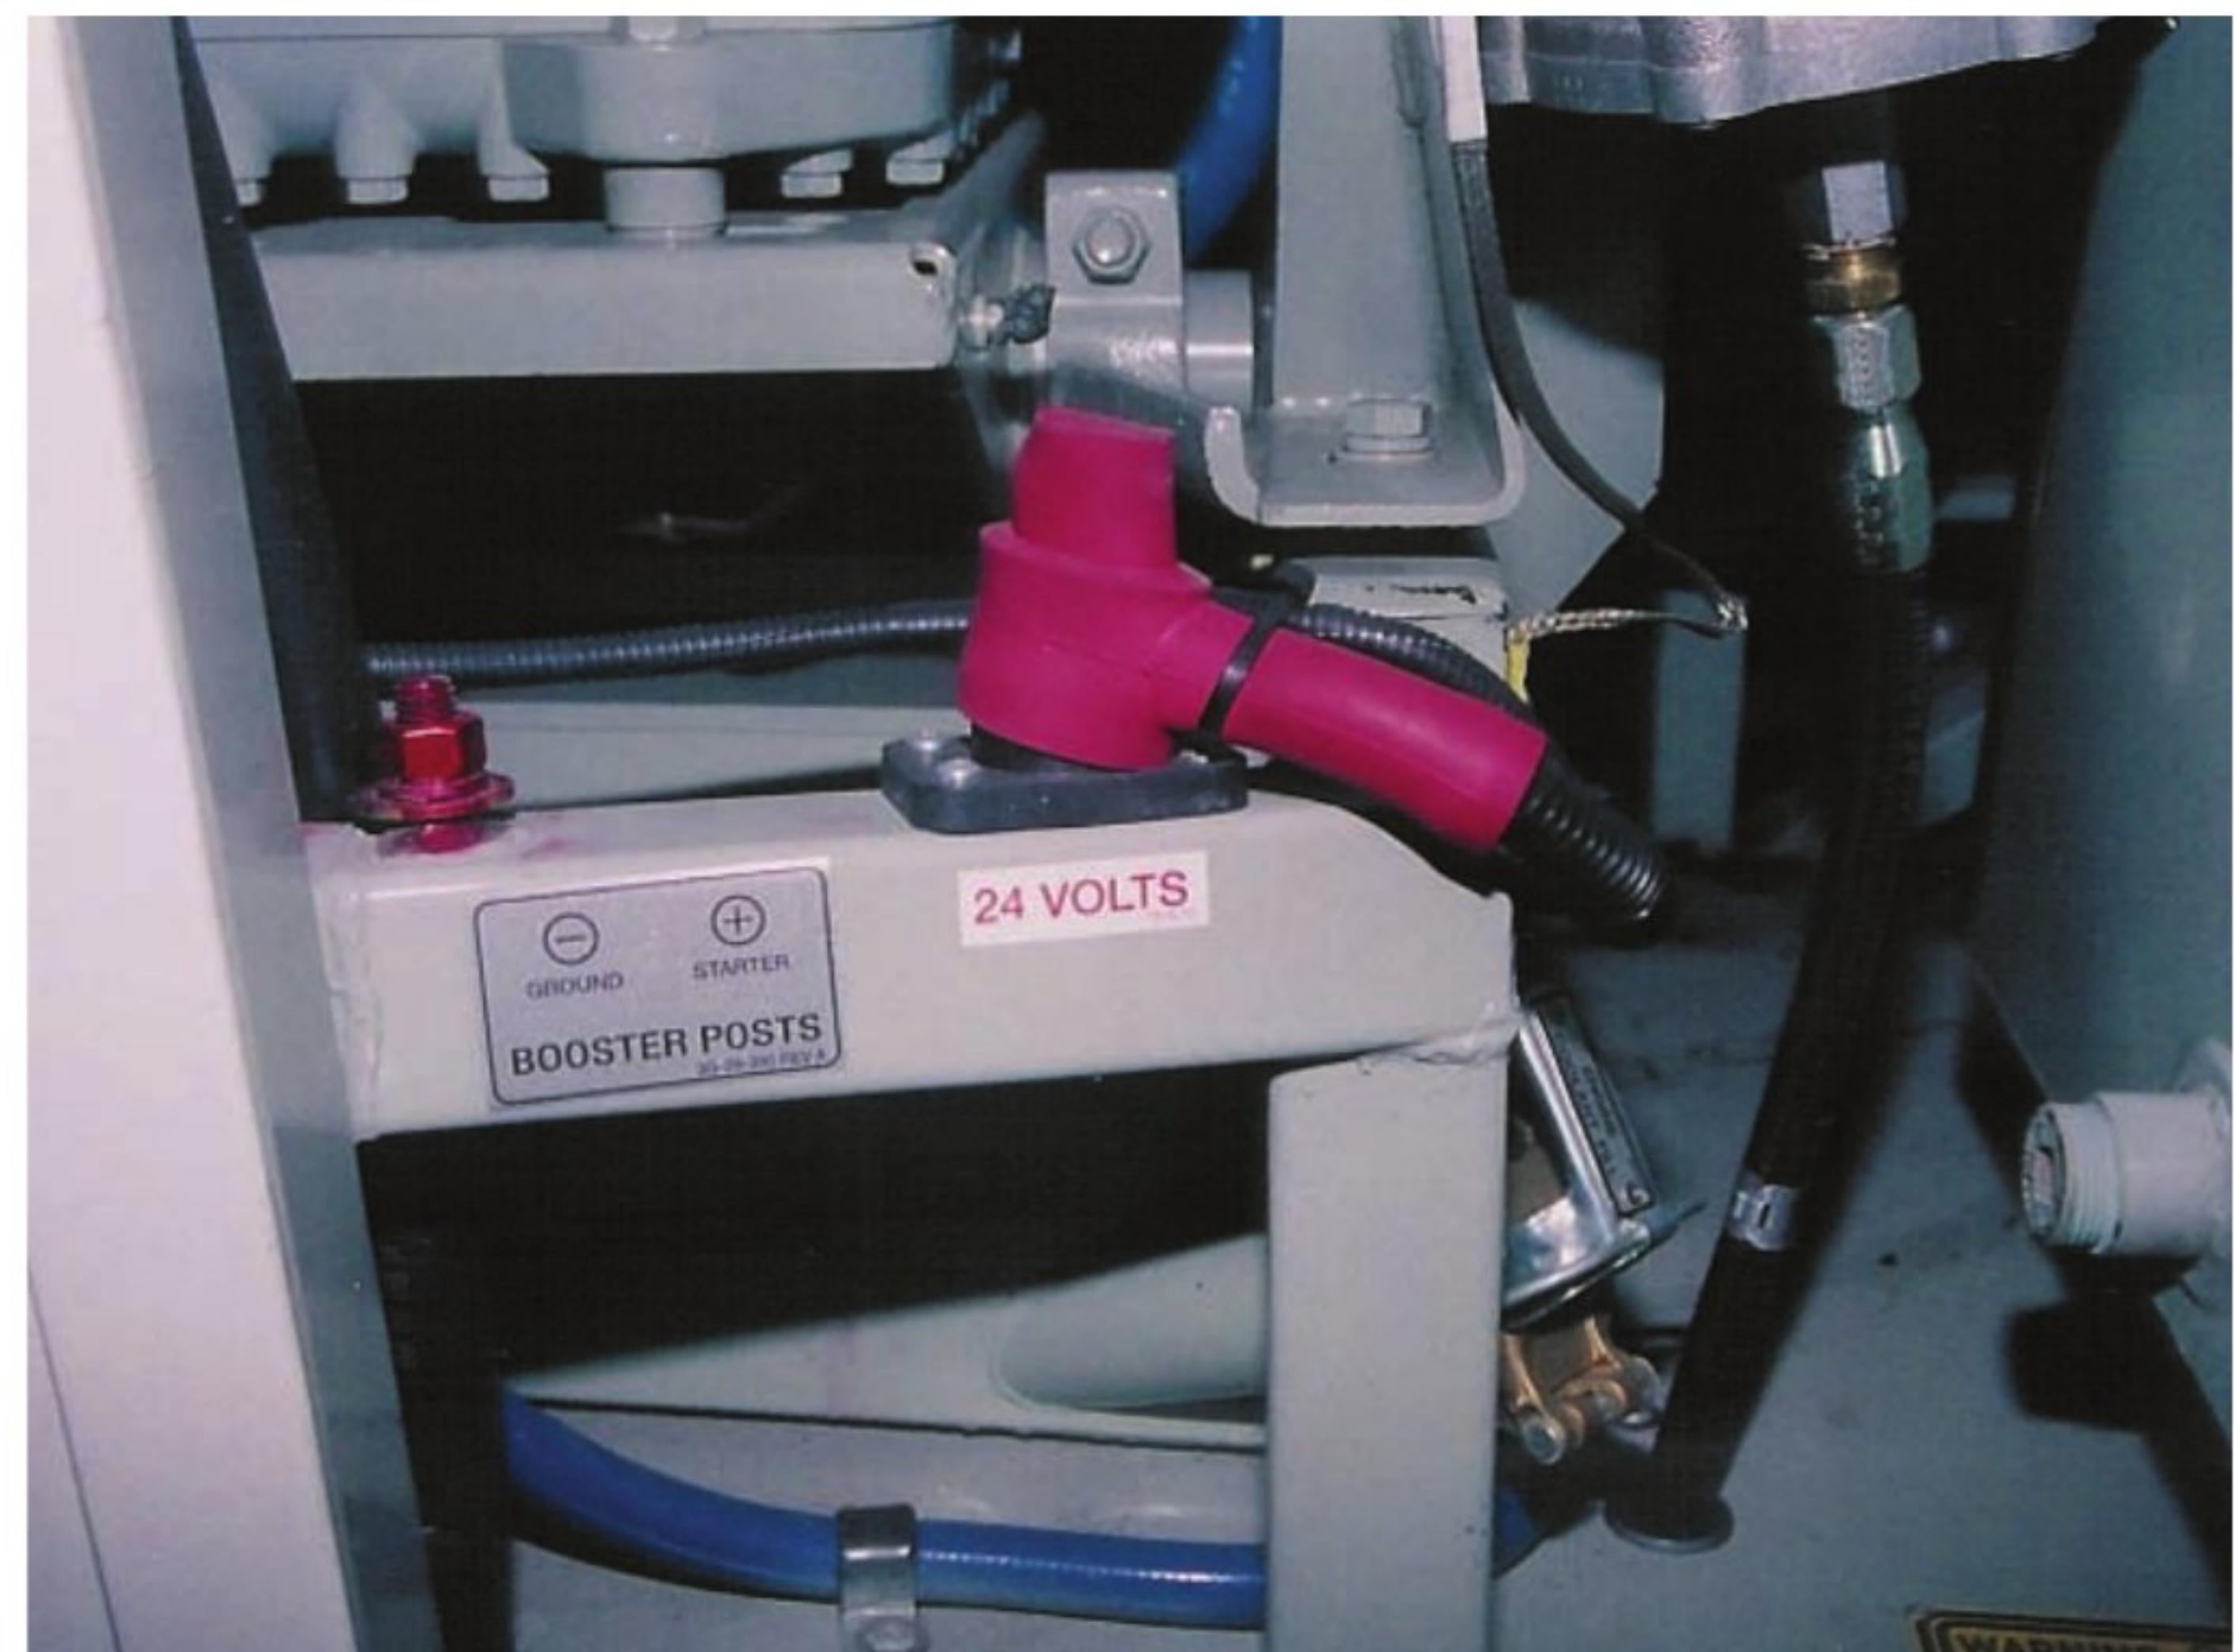
Photo 7: Remote Jump Post

**Remote Jump Post:** With some applications a convenience feature is provided in the engine compartment for "jumping" a disabled vehicle. This is typically a positive (+) cable running from the starter to an exposed stud. These connections must be inspected and maintained to provide integrity. Additionally, this stud is covered with a flexible rubber boot (Photo 7).

This boot must be in good condition and over the positive (+) stud at all times. A loose jumping stud/cable can create a sustained duration spark similar to the alternator B+ cable.
