# TECH TIPS

**Applications:** Various Coach Applications

# WHY MOTORCOACHES MAY BURN

(A MECHANICAL ANALYSIS)

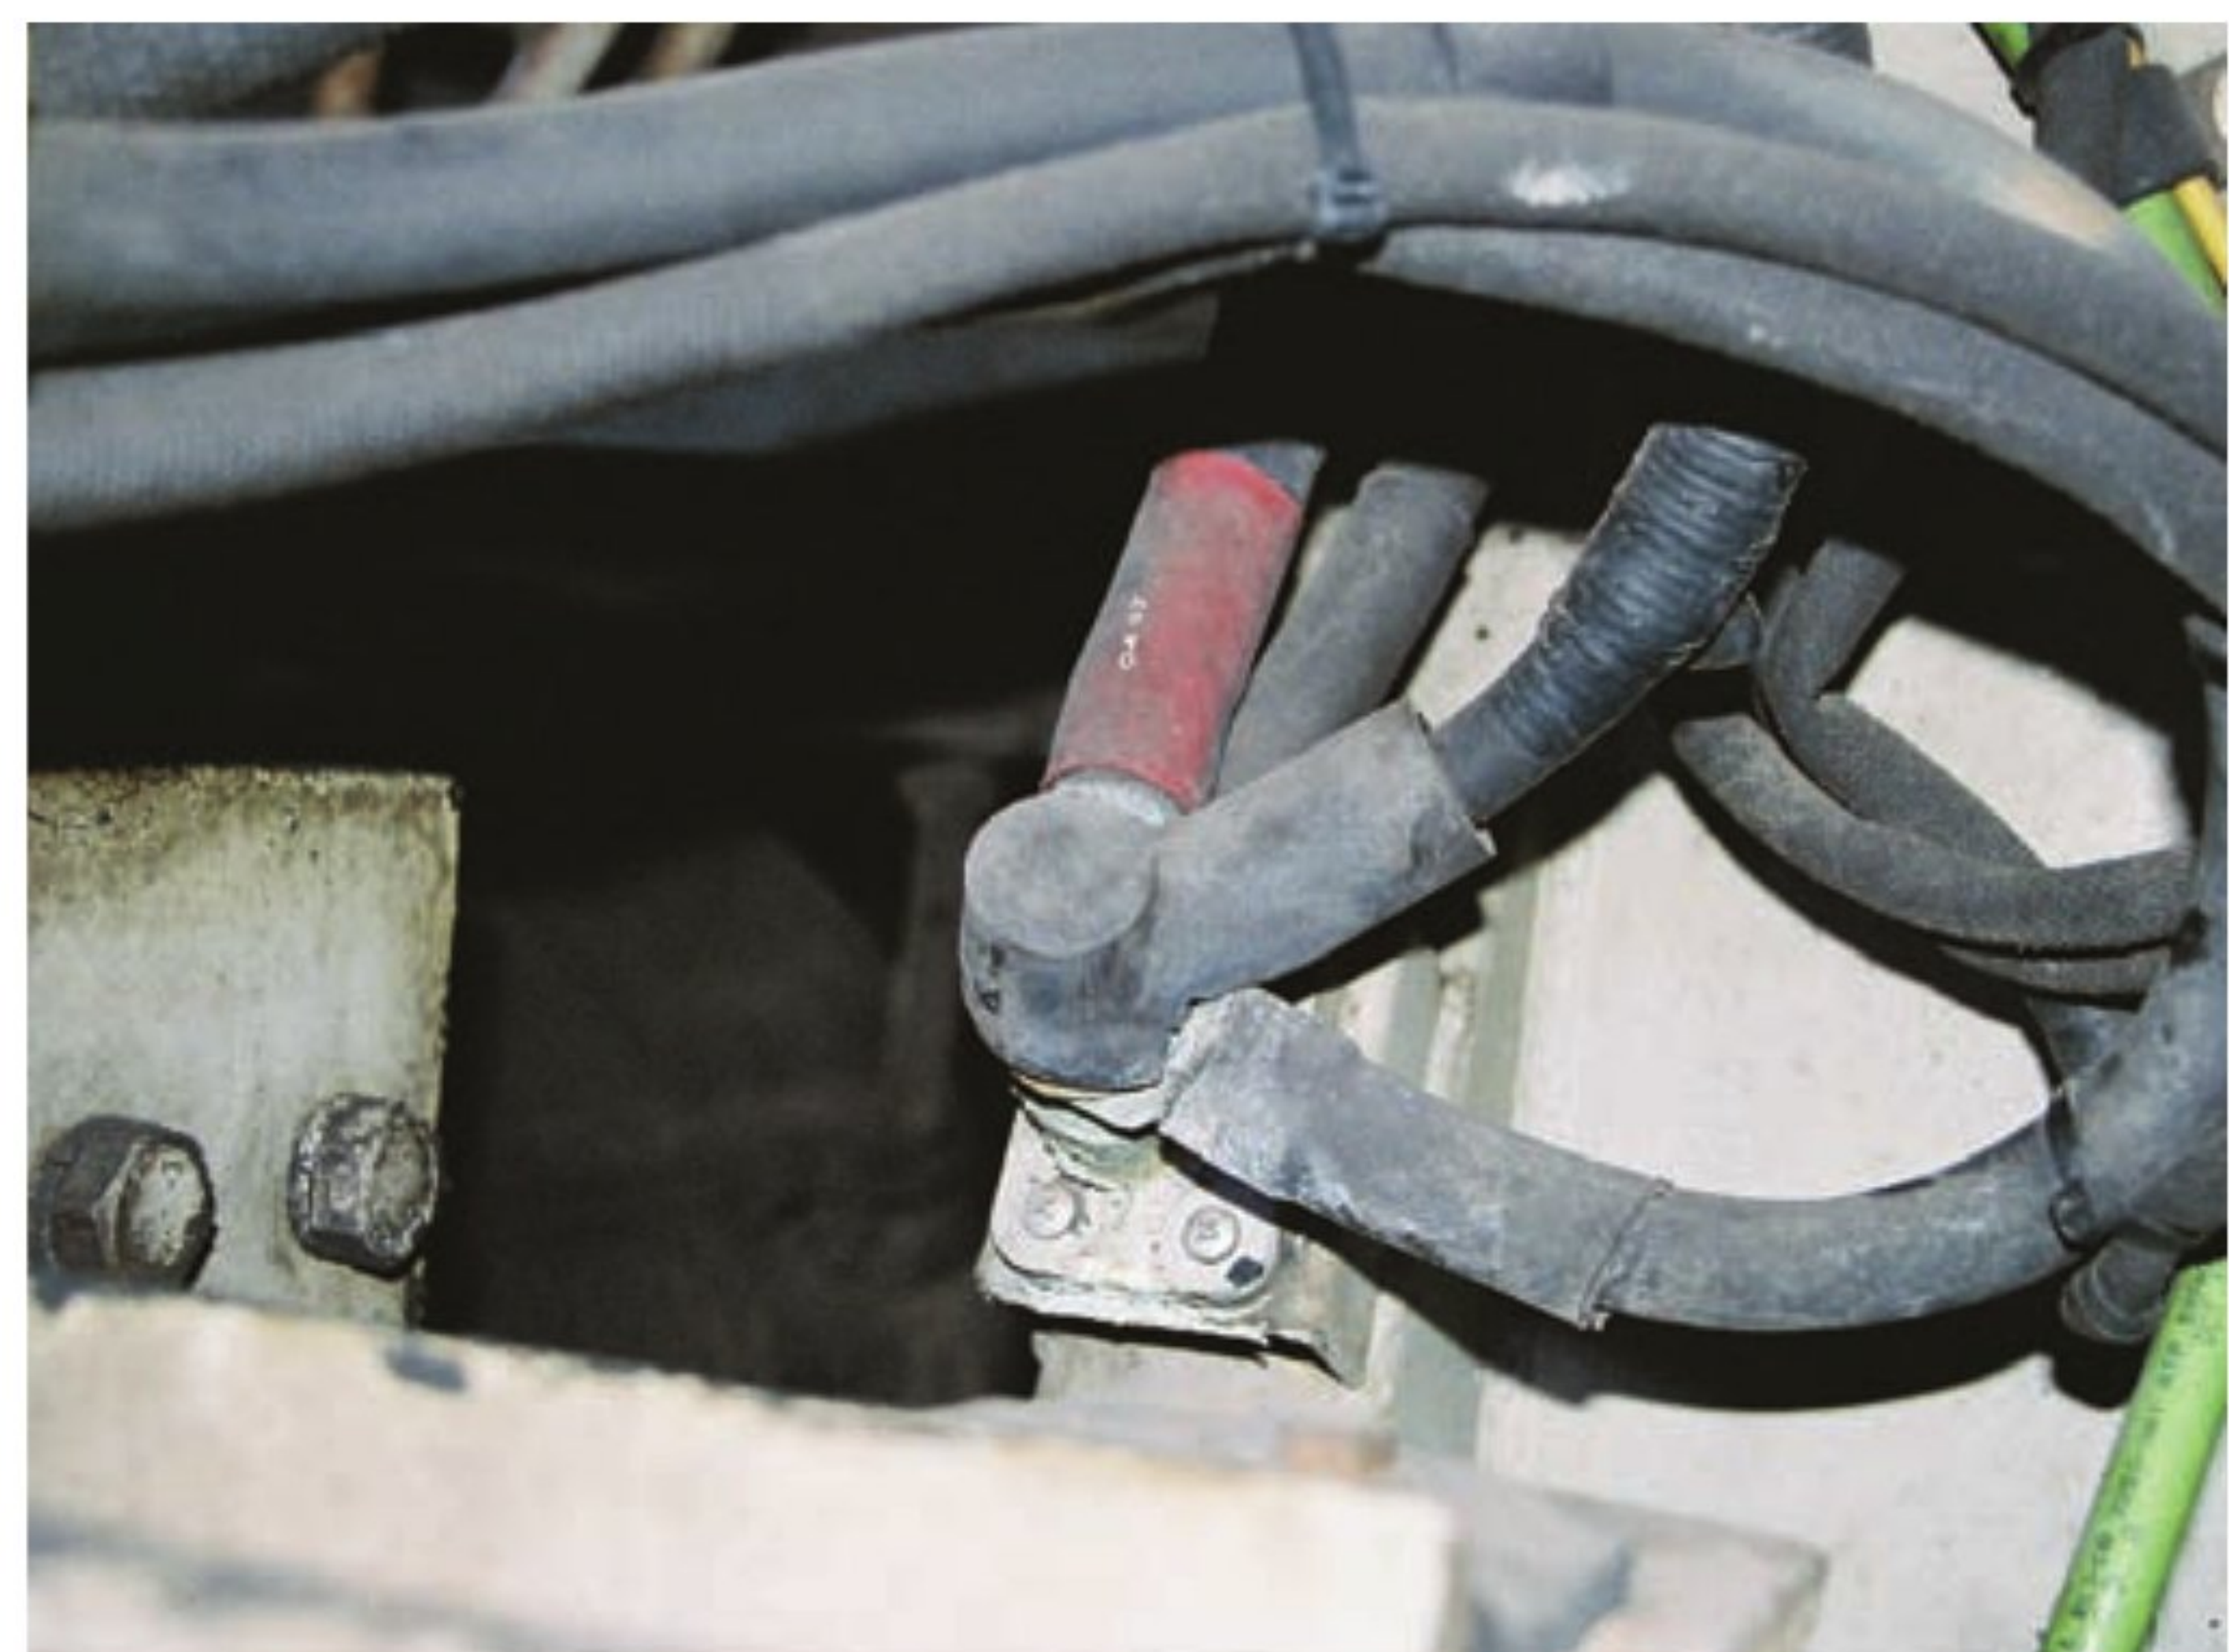
Photo 8A: Bulkhead Connection 50-DN

motor. However, this is initially routed to a bulkhead junction (Fig. 3; Photos 8a & 8b); again this is a heavy cable and must be properly connected and supported in its mounting.

Care must be given to the cable condition, cable to starter connections, as well as its' routing so that this B+ cable is not making unwanted contact and potentially coming in contact with ground as a result of an insulation breach.

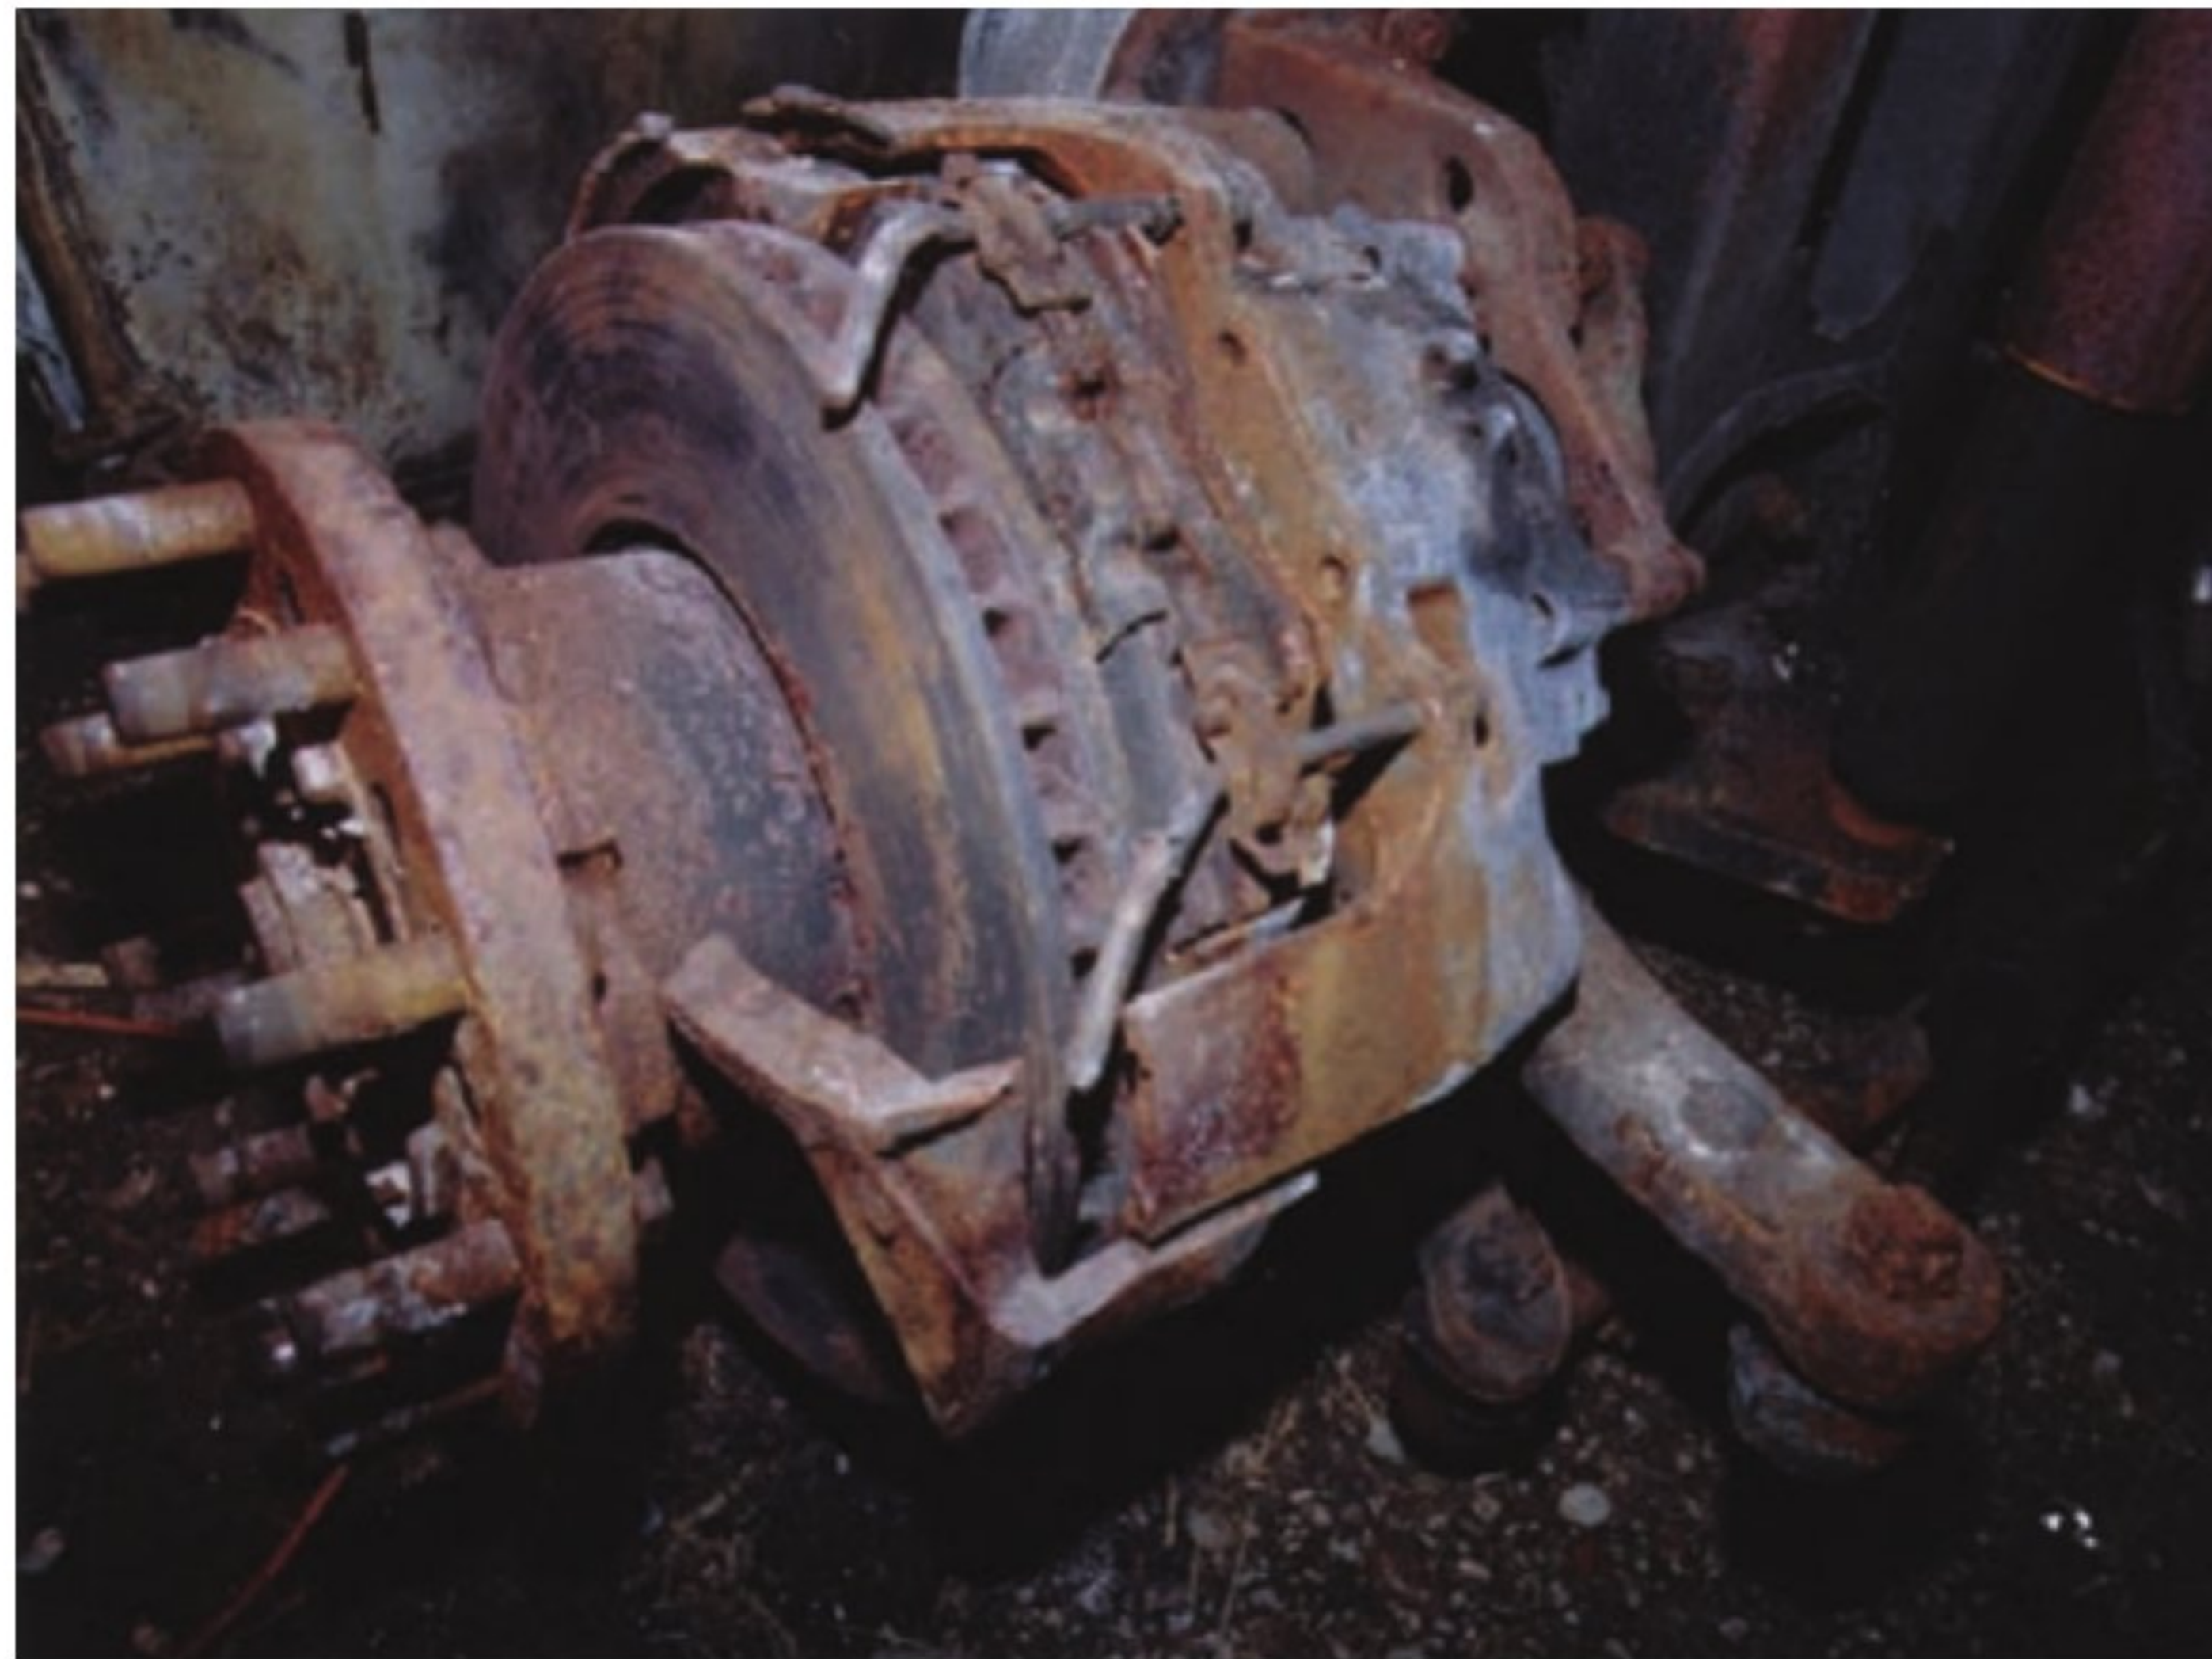
Photo 9: Disc Brake (RH Tag Axle) [Involved]

An additional risk exists, with disc brake applications, during a wheel bearing/hub failure. That is, as the outer bearing begins to fail, the hub load is transferred from the outer bearing to the brake caliper, brake pads and rotor. Once the outer bearing has failed completely, no longer able to support the hub load, the caliper, brake pads and rotor are then supporting that particular wheel end (Photos 9 & 10).

Once the brake caliper begins carrying the load, at that particular wheel end, the surface temperature of the brake pads and rotor (or drum) rise well above the auto-ignition temperature of the surrounding combustibles (due to friction) and eventually igniting them. The combustible material typically ignited by this failure mode is the tire(s). Tires generally revert (melt) at approximately 250°F and catch fire over the 600°F mark. It is common, although not mandatory, for the tire fire to occur when the vehicle comes to a stop. This is the condition with the least amount of air flow circulating around the brake rotors, brake drums and tires. Without air flow around these items, their temperature rises rapidly and is transmitted to the tire—subsequently igniting it. This concept of brake caliper/pad/rotor supporting the hub load can typically be seen by a thinner more worn outside brake pad as compared to the inner pad. This is due to the hub moving outward, away from the spindle. As a result of this temporary load support from the caliper, the

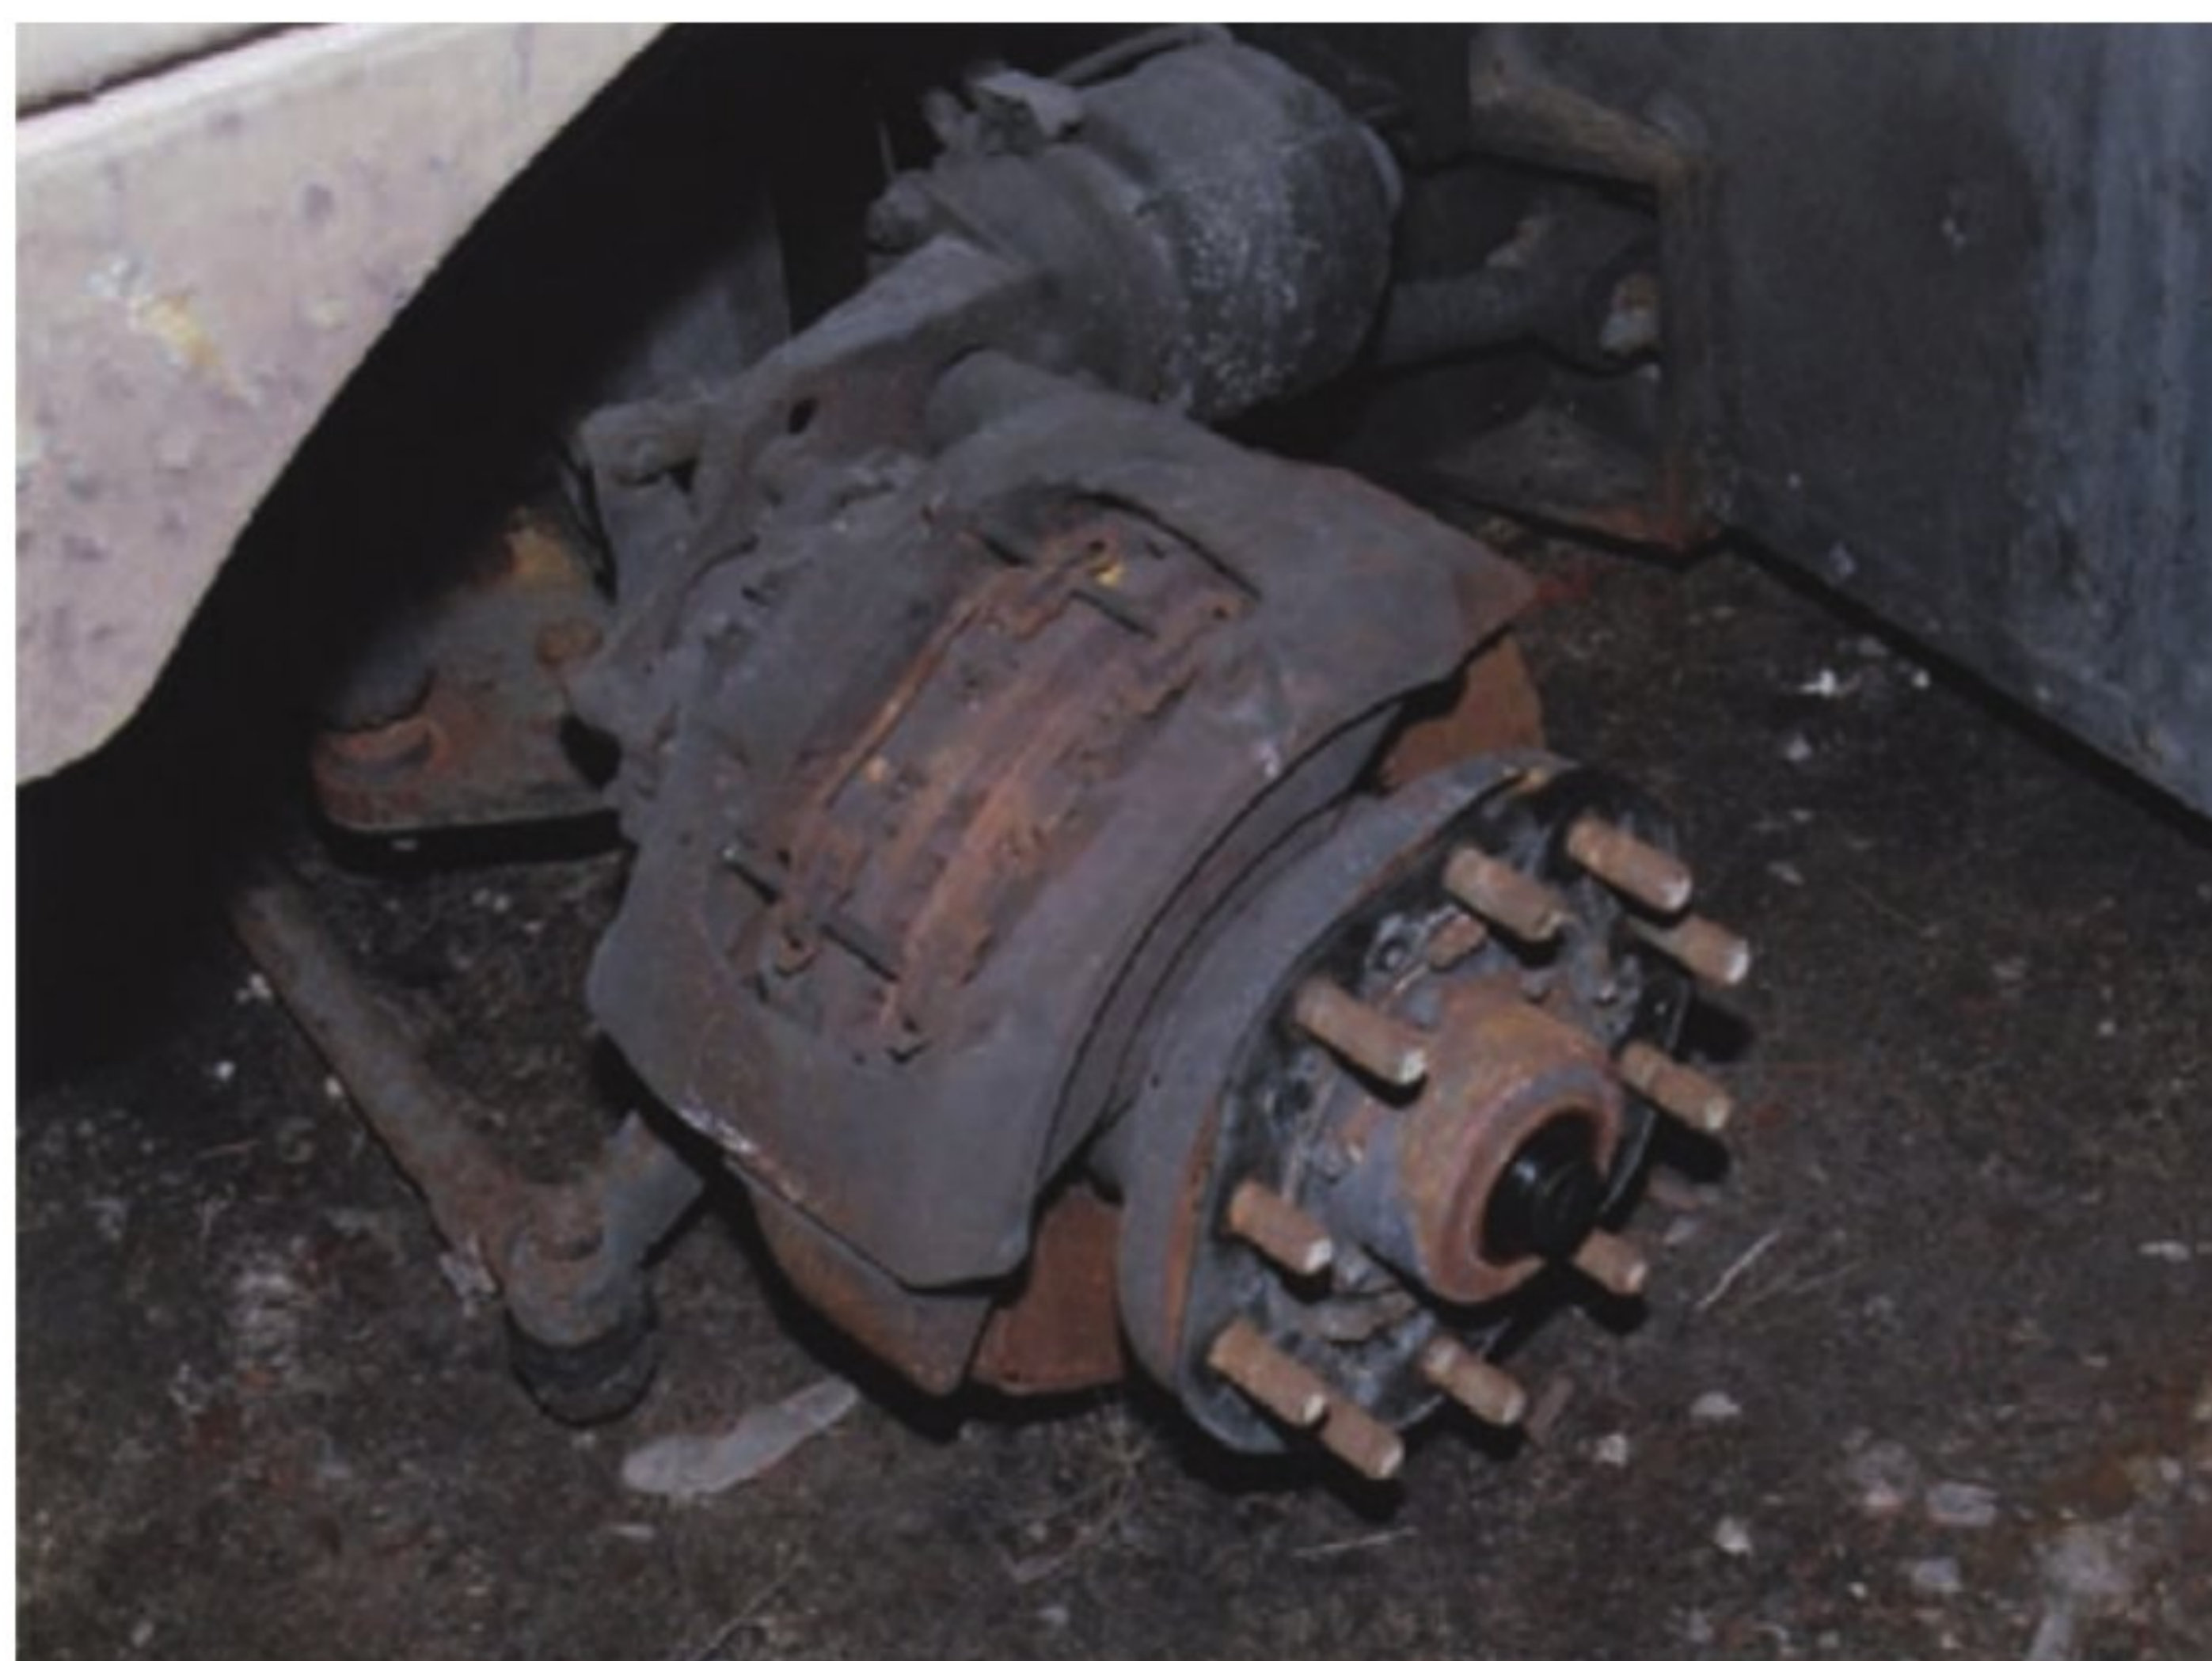
Photo 10: Disc Brake (LH Tag Axle) [Not Involved]

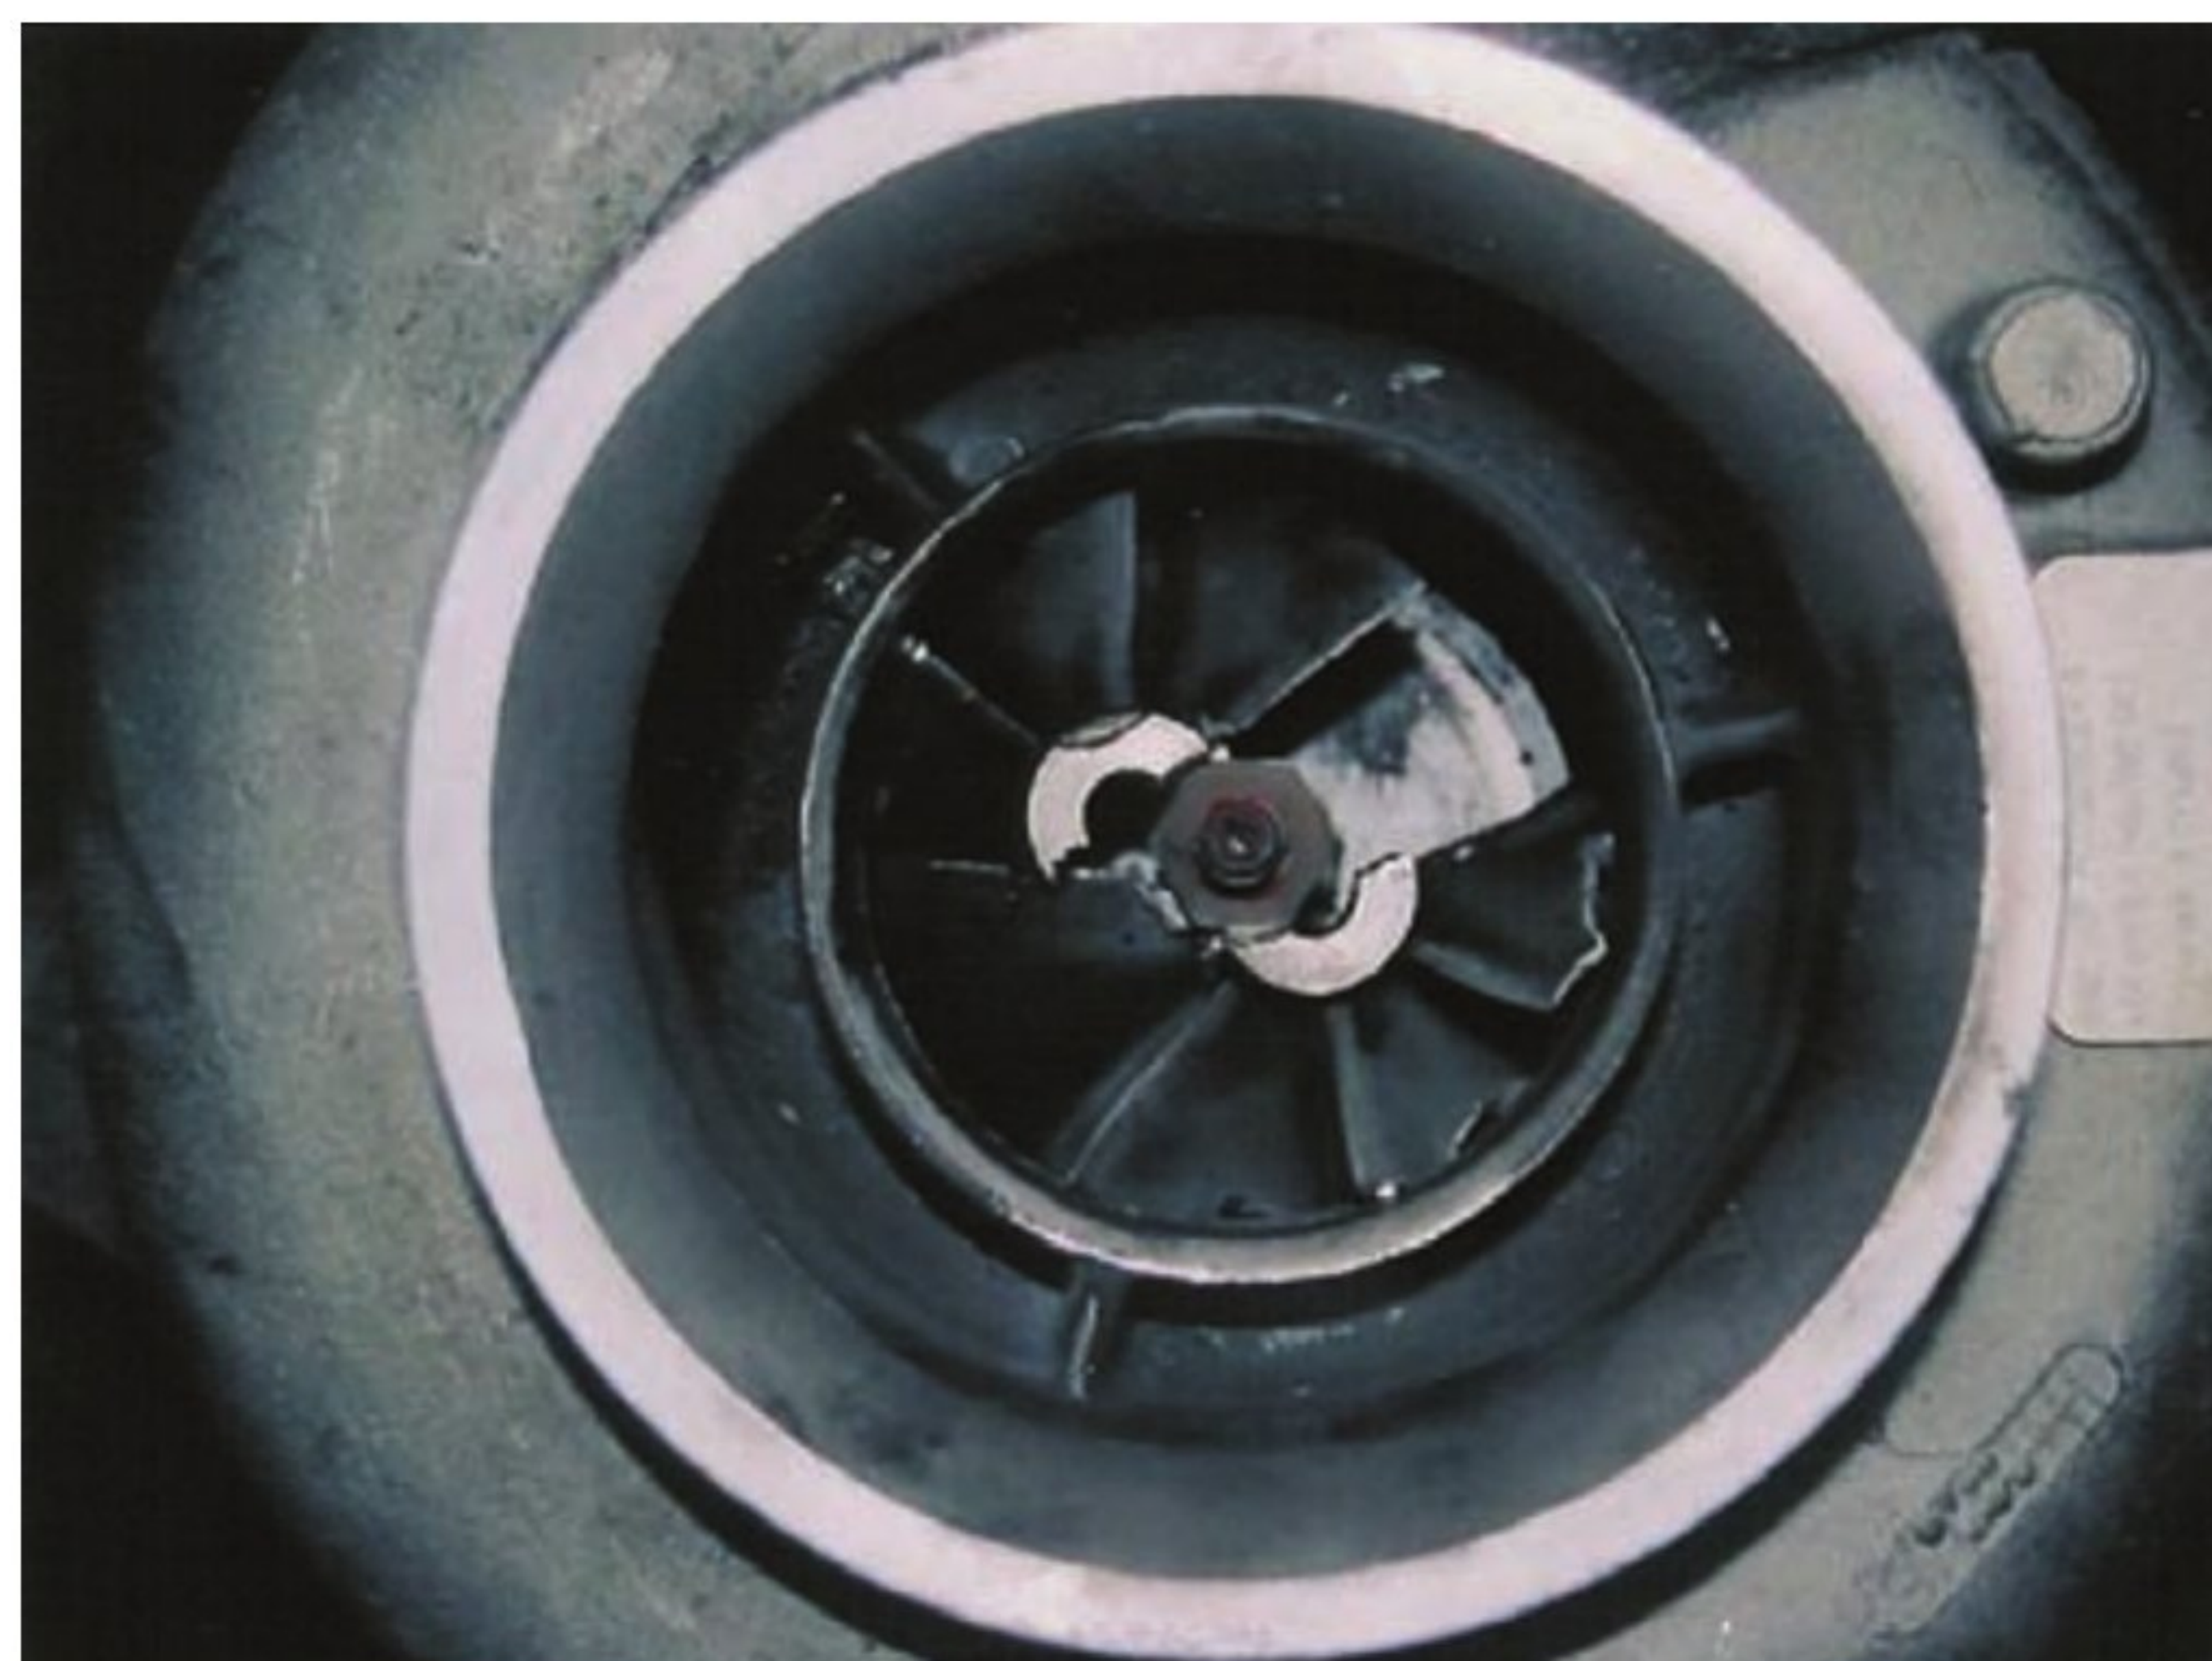
Upon a failure of this bearing system or an imbalance of either the turbine or compressor wheels contact is made within the turbocharger housing causing a rapid deterioration of the compressor and turbine (Photos 12 & 13).

Once the shaft has been re-oriented as a result of any one of the aforementioned failure modes, the shaft seal(s), which controls the lubrication oil within the bearing cavity, subsequently fails allowing oil to enter directly into the hot side (turbine) of the housing and then directly into the exhaust system (Fig. 8). This can create and auto-ignition fire within the turbocharger itself or exhaust system.

Photo 12: Failed Compressor, Series 60

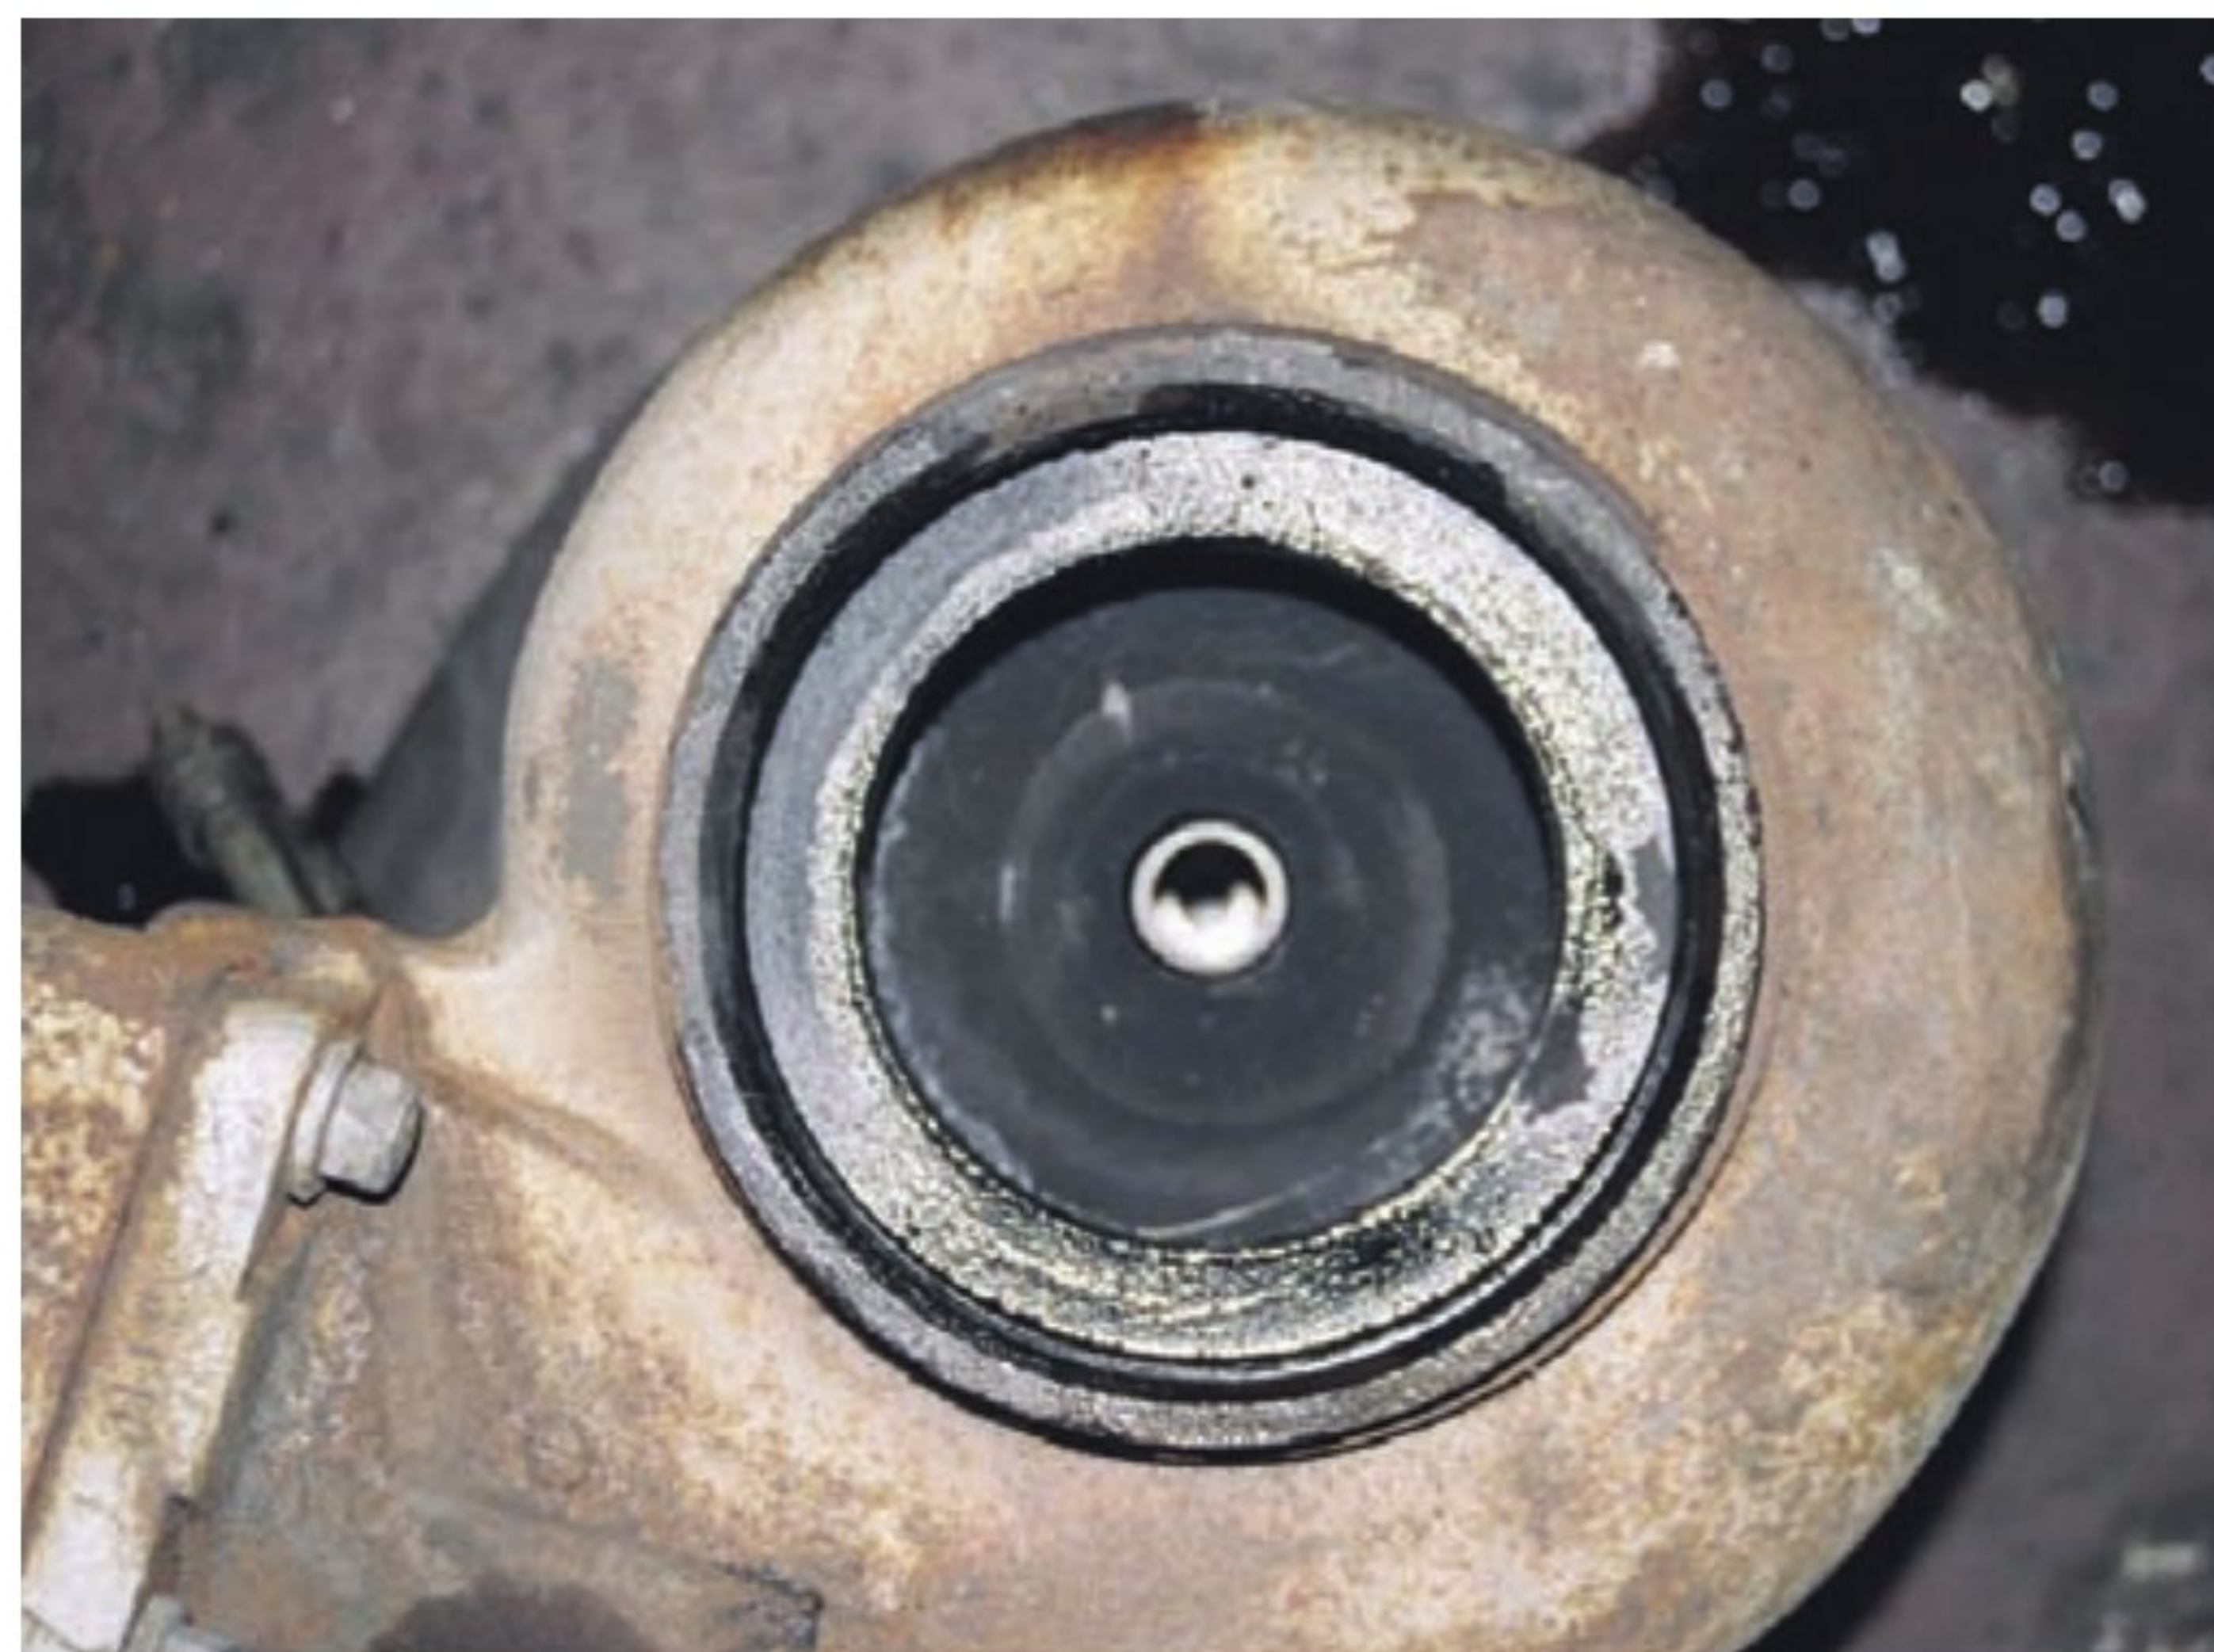
Photo 13: Failed Turbine, Series 92
