# TECH TIPS

**Applications:** Various Coach Applications

# WHY MOTORCOACHES MAY BURN

(A MECHANICAL ANALYSIS)

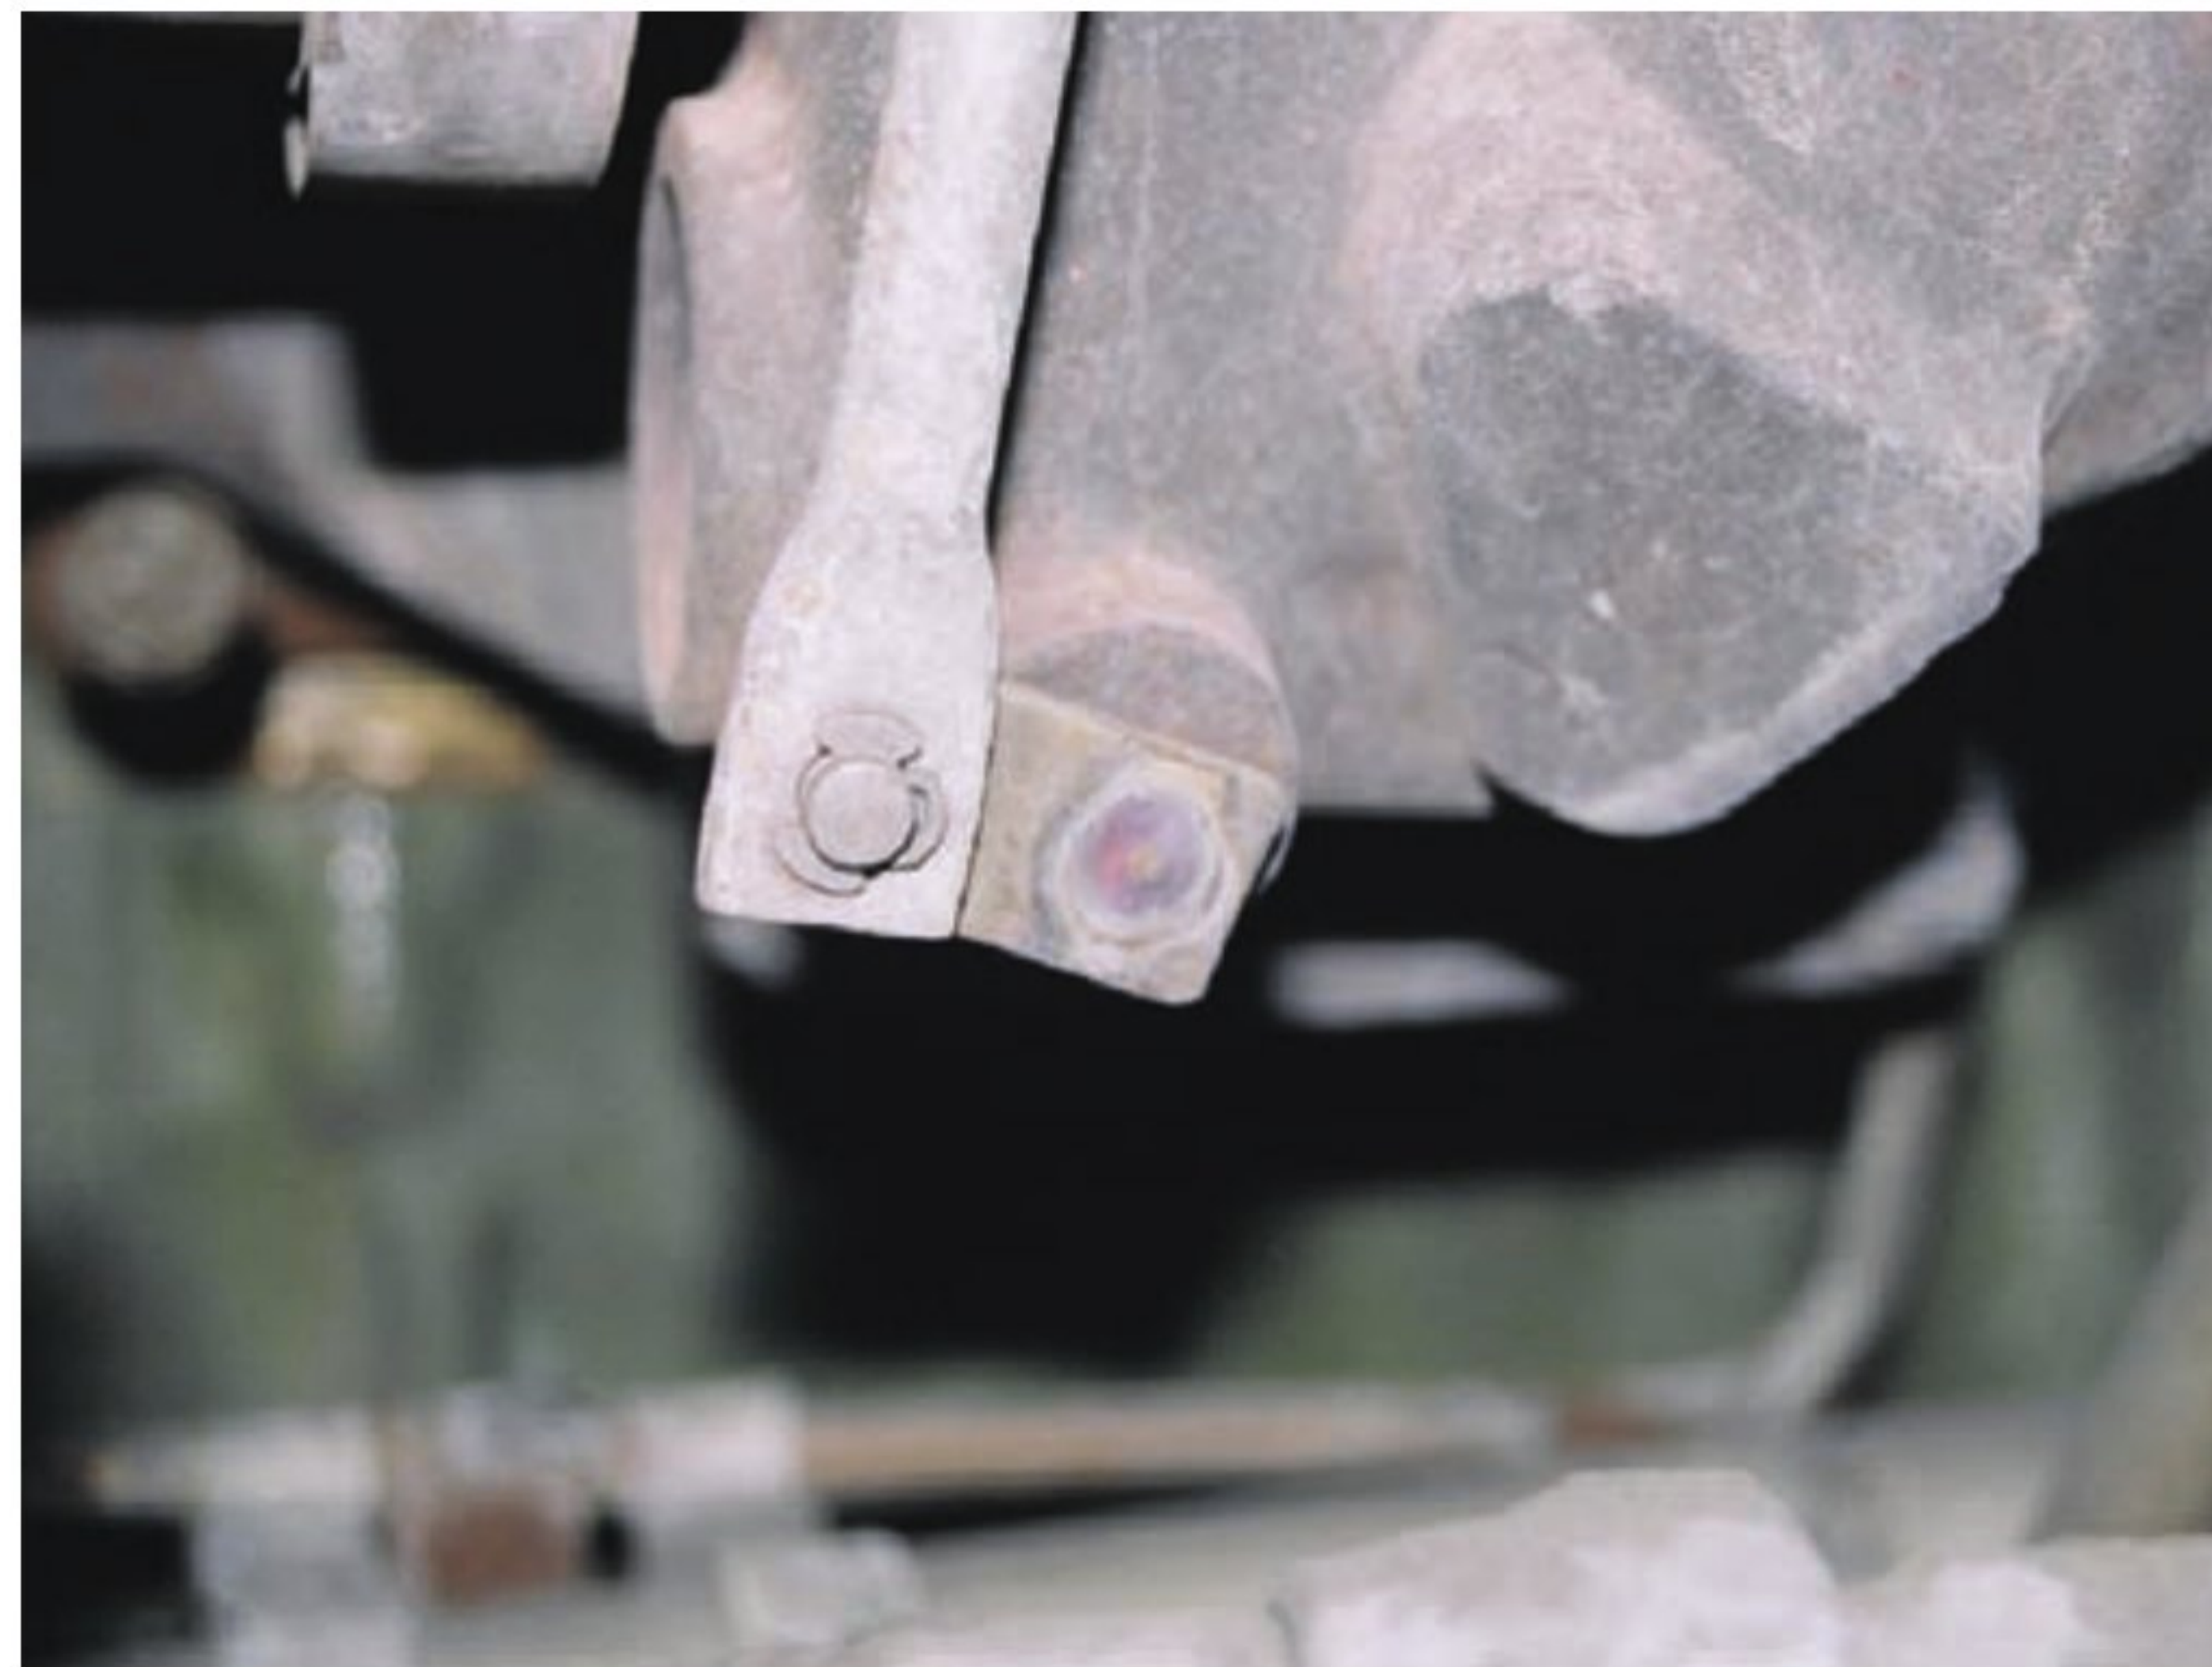
Photo 14: Waste Gate Pivot, Series 60

used to detect the onset of an internal turbocharger failure. If the turbocharger has experienced an internal failure the performance of the engine is compromised. Specifically, blue smoke, due to oil consumption along with reduced engine torque will be noticed. Also a specific oil leak, from the waste gate pivot point, can be observed (Photo 14). Once oil has begun to leak from this point on the tur-

bocharger it should be removed from service and the exhaust system should be thoroughly cleaned. To assist in preventing this failure mode; the turbocharger waste gate or variable geometry function (V.G.T.) must be confirmed. Additionally, the shaft free play, both axially and radially, must be inspected by a mechanic.

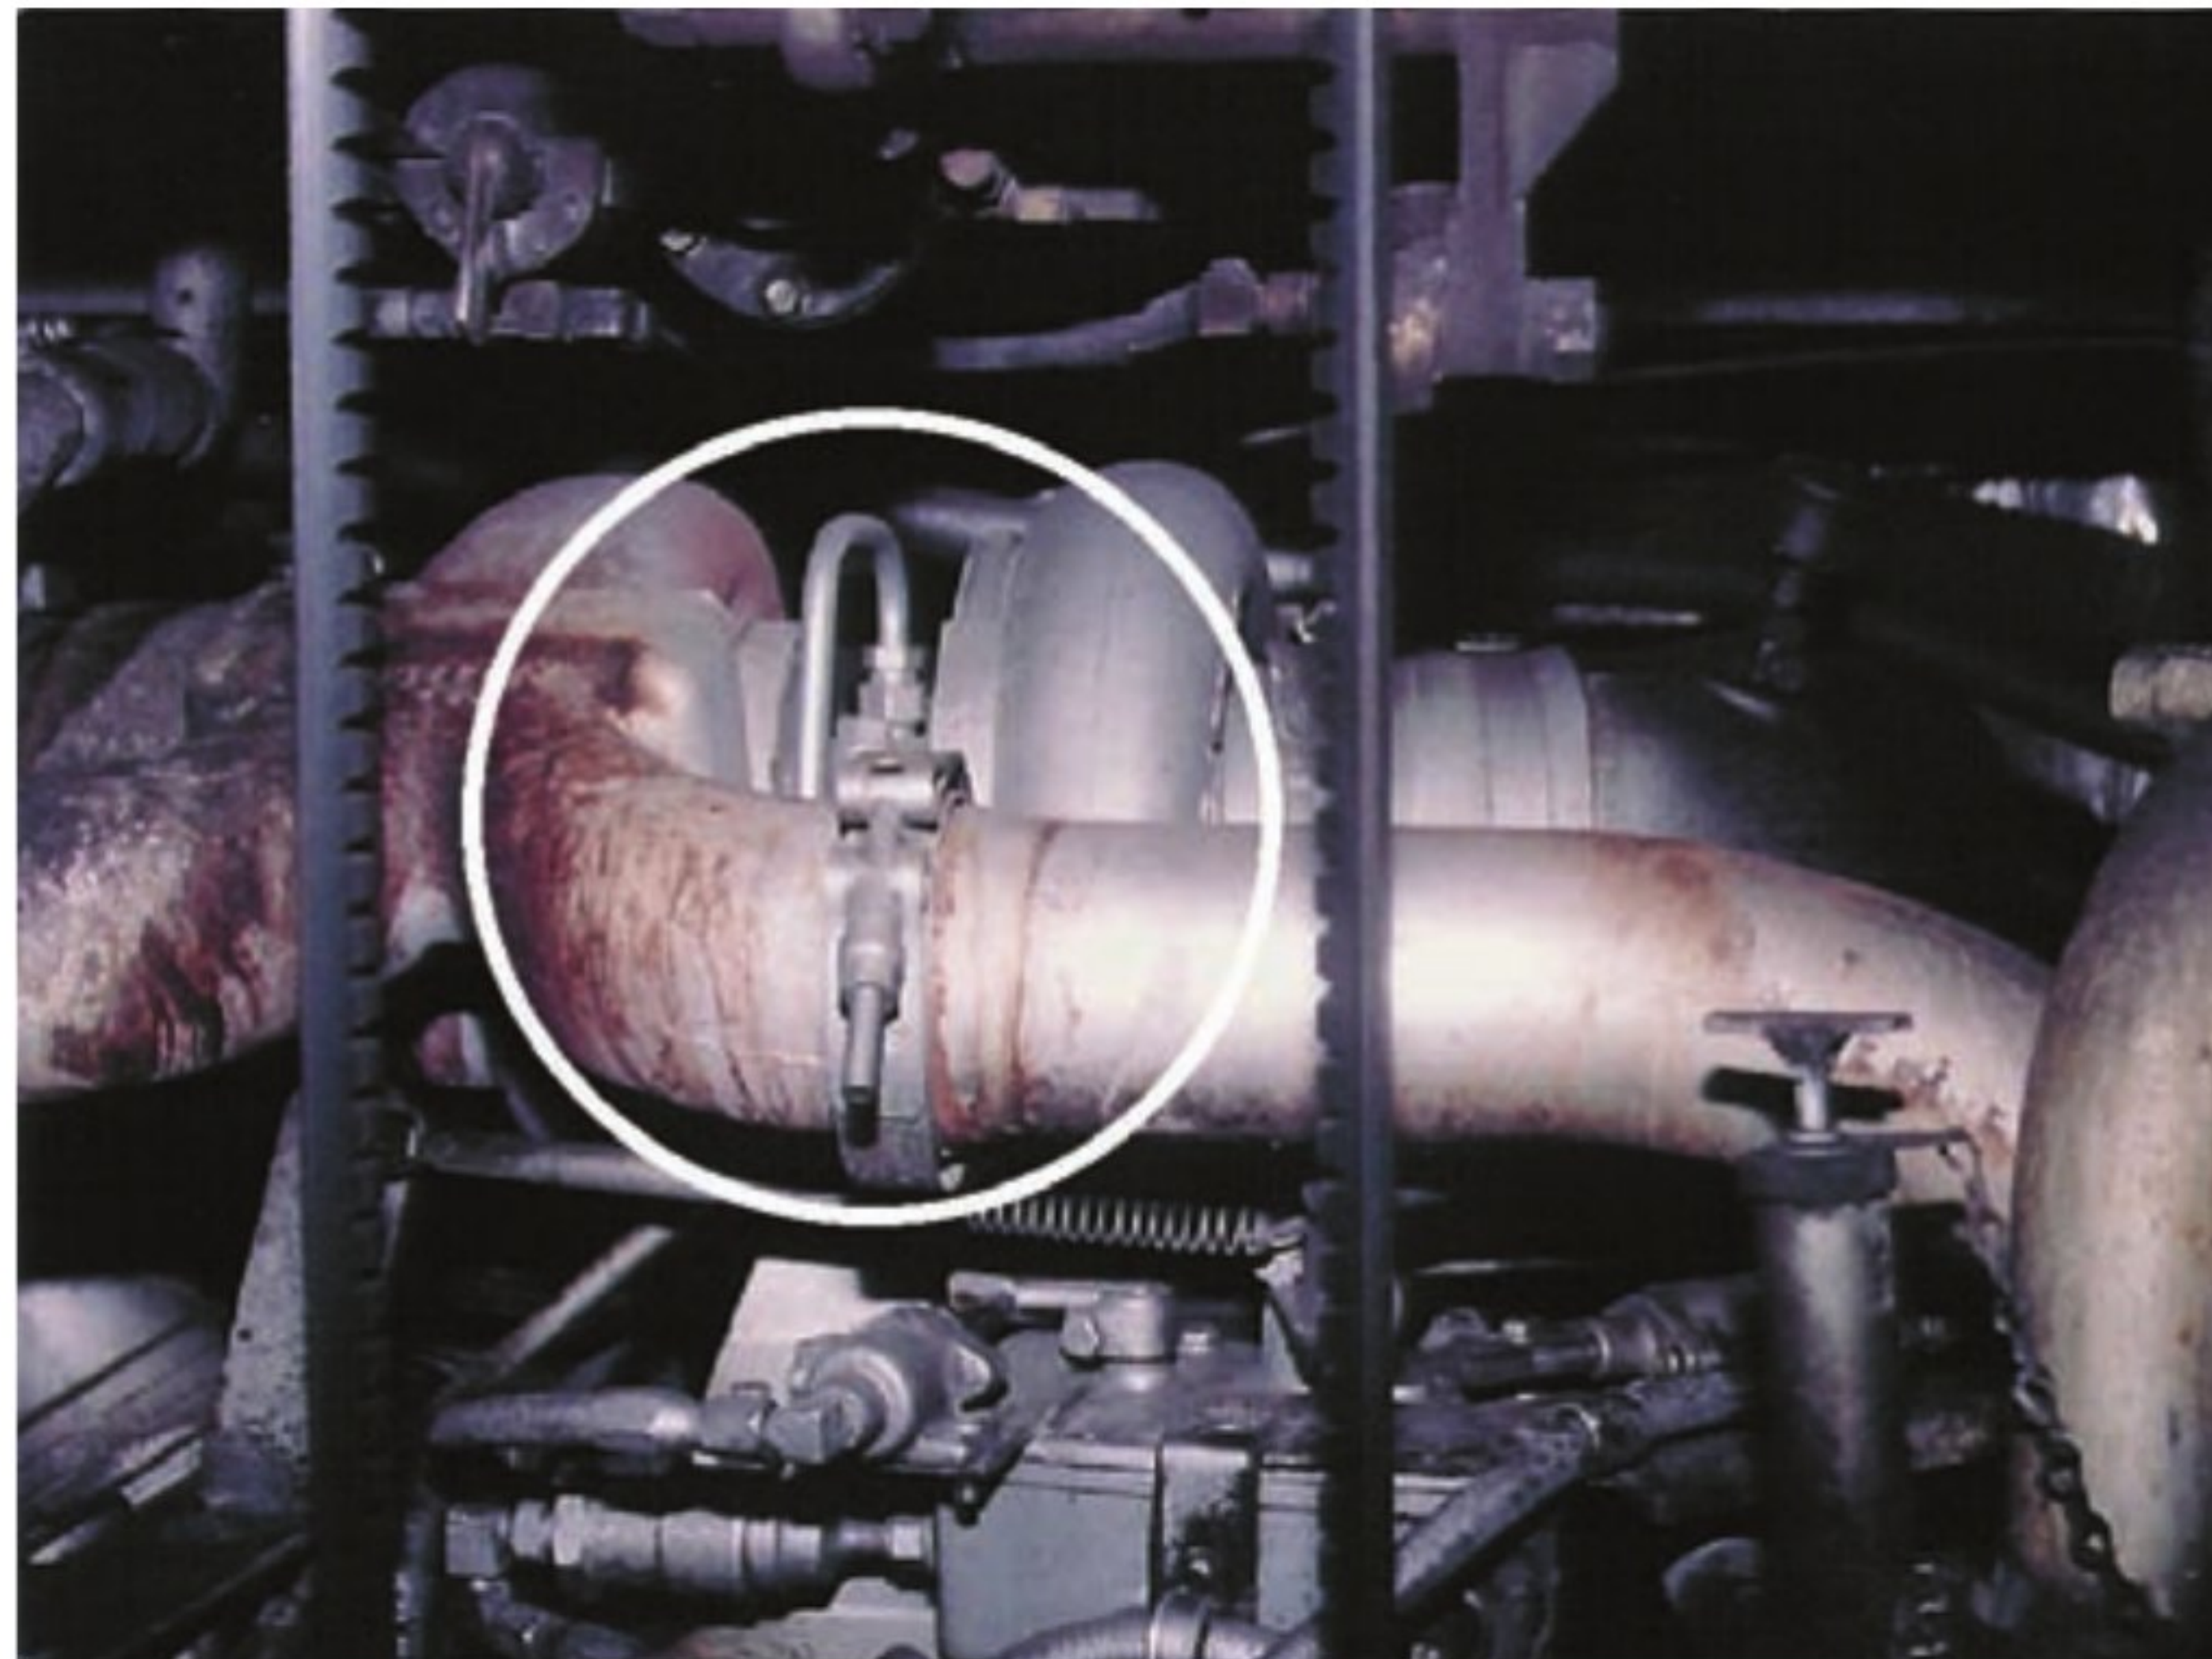
Photo 17: Turbocharger Oil Inlet Line, Series 92

**External Turbocharger Oil Lines:** With the Detroit Diesel Series 92 application, there is only one external oil line. The oil supply line is positioned on top of the turbocharger and must be inspected periodically for leaks (Photo 17).

inspected (Photo 18). These turbochargers have an external supply and return oil line. In either case, a leaking oil line must be repaired to prevent an auto-ignition fire.
