# TECH TIPS

**Dixie Part Numbers:** A-1645      A-1705      A-6548

**Applications:** 2010 Chevrolet Express – G Series Van  
2010 GMC Savana – G Series Van

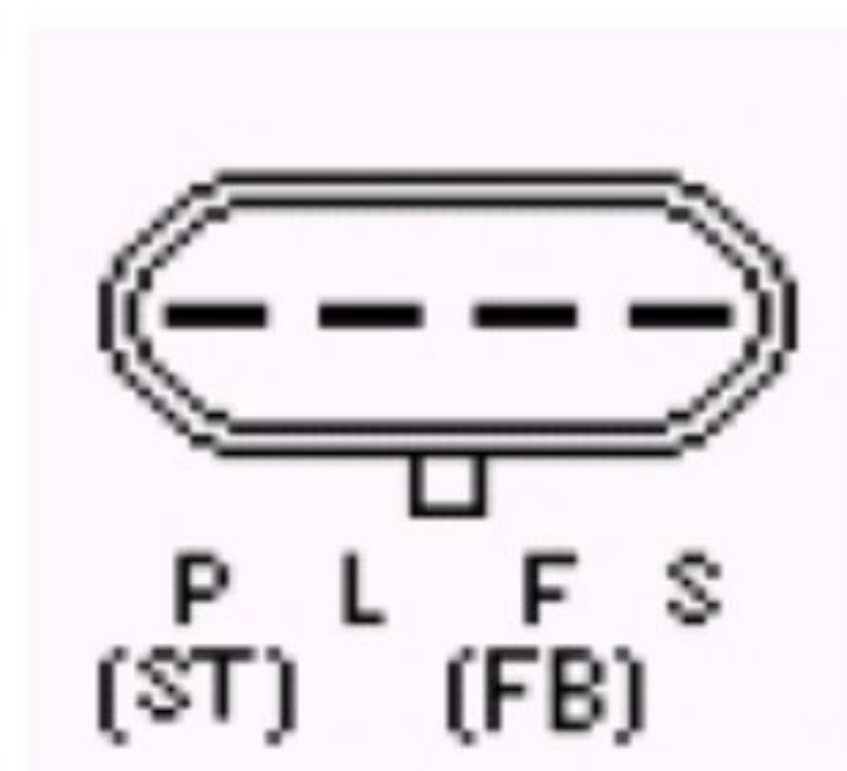
4 Pin Connection

Note: The number of physical connections is not important. Some vehicles with the 4 pin plug only use a single wire. If the plug on the alternator appears like the 4 pin connector, even with only 1 wire to the plug the ECM must still be programmed as the 4 pin connector in order for the alternator to function correctly.

**Correction:** Inspect the alternator and identify if it has the 2 pin connection or the 4 pin connection as shown below:
