# TECH TIPS

**Dixie Part Numbers:** A-1365 A-1384

**Applications:** 1992 – 1995 Chevrolet Lumina APV Van 3.8L  
1992 – 1995 Oldsmobile Silhouette 3.8L  
1992 – 1995 Pontiac Trans Sport 3.8L

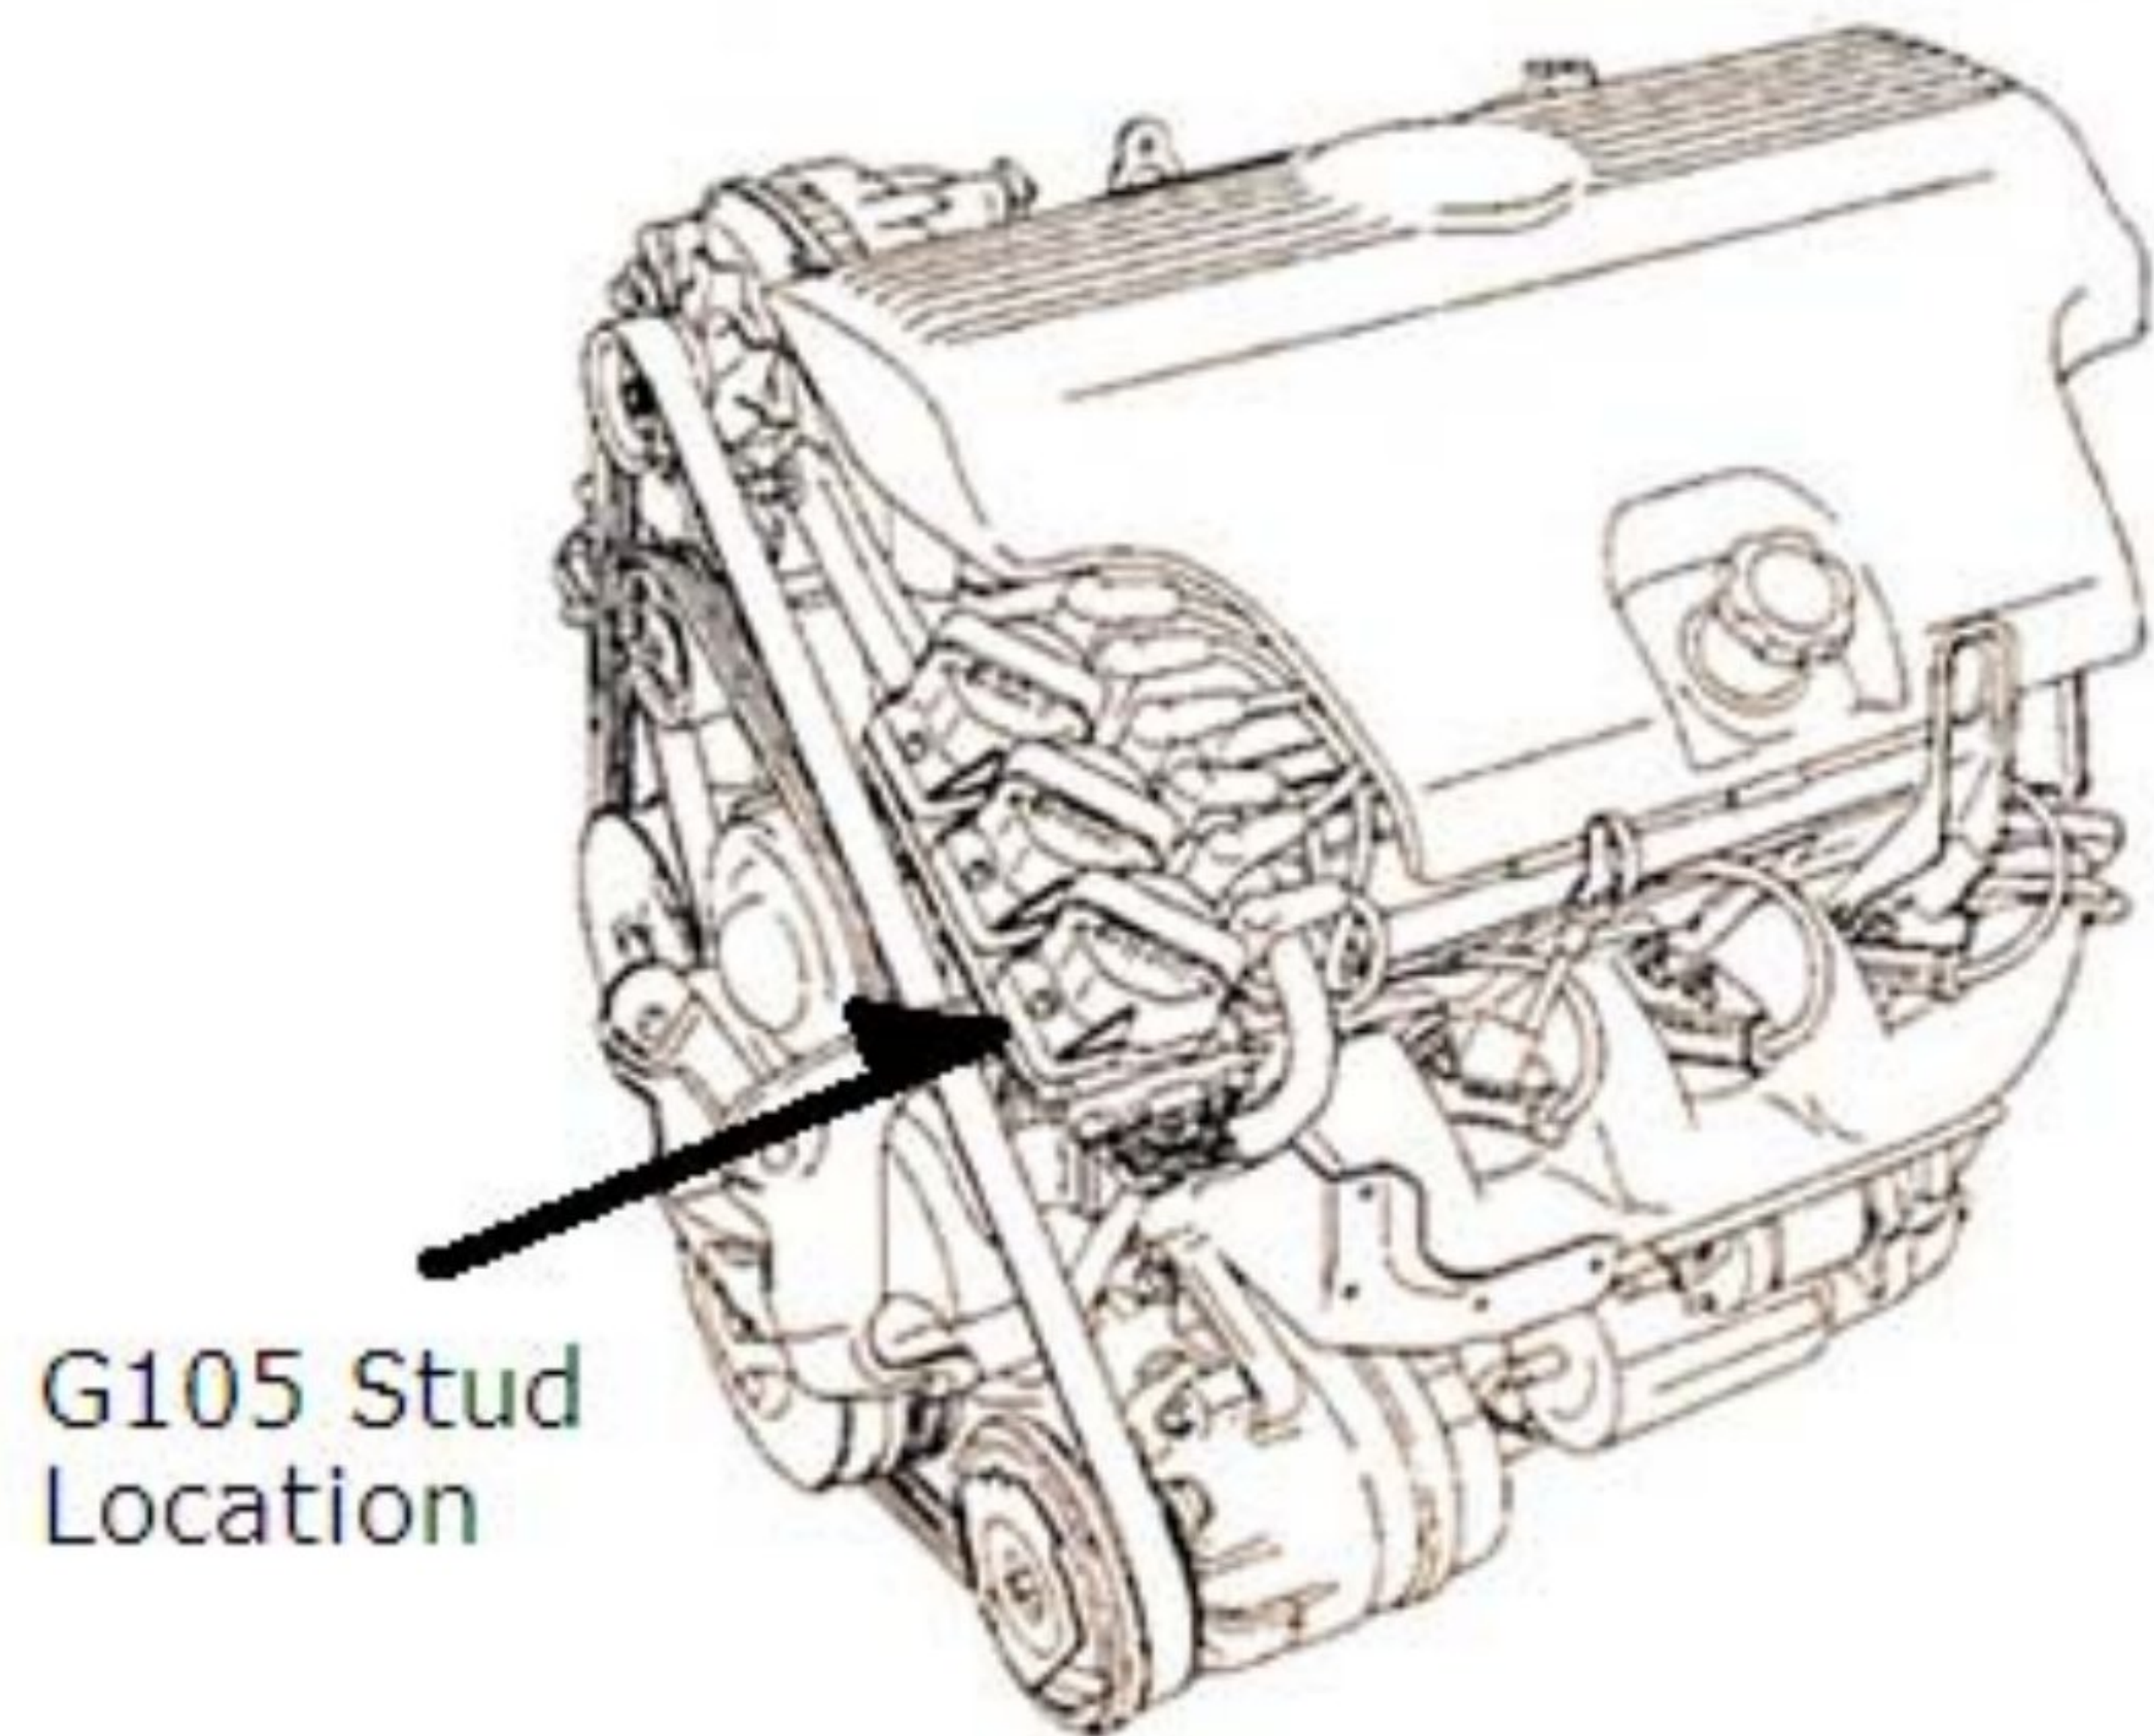
**Cause:** A possible cause for the above conditions is a loose ground wire at the G105 stud location.

**Correction:** Inspect the ground connection at the G105 stud. The G105 stud is located under the front coil of the distributorless ignition coil pack on the right side of the engine (left when facing the vehicle). Clean the surface and ensure the nut is torqued to the manufacturer's specifications.
