# TECH TIPS

## Applications:

This bulletin applies to various medium, heavy duty and industrial applications.

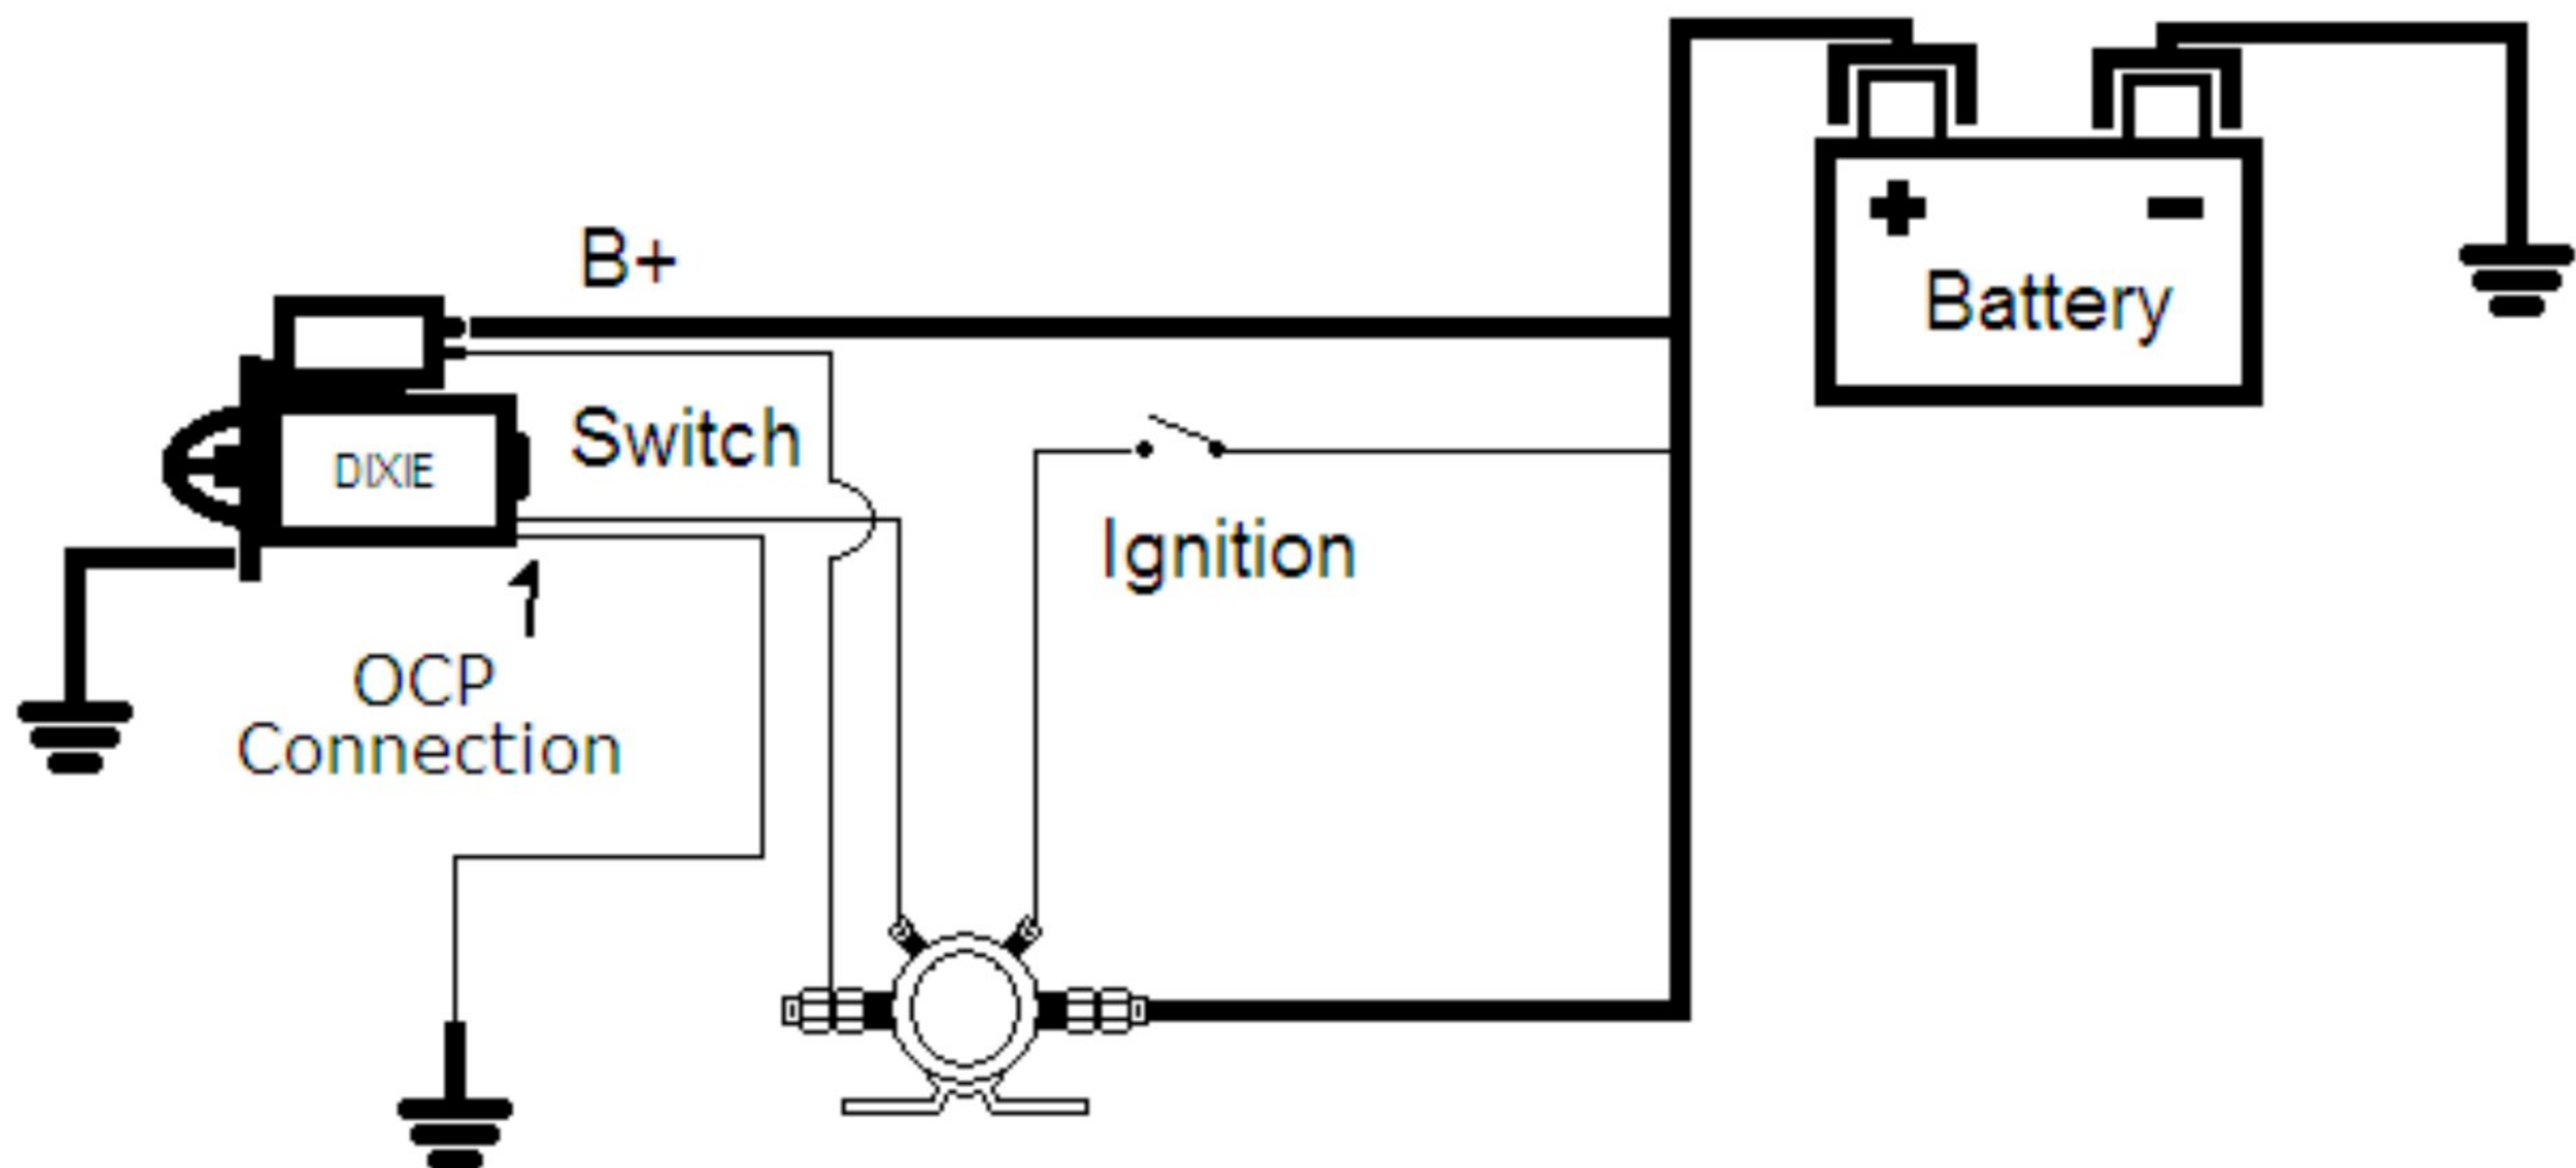
Simplified wiring diagram

The above starters, if installed with the required relay and wiring, have a built in over crank protection (OCP) feature. The OCP feature is designed such that if the starter is cranked too long, without allowing the starter to cool down to cause an open circuit to the solenoid switch terminal. This *temporarily* prevents the starter motor from functioning until it has sufficiently cooled down, at which point the OCP feature completes the circuit and allows the starter to function. In the case of the intermittent non-cranking issue, this may simply be the OCP functioning as it was designed to.

The OCP feature will not function if the starter is being used to replace a standard non-OCP starter **unless** there is a relay or magnetic switch added to the system.

Follow the manufacturer's recommended procedure for installing the relay or magnetic switch. Below is a typical wiring configuration for an OCP equipped starter. If no relay or magnetic switch is installed the OCP feature is completely bypassed.
