# TECH TIPS

**Dixie Part Numbers:** A-2054

**Applications:** 2001 – 2006 Ford Ranger 2.3L

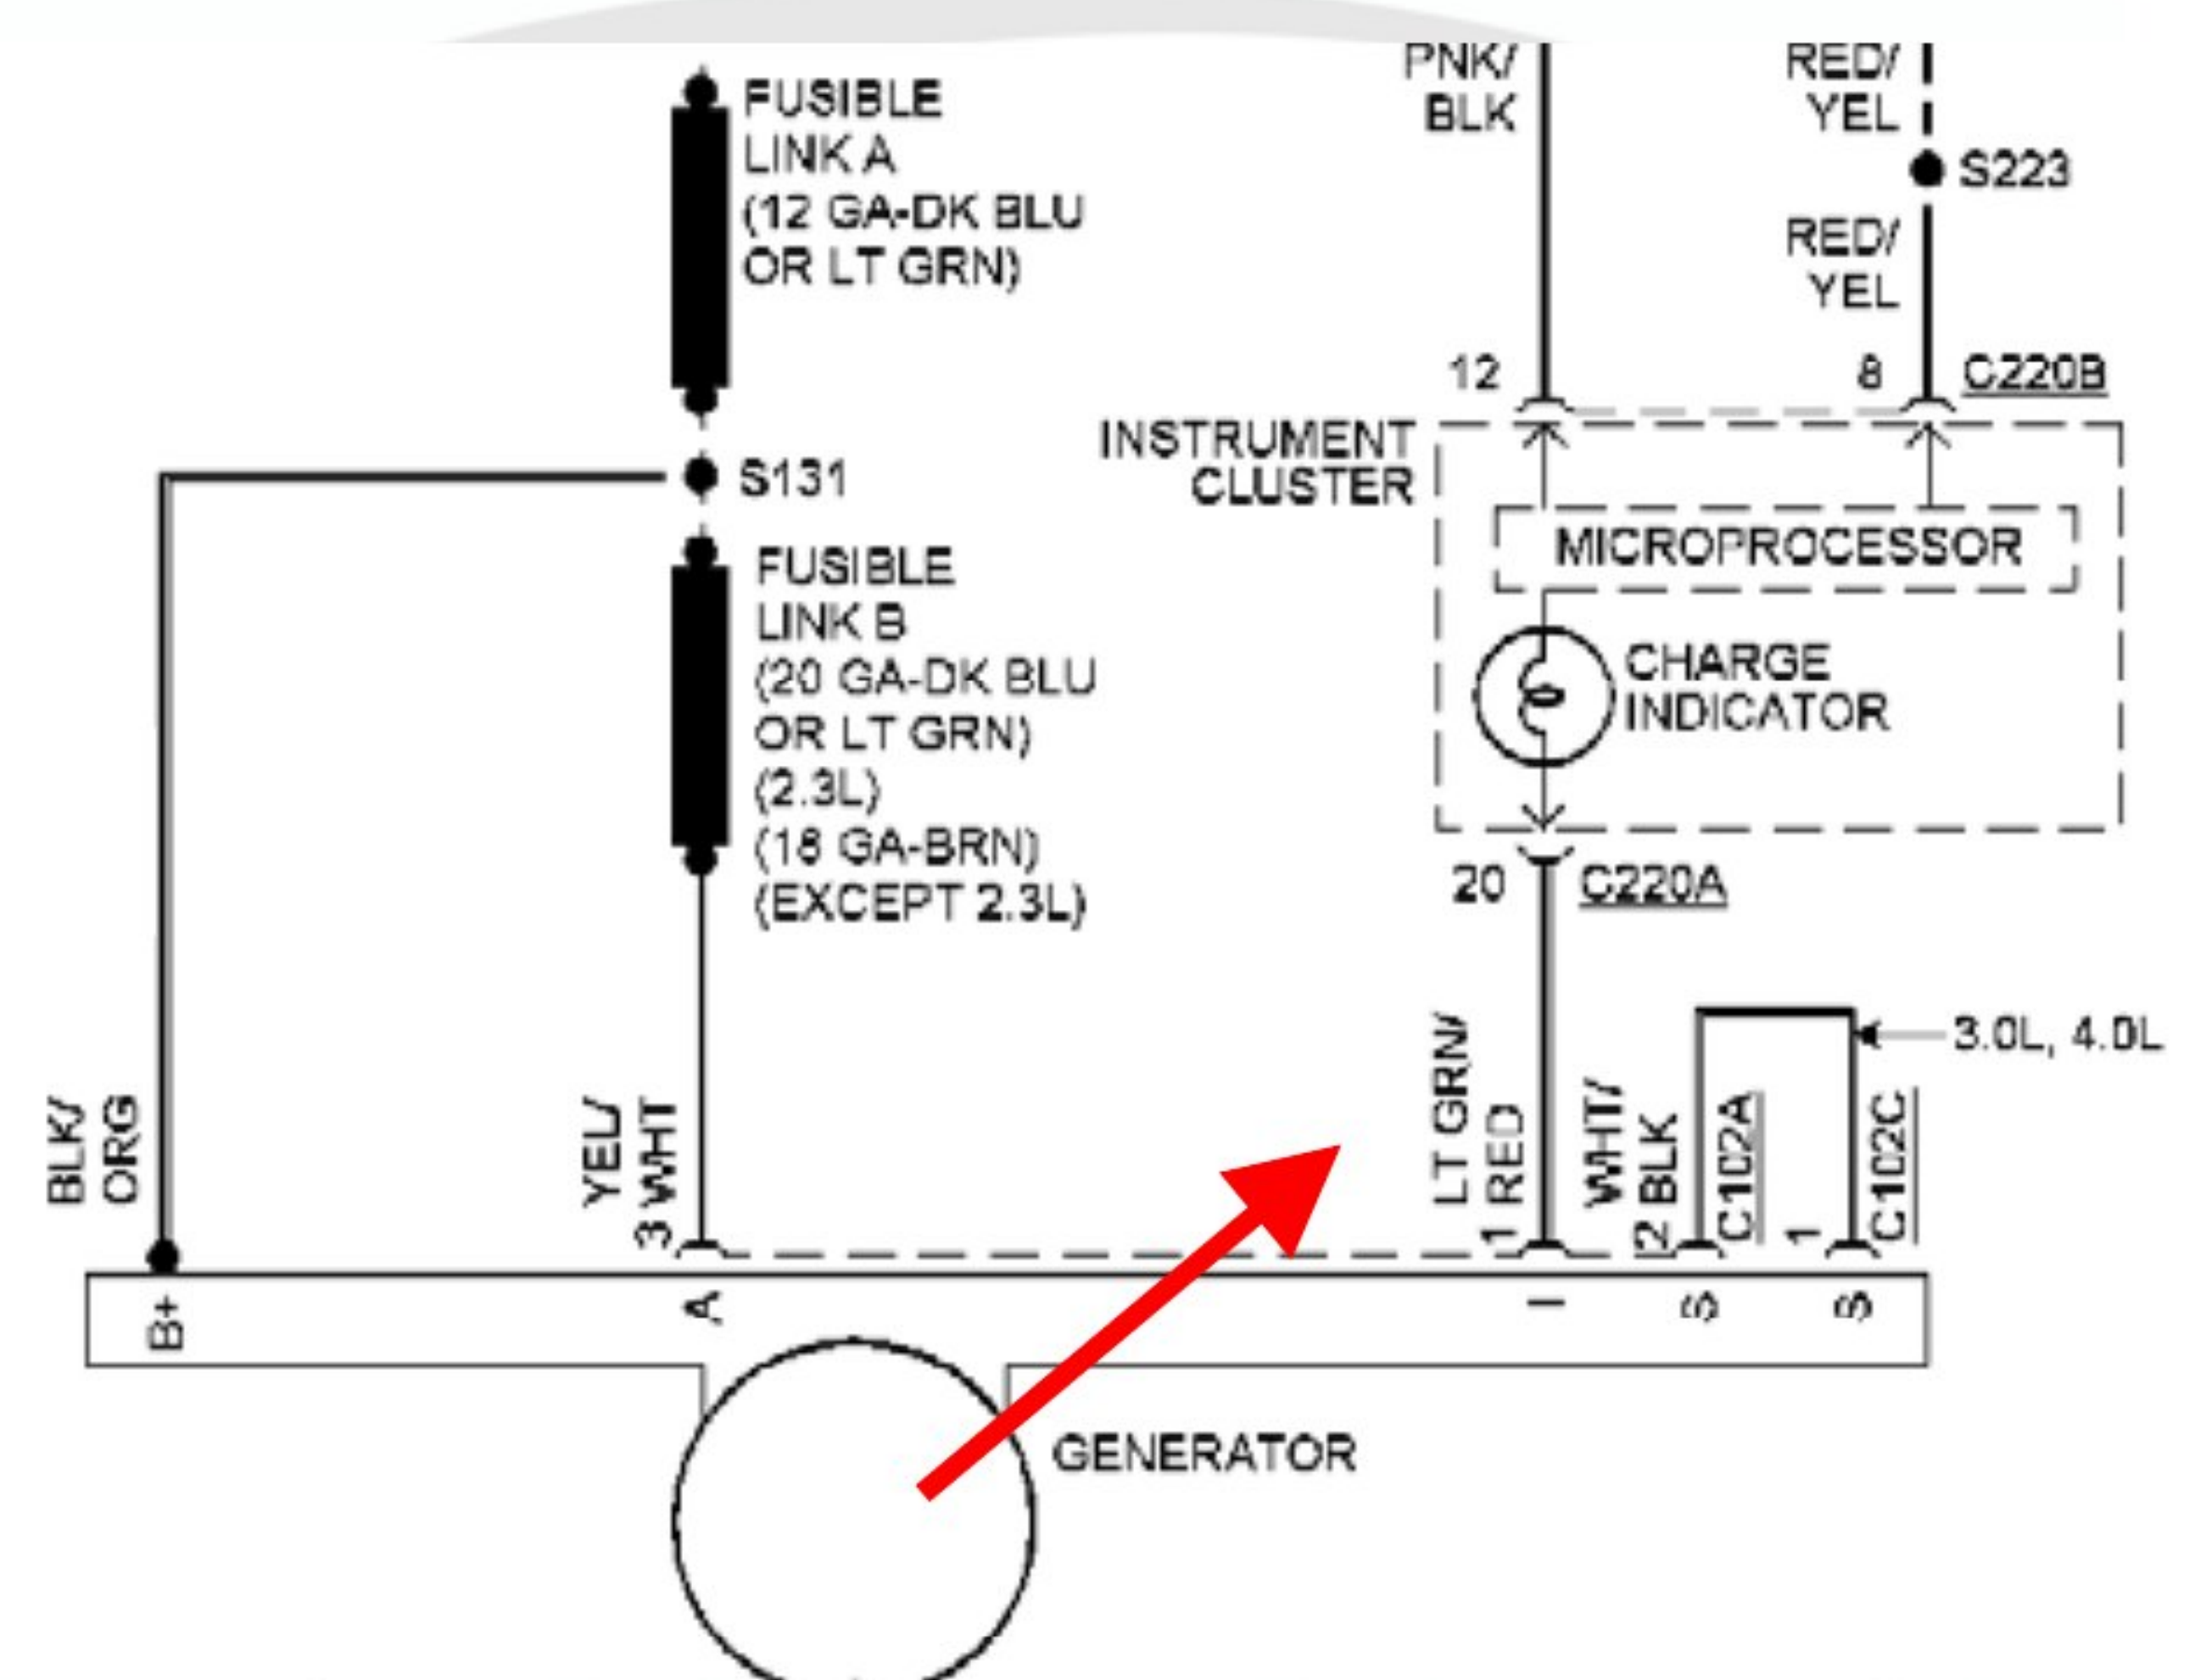
**Condition:** The operator of the vehicle may complain that the charge indicator light is coming on. The technician may observe that changing the alternator does not rectify the problem and that the voltage intermittently goes to an overcharge condition.

**Cause:** A possible cause for this condition is an intermittent short circuit to ground in the vehicles wiring. The green wire with the red trace is used to provide information to the vehicles' on-board computer and if grounded triggers the light and causes voltage fluctuations.

**Correction:** Inspect the vehicle wiring for damaged insulation and repair any damaged sections and protect them from chaffing as appropriate. **TIP** running a clean hand over the wire may assist in finding damaged portions of the wire. When damaged, the copper wire deteriorates, leaving a film of green oxide, which will transfer when rubbed.
