# TECH TIPS

**Dixie Part Numbers:** A-80409

**Applications:** 1990 – 2000 Honda GL1500  
Gold Wing

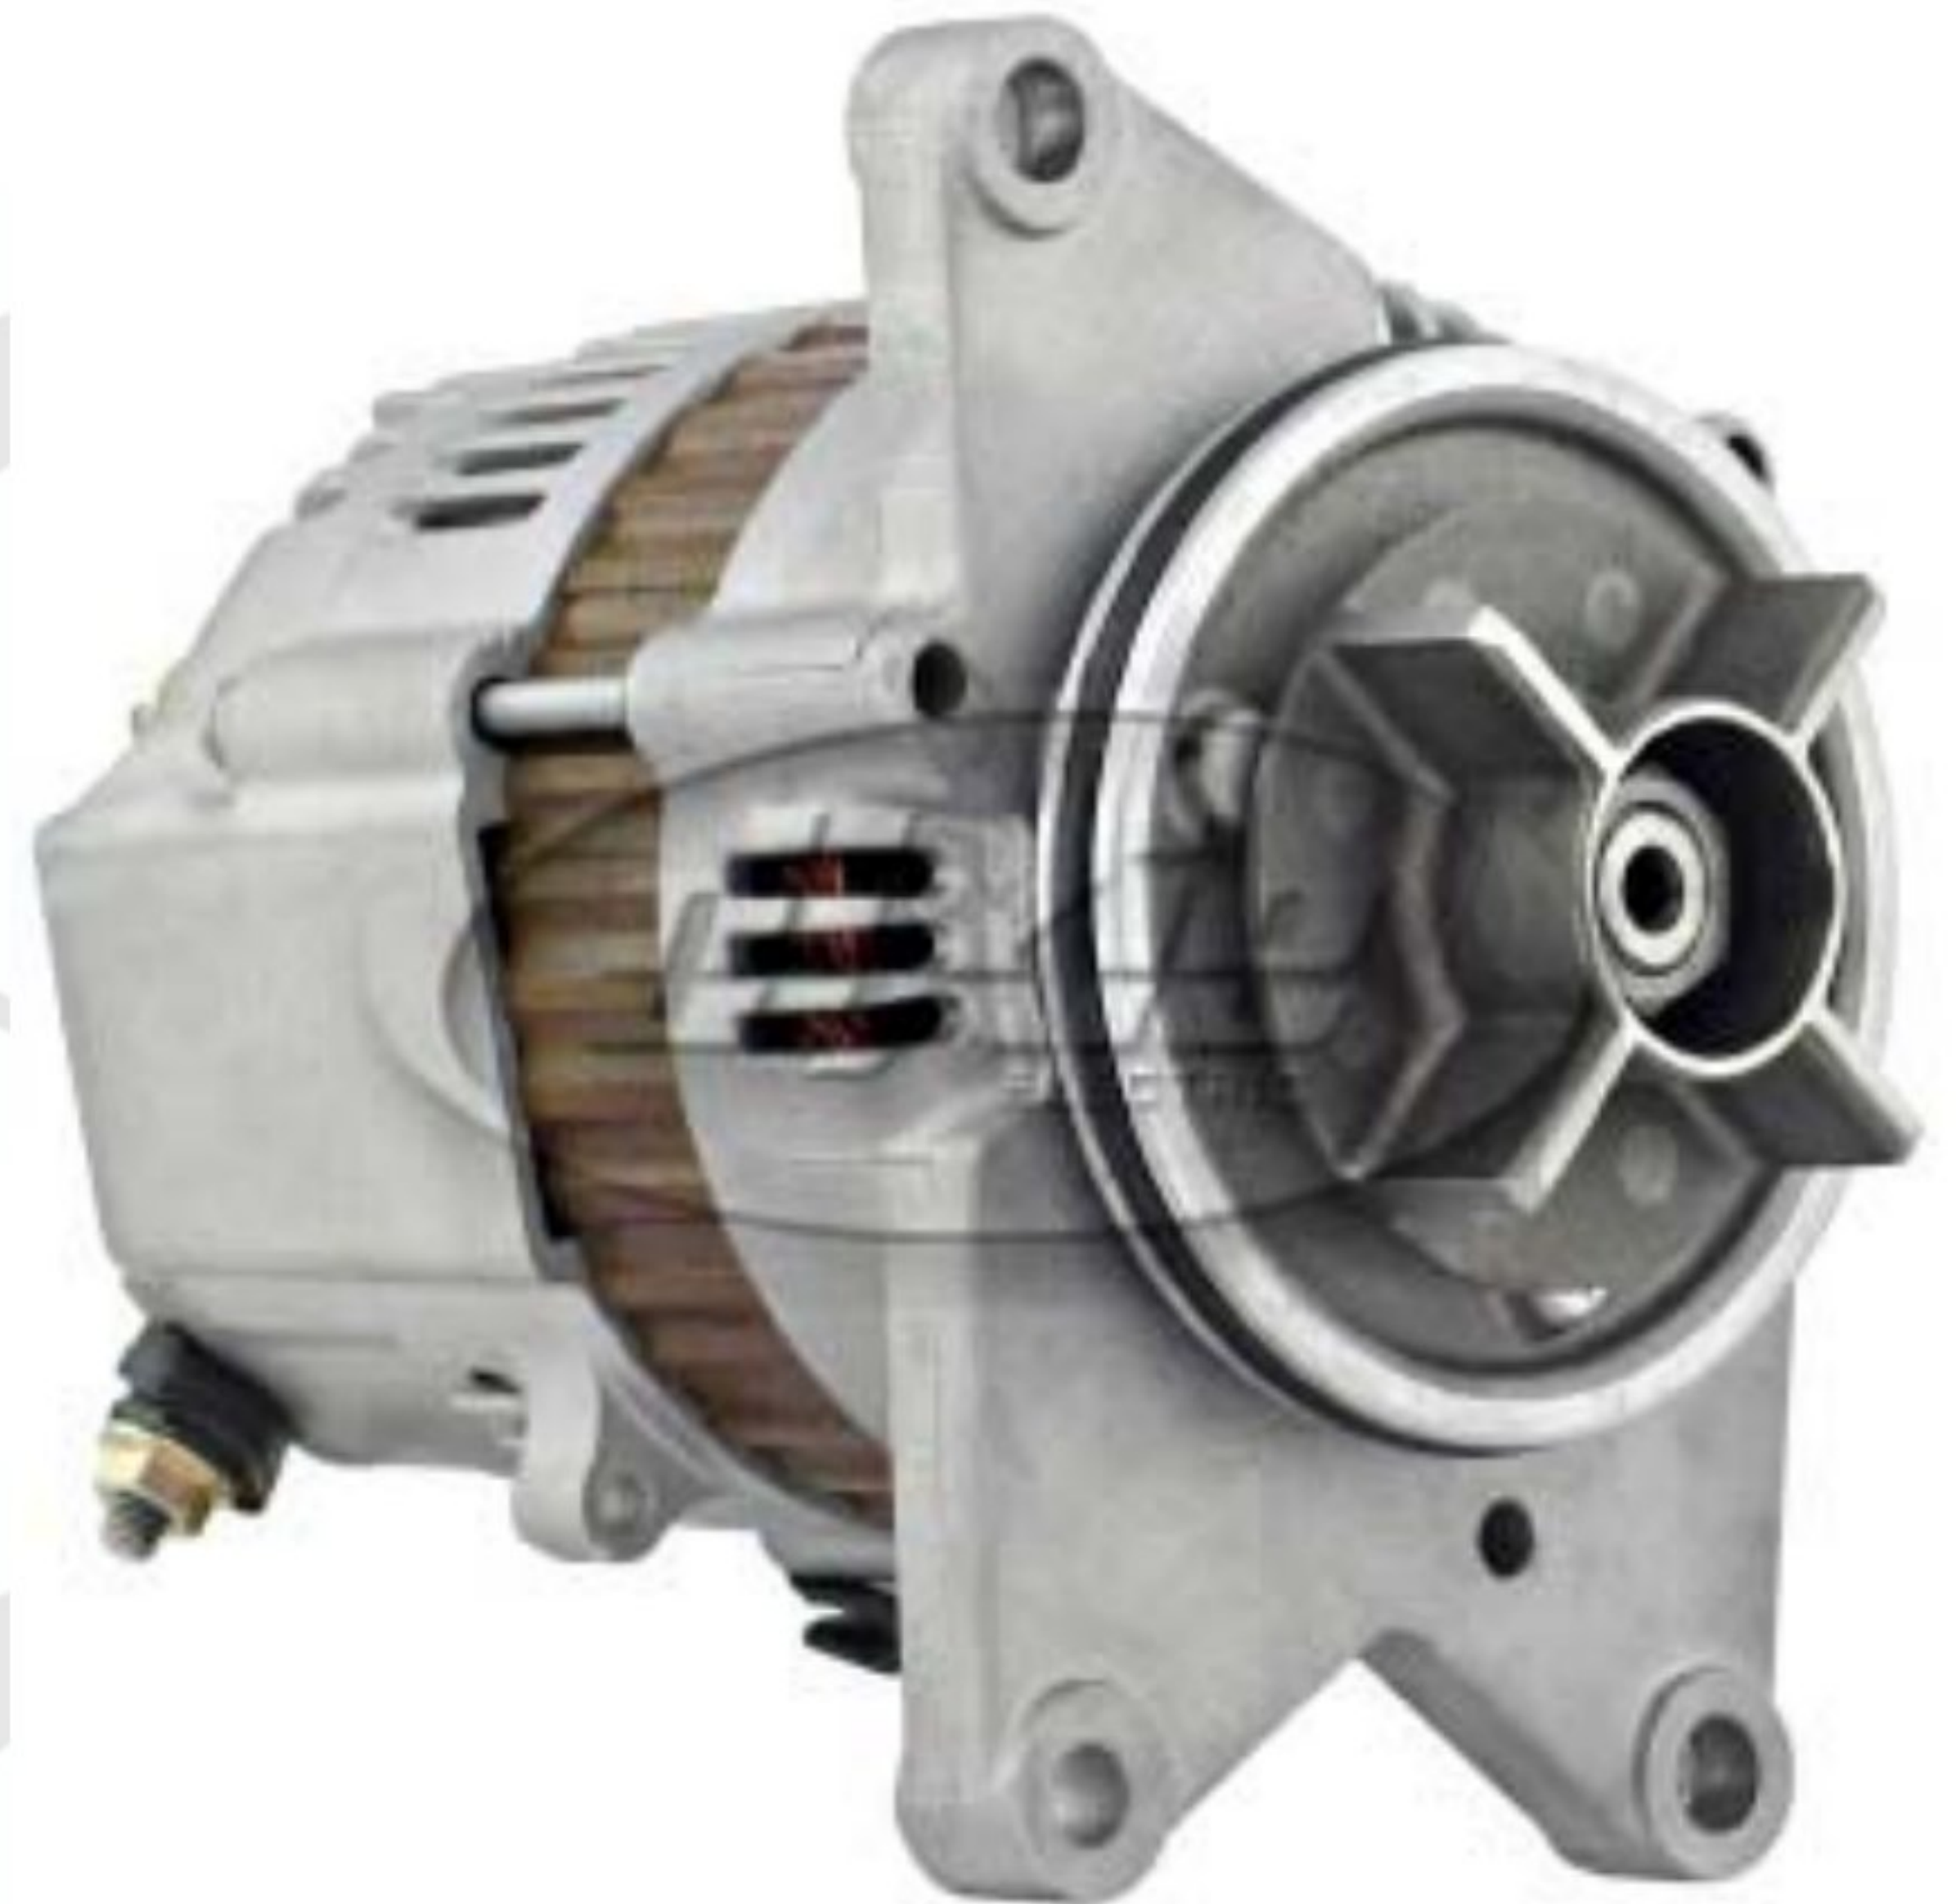
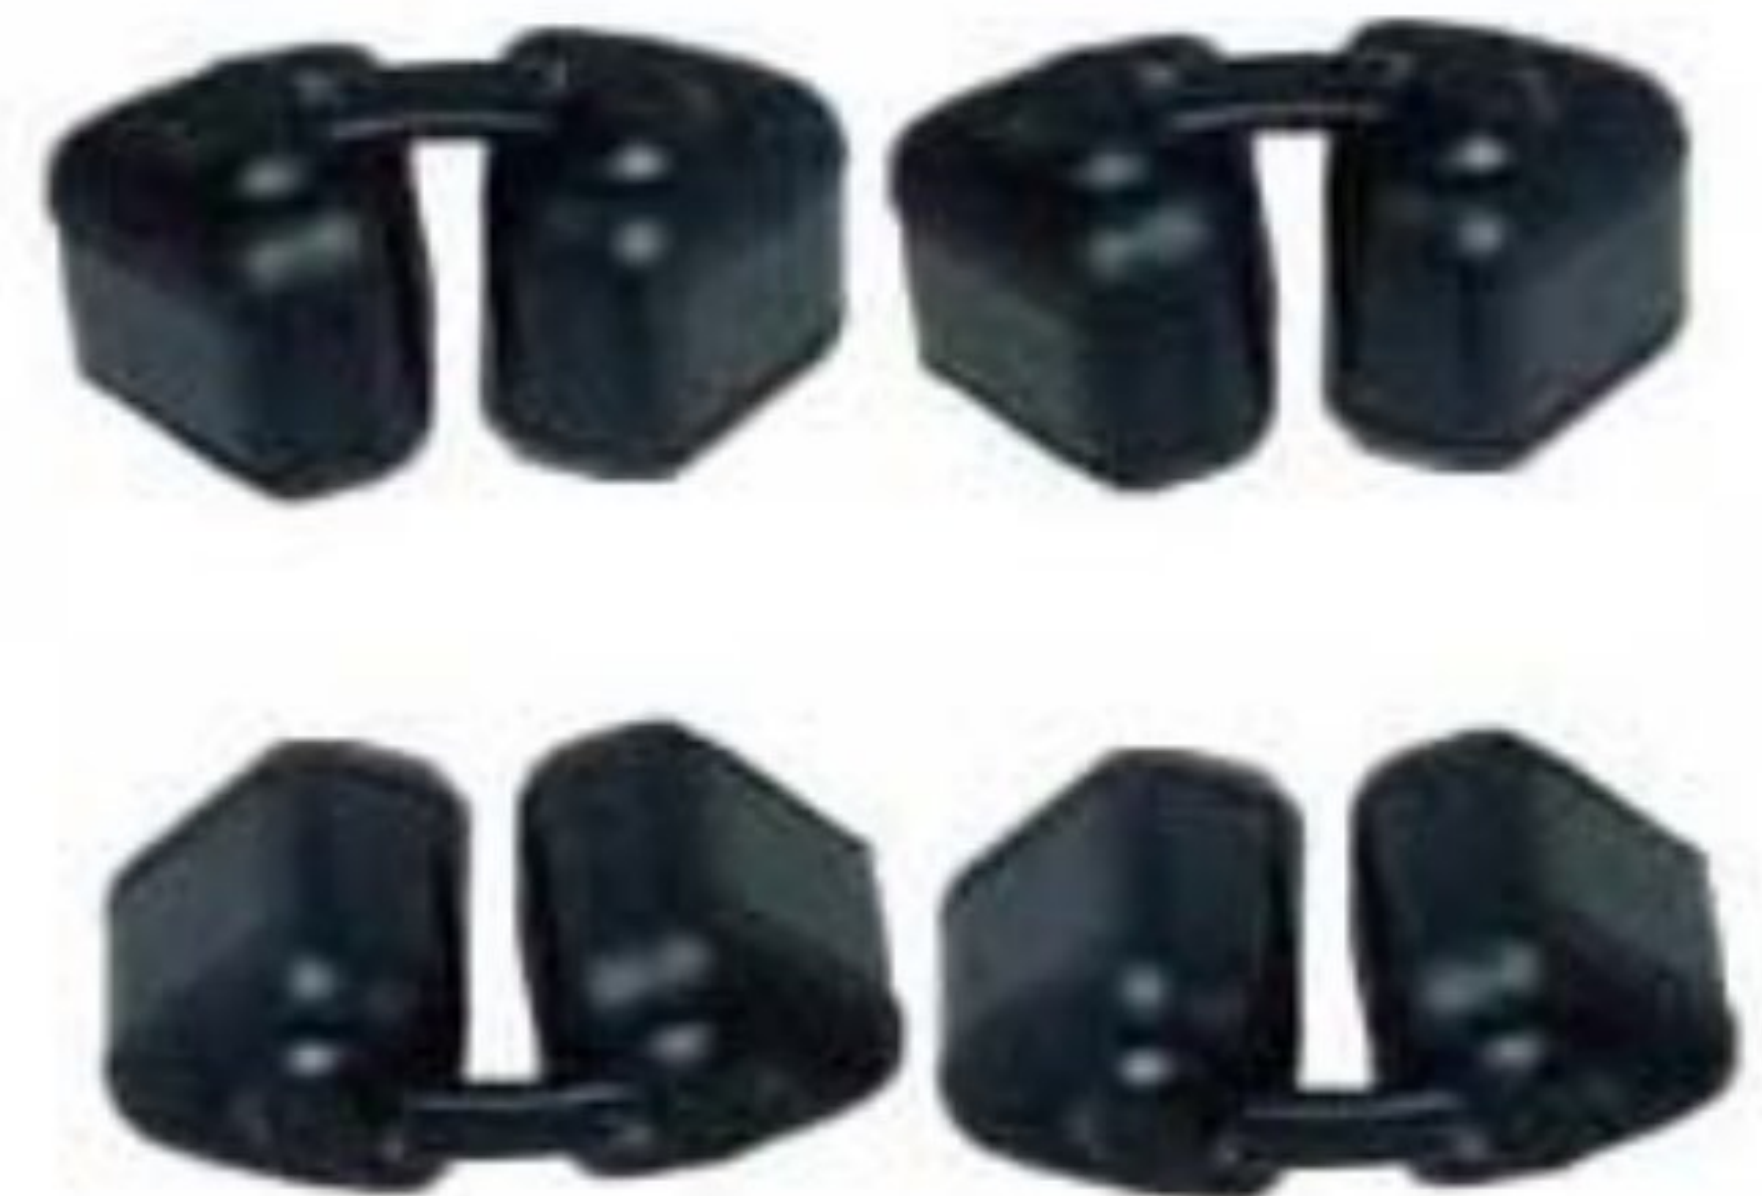
**Condition:** The operator of the vehicle may complain of one or more of the following conditions:

- There is vibration at idle
- There is a “clunk” sound on deceleration

**Cause:** The coupling cushion for the alternator may be worn out or the rubber deteriorated.

**Correction:** It is recommended that when replacing the alternator that the coupling cushion be replaced as well. Verify with your distributor as some sell these individually versus as a kit of 4 (required).
