# TECH TIPS

**Dixie Part Numbers:** A-8890

**Applications:** 2000 – 2001 Mazda MPV

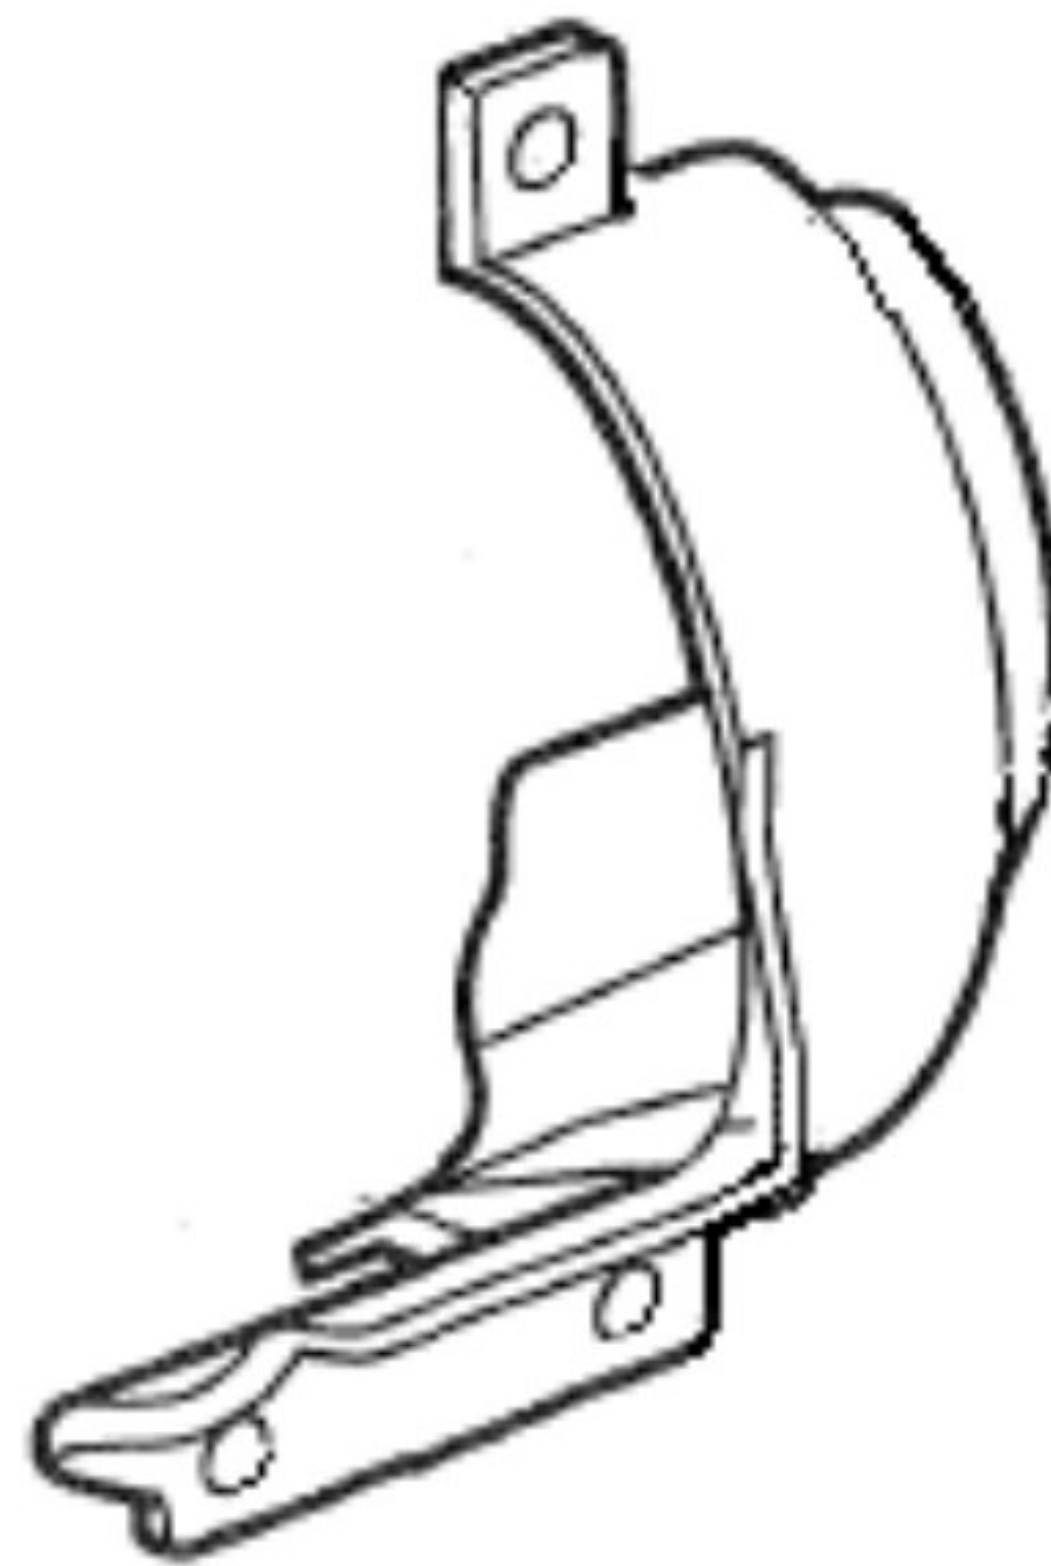
The charge light could be coming on intermittently and/or the vehicle may exhibit hard to start symptoms.

Road salt and/or other chemicals used to melt the snow in winter months could cause corrosion inside the alternator.

Follow the manufacturers procedure for removing the alternator. Remove and discard the small steel bracket and replace it with GY01-18-300R-0J. The new shield may have already been replaced during a previous vehicle service and can be identified by the alternator belt guard, which the one from the factory did not have. The GY01-18-300R-0J outline is shown below for reference.

Reinstall the alternator following the manufacturers recommended procedure.
