# TECH TIPS

**Applications:**

- 2008 - 2009 Suzuki AN400
- 2008 - 2009 Suzuki DL1000
- 2008 - 2009 Suzuki GSF1250S
- 2008 - 2009 Suzuki GSX650F
- 2008 - 2009 Suzuki GSX-R600
- 2008 - 2009 Suzuki GSX-R750
- 2008 - 2009 Suzuki VLR1800
- 2008 - 2010 Suzuki GSX1300R
- 2008 - 2010 Suzuki VL800
- 2008 Suzuki GSX1300BK
- 2009 - 2010 Suzuki SFV650F
- 2009- 2010 Suzuki VZ1500

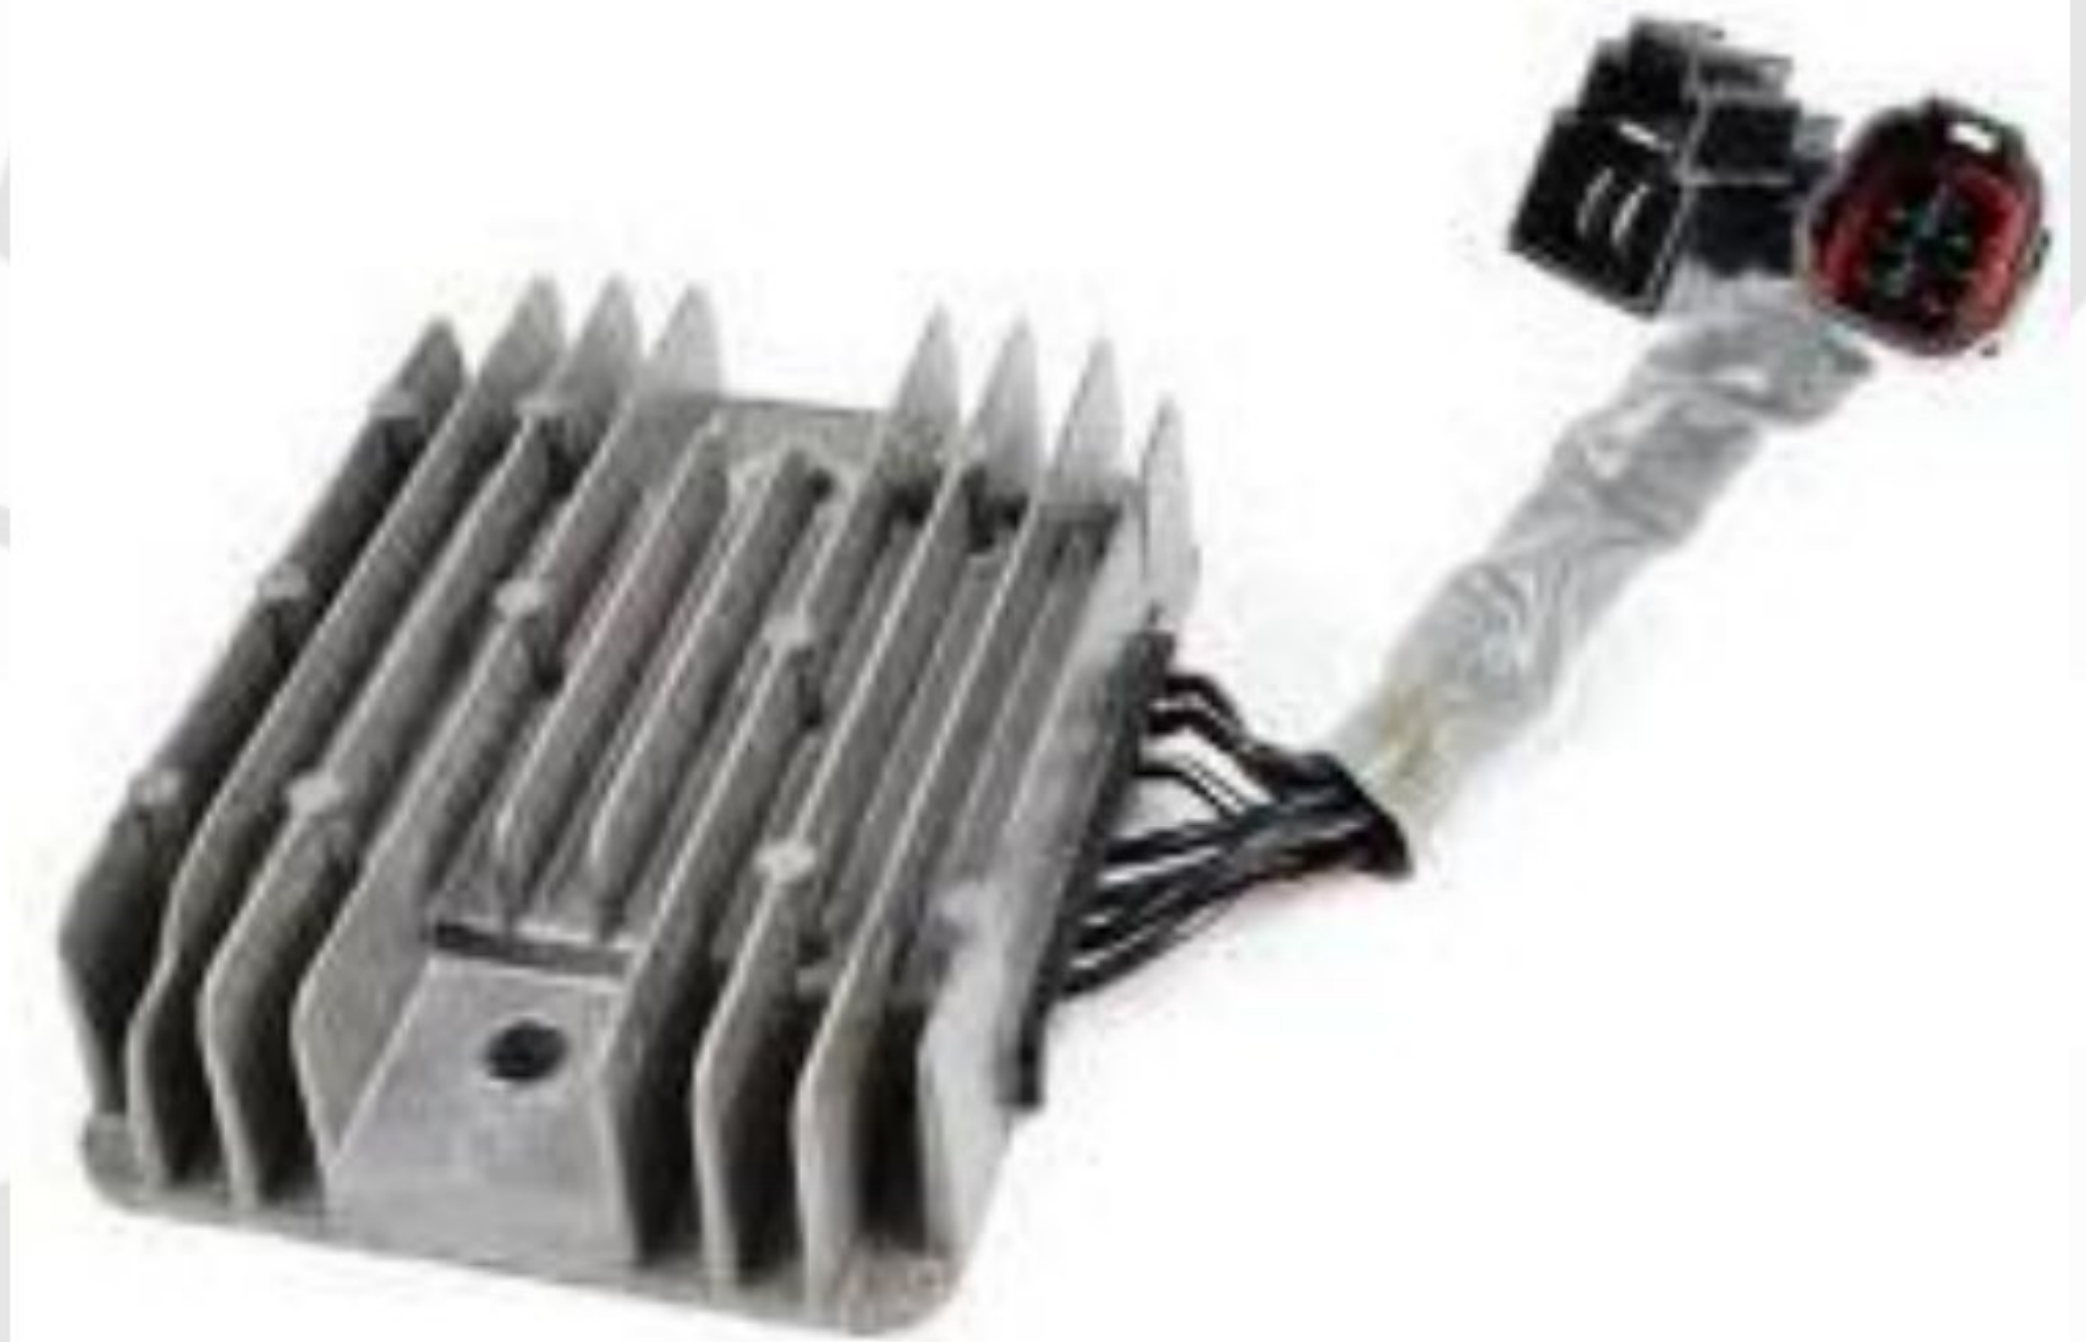
**Conditions:** The operator of the vehicle may complain of one or more of the following conditions:

- High system voltage (extremely bright lights).
- A damaged battery.
- A failure to crank or start.
- The engine stalls and cannot be restarted.

When testing the electrical system the technician may observe uncontrolled voltage.

**Cause:** A potential cause for the above conditions is a manufacturing flaw in the voltage regulator/rectifier assembly. The assembly was manufactured with inadequate adhesive between the circuit board and heat sink resulting in poor heat transfer and damage to the voltage control circuit. Affected voltage rectifier/regulator assembly numbers are:

**Correction:** Follow the manufacturer's recommended diagnostic and repair procedures when applicable.
