# TECH TIPS

**Dixie Part Numbers:** S-80025 and S-80026

**Applications:** 2002 – 2003 Nissan Maxima

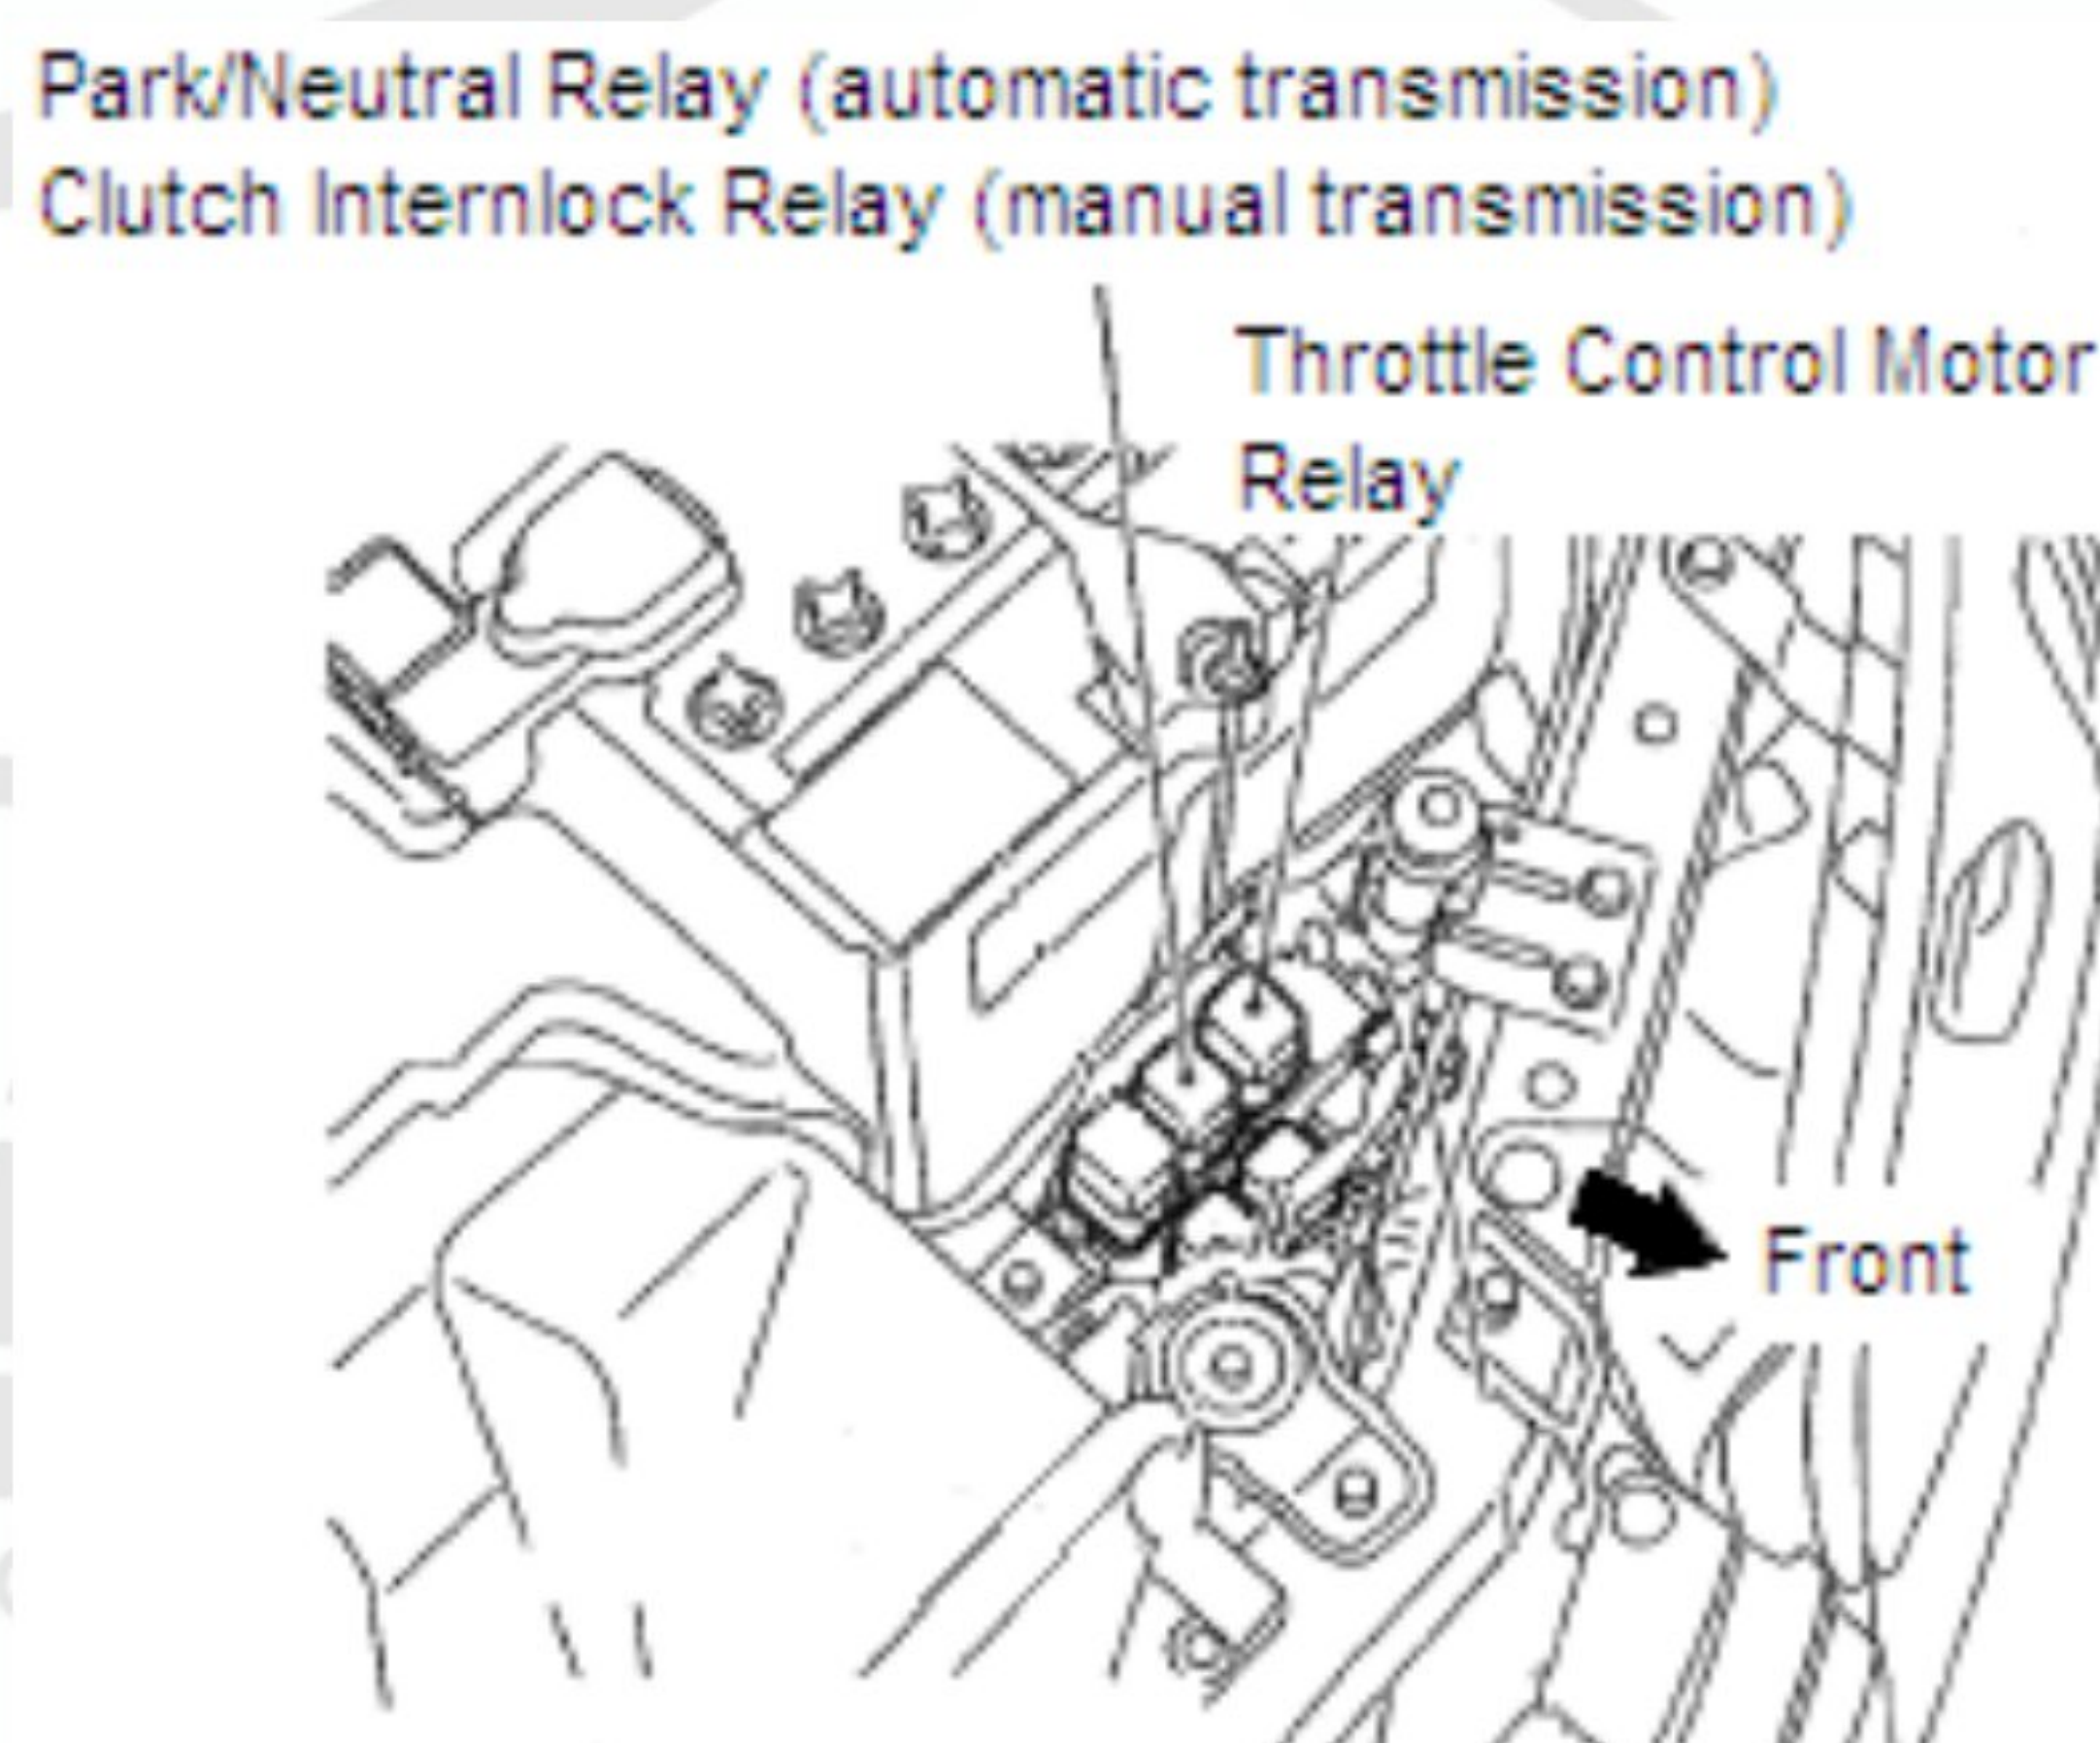
A potential cause for the above are faulty/sticking relays. There is an OE Service Bulletin showing that when the above situation occurs the Park/Neutral Relay (automatic transmission) – Clutch Interlock Relay (manual transmission) and the Throttle Control Motor Relay are faulty.

The vehicle manufacture suggests changing the 2 relays to correct the problem. The part number has not been revised so at this time there is no way to check if a vehicle has had this work performed already (if the owner does not recall). The part number for the relays is 25230-79917 and 2 pieces will be required. When facing the engine from the front they are the 2 relays (in the series of 3) closest to the battery and on the right side.
