# TECH TIPS

**Dixie Part Numbers:** S-80352

**Applications:** 2006 – 2007 Ford Fusion 2.3L  
2006 – 2007 Mercury Milan 2.3L

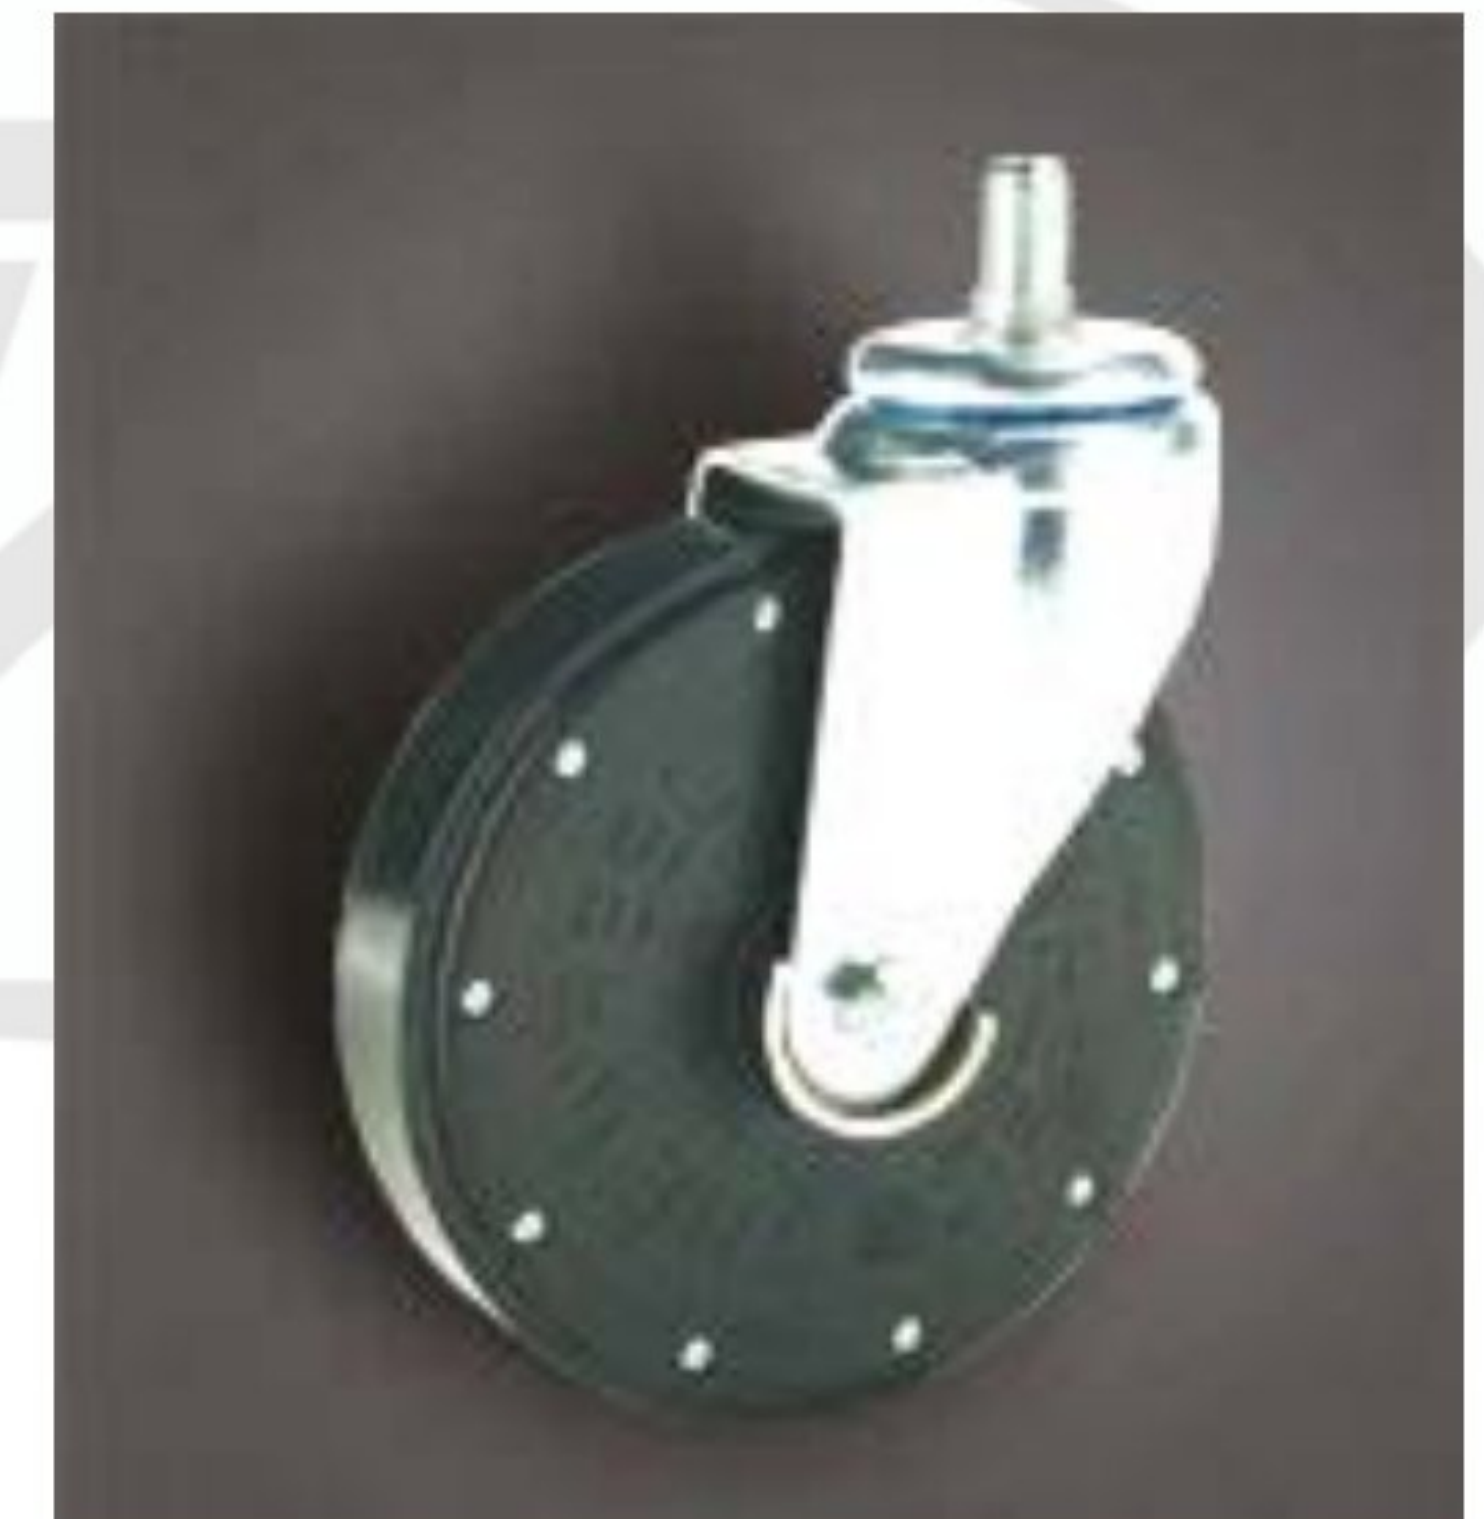
**Cause:** A possible cause for the above condition is... shopping cart interference. Shopping carts are being fitted with anti-theft devices, which have been found to interfere with the anti-theft system in the vehicle. The shopping cart system works with a buried cable around the parking lot that triggers the wheel to lock once it is passed.

**Correction:** The vehicle manufacturer has released updated calibration files for the powertrain control module to address this issue. The IDS release 45.5 and higher has this issue eliminated.
