# TECH TIPS

**Dixie Part Numbers:** A-8245 A-8302 A-8304  
A-8321 A-8330

**Applications:** 1990 – 1994 Eagle Talon  
1990 – 1994 Plymouth Laser

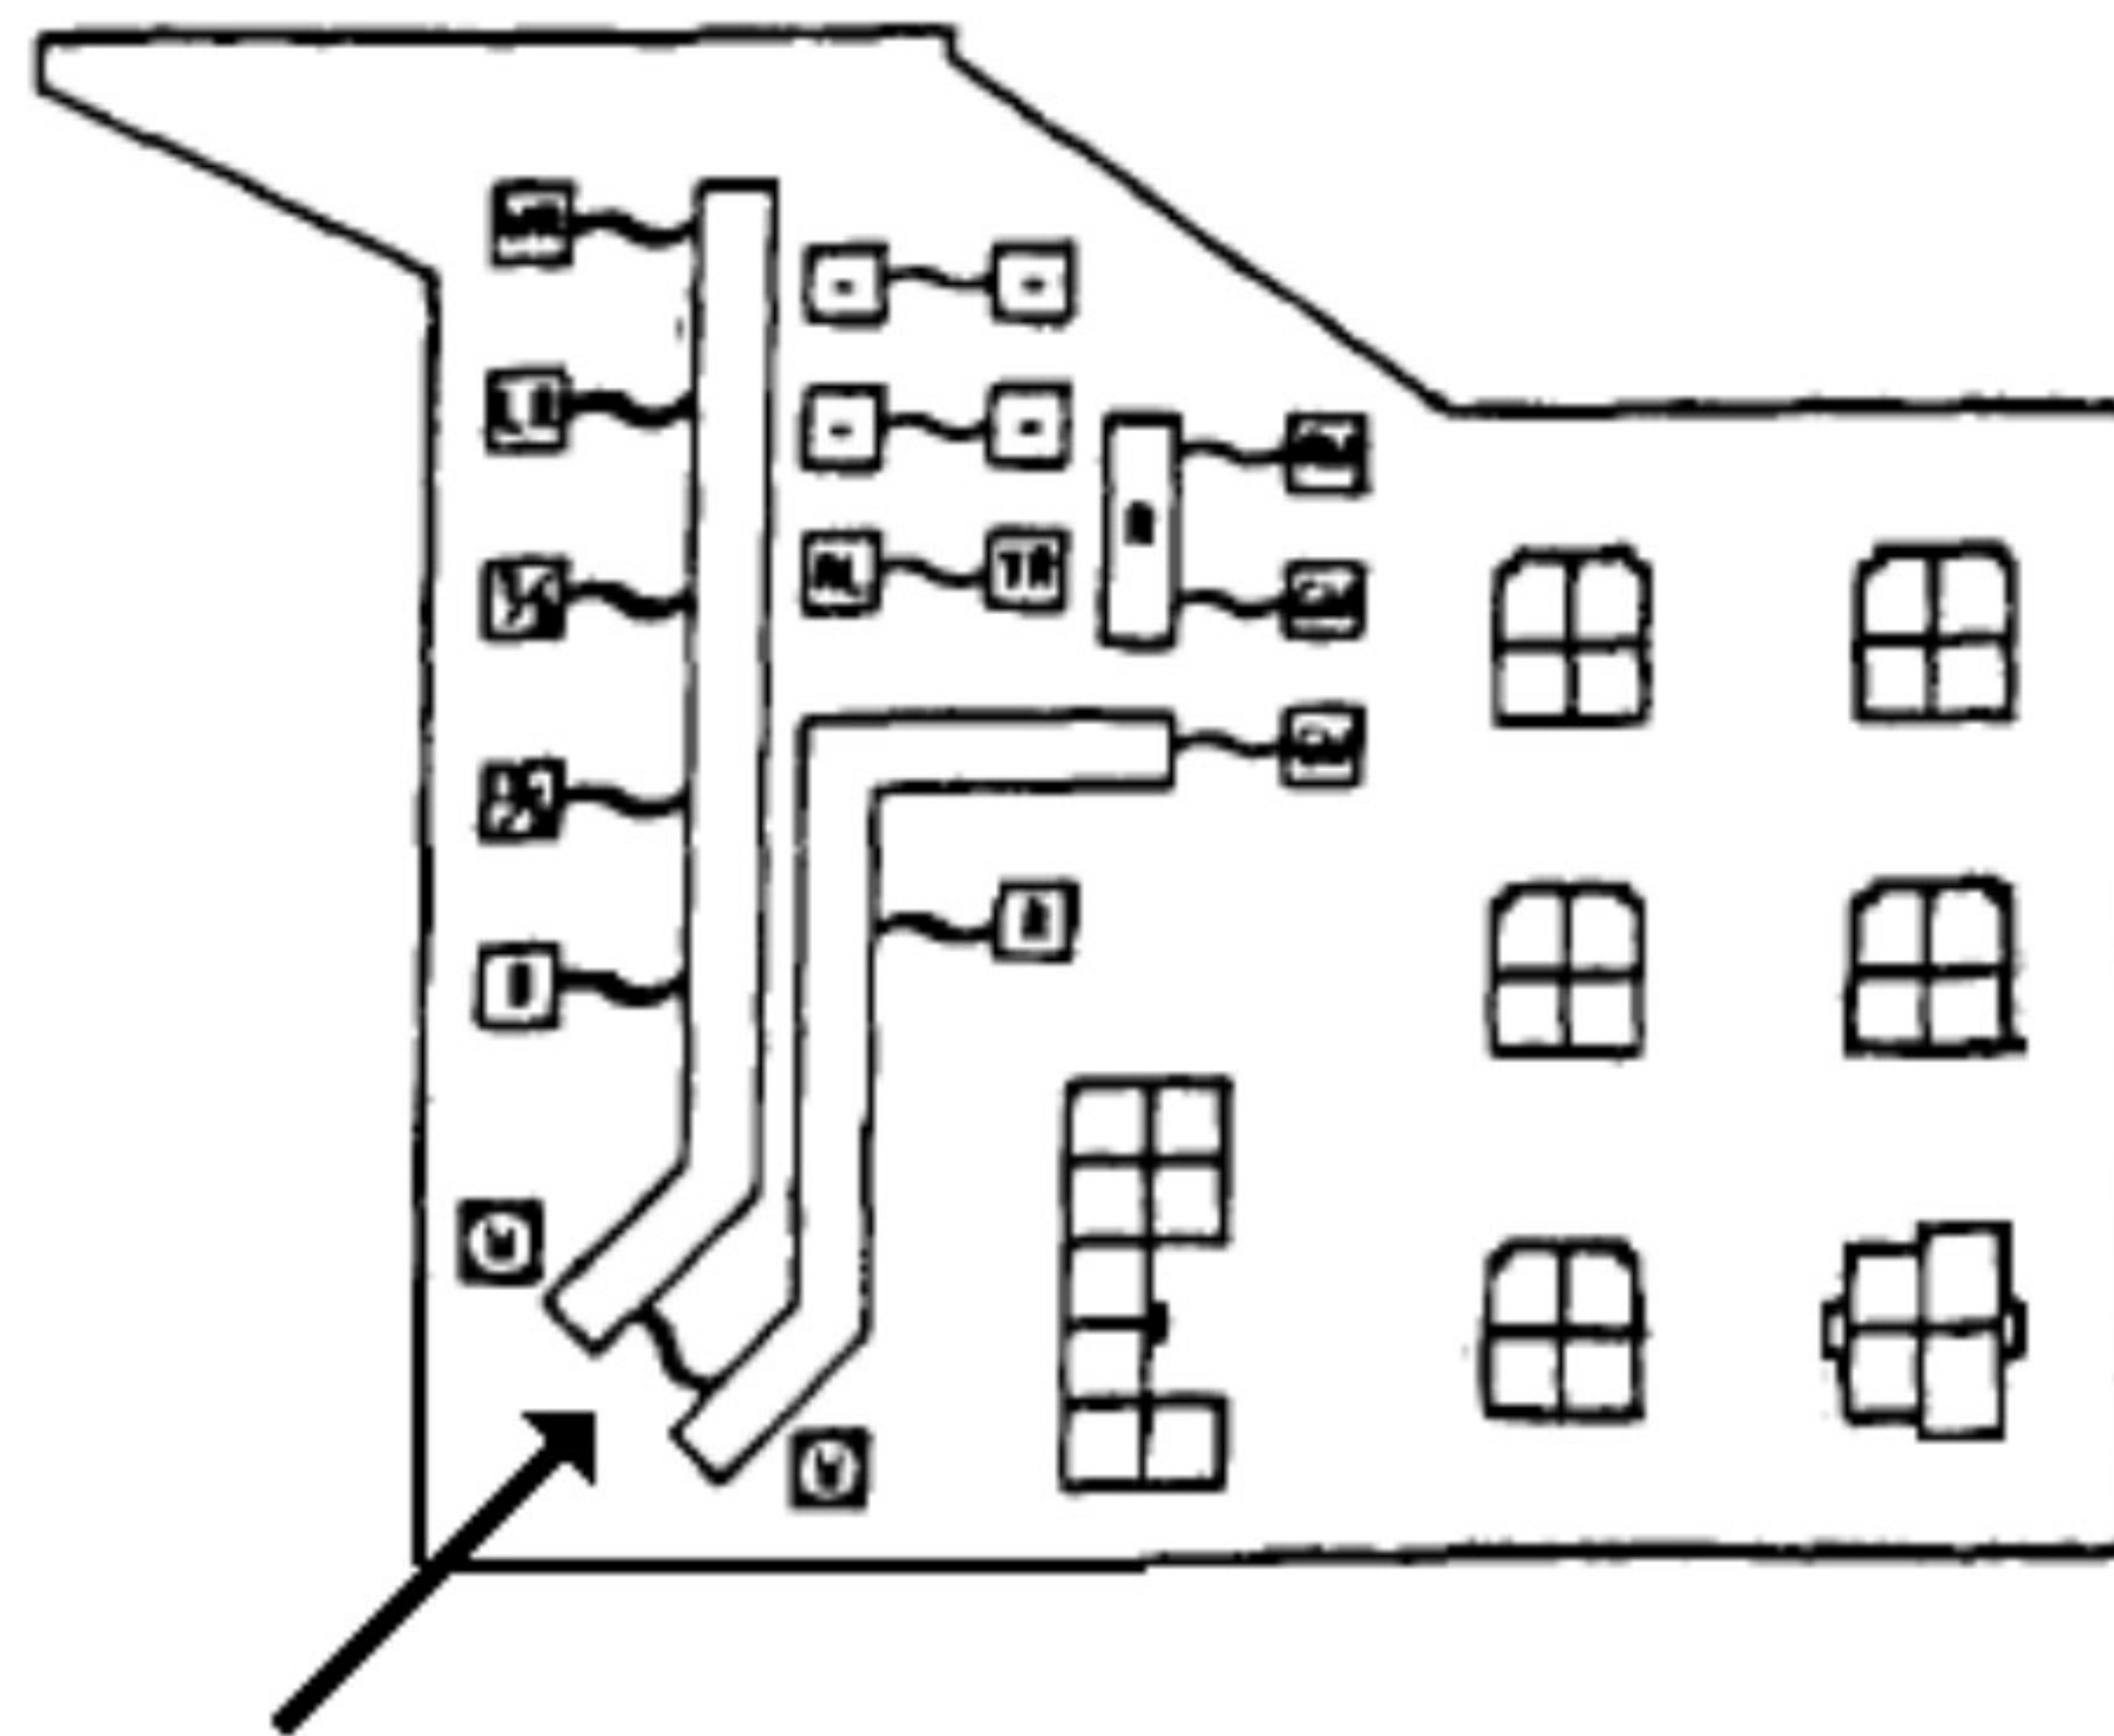
Alternator Circuit  
Sub-fusible link

**Condition:** The technician may have problems trouble shooting the charging system.

**Cause:** A possible cause for this is the generator circuit sub-fusible link (80A) located in the generator circuit.

**Correction:** Check the generator circuit sub-fusible link located on the right hand side of the engine compartment. See the sketch below for the location of the alternator circuit sub-fusible link.
