# Delco 50MT Shift Fork Problems

by Larry Hagemeister

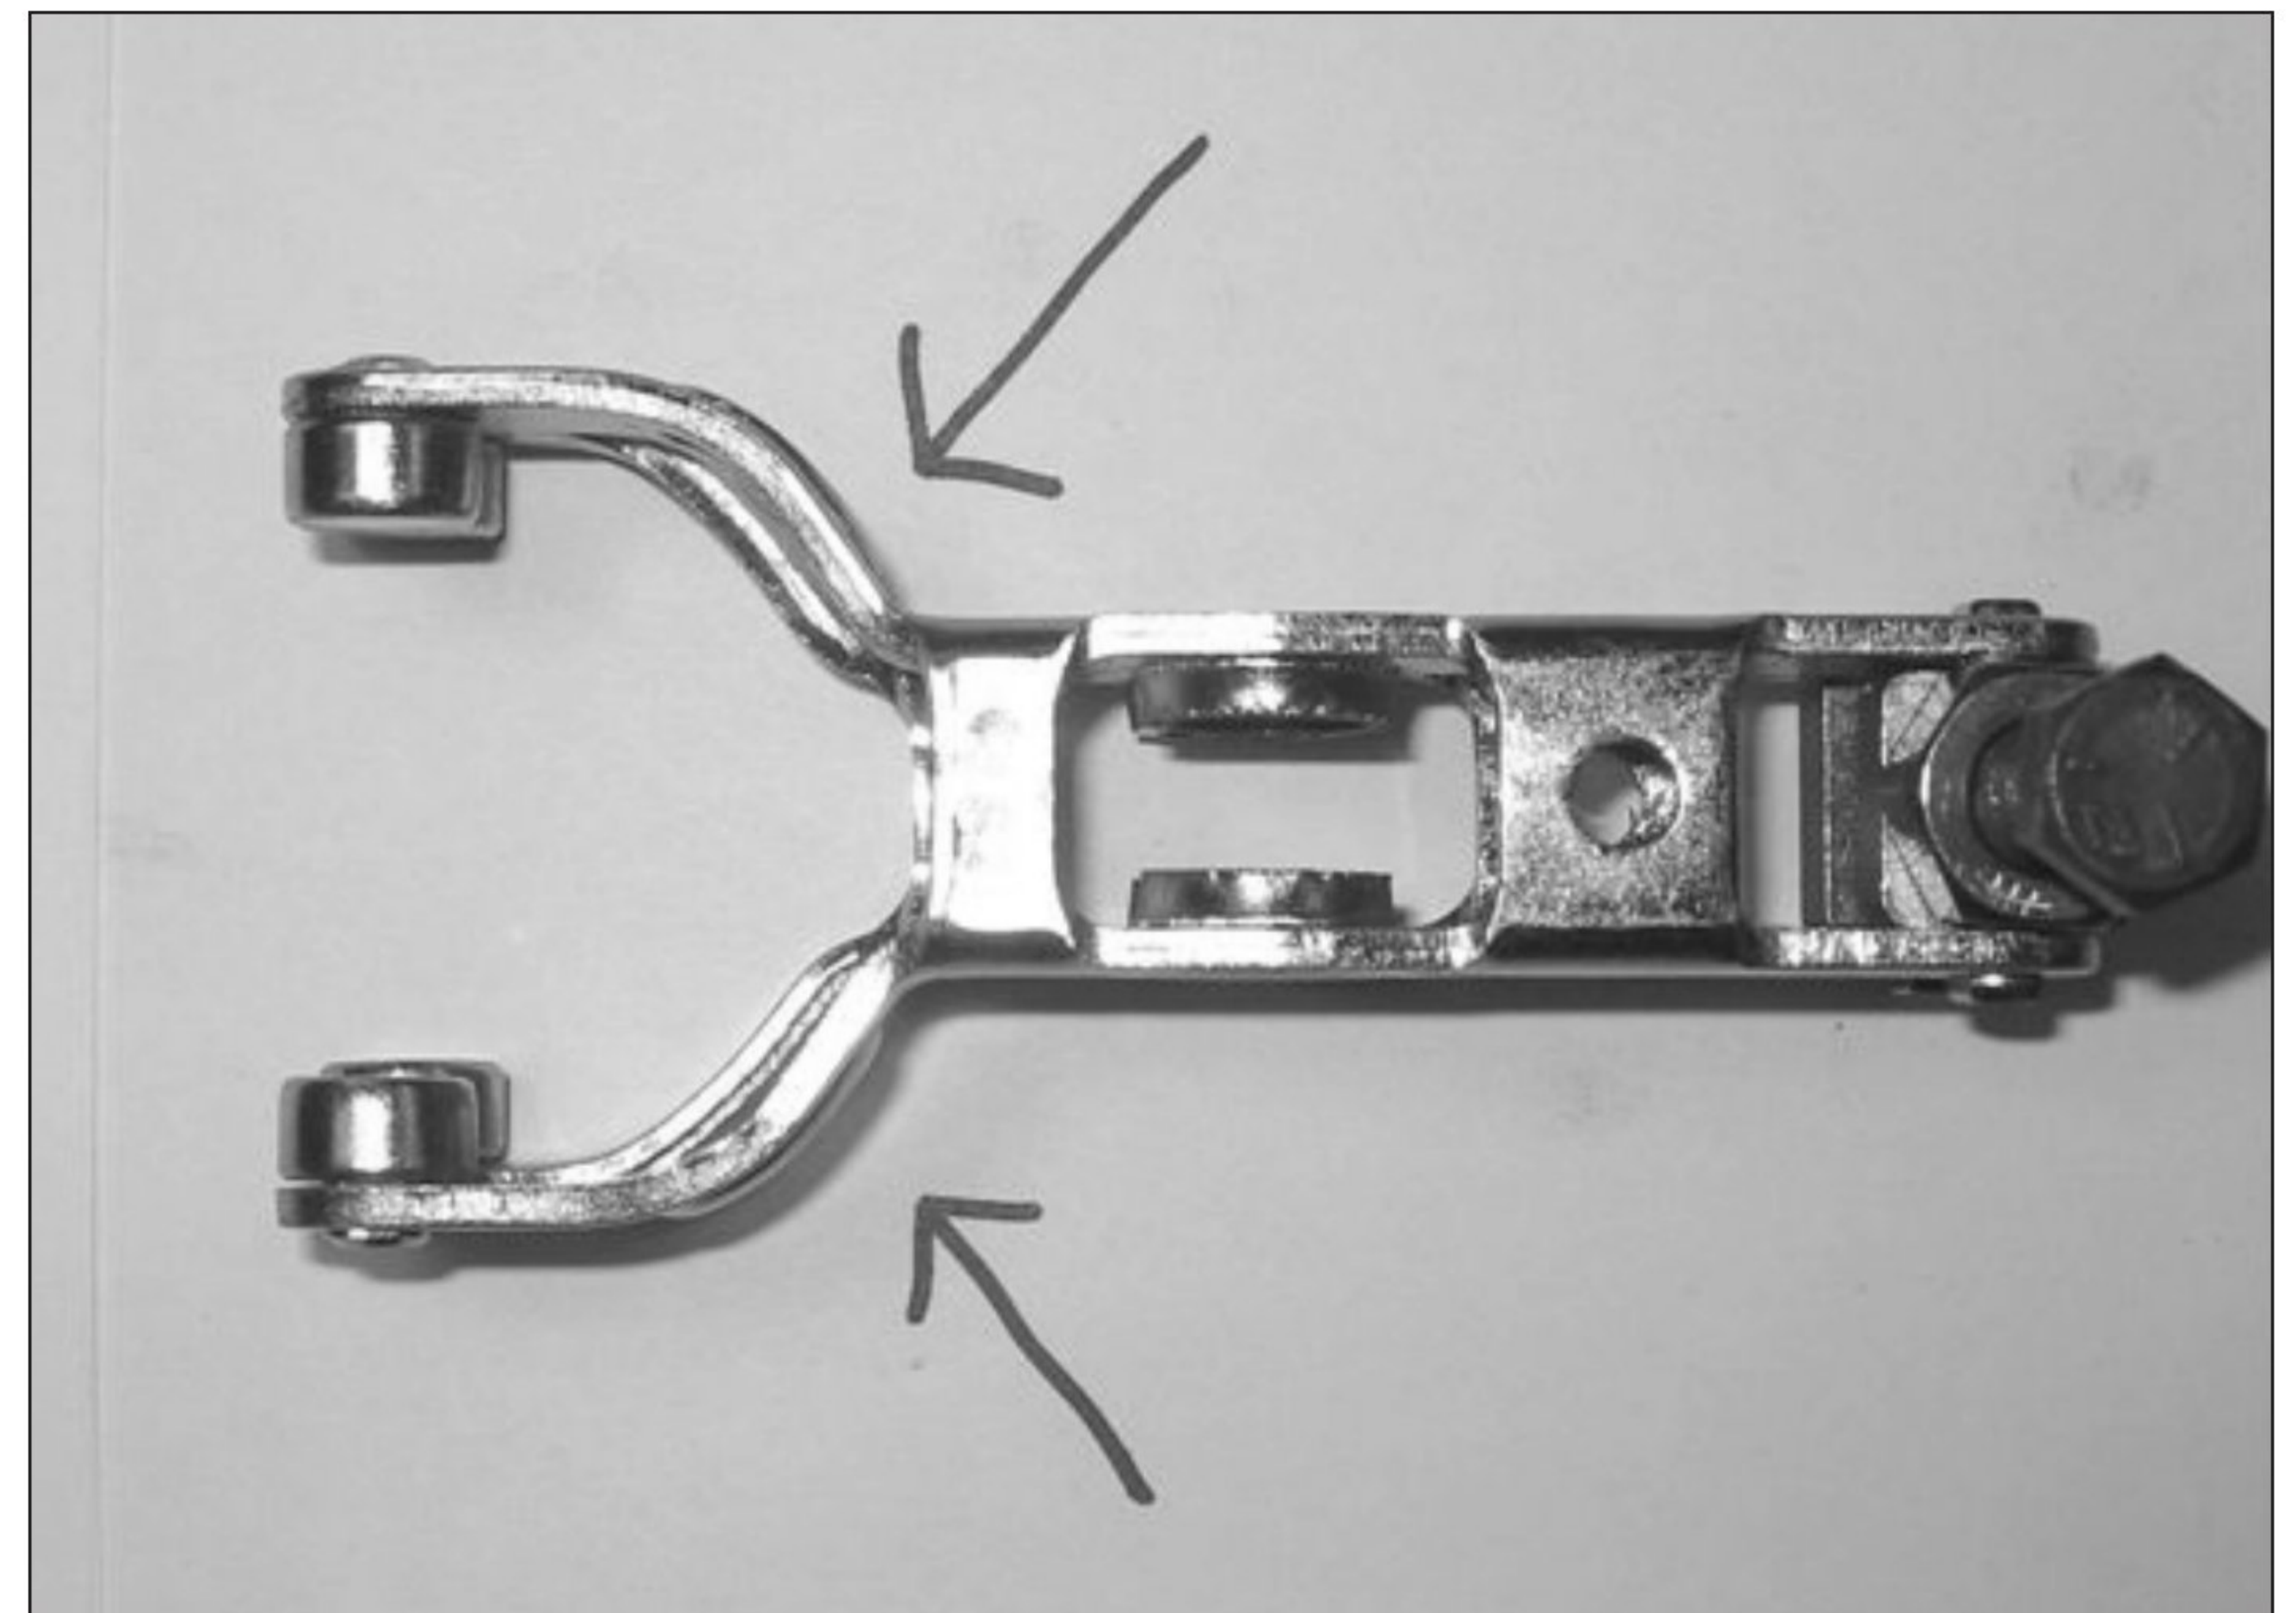
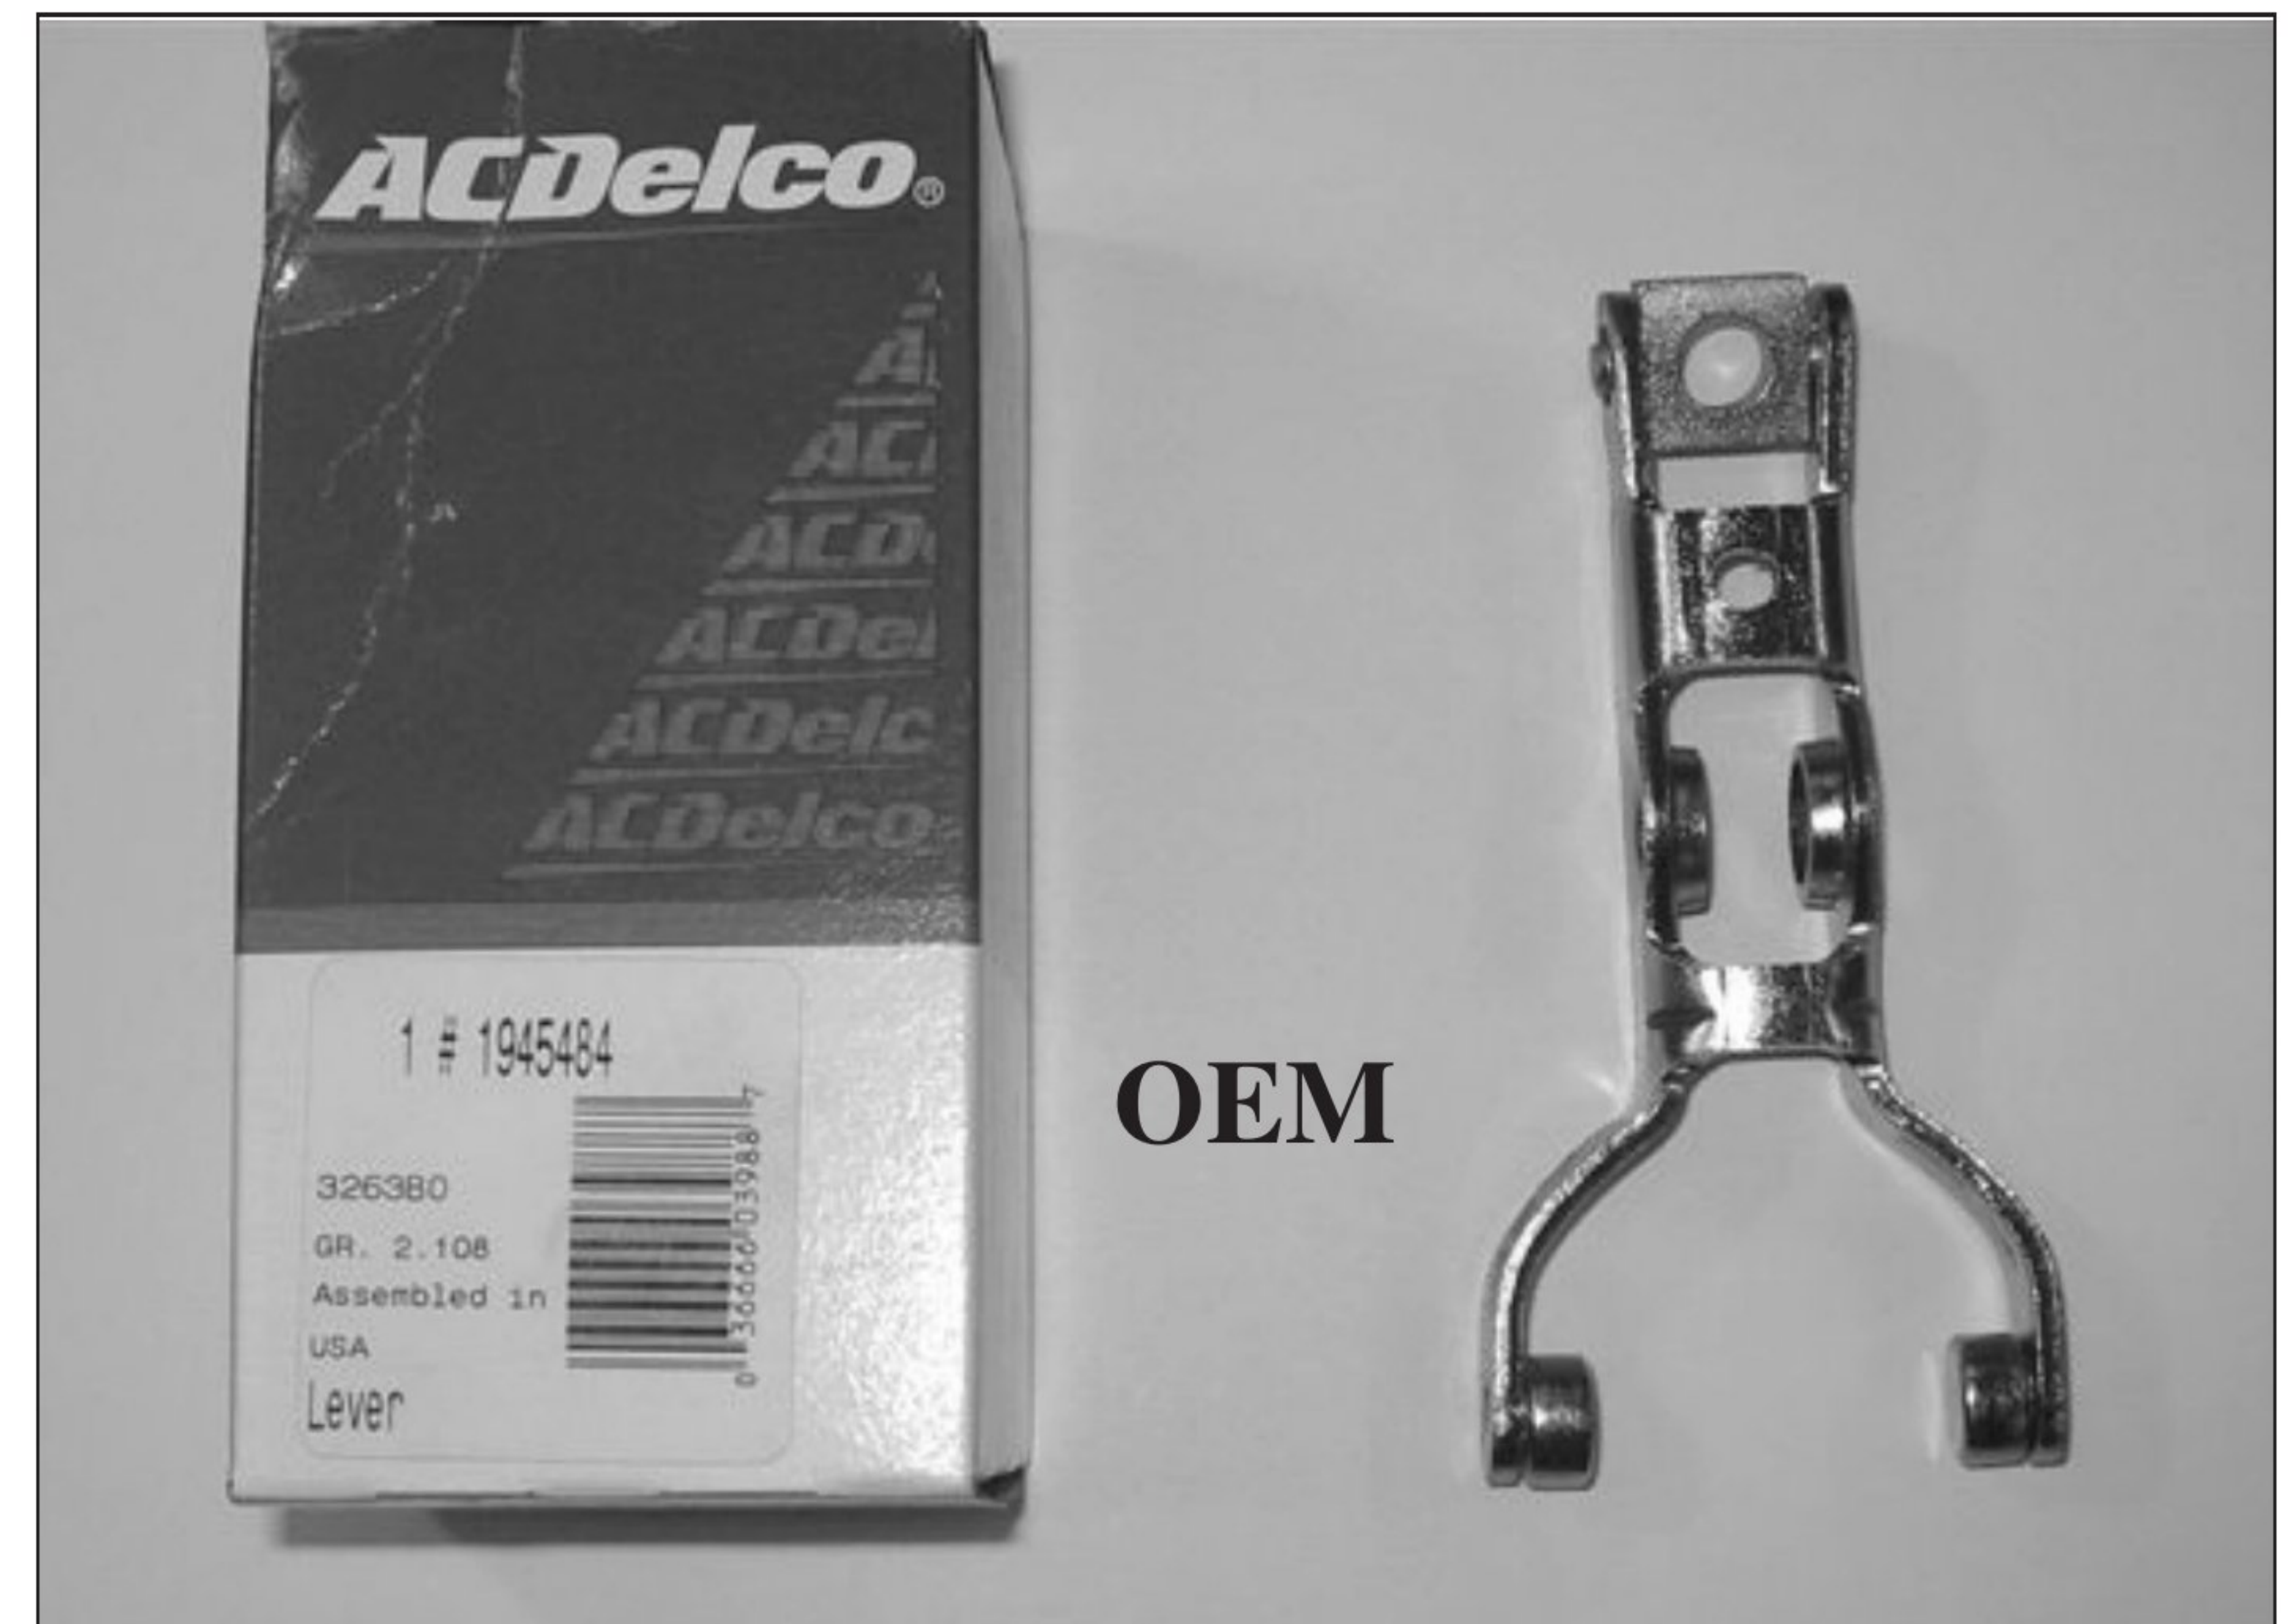
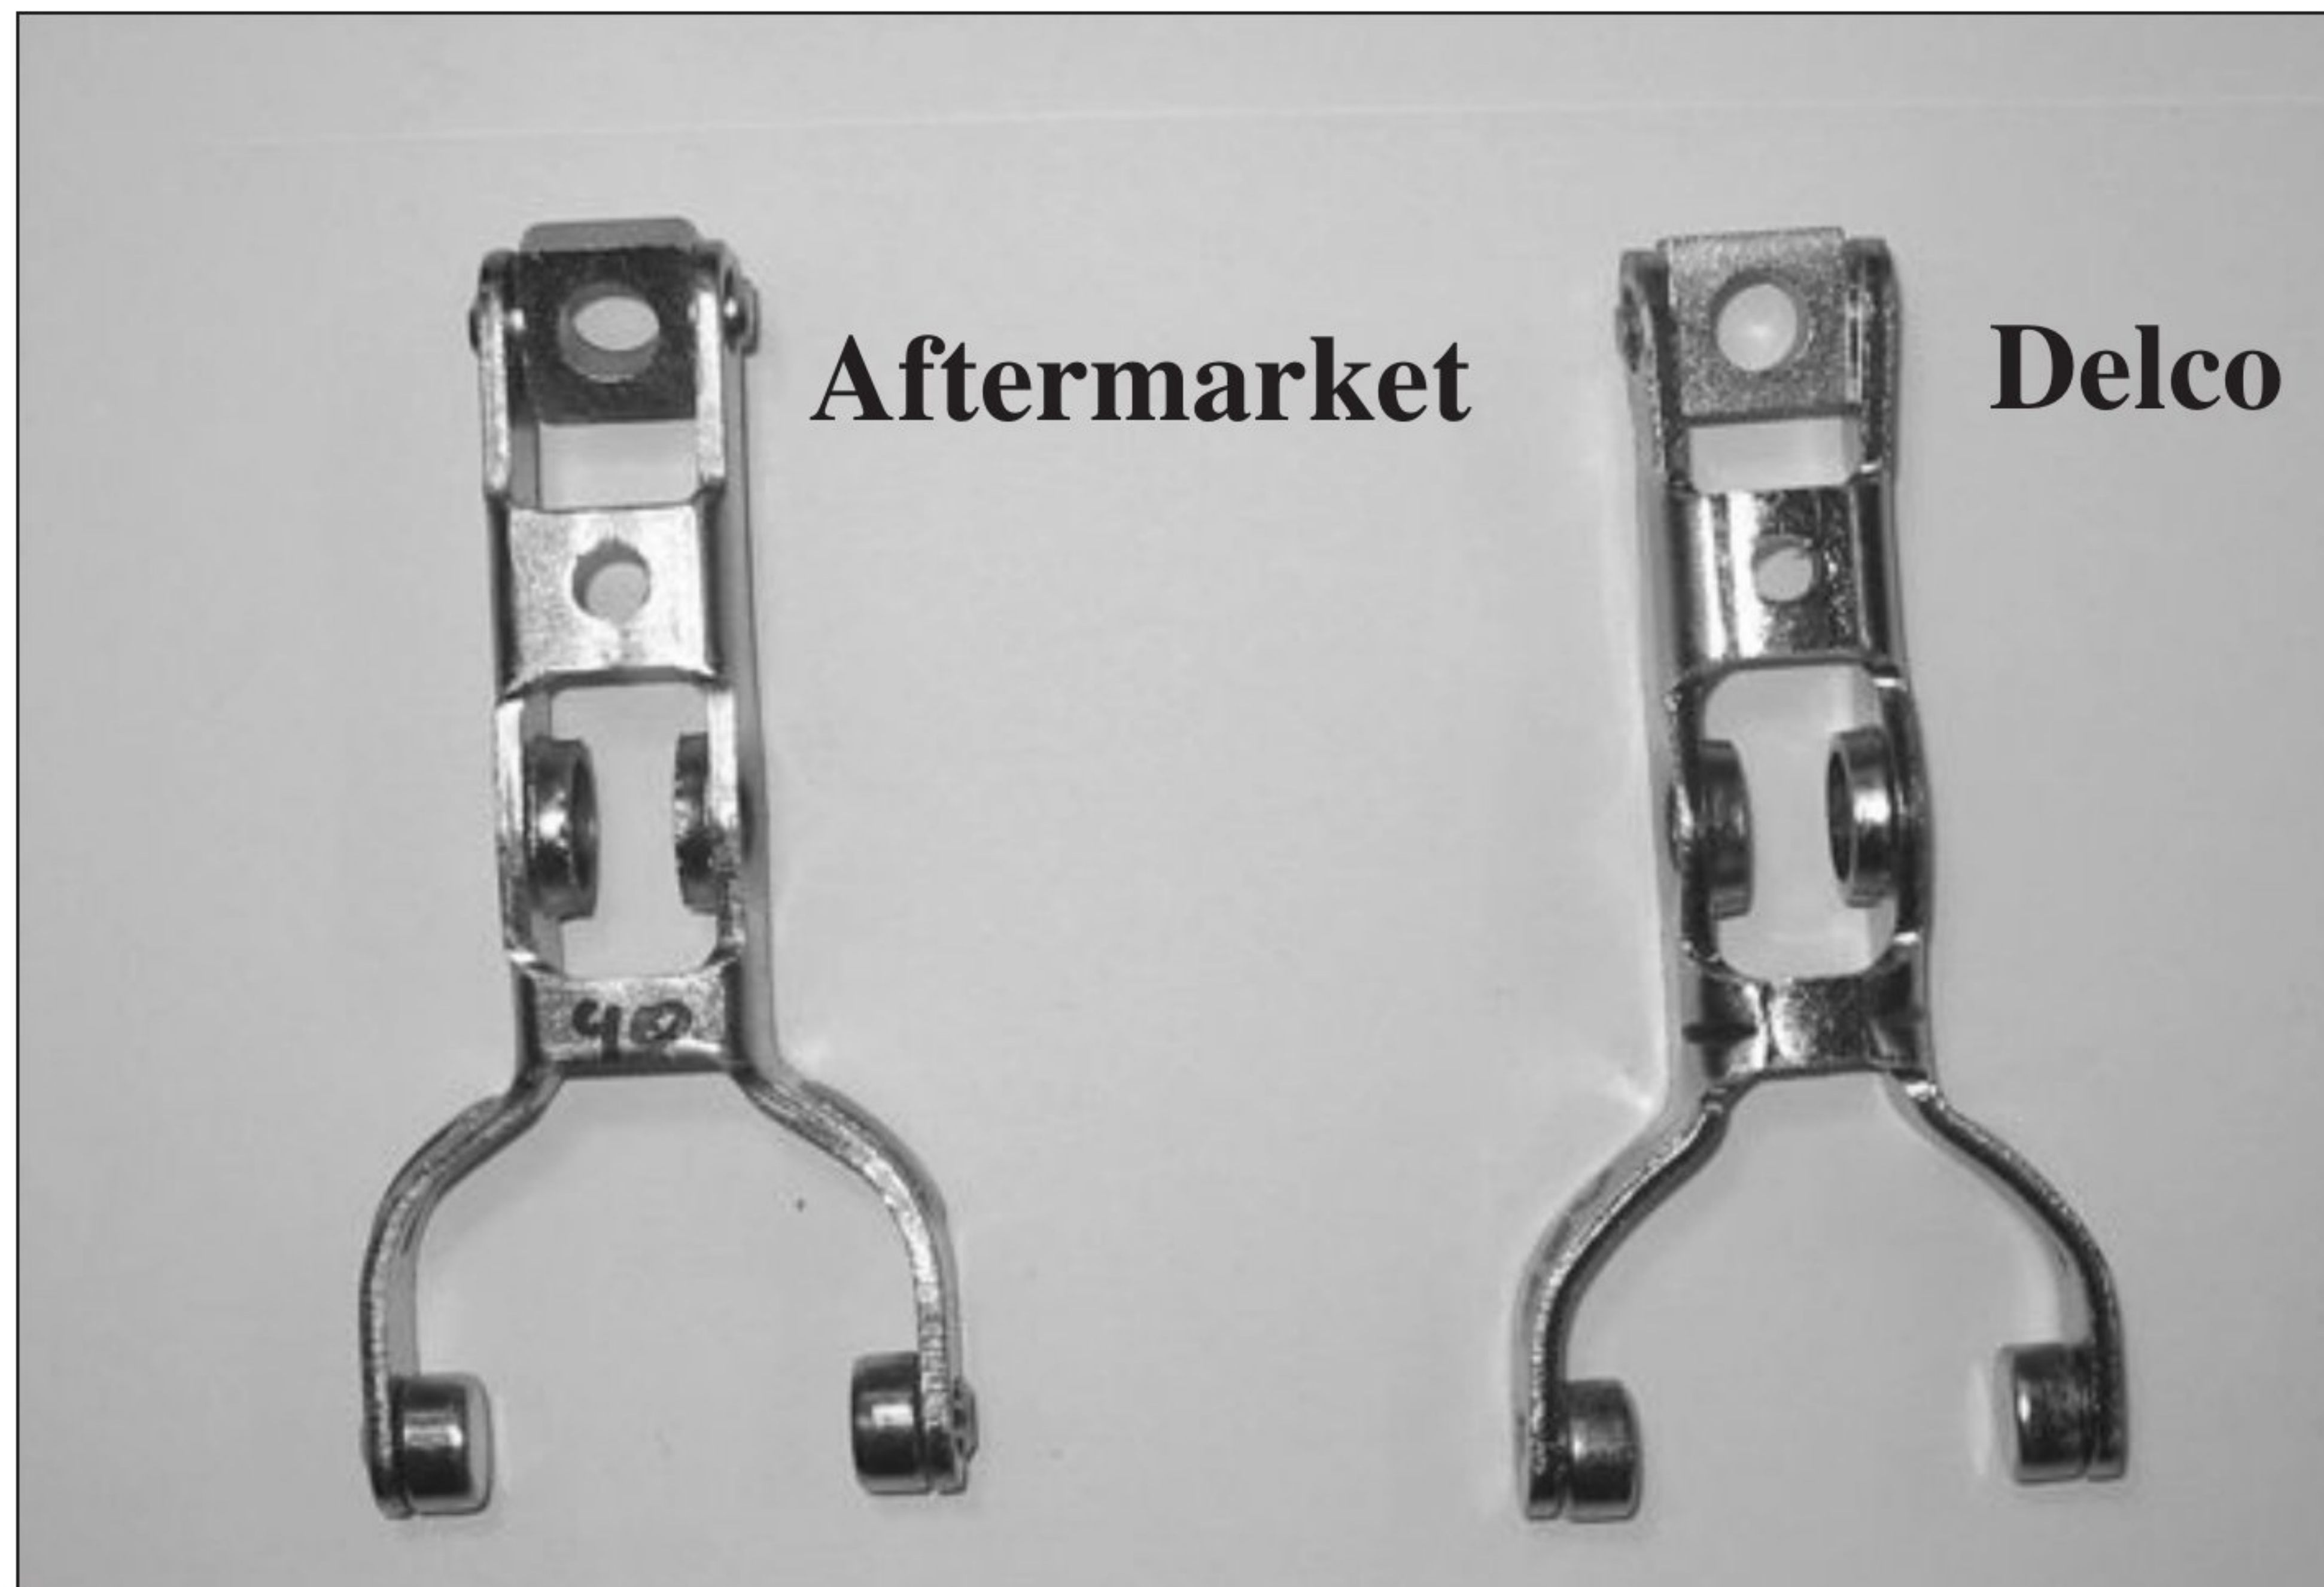
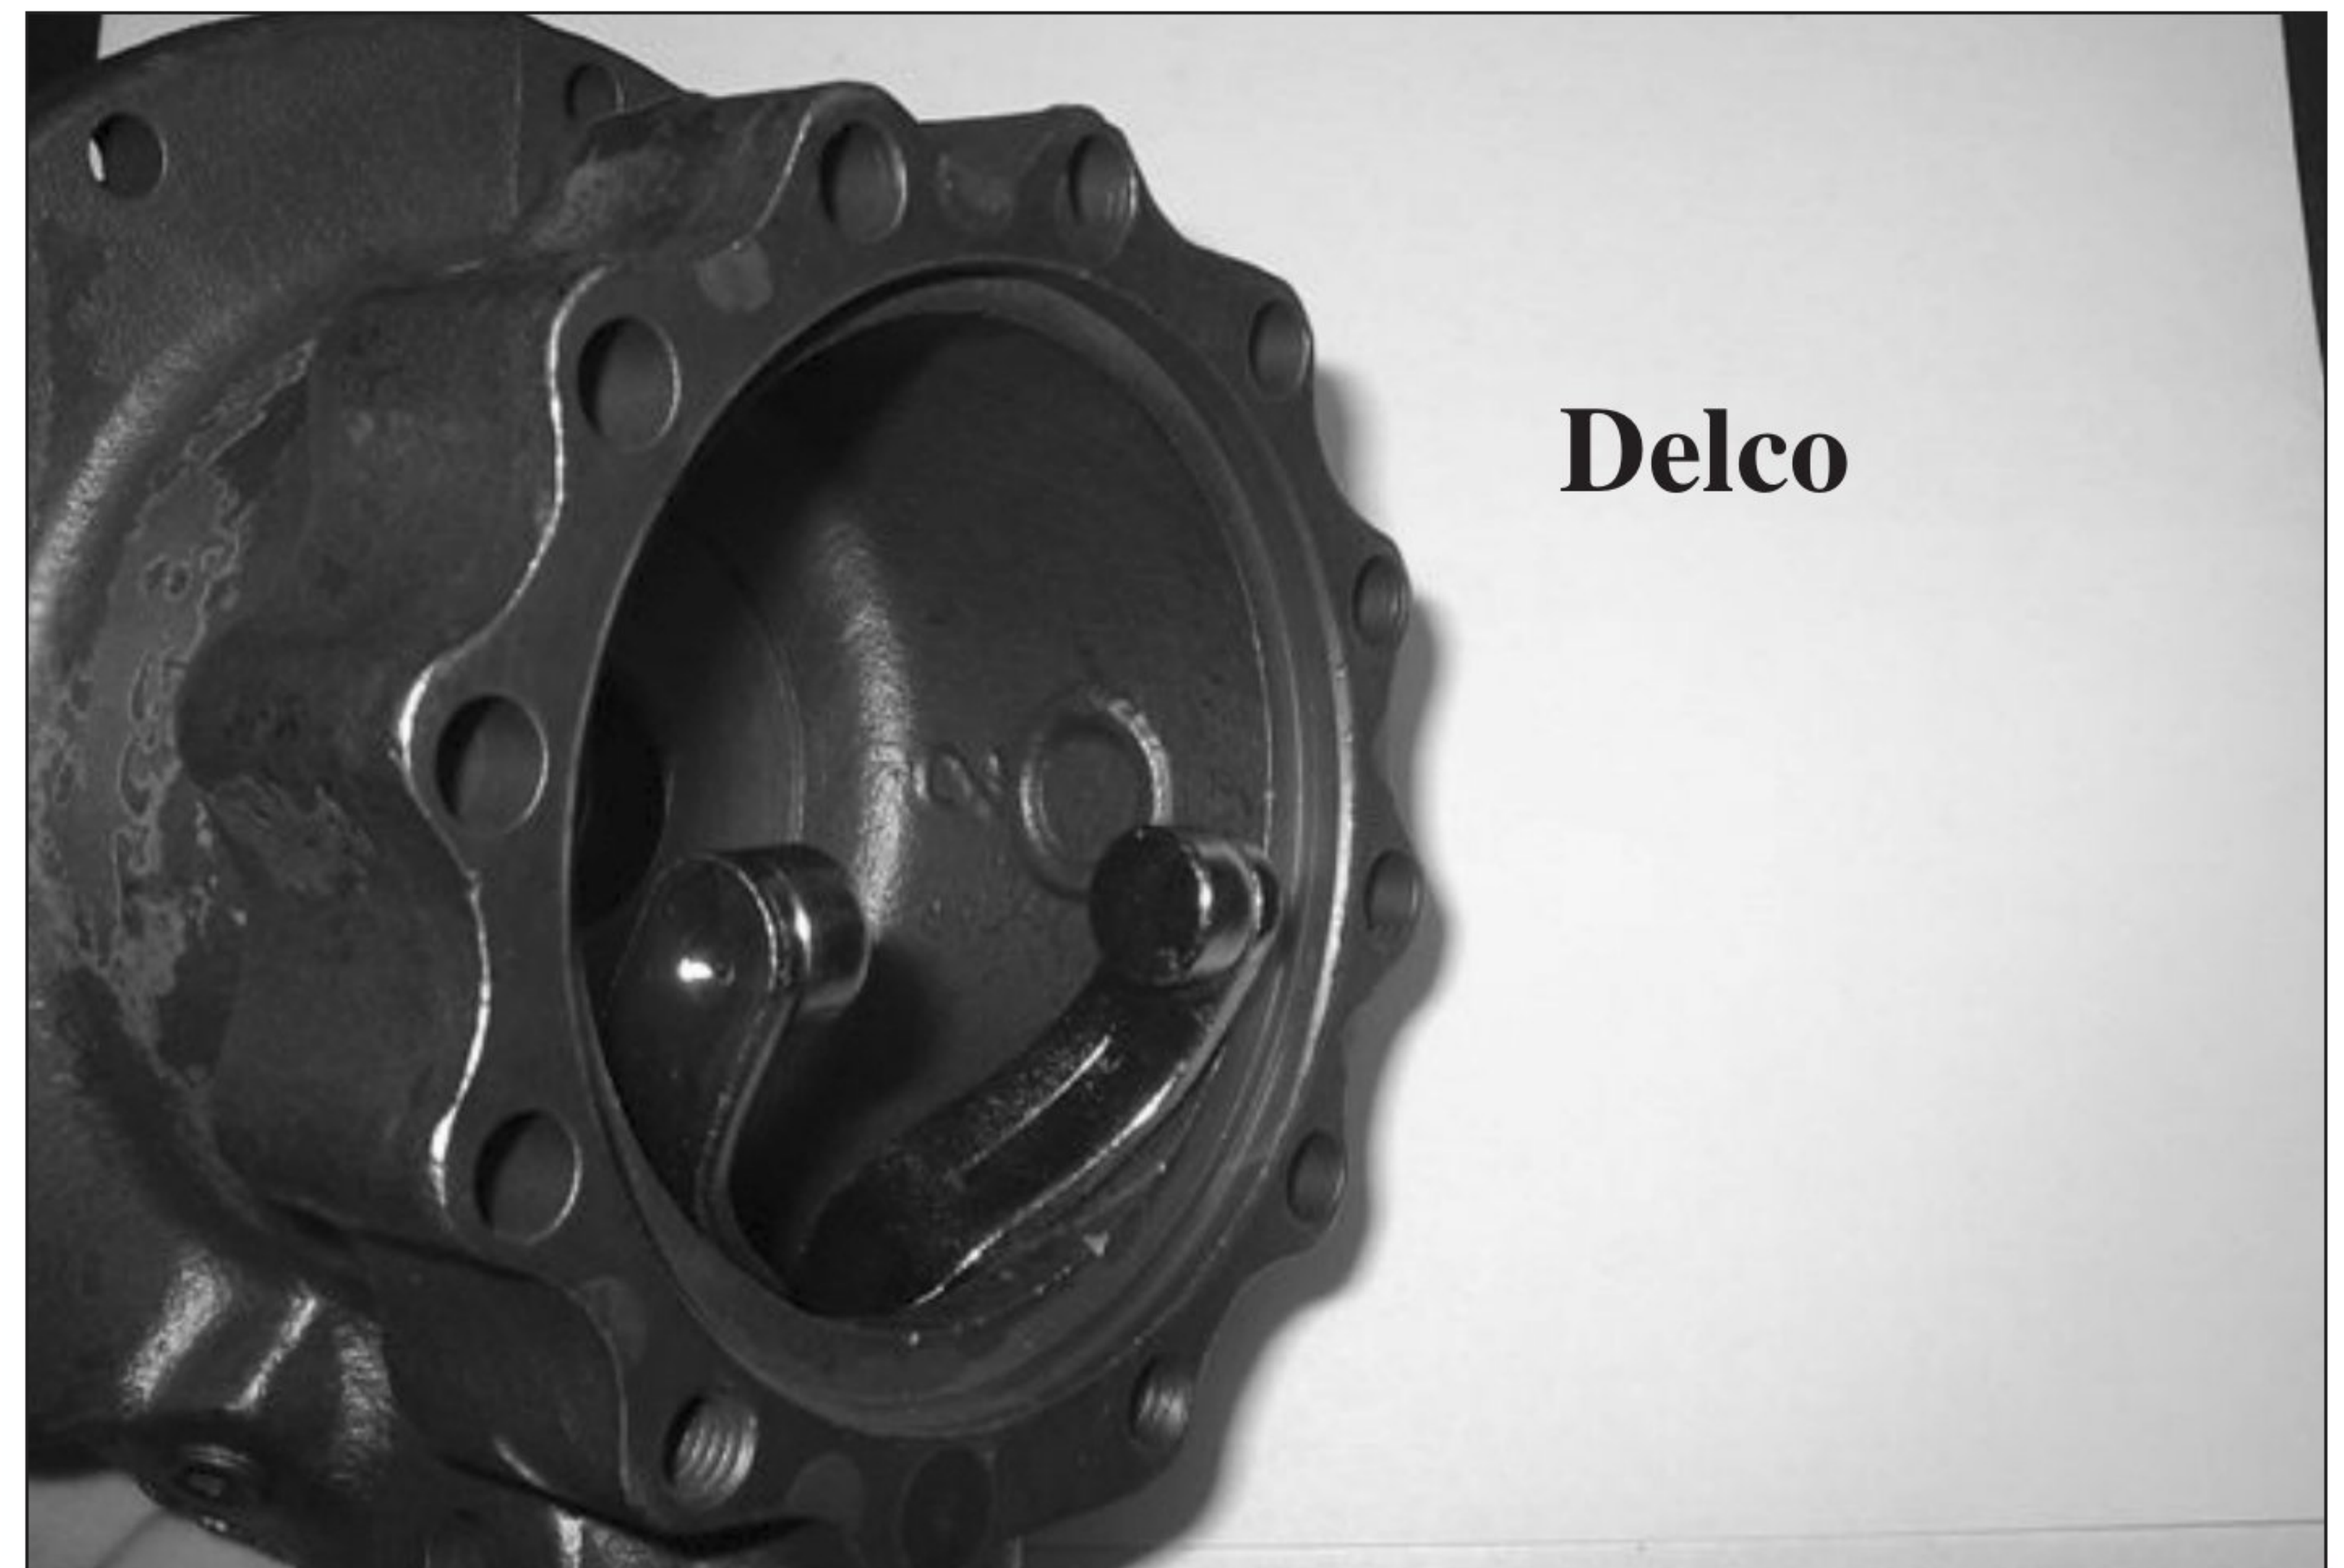
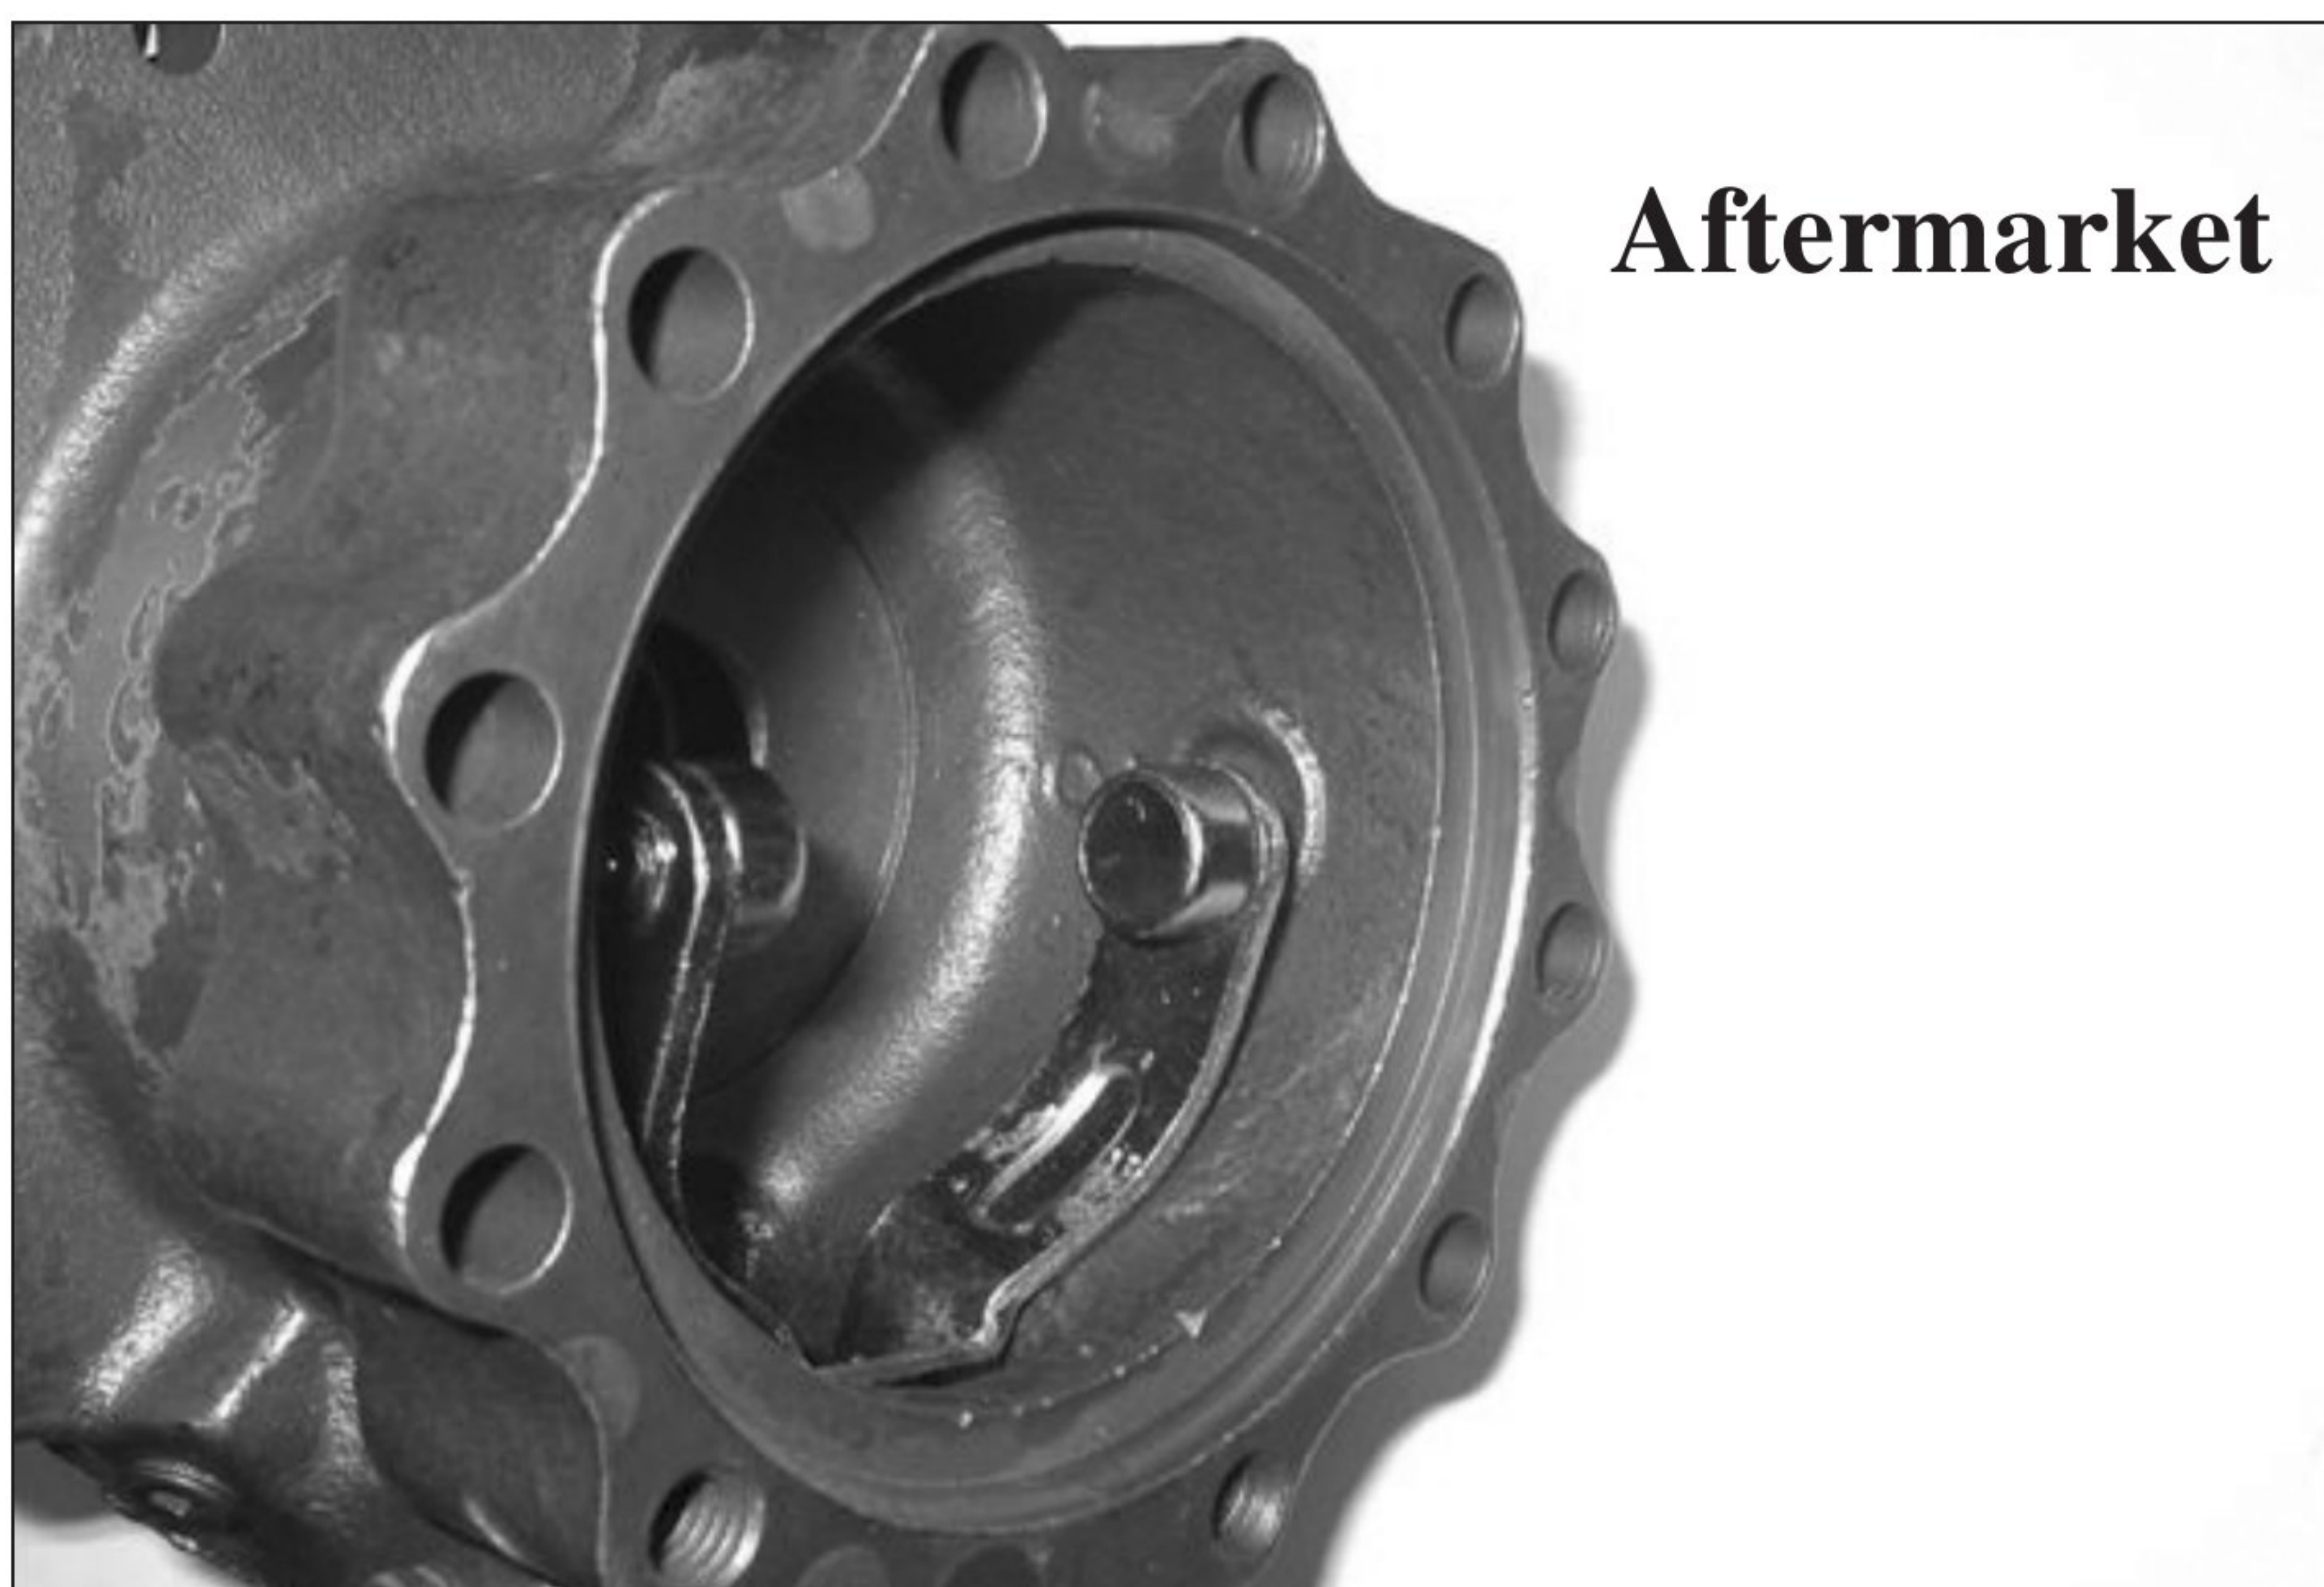
Rebuilders need to be aware of a problem in the industry with 40/50 shift forks. A couple of months ago, Chris Thompson at Electric Motor Service (EMS) posted a problem on the ERA Web site, about the 50MT shift forks. Thompson mentioned that they were hitting the center housing because the bend is wrong on the shift fork. EMS tried several different suppliers and they were all the same.

We experienced the problem first hand at Hagemeister Auto Electric when we were installing a 50MT on a silver 92 Detroit in a 1979 Peterbuilt truck. The starter would not engage properly. After removing the starter and doing some measuring, we found that the shift fork was binding against the center housing. We ordered a new one from Delco, part no. 1945484. As you

can see from the pictures on pages one and 12, there is a significant difference in the shift forks. Also, there is a picture of an old-style two-piece Delco shift fork. I don't think anyone is manufacturing shift forks this way anymore.

Hopefully the suppliers will take a look at this problem and make the necessary changes to the way the shift fork is made to solve this problem. I also understand that many rebuilders are grinding out the 50MT center housing to allow clearance for the shift fork.
