# Look Beyond the Obvious with Bad Scope Patterns

By Richard R. Vensel

Following are the existing conditions of the IG Ford alternator under discussion:

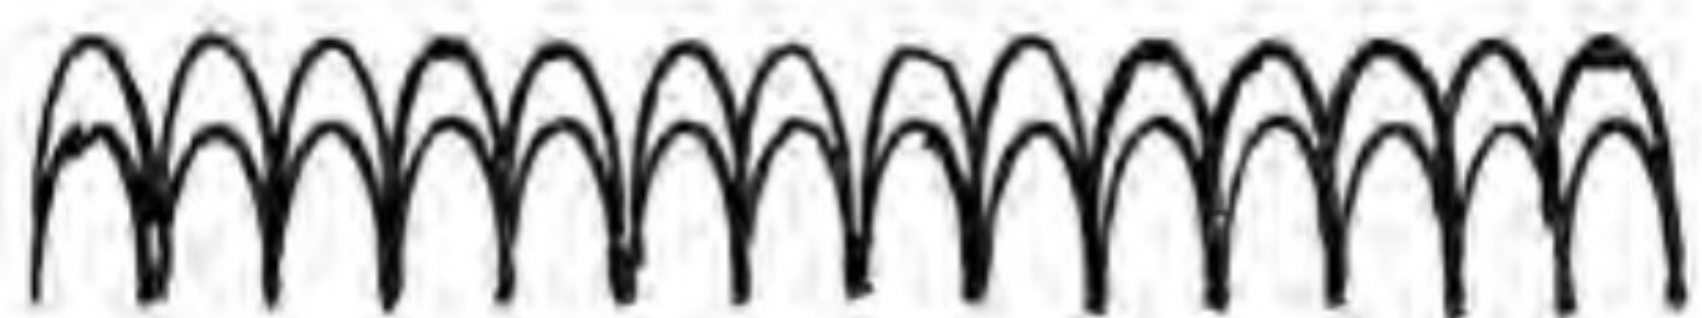
Pattern Under discussion  
(With all major parts replaced)

What we are seeing here is a noise mixed with the normal scope pattern. This produces a distorted pattern like above. This distortion can also be a snakelike pattern across your screen and sometimes fine lines running above and below the “Good M” pattern.

A bad needle bearing caused this pattern. This is not unusual on Ford units with needle bearings. The OD of the bearing could be too large, or the housing could have been left in a steel shot machine too long causing it to expand, or the housing could have been knurled too much.

This problem can be fixed by pressing the old bearing out and reinstalling two times. This corrects the hole size. Then replace the bearing with one that has the correct OD.
