# AUTO ELECTRIC CORNER —

## Hybrid Vehicle Batteries & 14557 Mitsubishi Alternator

### HV Battery Change...!

### Visiting an Old Unit

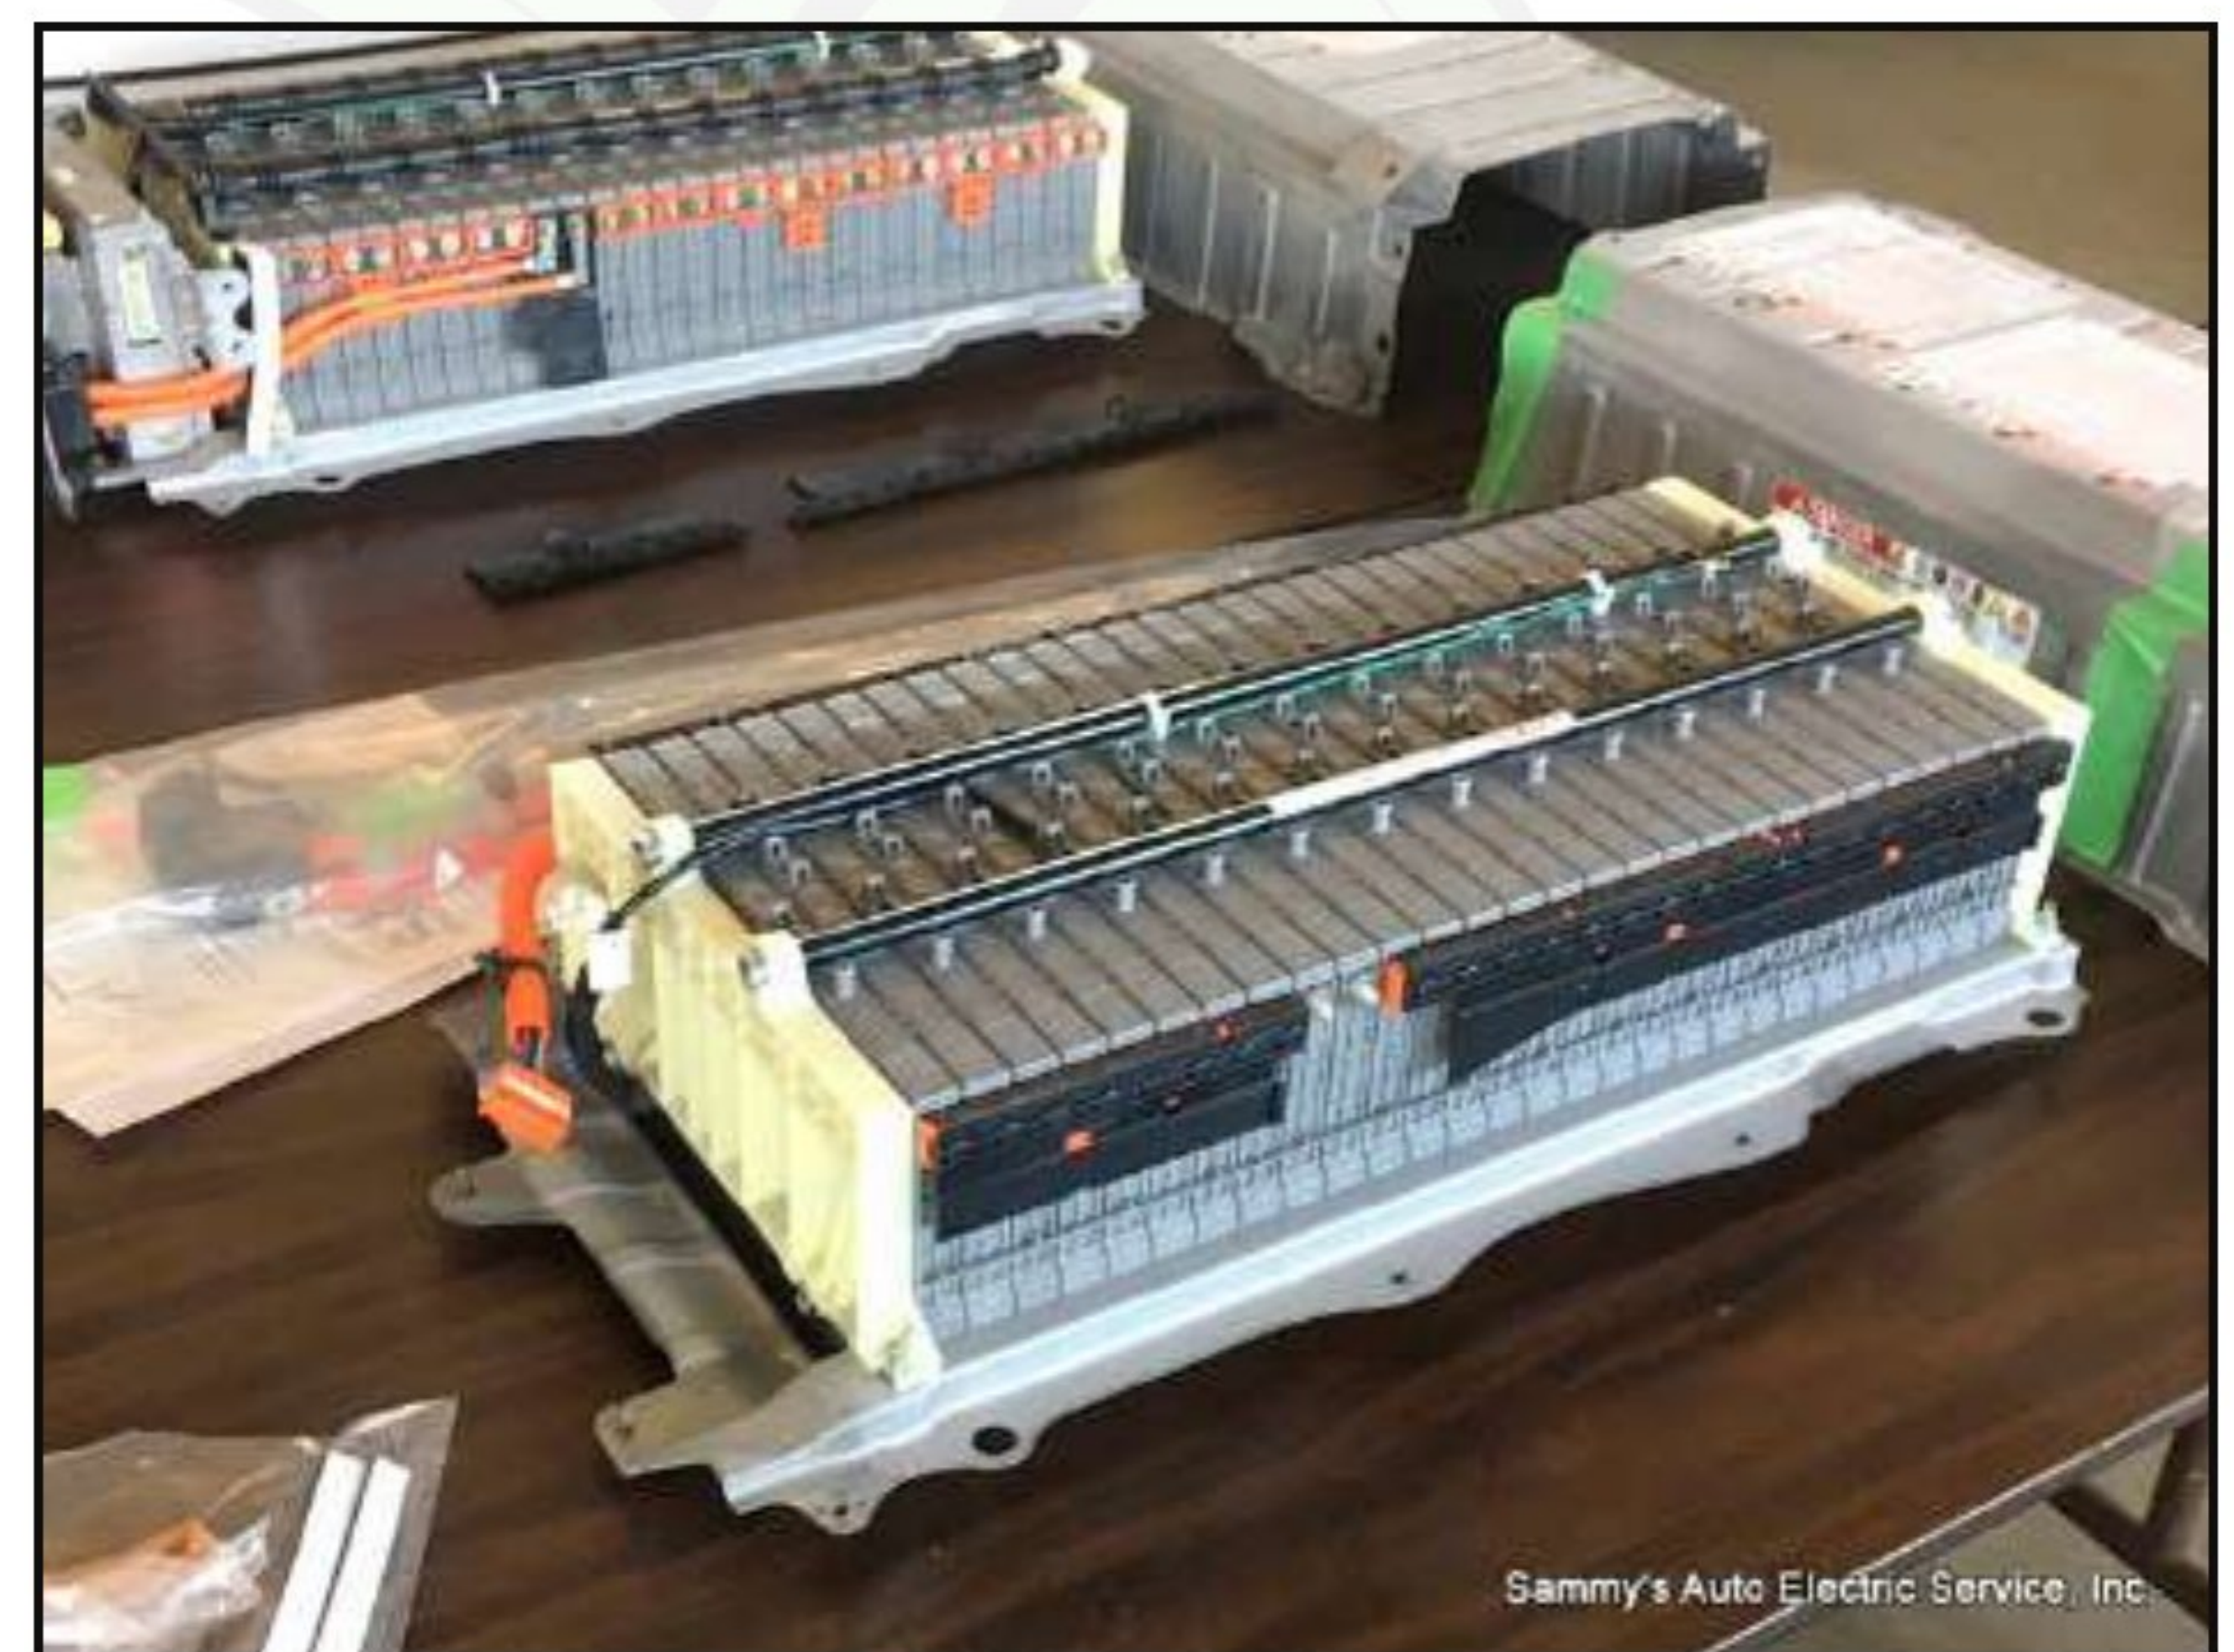
Figure 2 – Old and New Batteries with Covers OFF

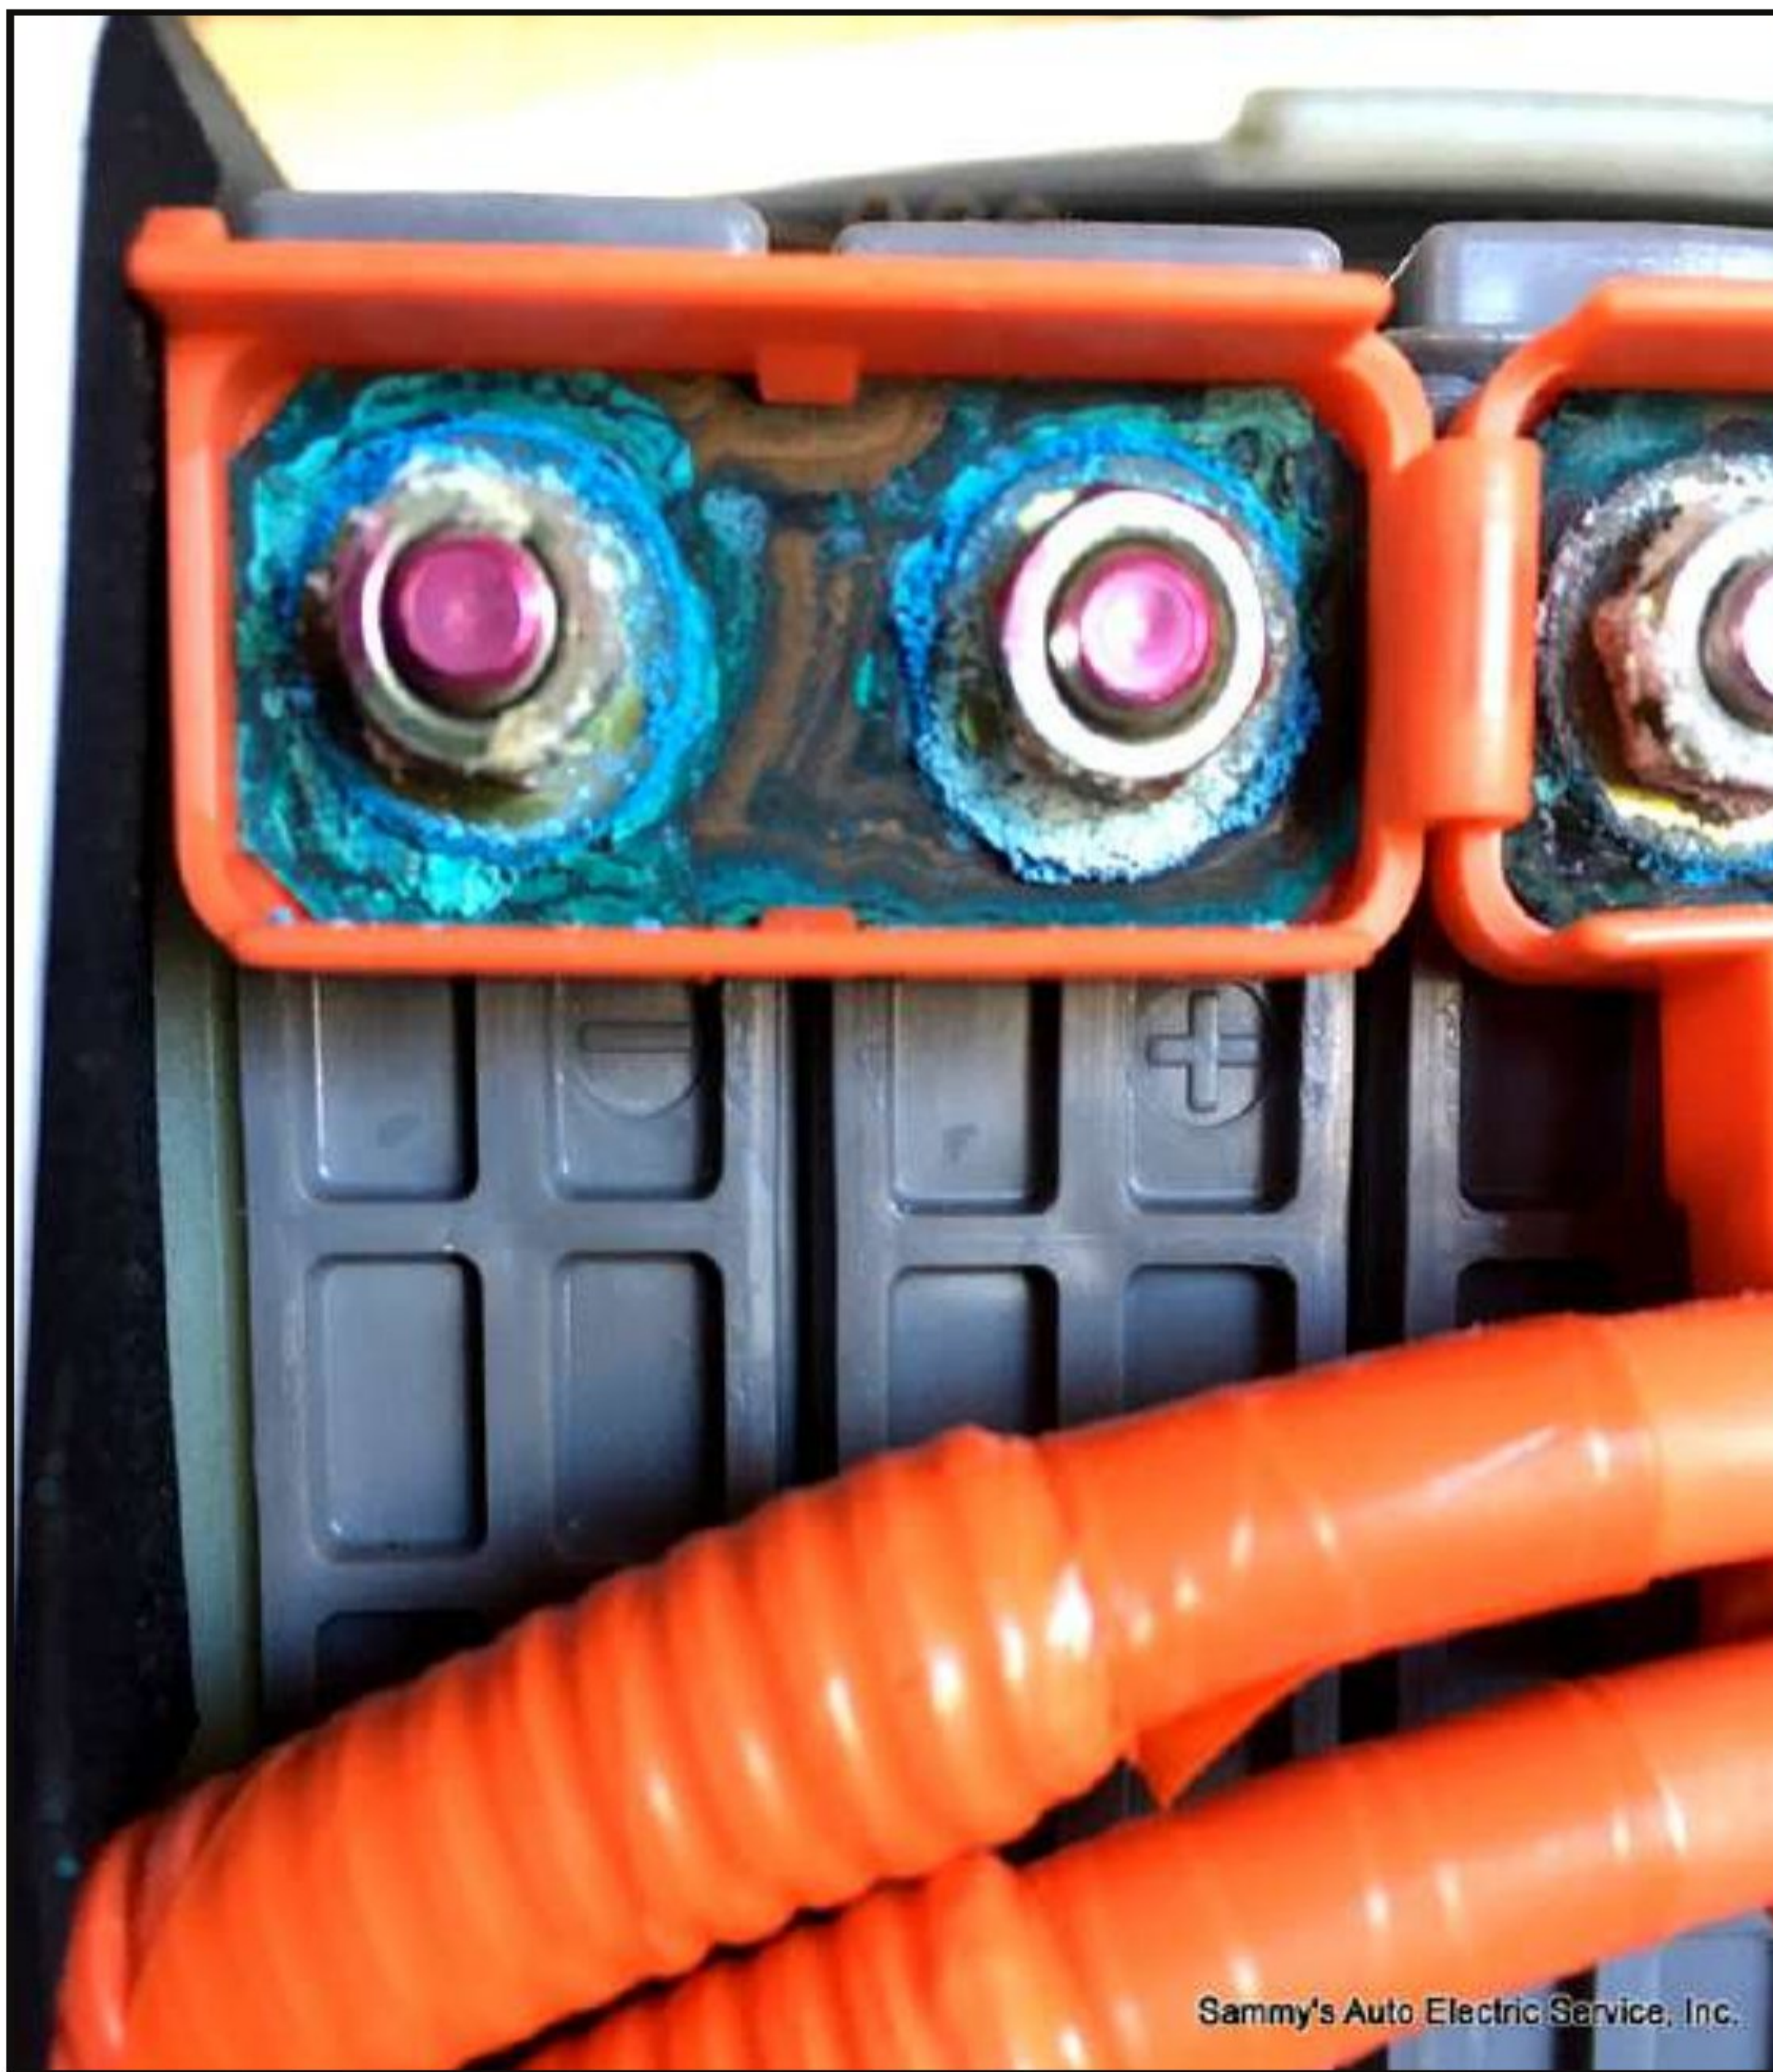
The system is designed to maintain each block at 45 to 55% state-of-charge. Seeing a 50% SOC is a good sign. At the same time, we are looking for the least amount of variation. The closer the variations in Delta SOC is to zero, the better the battery is. In new batteries after the installation this figure is always near 0% (see Figure 7). Bluish corrosion and salt build-up around each module's post is always a sign of a deteriorated module and necessity for HV battery replacement (see Figure 8).

Figure 8 – Blue Corrosion is a Sign of Battery Module Gone Bad

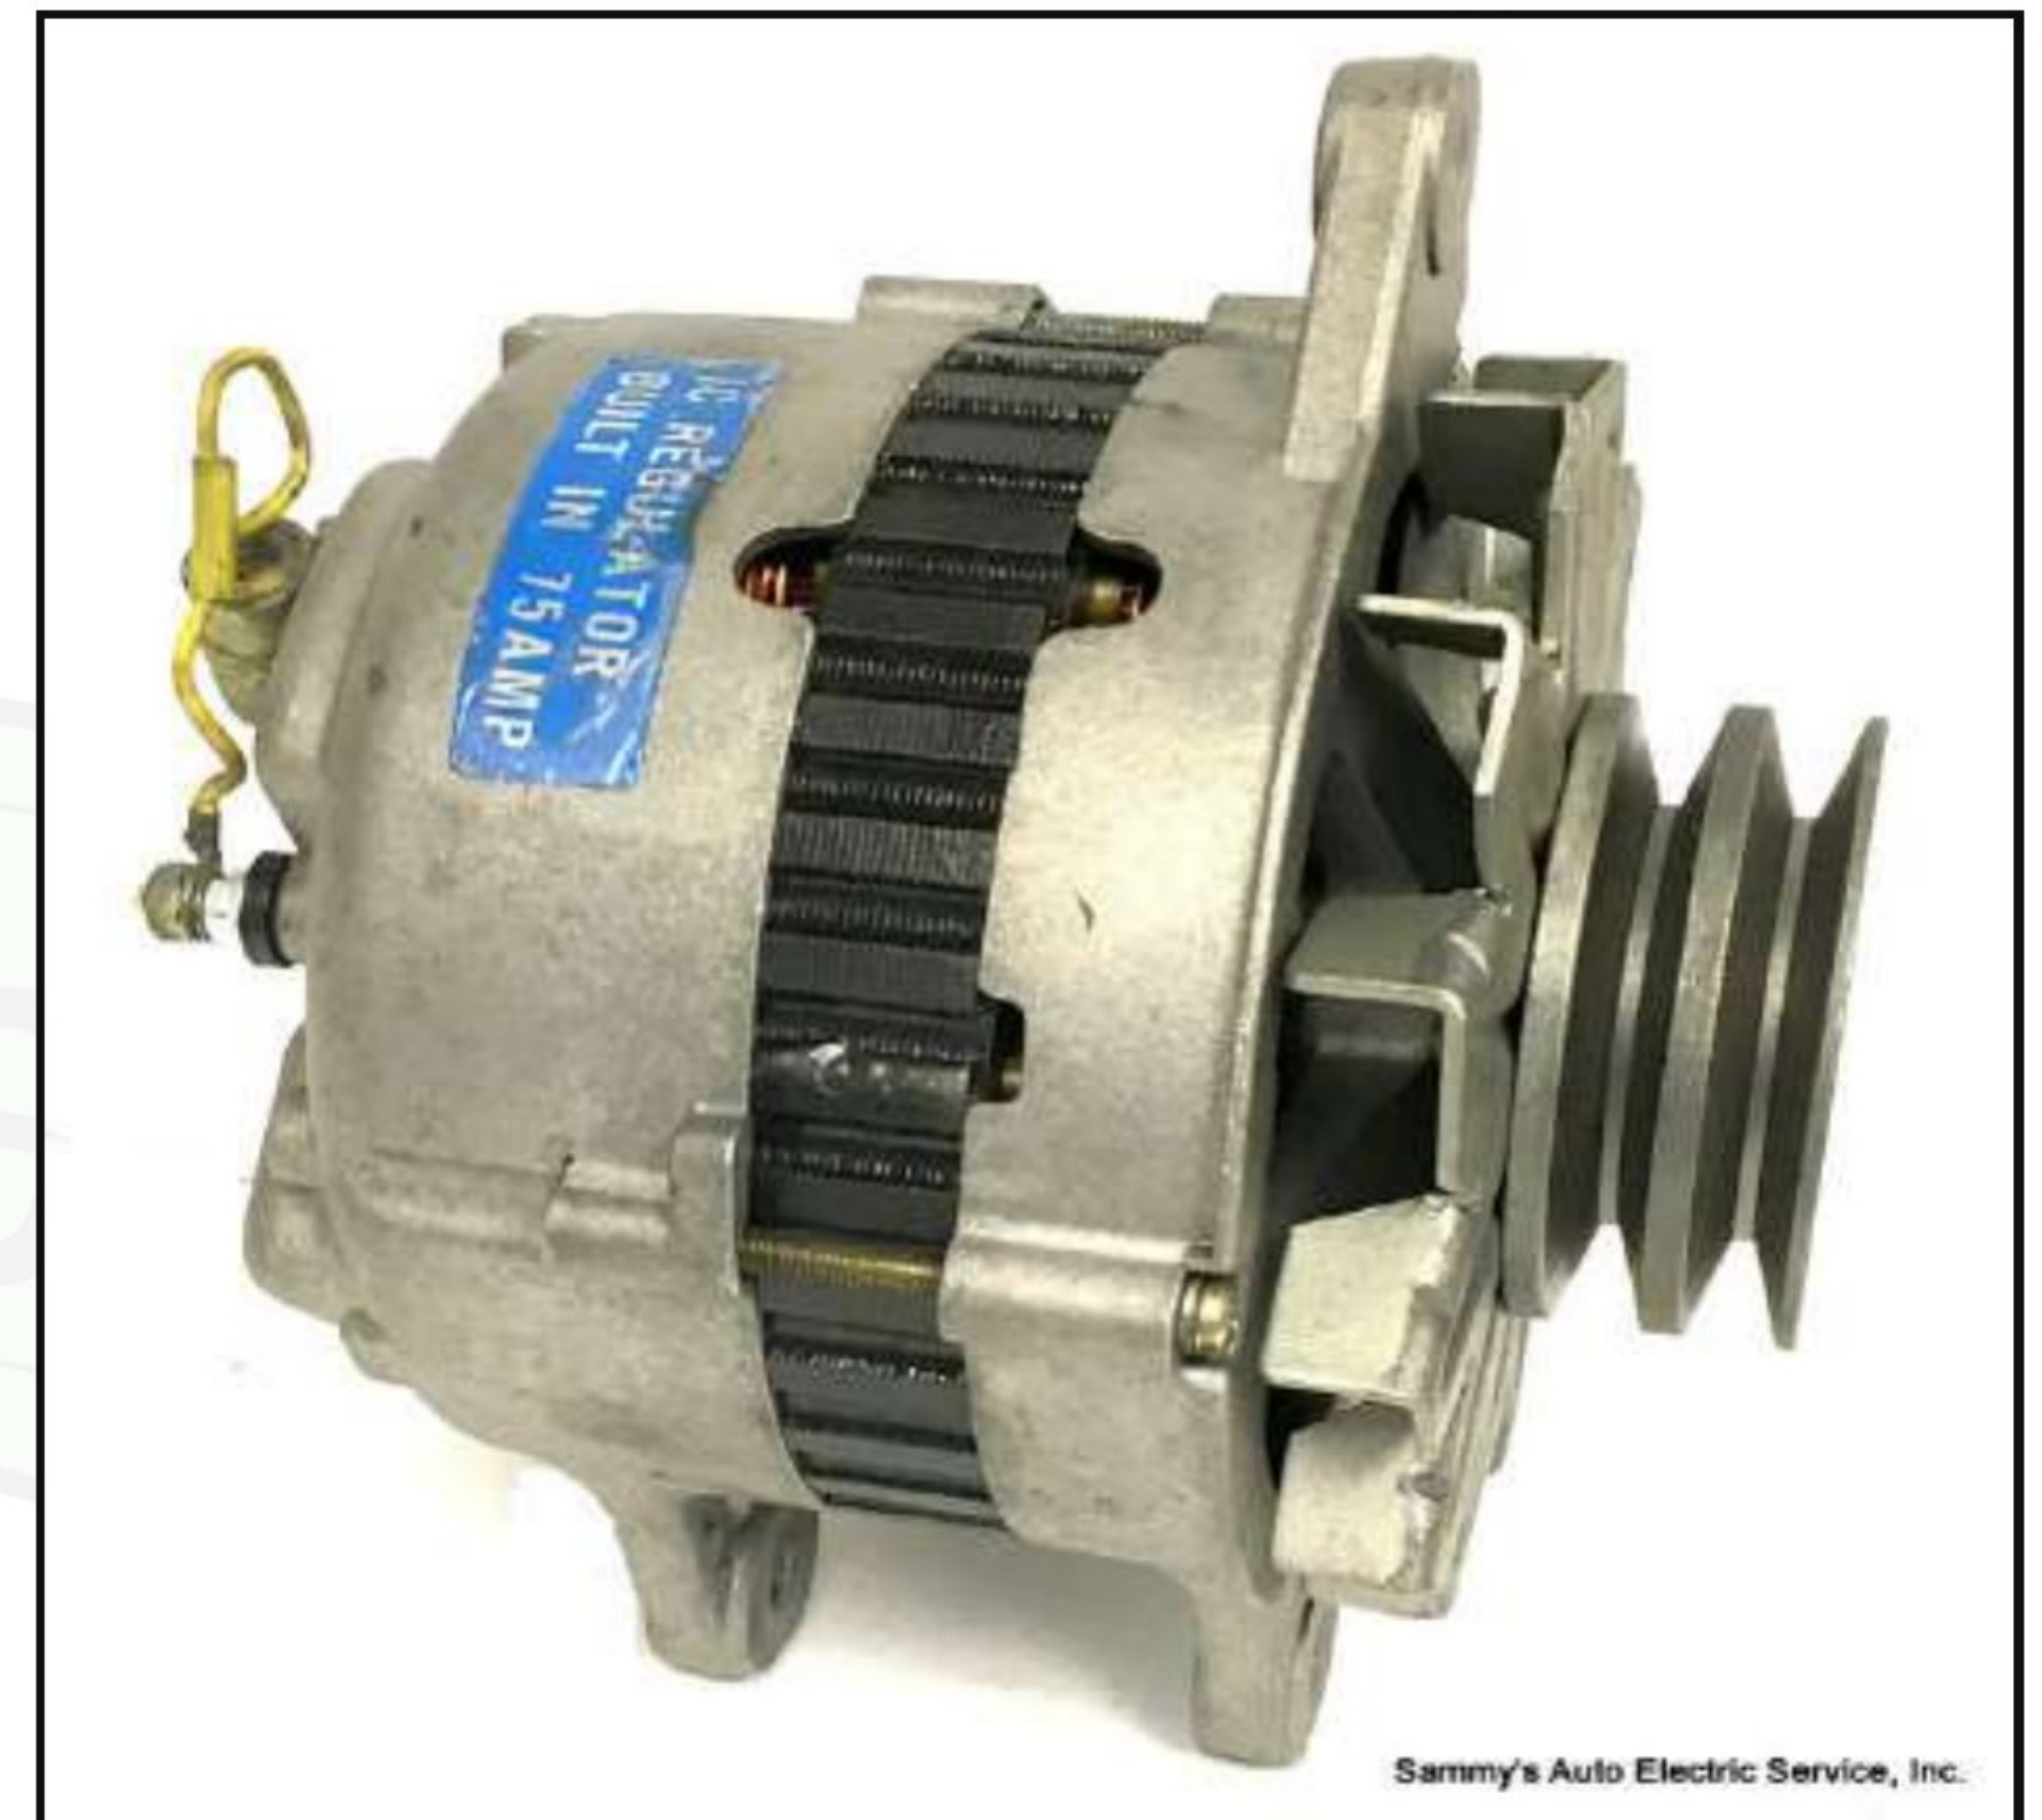
The vehicle in question which belonged to an acquaintance of mine (a retired electrician) was a surprise exception. It was a 1982 Chrysler LeBaron convertible, purchased new 38 years ago, kept in his garage, and occasionally driven on nice summer days with the top down. It was truly like new, in showroom condition with only 12,000 miles on the odometer...but now with a charging problem!

To make the story short, the auto part store's alternator (a national brand-name) that was recently installed while away from town had failed, and now he wanted me to investigate and repair the problem. Luckily he had kept his core which facilitated the repair. Thinking I would never see any of these again, I had recently disposed of a couple of such alternator cores that I had kept for years. Therefore I had no available core to rebuild.

Figure 11 – 14557 Mitsubishi Alternator

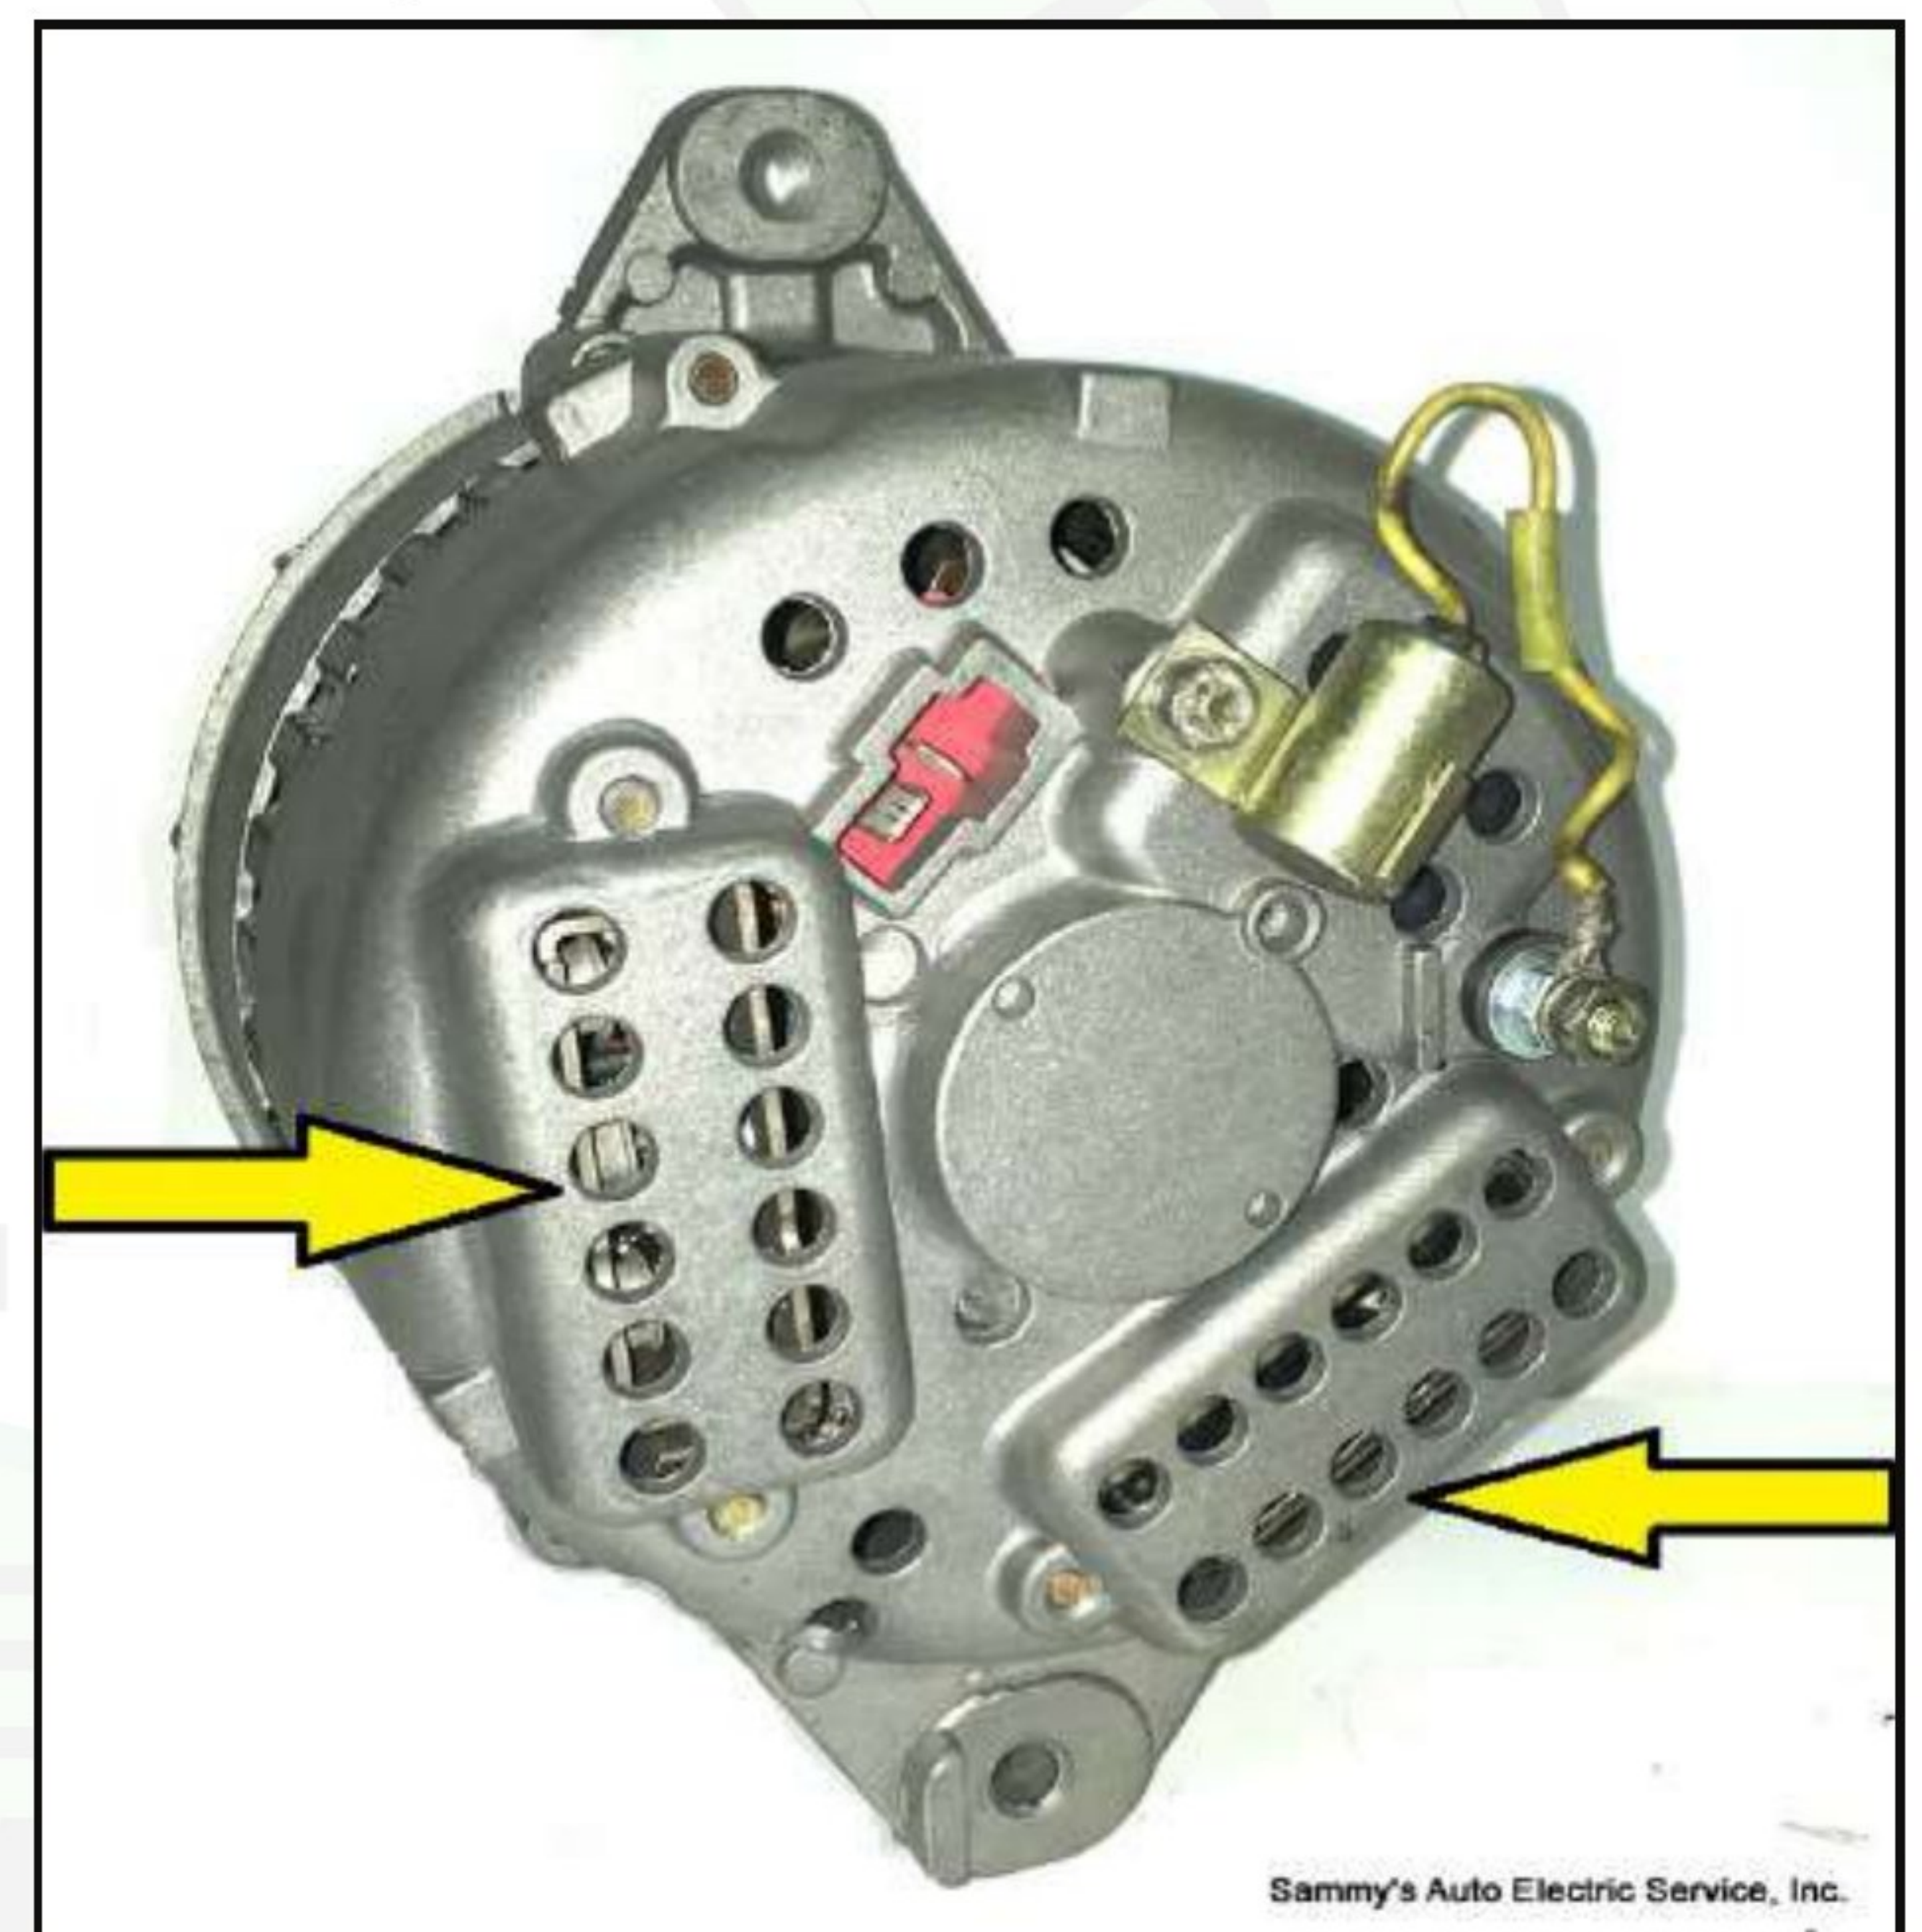
The 14557 alternator (see Figure 11) was our first experience then with an automotive unit that had dual rectifiers and a dual-wound stator on one stack, sharing the same rotor and voltage regulator (see Figure 12). The regulator (WAI's IM-204) has "IG" and "L" pins but is energized through the "IG" and not "L" terminal (see Figure 13). More about the "L" terminal later.

but needed one rectifier and a regulator to be functional again, which was taken care of and all worked well after the installation. The peculiarity of this alternator is this: only one of the rectifiers has a diode trio. The other one—the one I had to replace—does not. The diode trio, in addition to being a source of field current, also feeds the radiator cooling fan relay's control coil. I remembered one of the issues with this alternator in its heyday was that a shorted radiator fan relay would blow the diode trio and disable the alternator. If left unnoticed, the alternator would fail repeatedly and rebuilders used to get the blame for inferior work!

Figure 12 – Dual Rectifier Arrangement

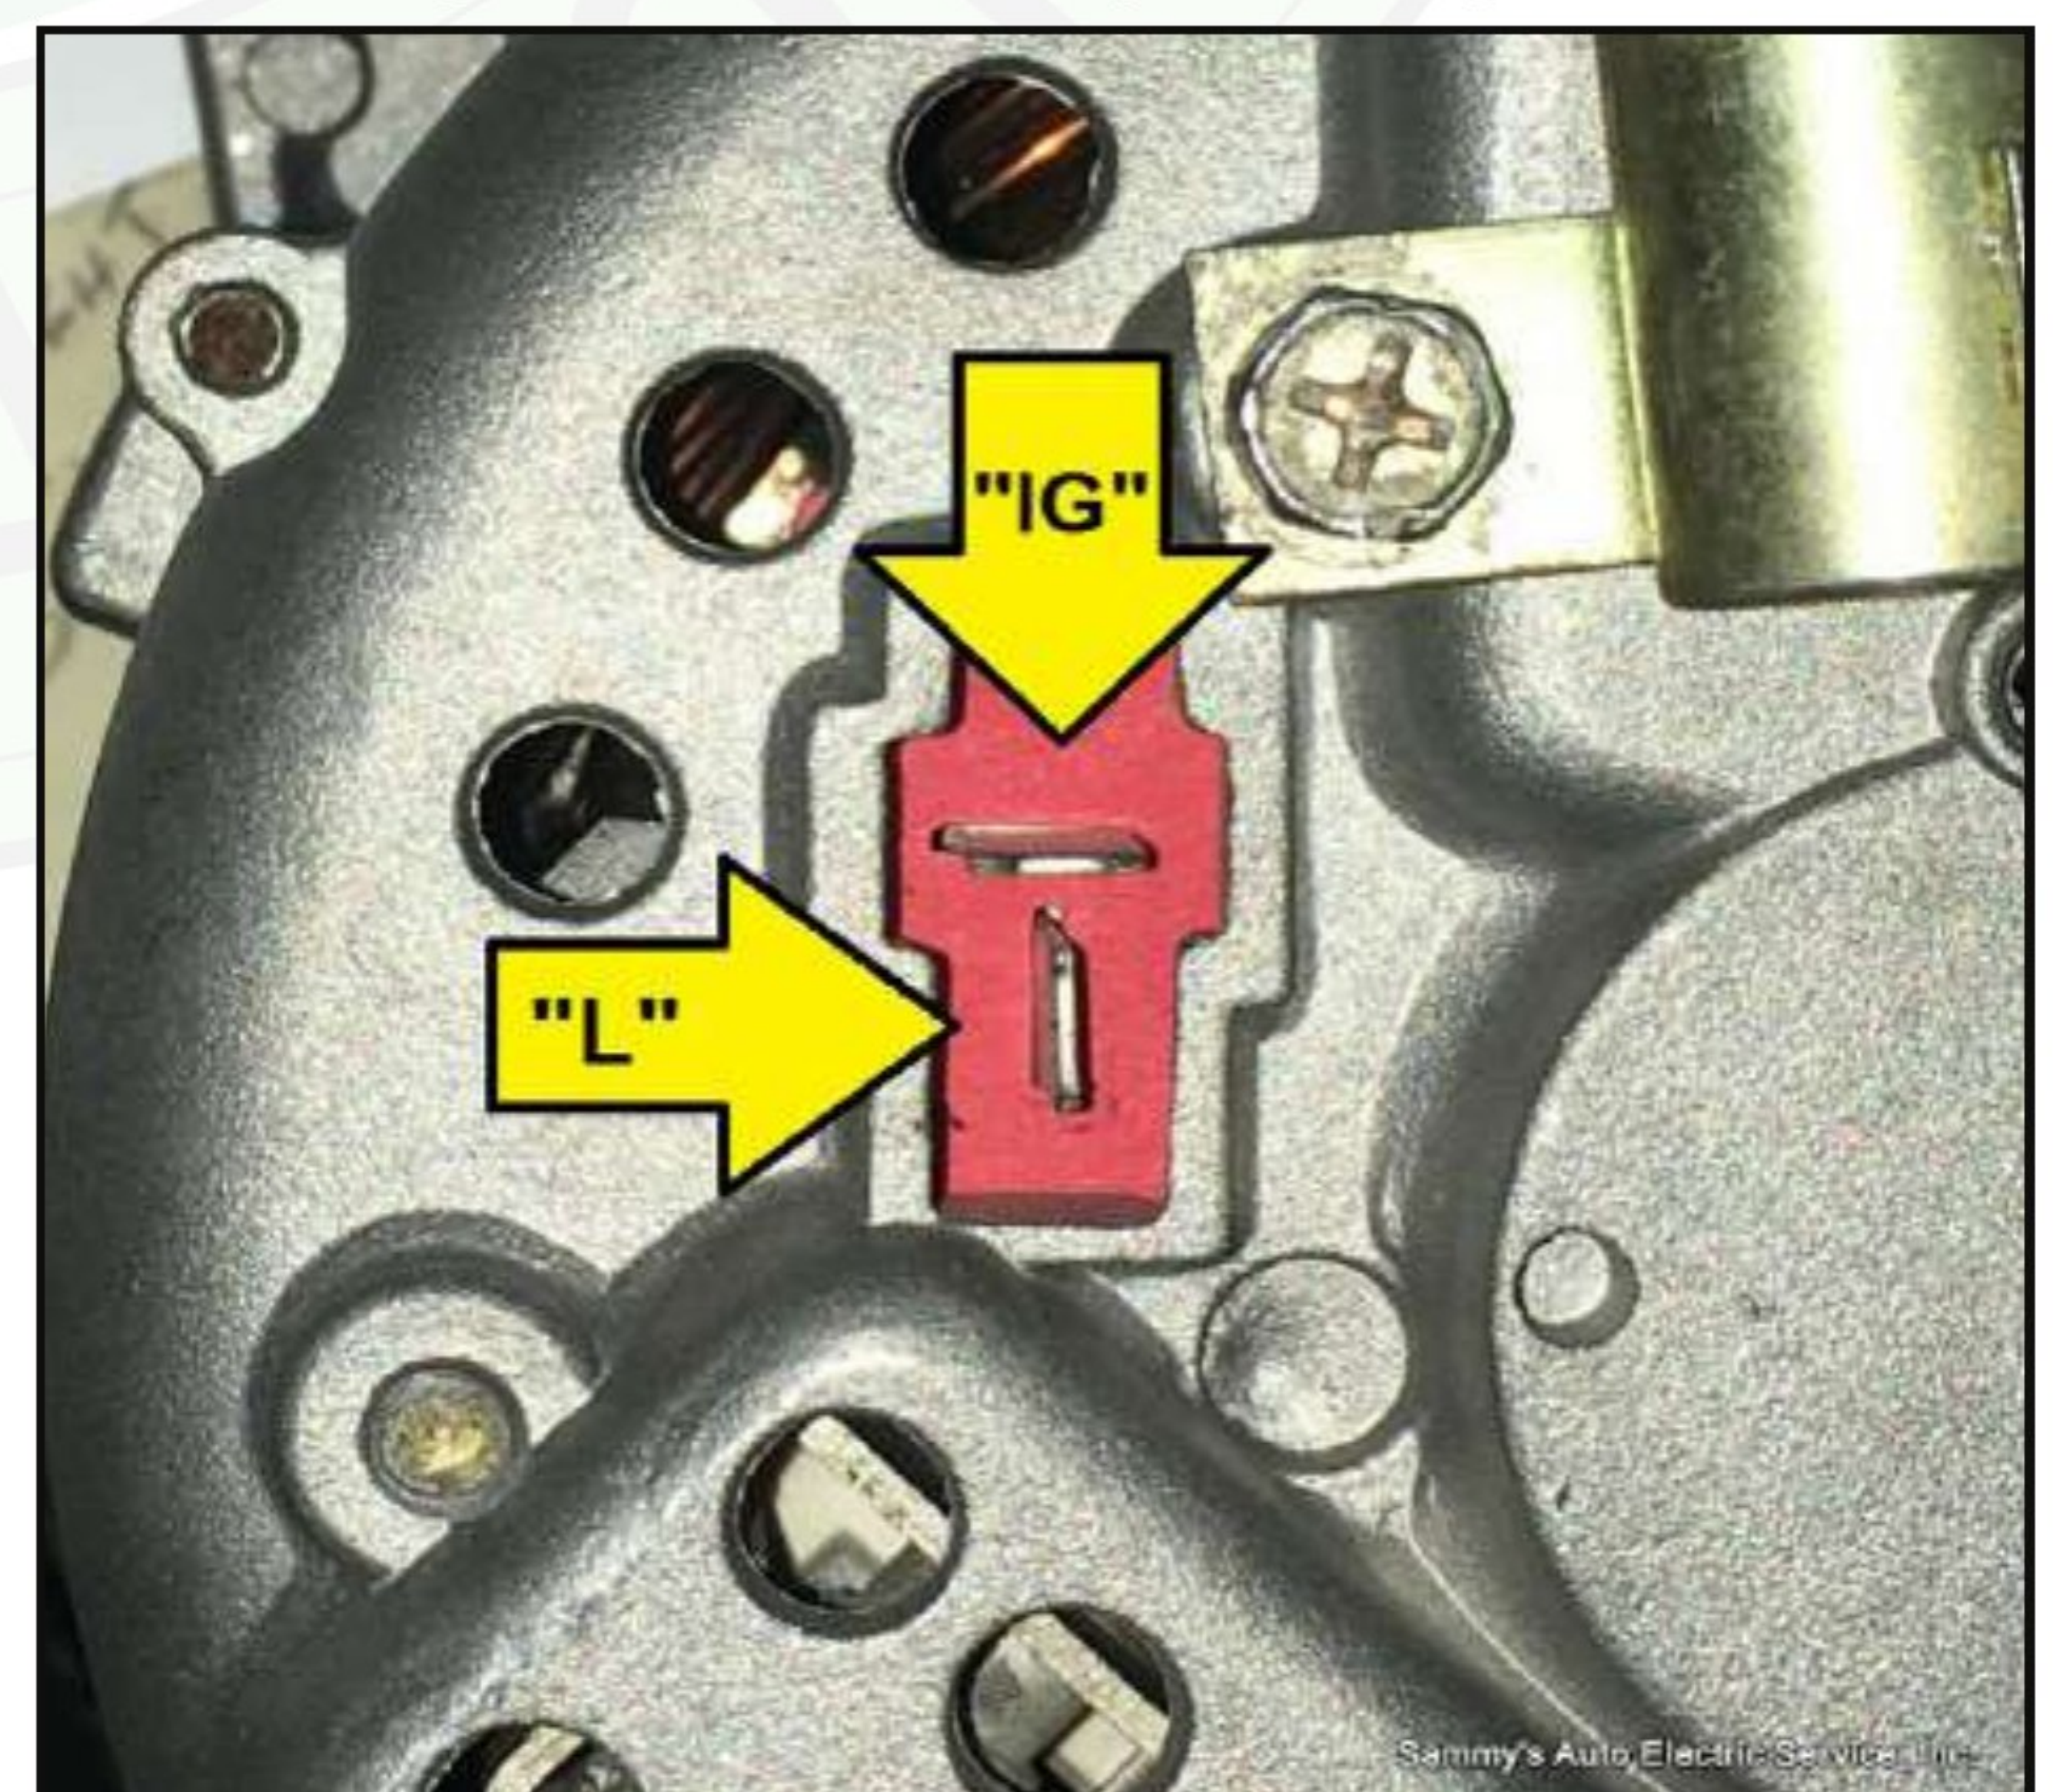
This vintage 2.6L engine was known for oil leaks, and having a very massive, highly sophisticated and hard-to-rebuild carburetor. In the above car, in addition to the charging problem, my friend's concern was also that turning on the A/C no longer raised the engine idle speed, which is a built-in feature of this car. After rebuilding the alternator, the idle RPM kick-up problem disappeared, confirming also that it had something to do with the now active "L" terminal.

Figure 13 – Plug Code 192 (IG - L) Arrangement
