## Tech Tip

### Chrysler mechanical voltage regulators

BY BOB THOMAS

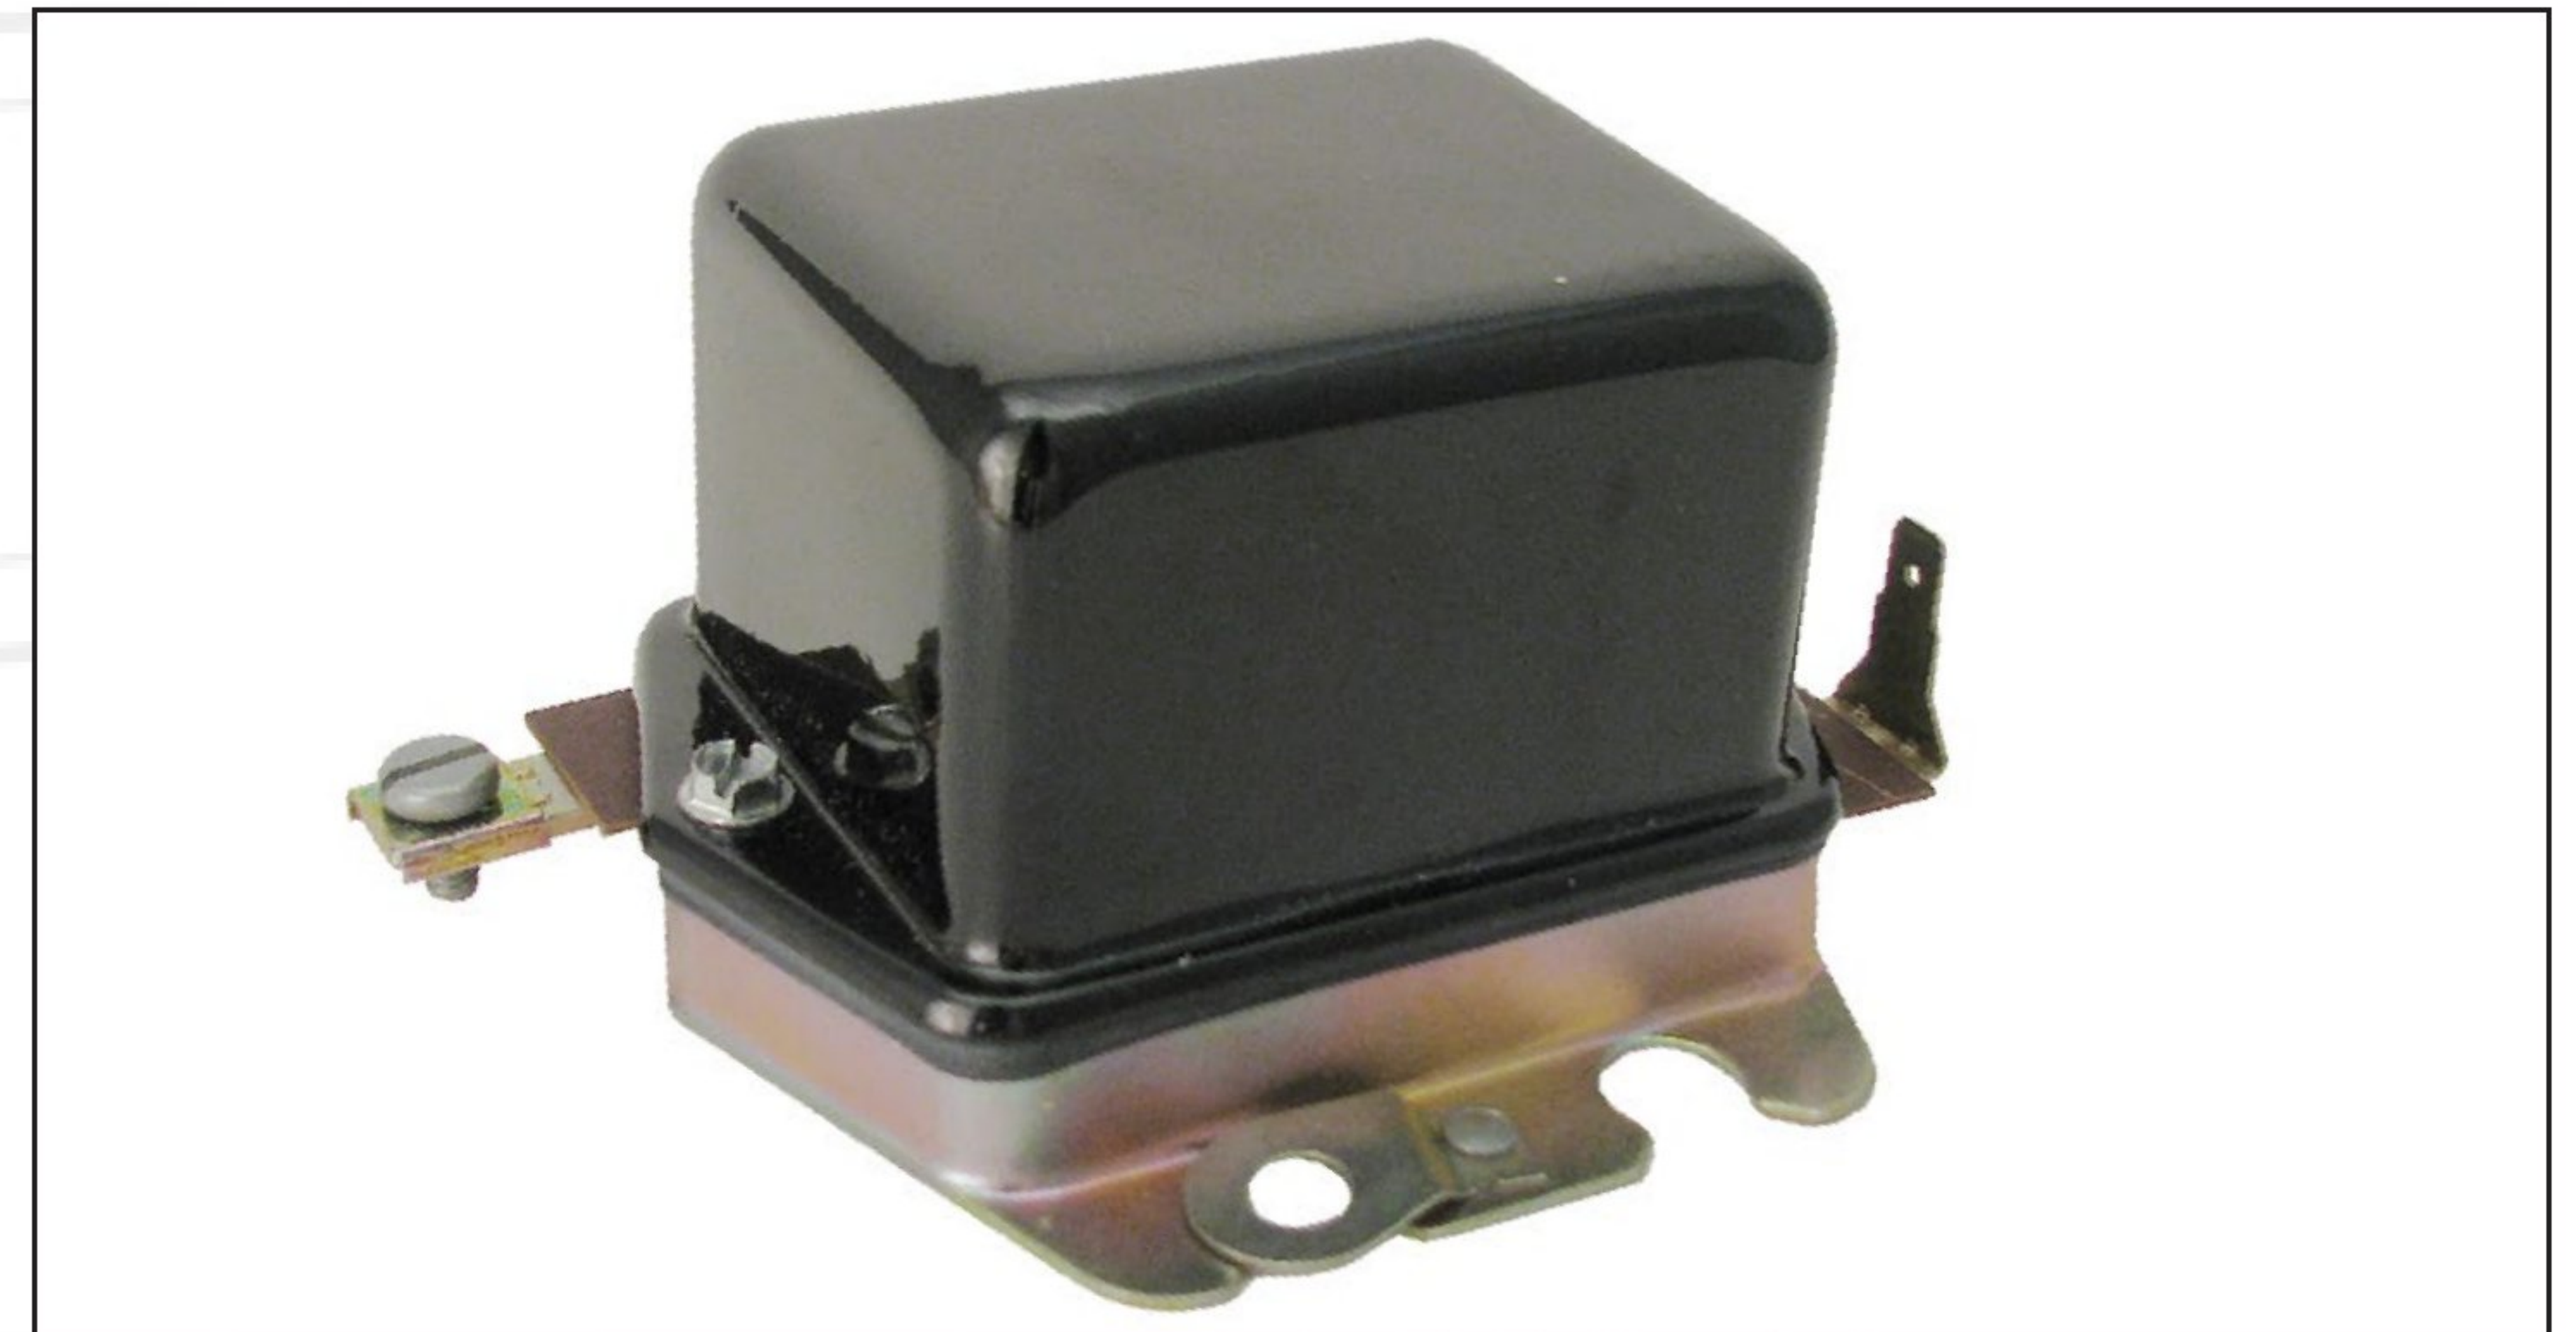
As pointed out in the article on page five, the mechanical B-circuit voltage regulators (see Figure 1) that were originally used with Chrysler's first alternator from 1961 to 1969 are unable to handle field-current loads over 3 amps. Normal rotor field-current draw for a Chrysler single-field alternator with a mechanical regulator is 2.3 to 2.7 amps. Checking and verifying rotor amperage draw is vital when rebuilding one of these alternators. Rotors that require higher amperage will damage mechanical regulators.

Figure 1—Chrysler mechanical voltage regulator 1961–1969

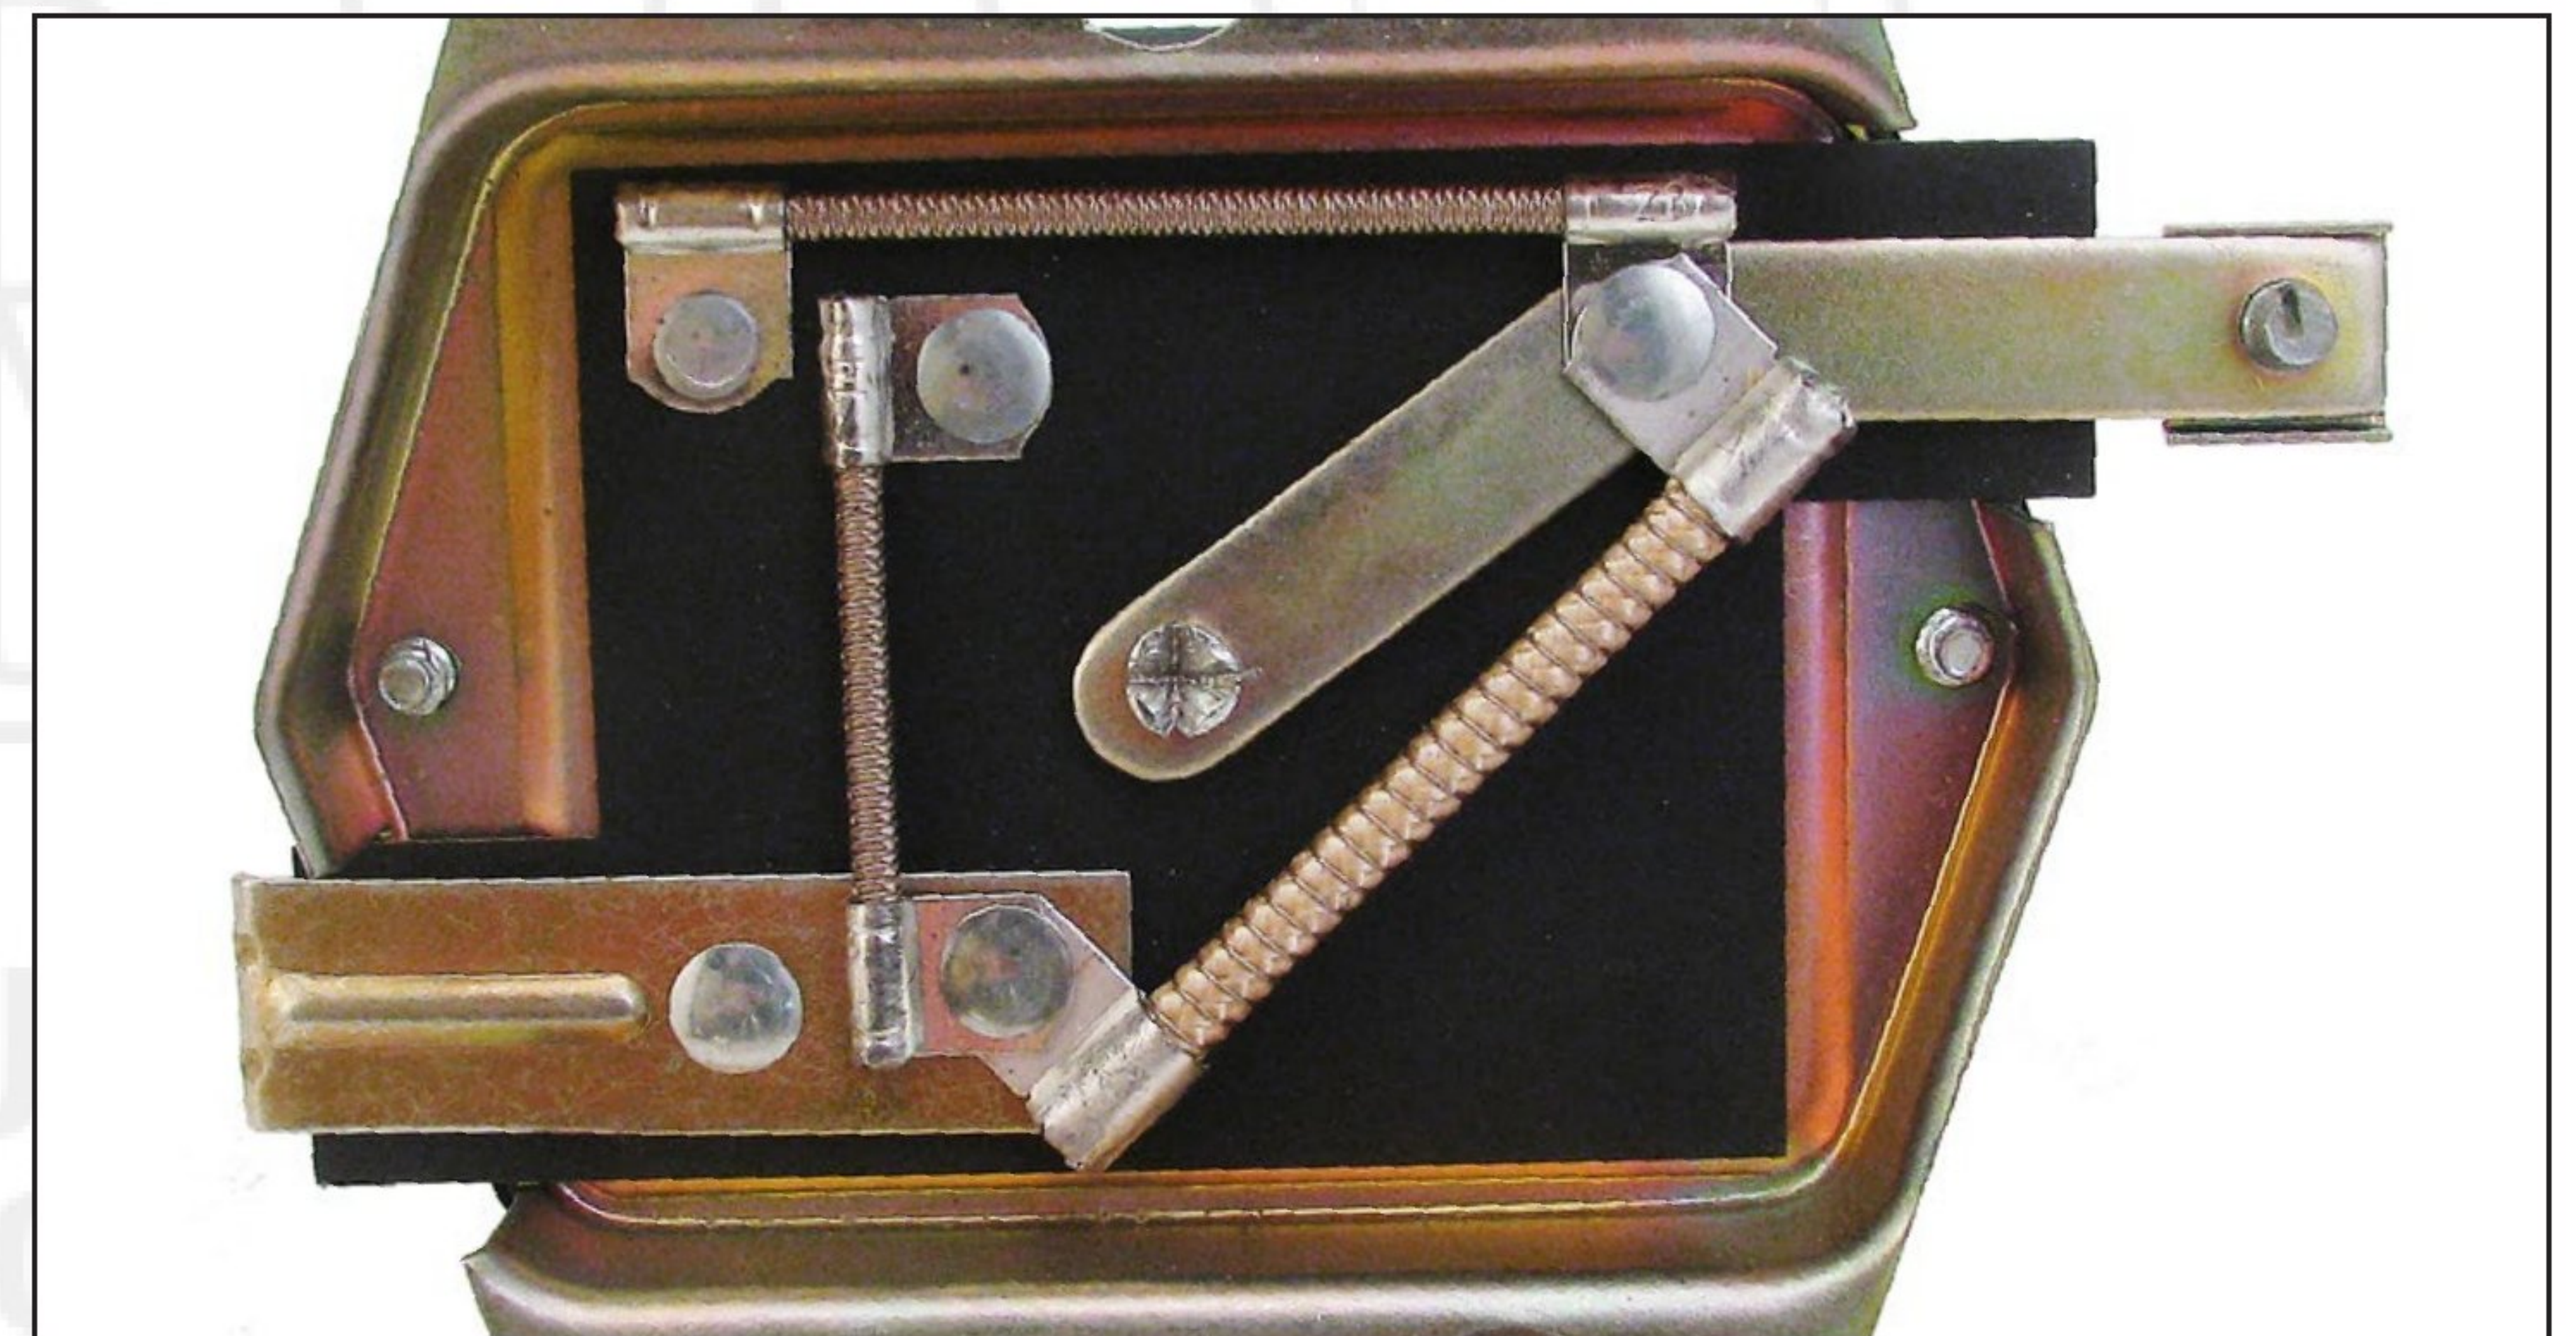
Note also, that electronic versions of the B-circuit regulator are able to handle higher field current. Electronic replacement regulators have been readily available in the aftermarket for many years now and can be easily identified by their lighter weight. Mechanical regulators are heavier, because of the relay which has an iron core. Mechanical regulators also require wire-wound resistors that are usually visible on the bottom the regulator (see Figure 2).

Figure 2—Resistors verify that this regulator is mechanical.

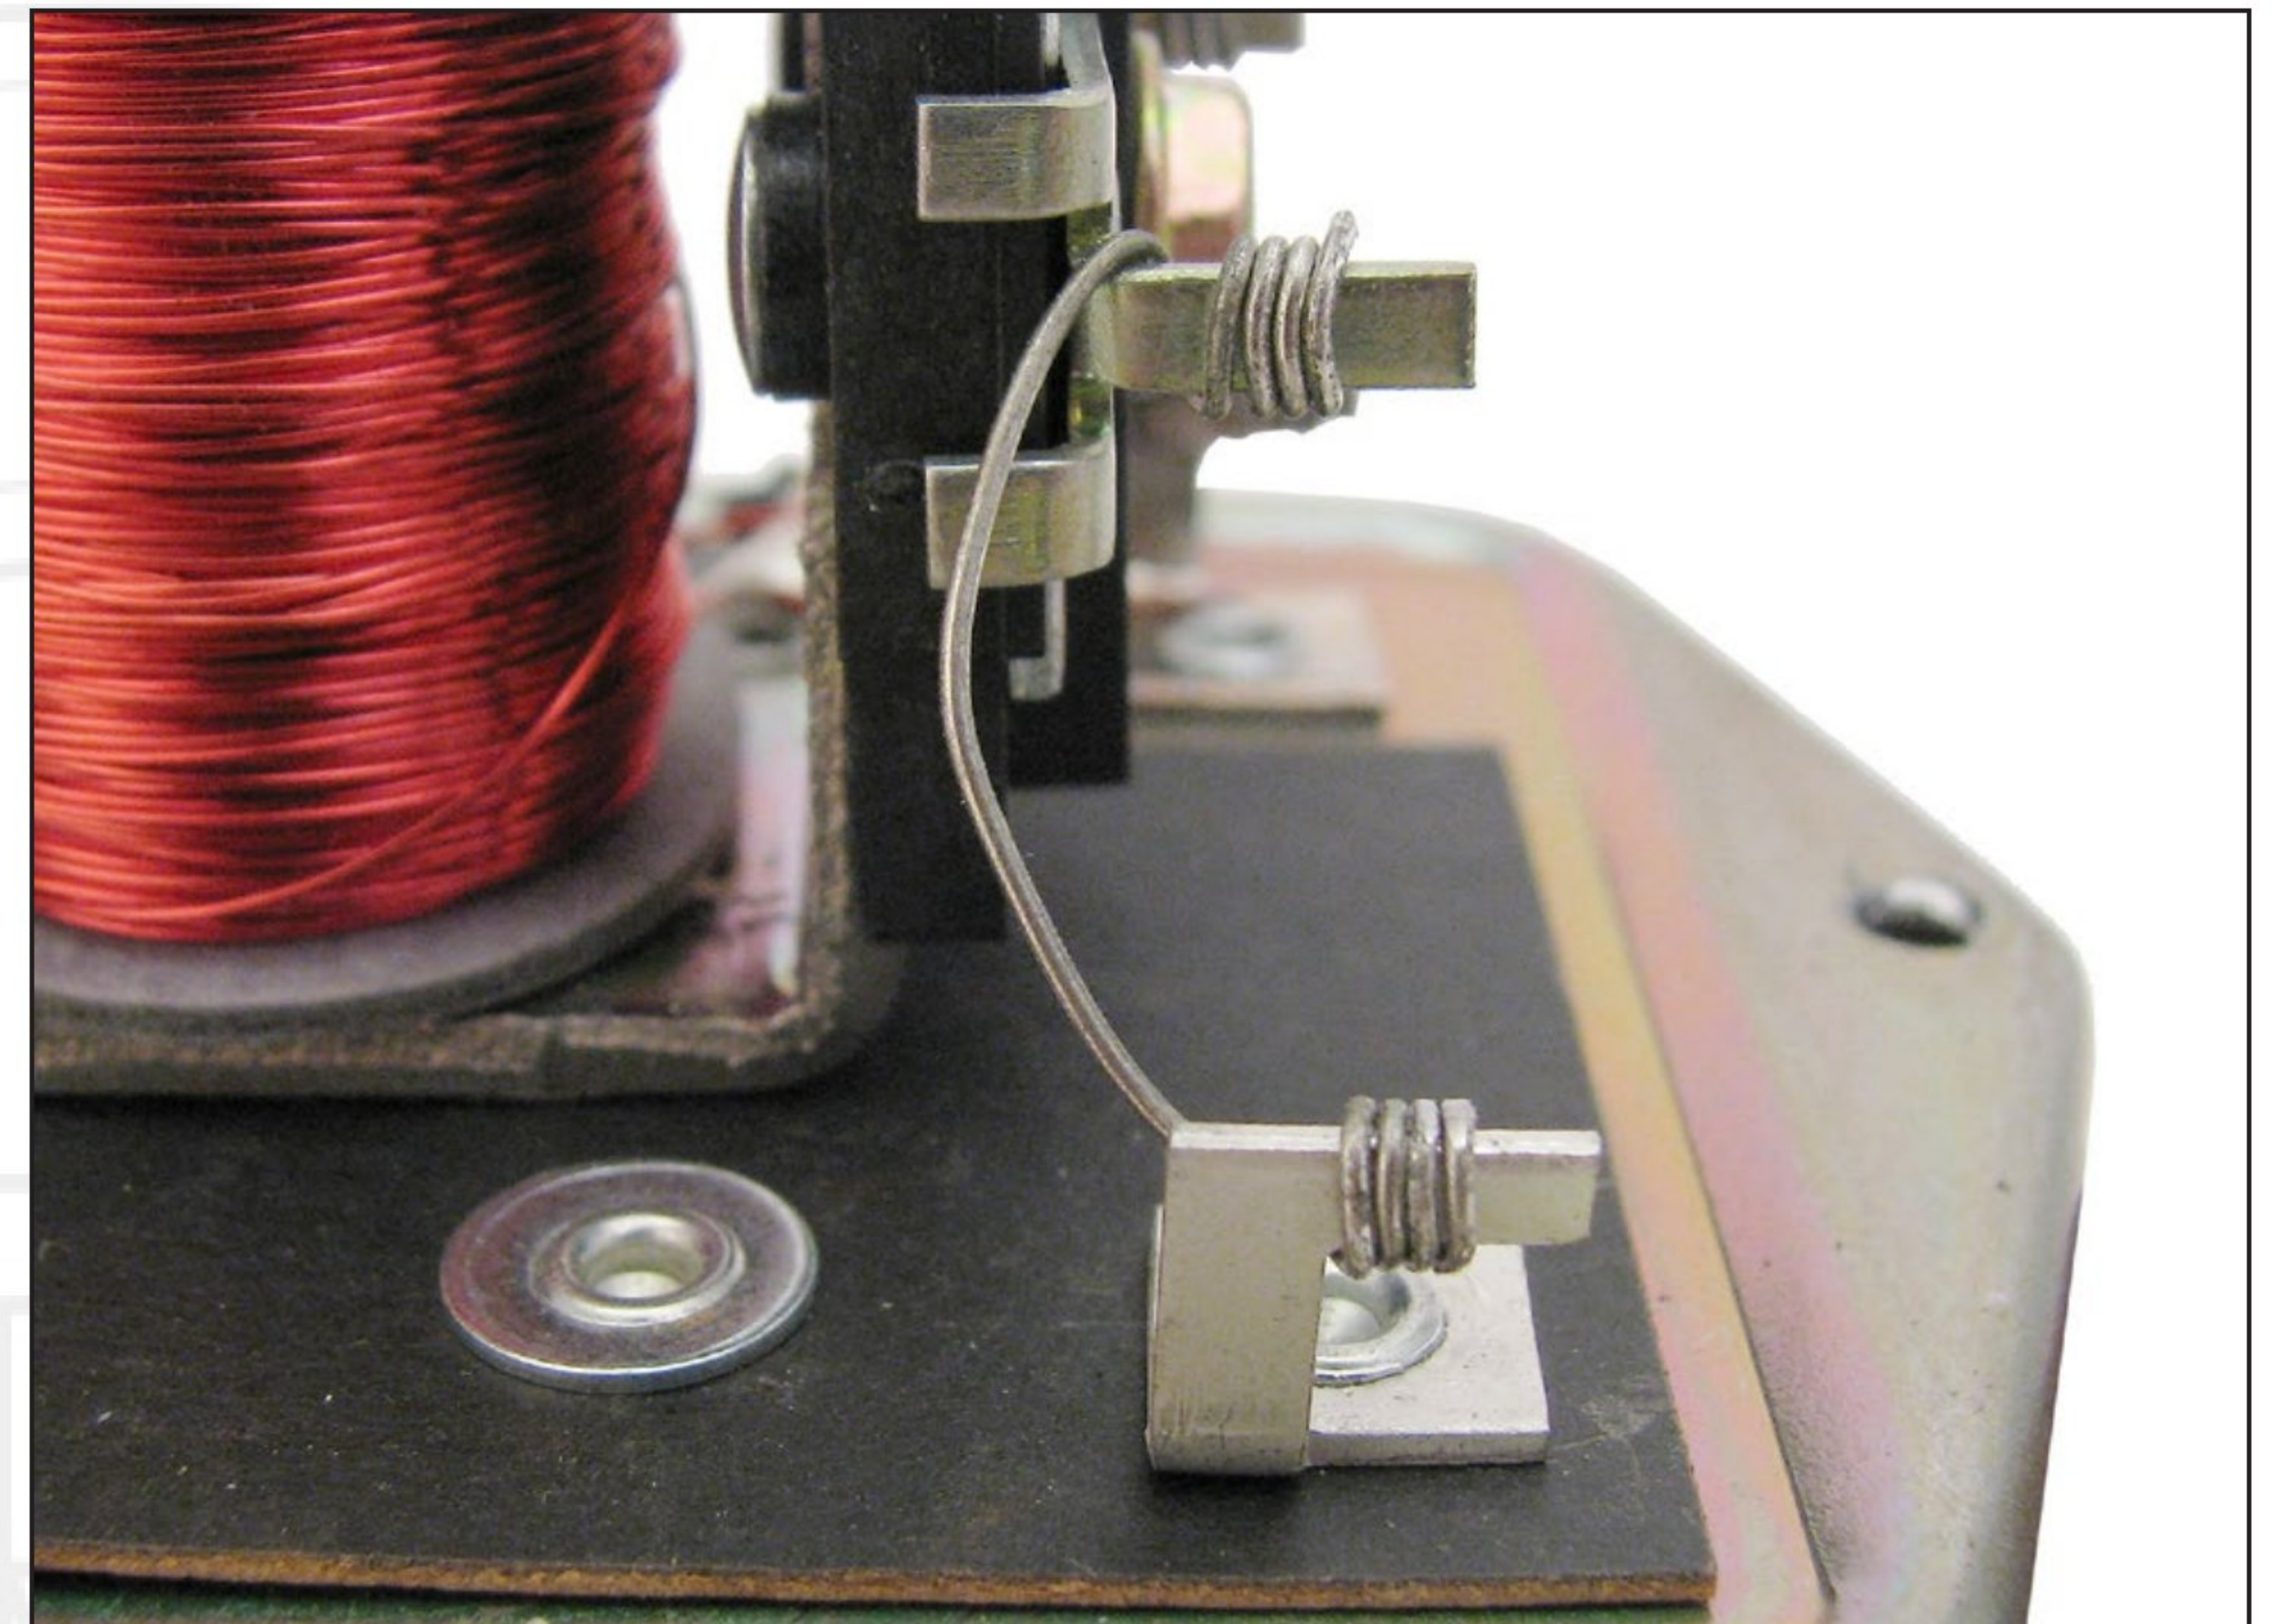
If you happen to encounter a Chrysler vehicle from the 1960s with a failed regulator, you should carefully examine and test both the rotor and the regulator. With the cover removed, notice that this mechanical regulator has a small wire connecting the ignition terminal to the relay (see Figure 3). That wire is actually a fuse link. It is there to protect the ignition circuit in the event that the rotor shorts internally to ground. In the original Chrysler regulators, this fuse link was even smaller and more sensitive. Chrysler, like most manufacturers of the 1960s, did not run their ignition circuit through a fuse.

If you find that the regulator's fuse link has burned in two, then the field draw was excessive, or the rotor, brush or field terminal were very likely shorted to ground in the alternator. That fuse link can be repaired or replaced with the same size and length fuse link. The fuse link in the original Chrysler regulators, for these applications, had a smaller more sensitive fuse link wire than our example. Some aftermarket mechanical regulators have since substituted a glass or plastic fuse for the fuse link. Installing a fuse in place of a burned fuse link is another option for repairing a mechanical regulator of this type.

Figure 3—Fuse link wire connects IGN terminal to field relay.

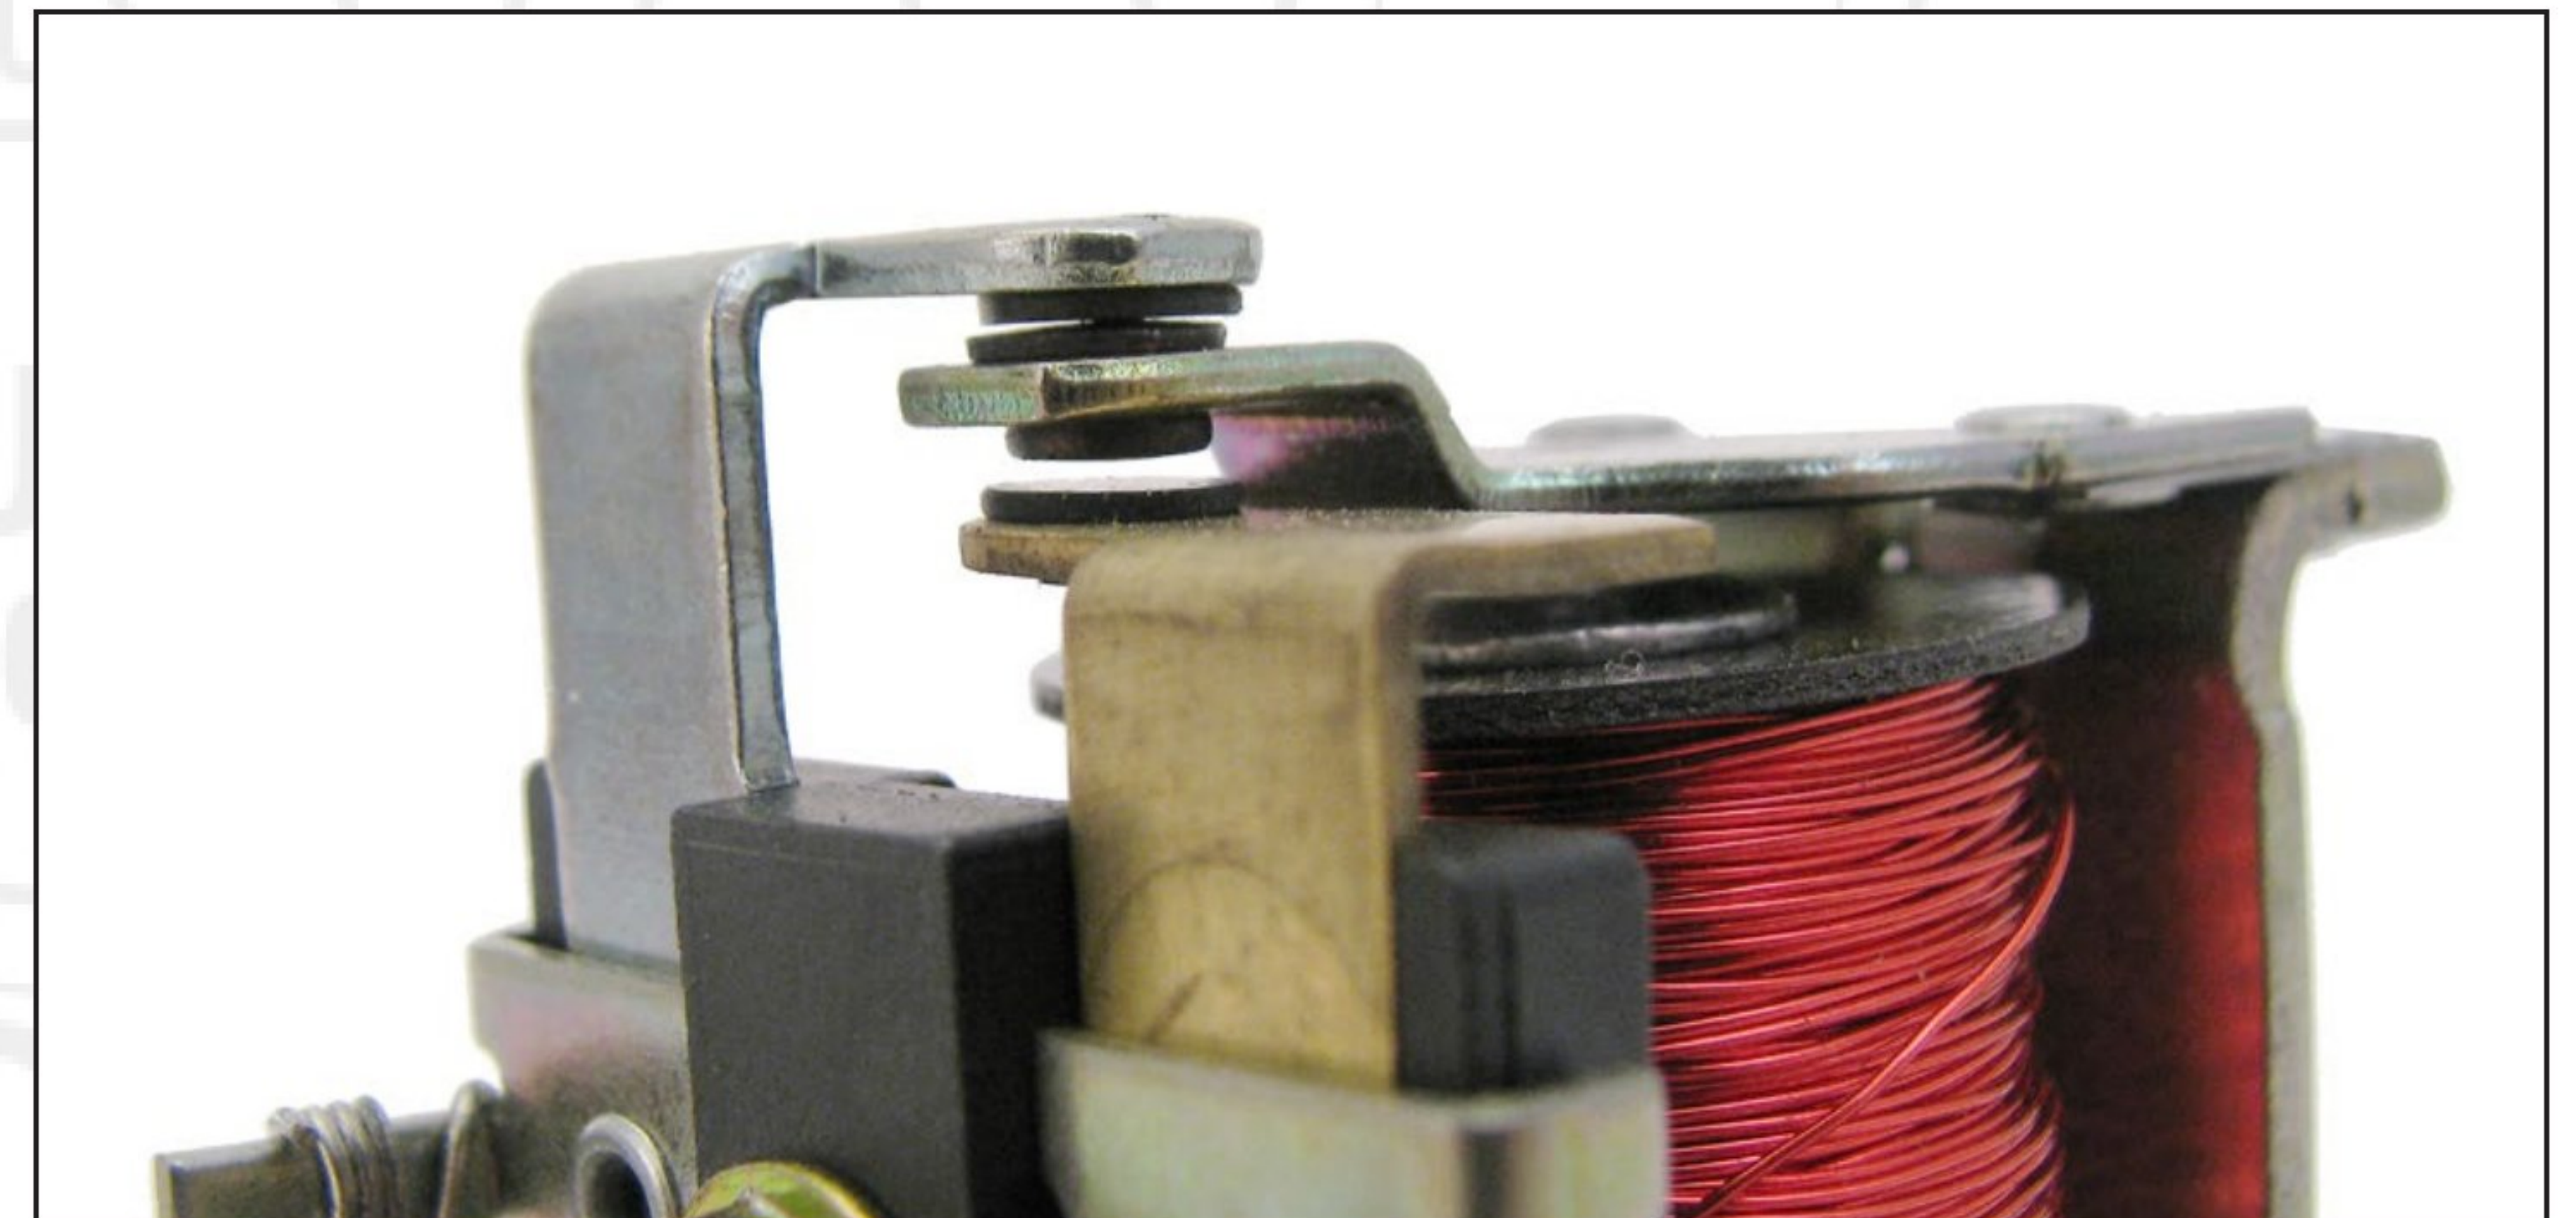
High amperage draw from the wrong rotor can also burn the regulator's

upper contact set or even cause the contacts to fuse together and stick. This can cause either a no-charge if open or overcharging if stuck closed (see Figure 4).

Figure 4—Upper contacts can stick if the wrong rotor is used.
