# VALEO SPRINTER ALTERNATOR

## Power to Spare

BY BOB THOMAS

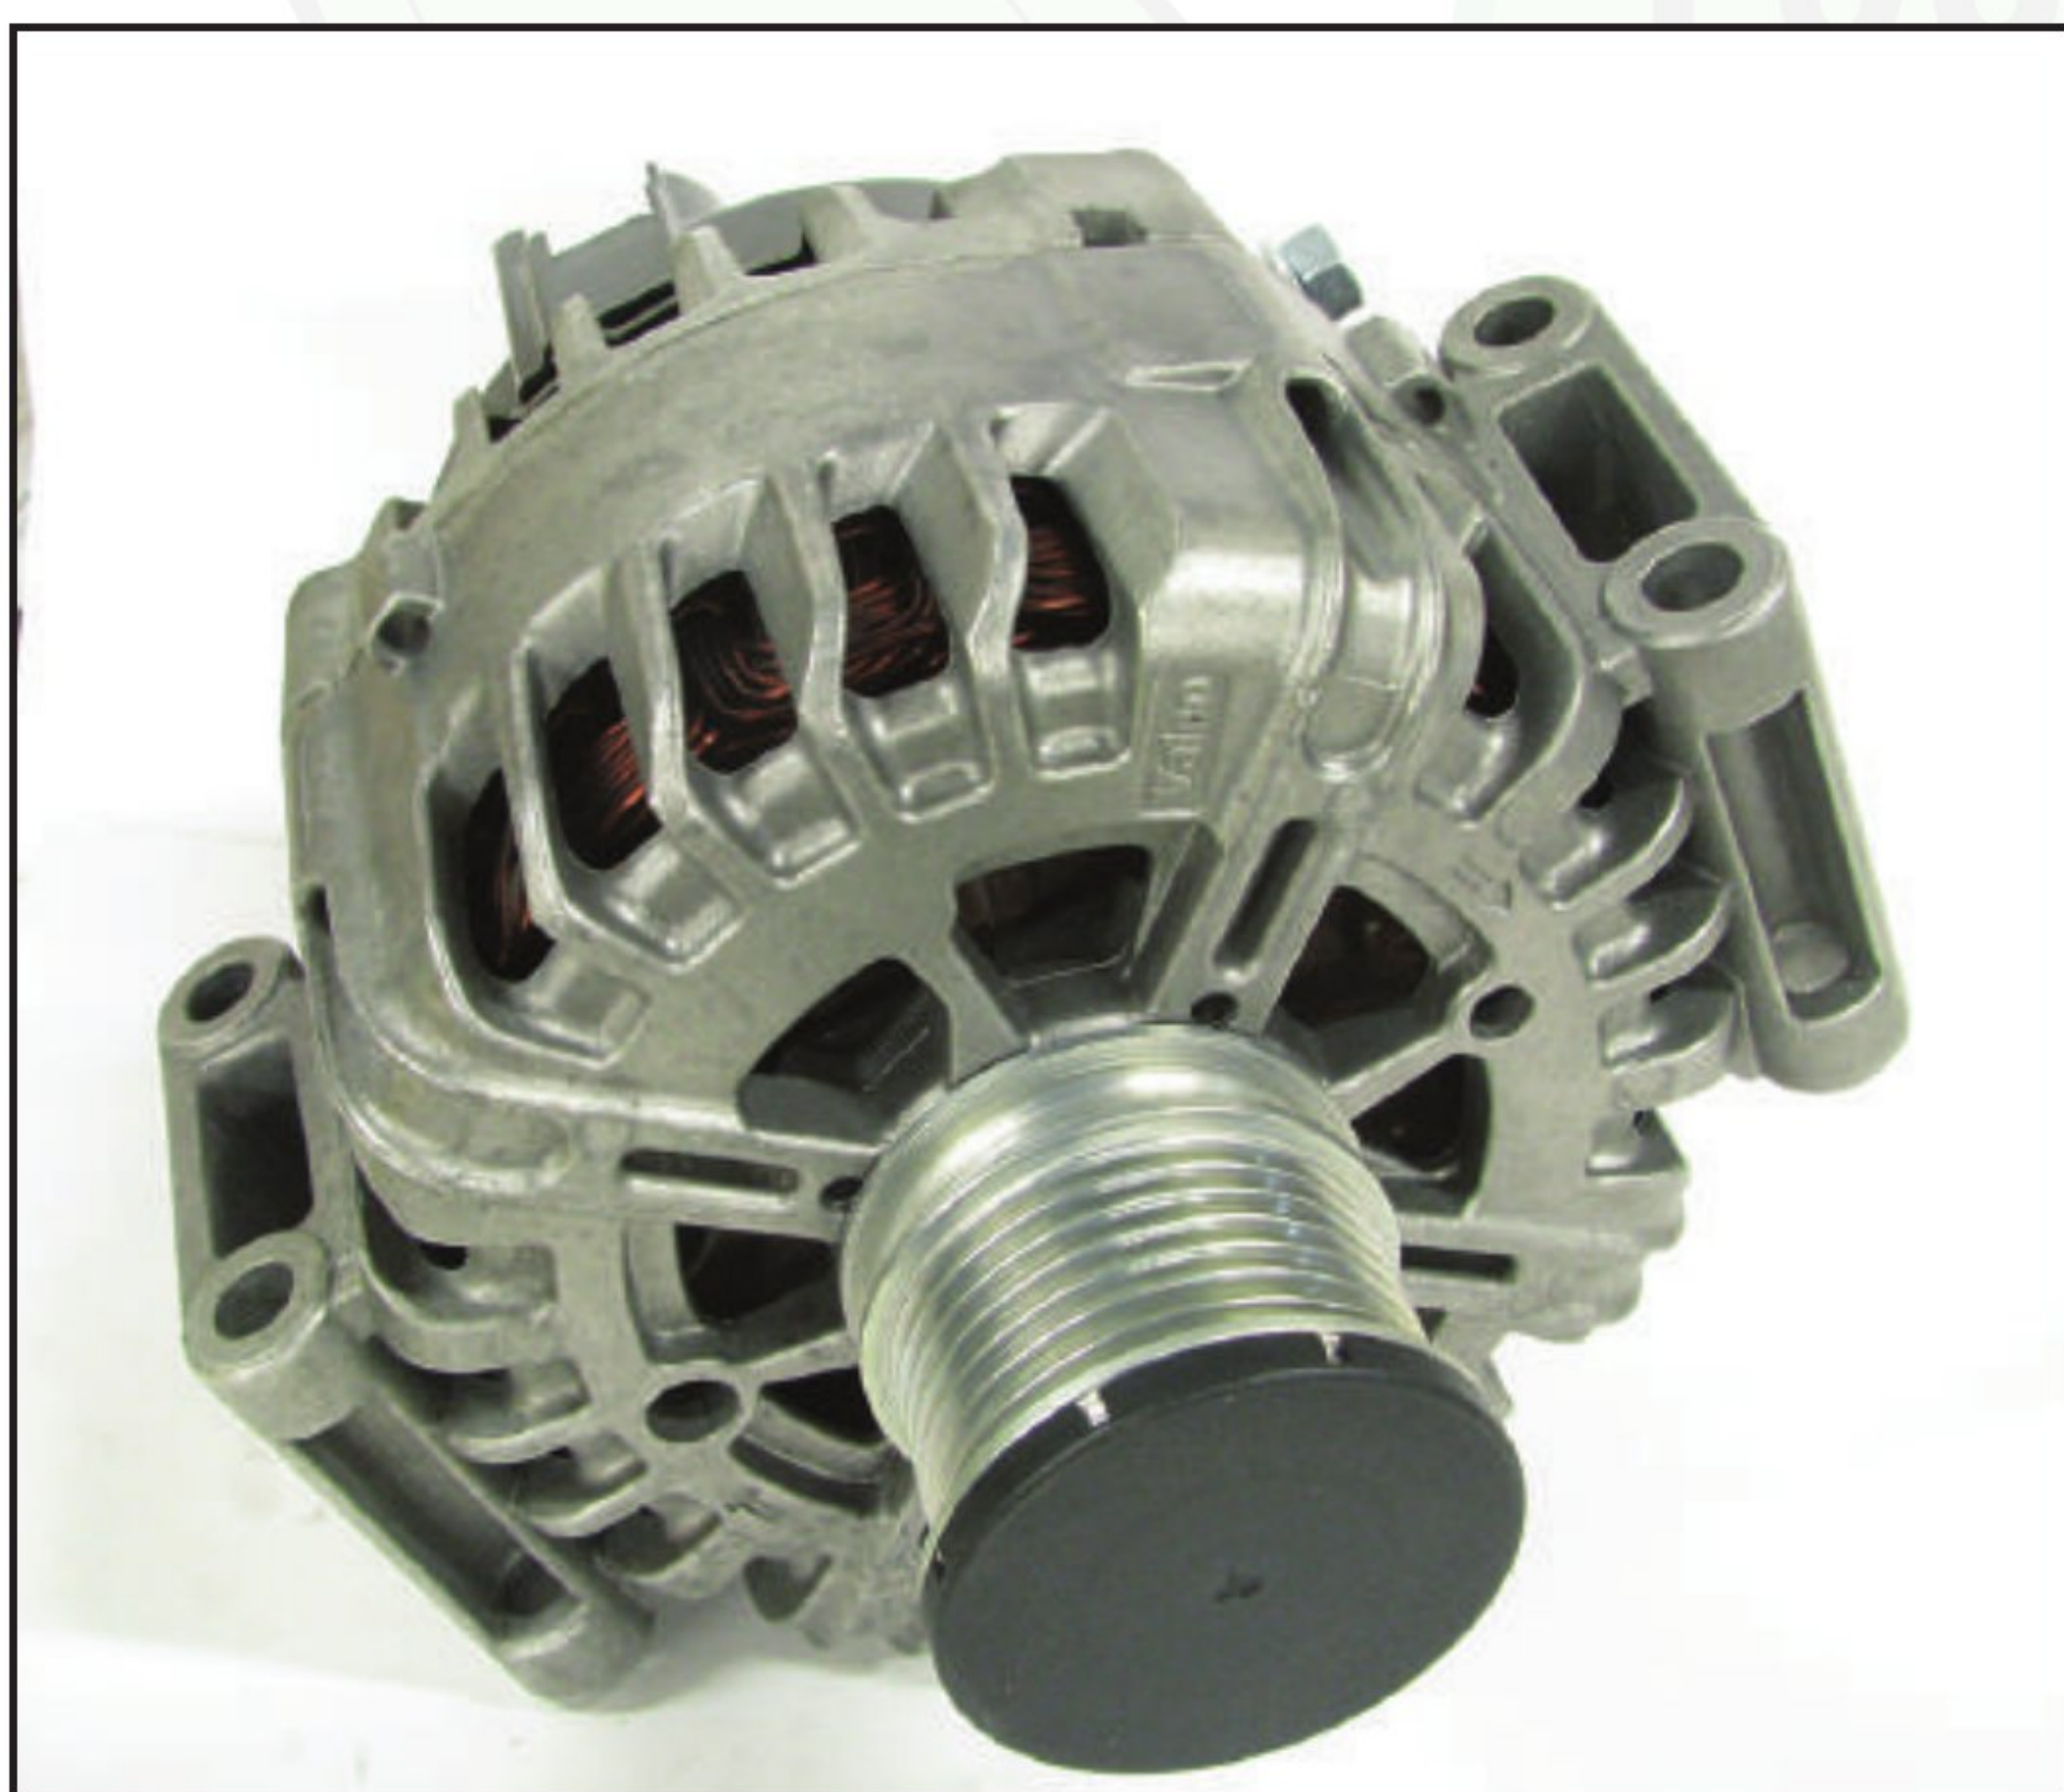
Figure 1 – This Valeo alternator (TG23C019) for Sprinter vans can provide up to 220 amps of power. It uses a 7-groove clutch pulley.

It is a 220 amp unit (see Figures 1, 2 and 3) with four bolt pad mounting and a seven-groove clutch pulley. It was installed as a popular option beginning in 2007. In 2010, a nearly identical 180 amp version, TG17C030B (Lester 11306), became standard equipment while the higher amperage TG23C019 continued as an option.

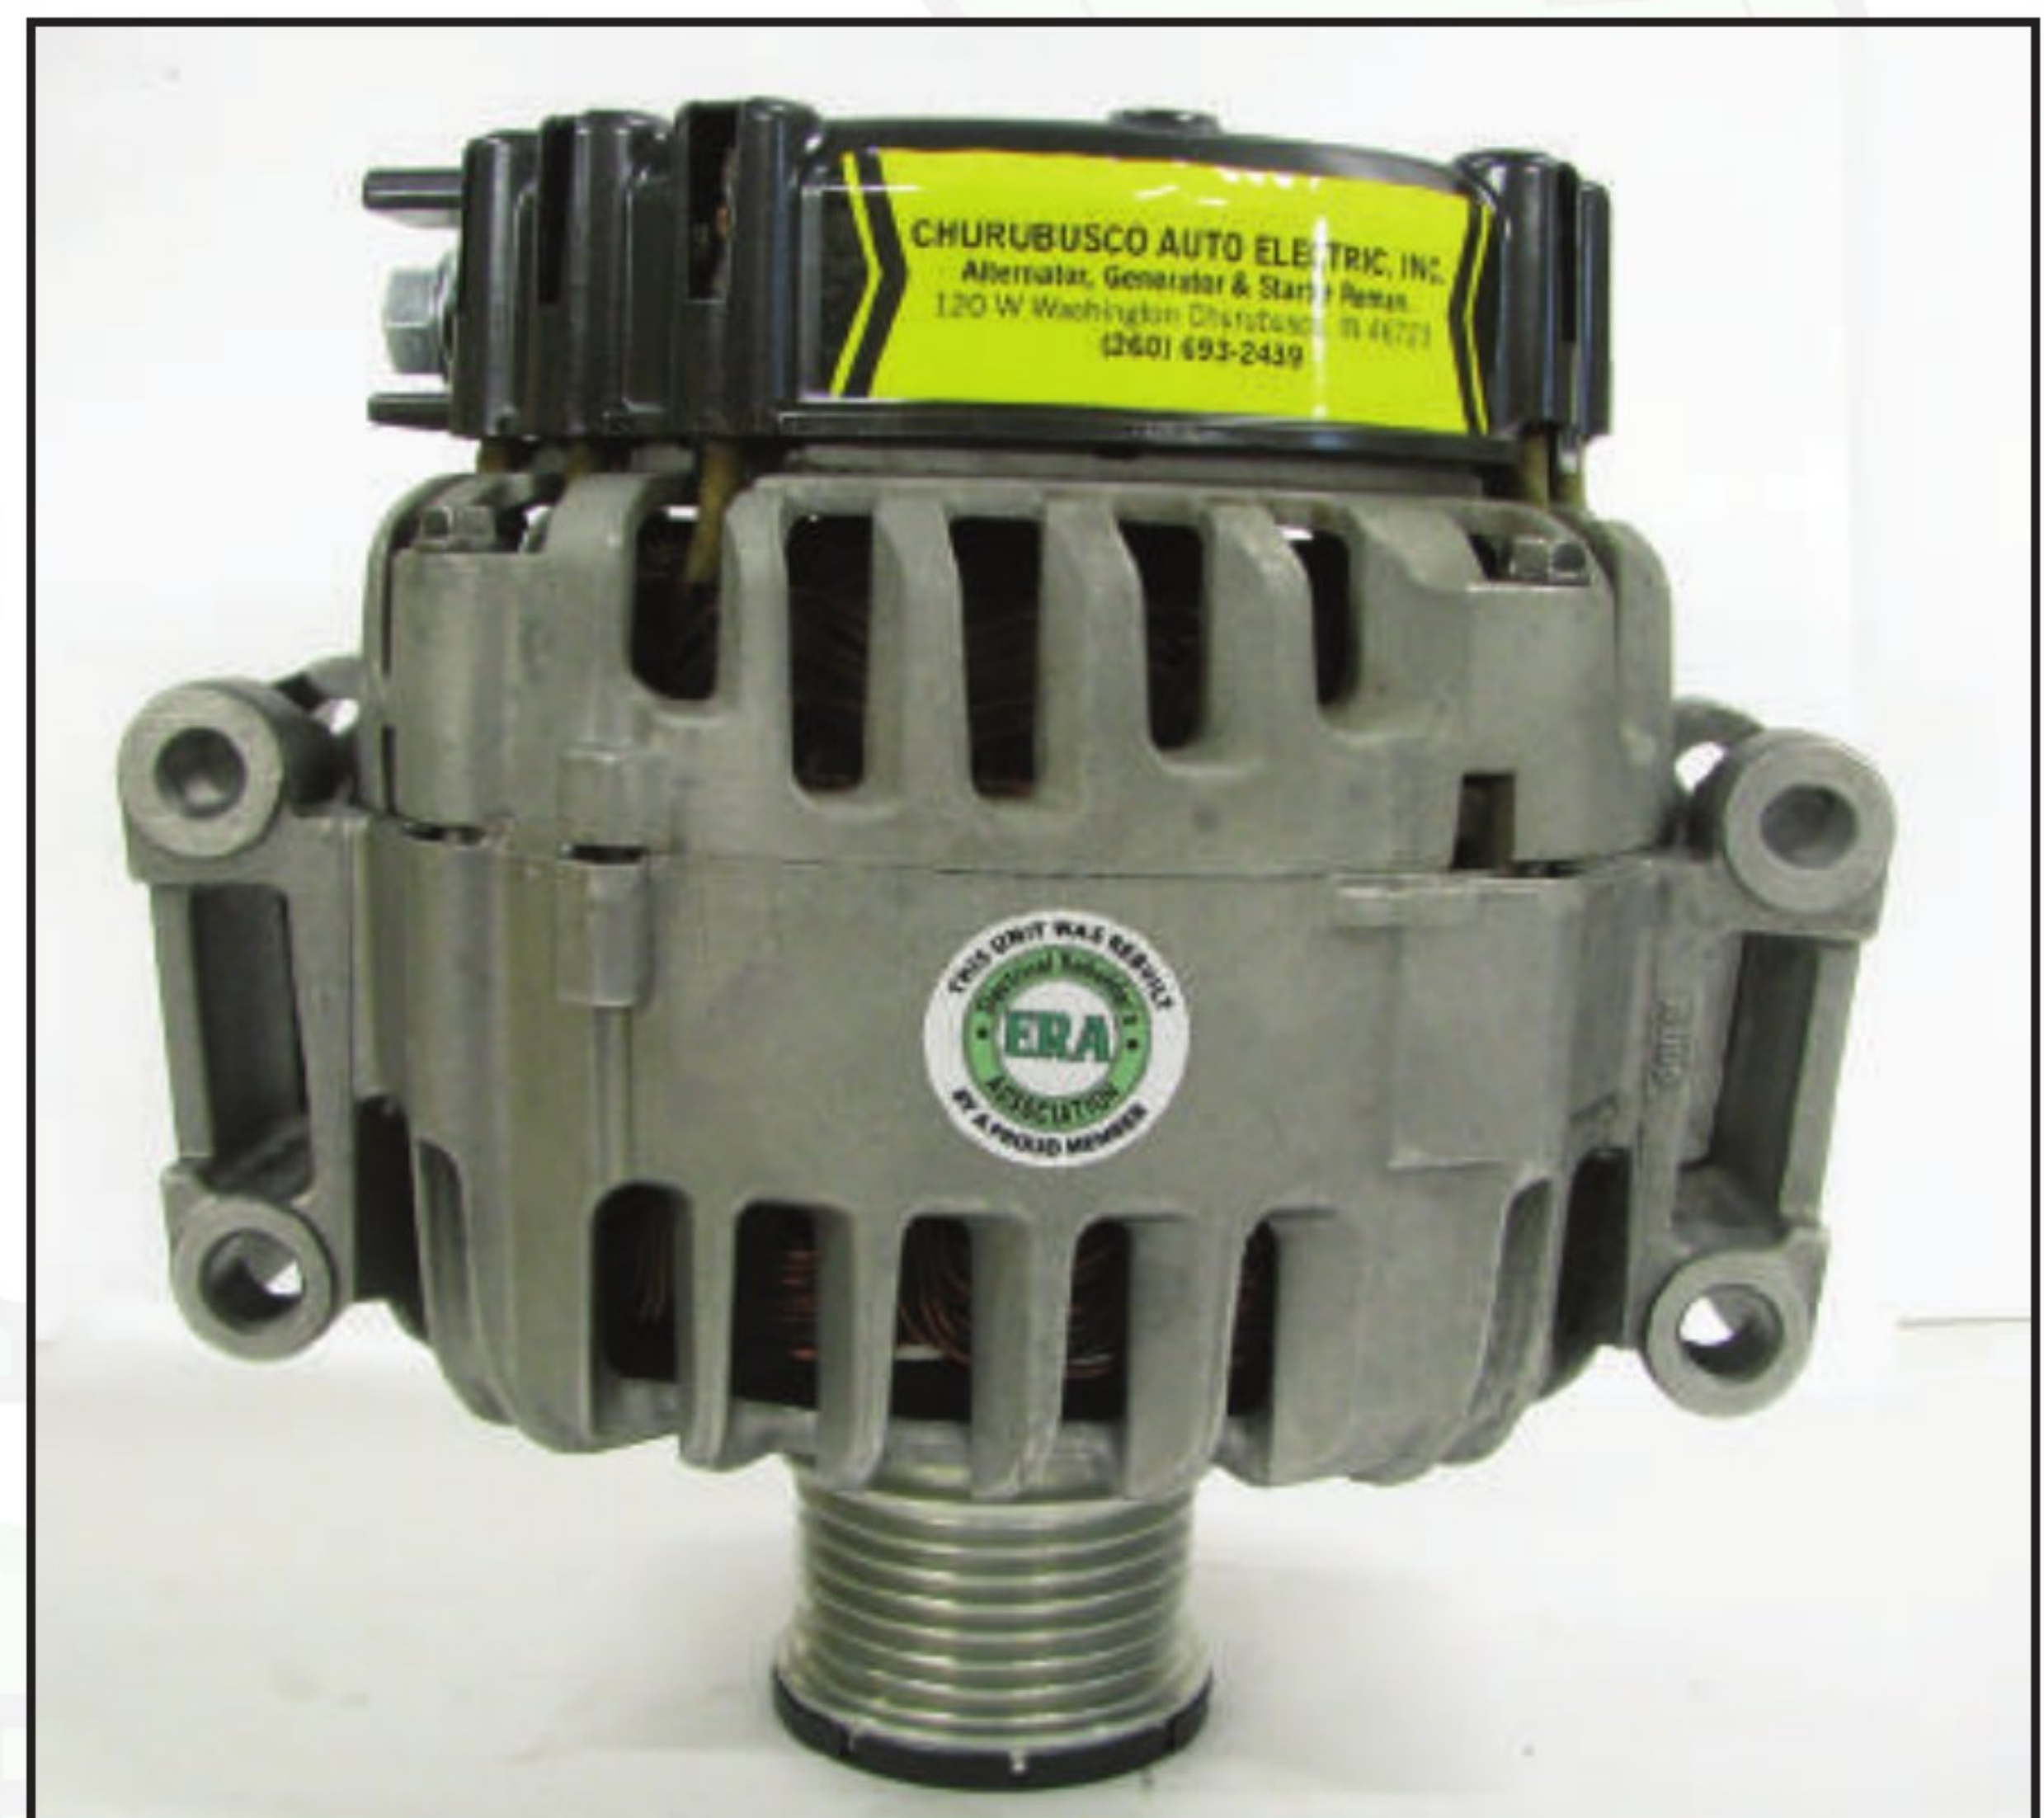
Figure 3 – This side view shows that the pad-mount bolt locations are not in a square pattern, making test bench mounting a challenge.

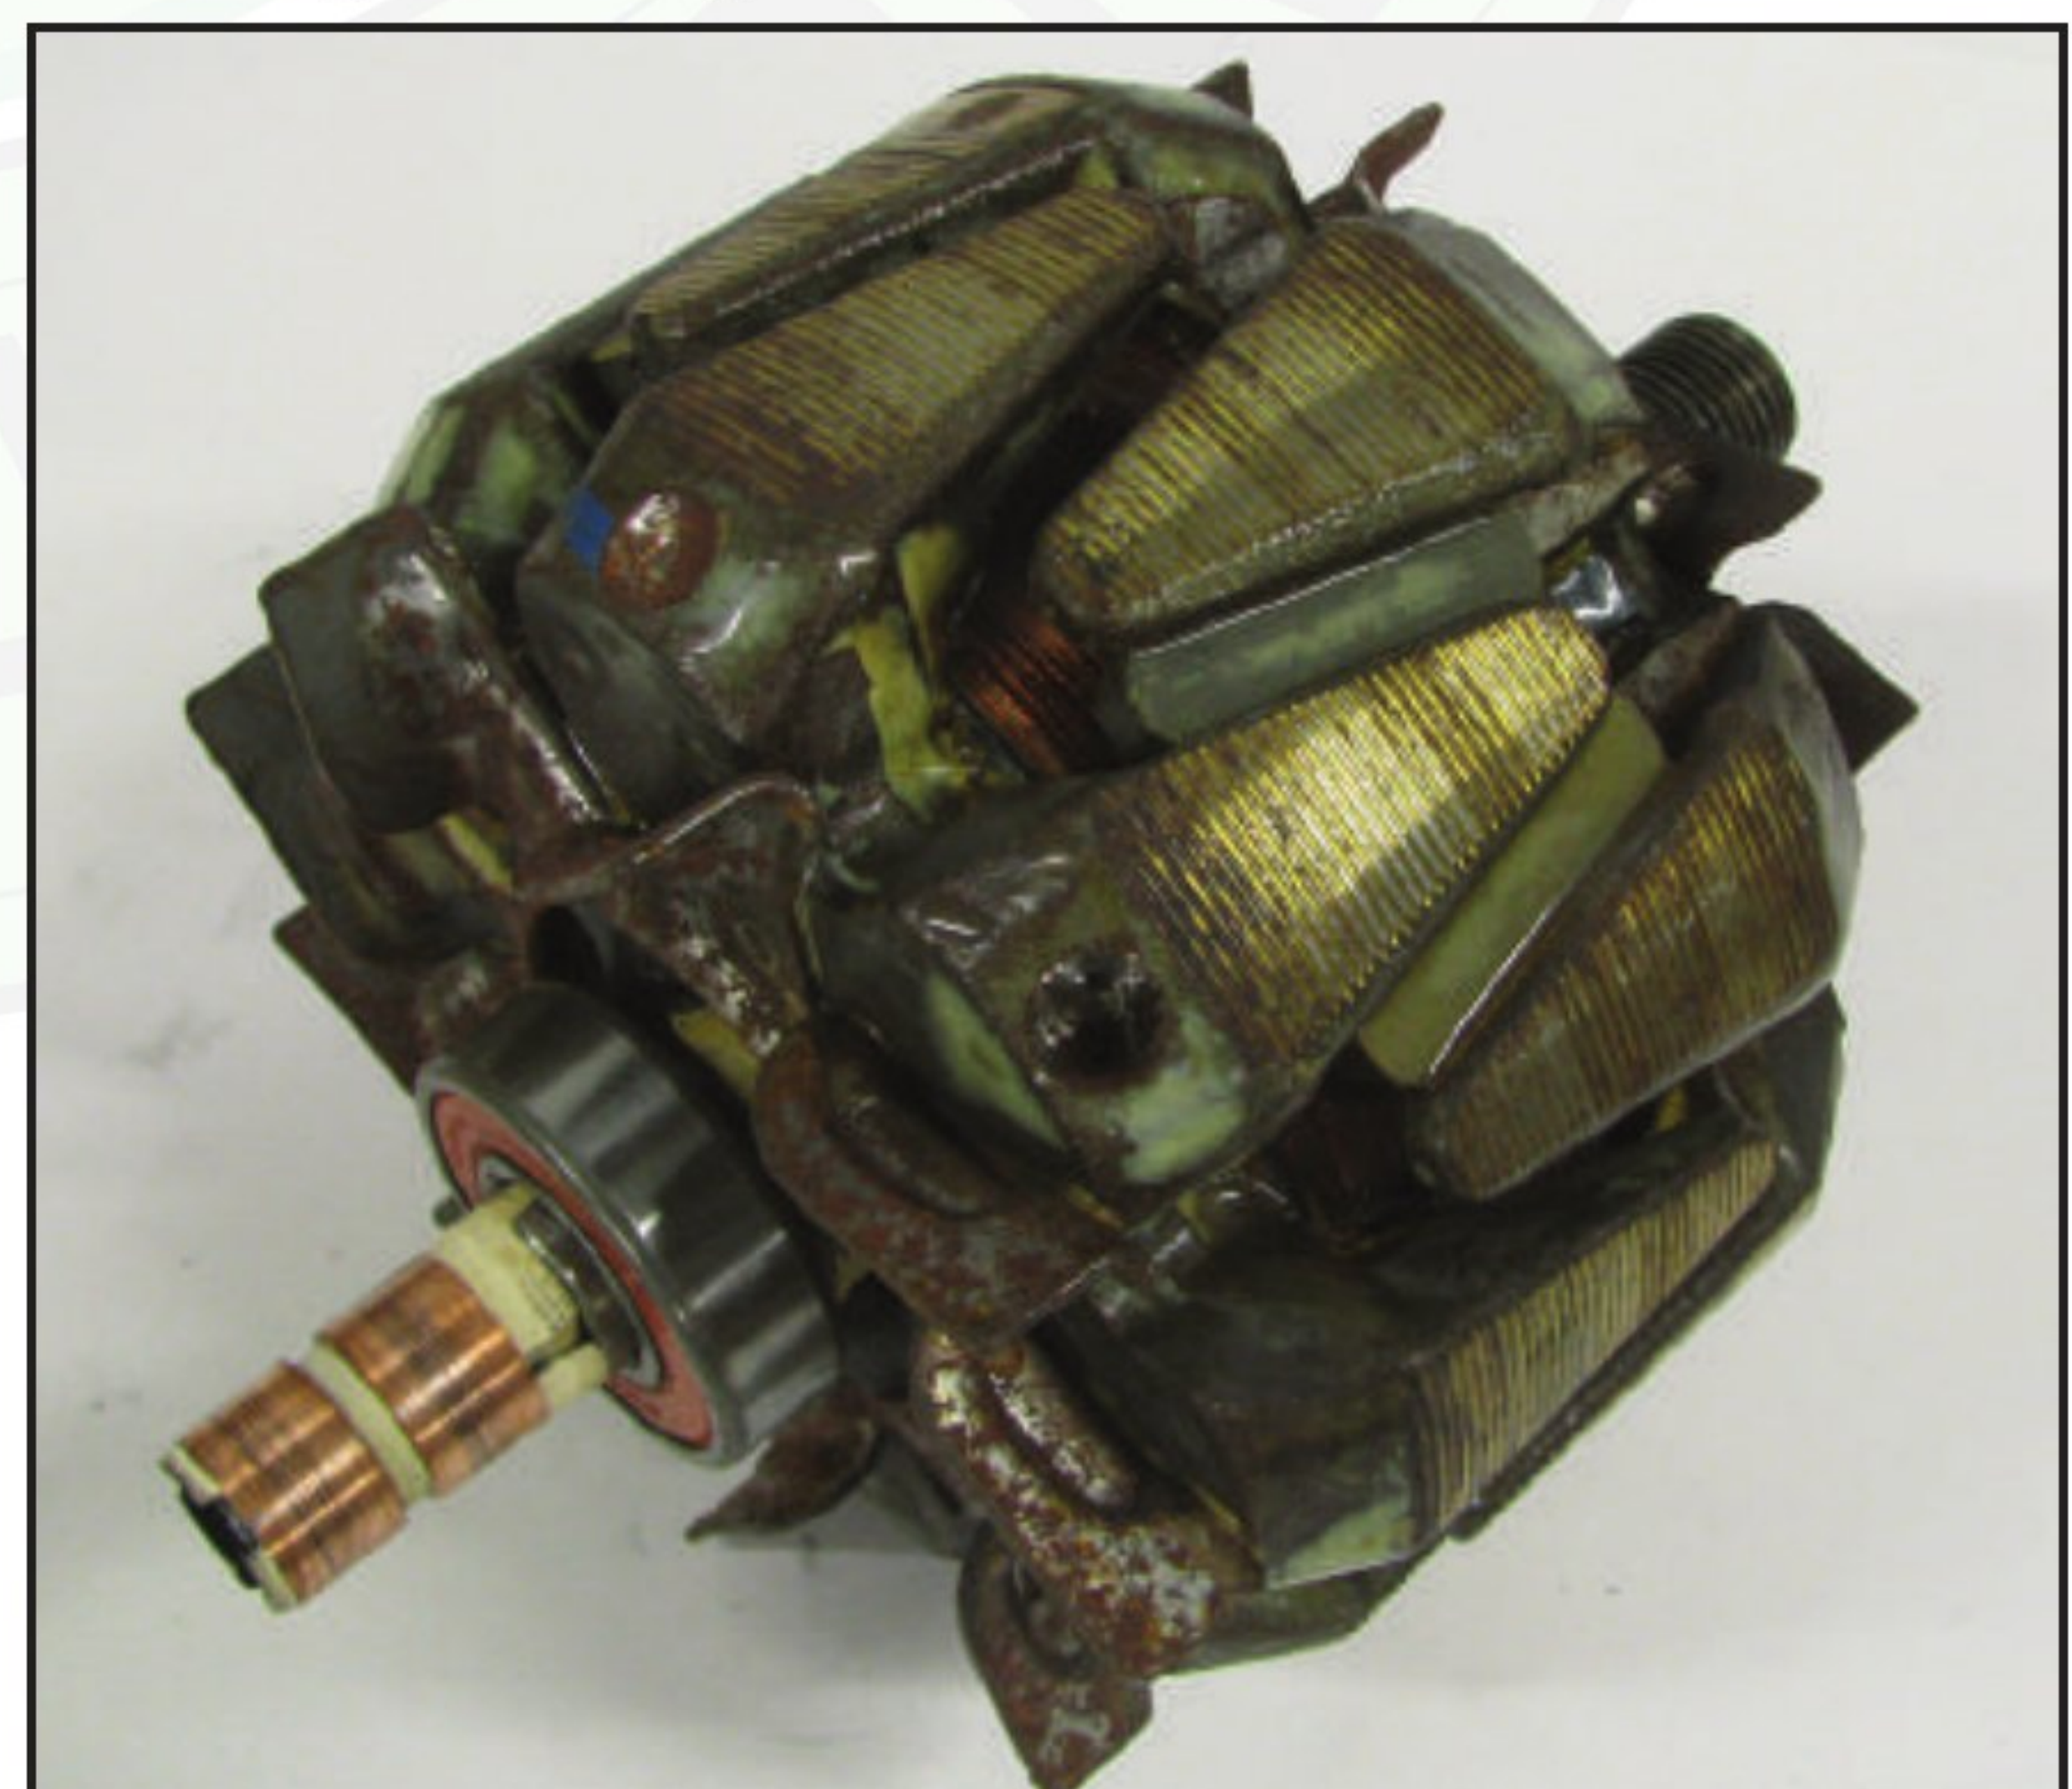
Figure 4 – This Valeo rotor has eight permanent magnets that are epoxied in four evenly spaced locations around the rotor.

There are a few things that you must be aware of when rebuilding this alternator, starting with the rotor (see Figures 4 and 5). As you can in the photos, there are four sets of permanent magnets glued on each side of every other drive end pole claw. It is most important to mark the slip ring leads when changing them so as to not oppose the polarity of the permanent magnets. It is also prudent to test this rotor in the same polarity it will normally operate at (see Figure 6).
