# DENSO PA90S STARTER — Completely Different But Strangely Familiar

BY BOB THOMAS

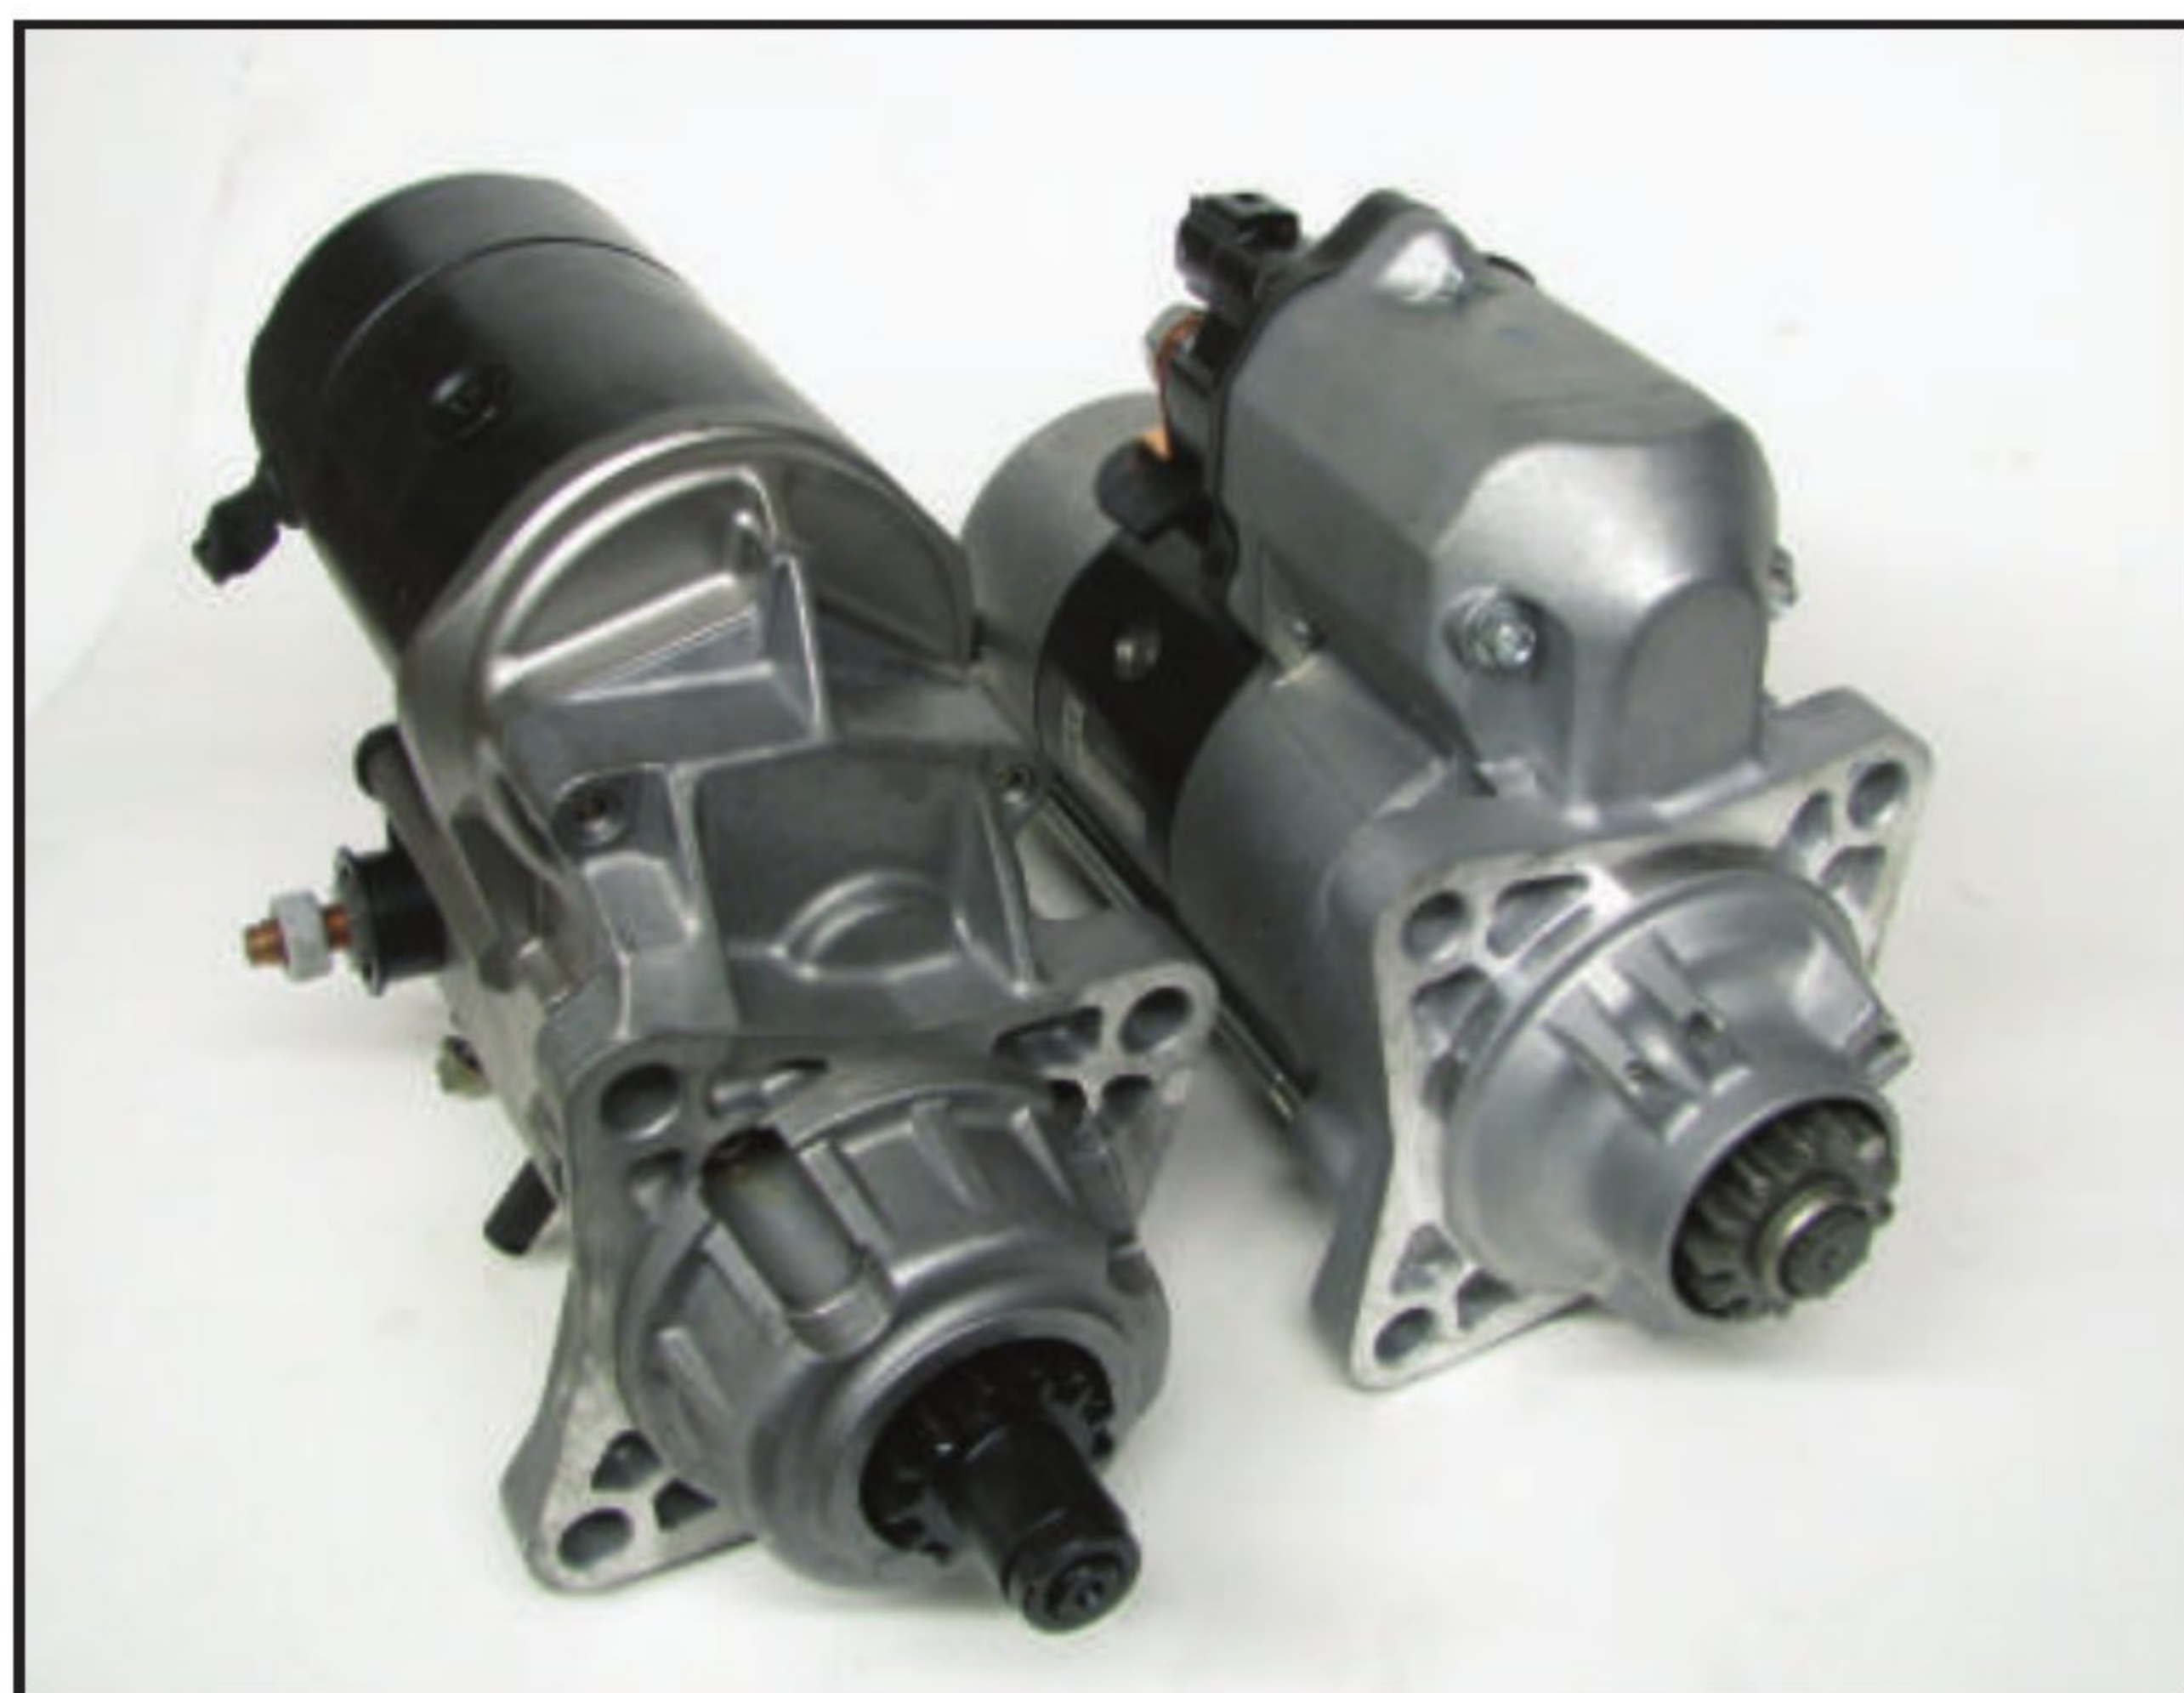
Figure 3 – The PA90S (right) is significantly smaller than the OSGR starter.

The PA90S is a series-wound planetary gear reduction starter for diesel-powered medium duty trucks and equipment. The part number of the one we have here is 428000-6110 (see Figures 1 and 2). It first appeared on Dodge Ram pickups with diesel engines in 2007 and is rated at 3.0kW. As you can see in the third photo (see Figure 3), it is noticeably smaller than its OSGR cousin. Interestingly, this PA90S starter can be used to replace the 228000-2292 in the photo, Lester 17548. Some sources show they will interchange. However, I suspect that may depend upon the amount of room that is available for a bulkier OSGR starter in the post-2007 trucks and the installer's willingness to accept it.

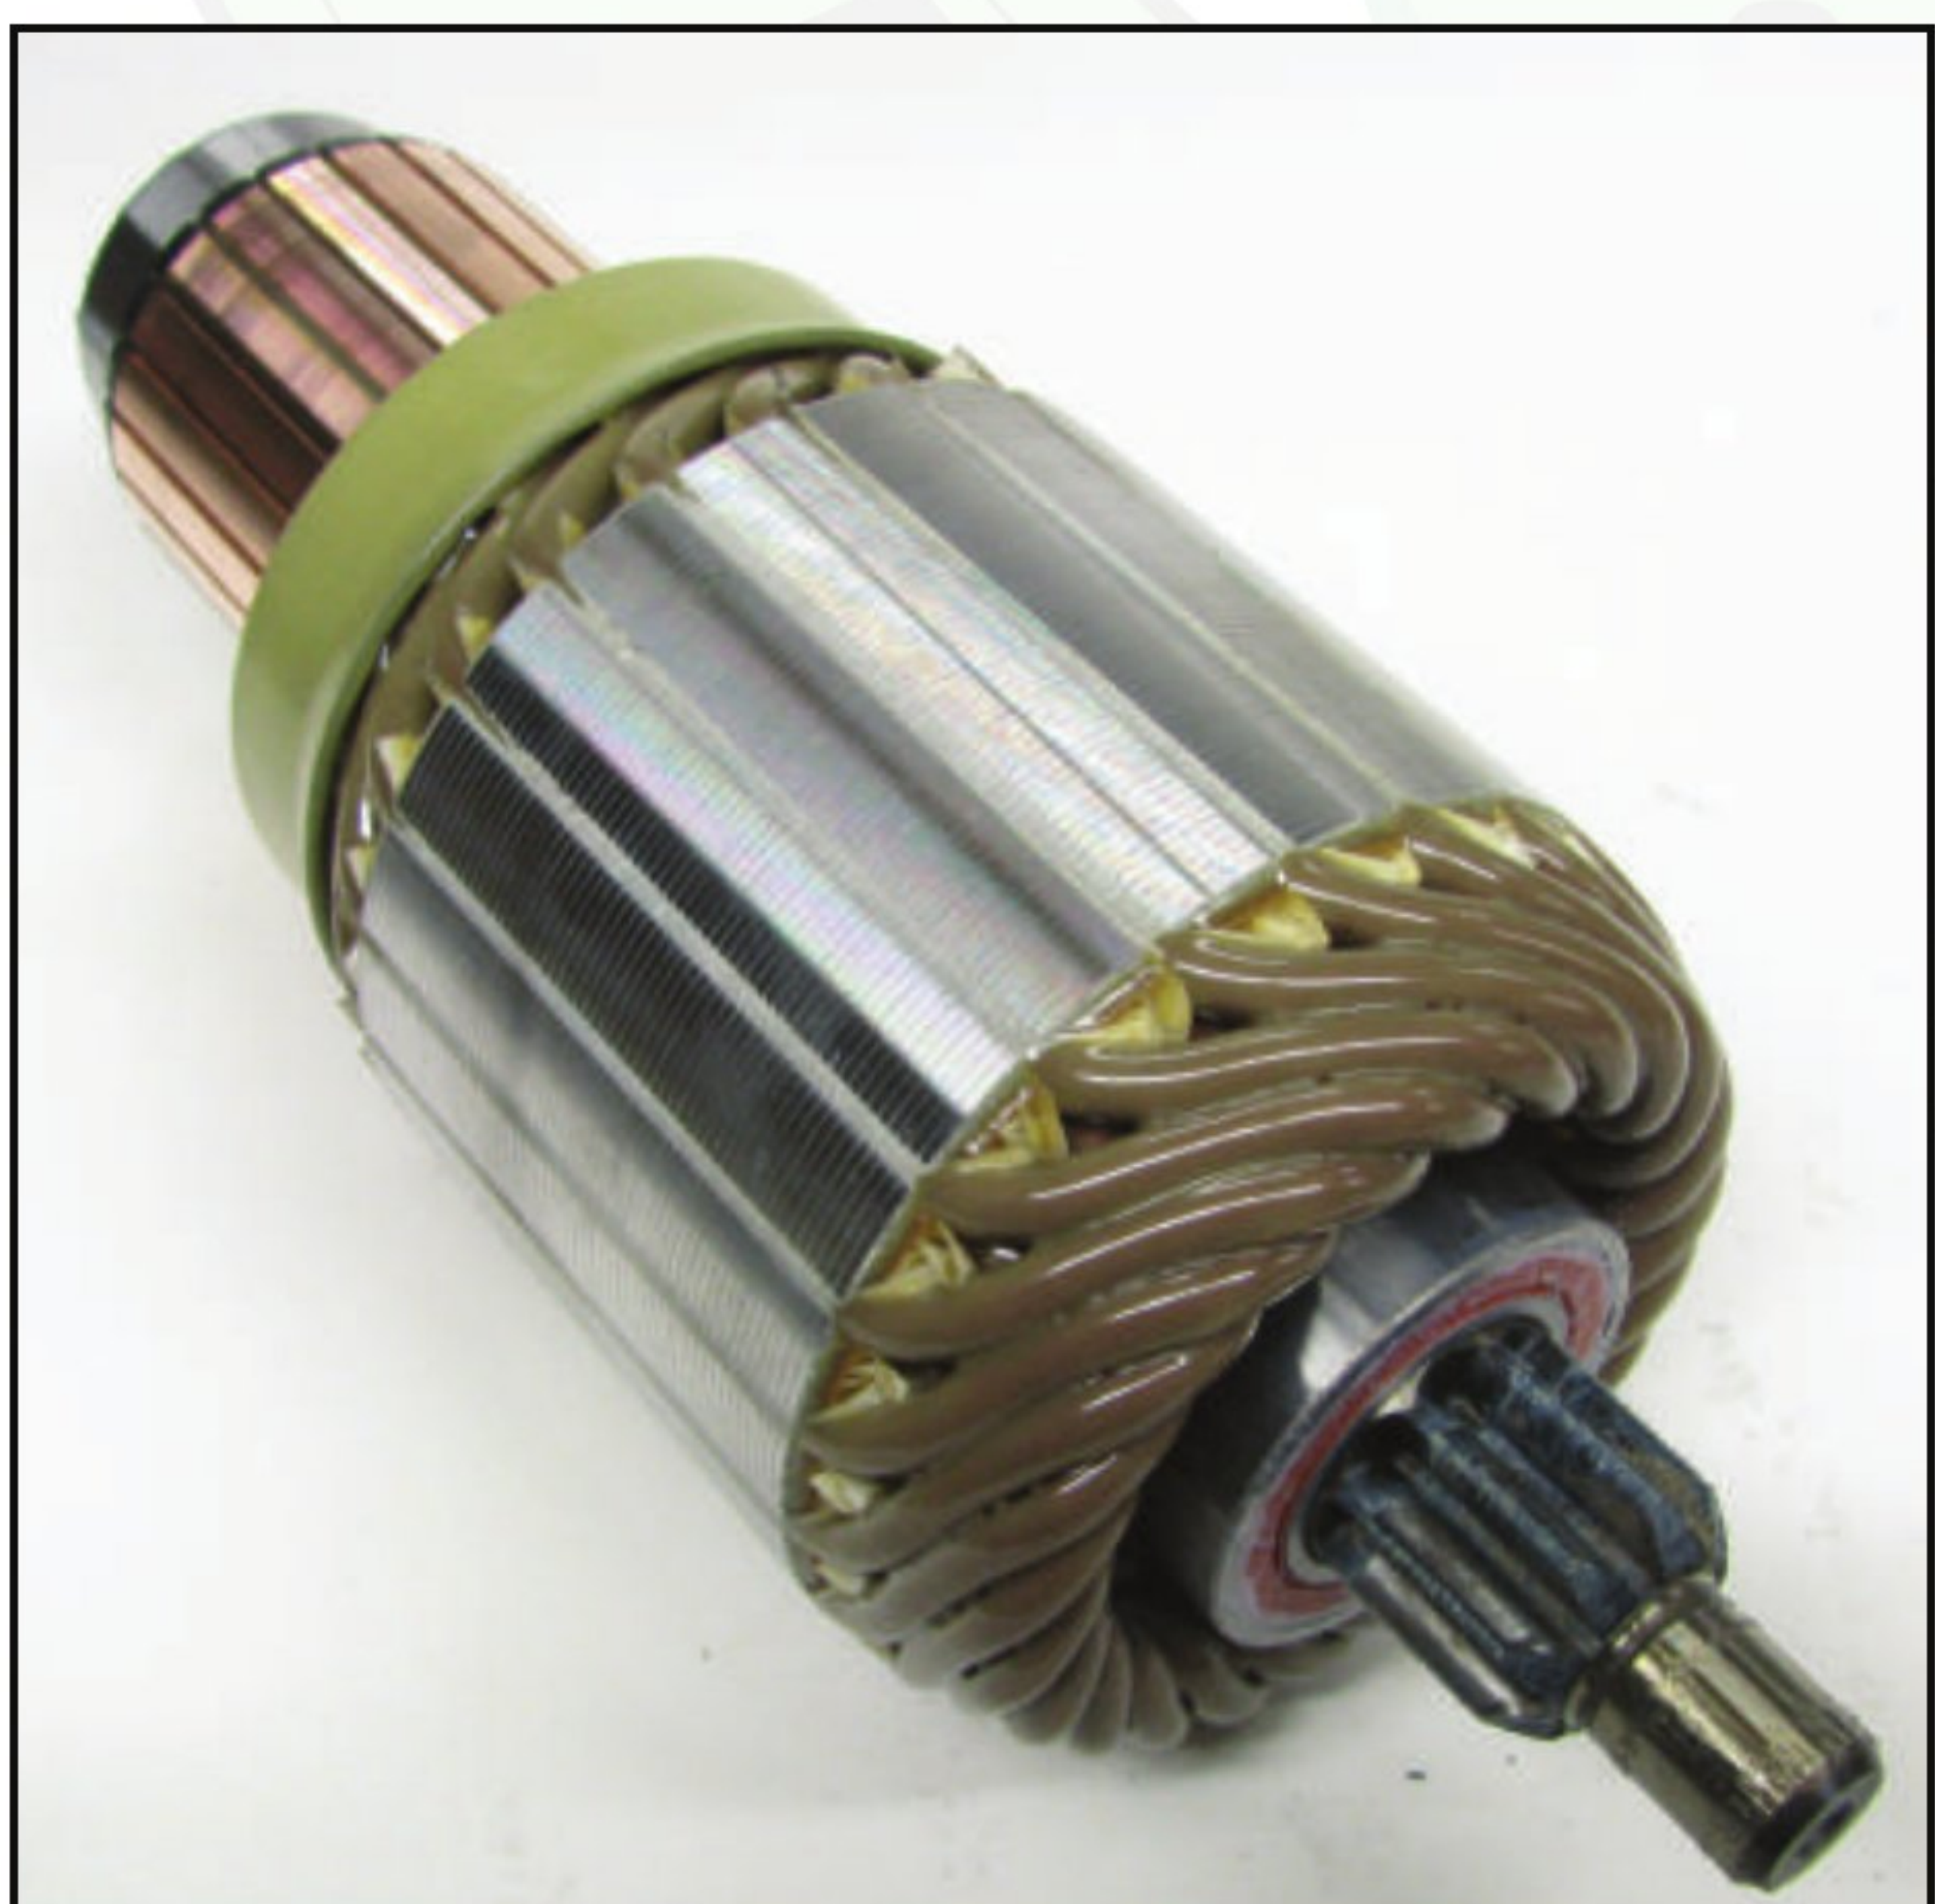
Figure 5 – The PA90S armature's DE bearing will be a challenge to remove.

To disassemble this starter you must begin by removing the brush holder screws and through bolts. That allows you to remove the commutator end housing, brush holder (see Figure 4), armature (see Figure 5) and field case (see Figure 6). Like many of the small engine Denso starters of the past, the pole shoes are riveted into this case. These coils are quite different too, wound from a heavy flat wire. However, note that the wide side of the flat wire is parallel to the housing (see Figure 7). You can see that there are just three turns per coil.

As a protection feature, Denso has built four fusible connections into these coils, two where the positive brushes attach (see Figure 8) and two where the coils attach to the field case lead (see Figure 9). They are there to prevent a critical failure. But you have to wonder for whom. It obviously cannot benefit of the end user. Once these fuses burn open, the starter is disabled until the fields are replaced or repaired. More about that later. Note that the armature's drive end support bearing is

recessed in such a way that it will be a challenge to remove.

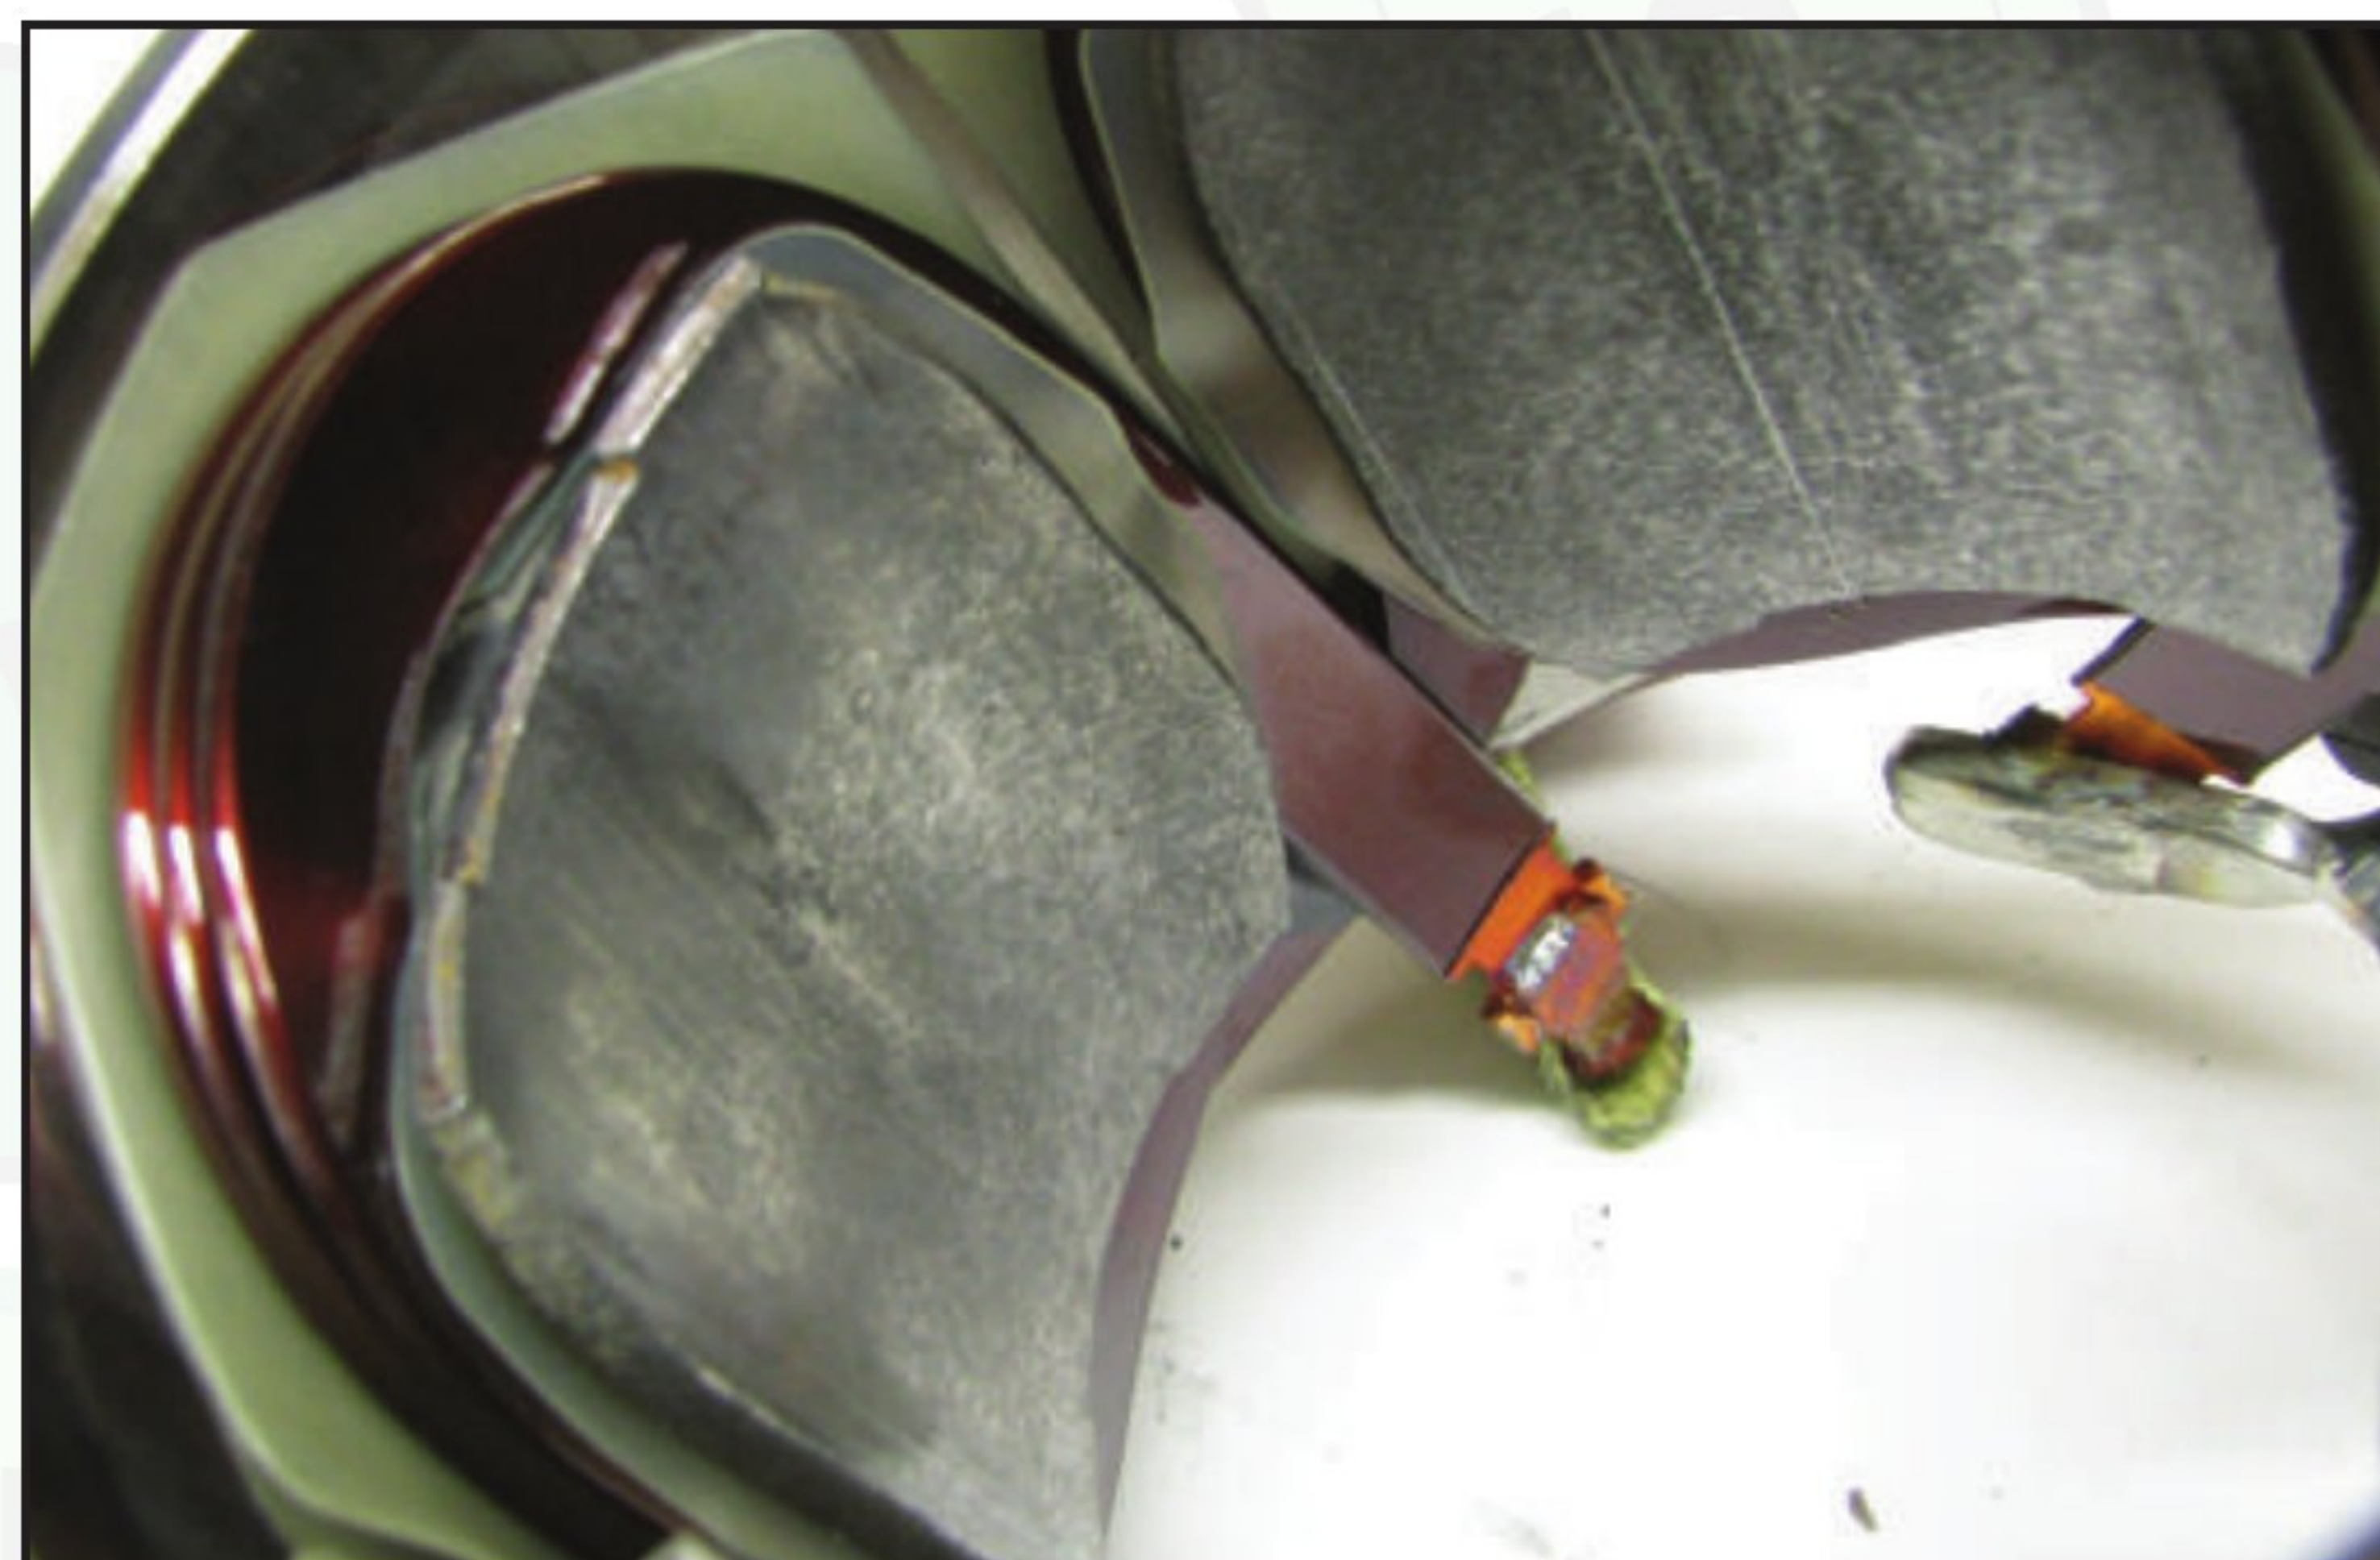
Figure 7 – Note the way that these field coils are wound, the number of turns and the size of the wire.

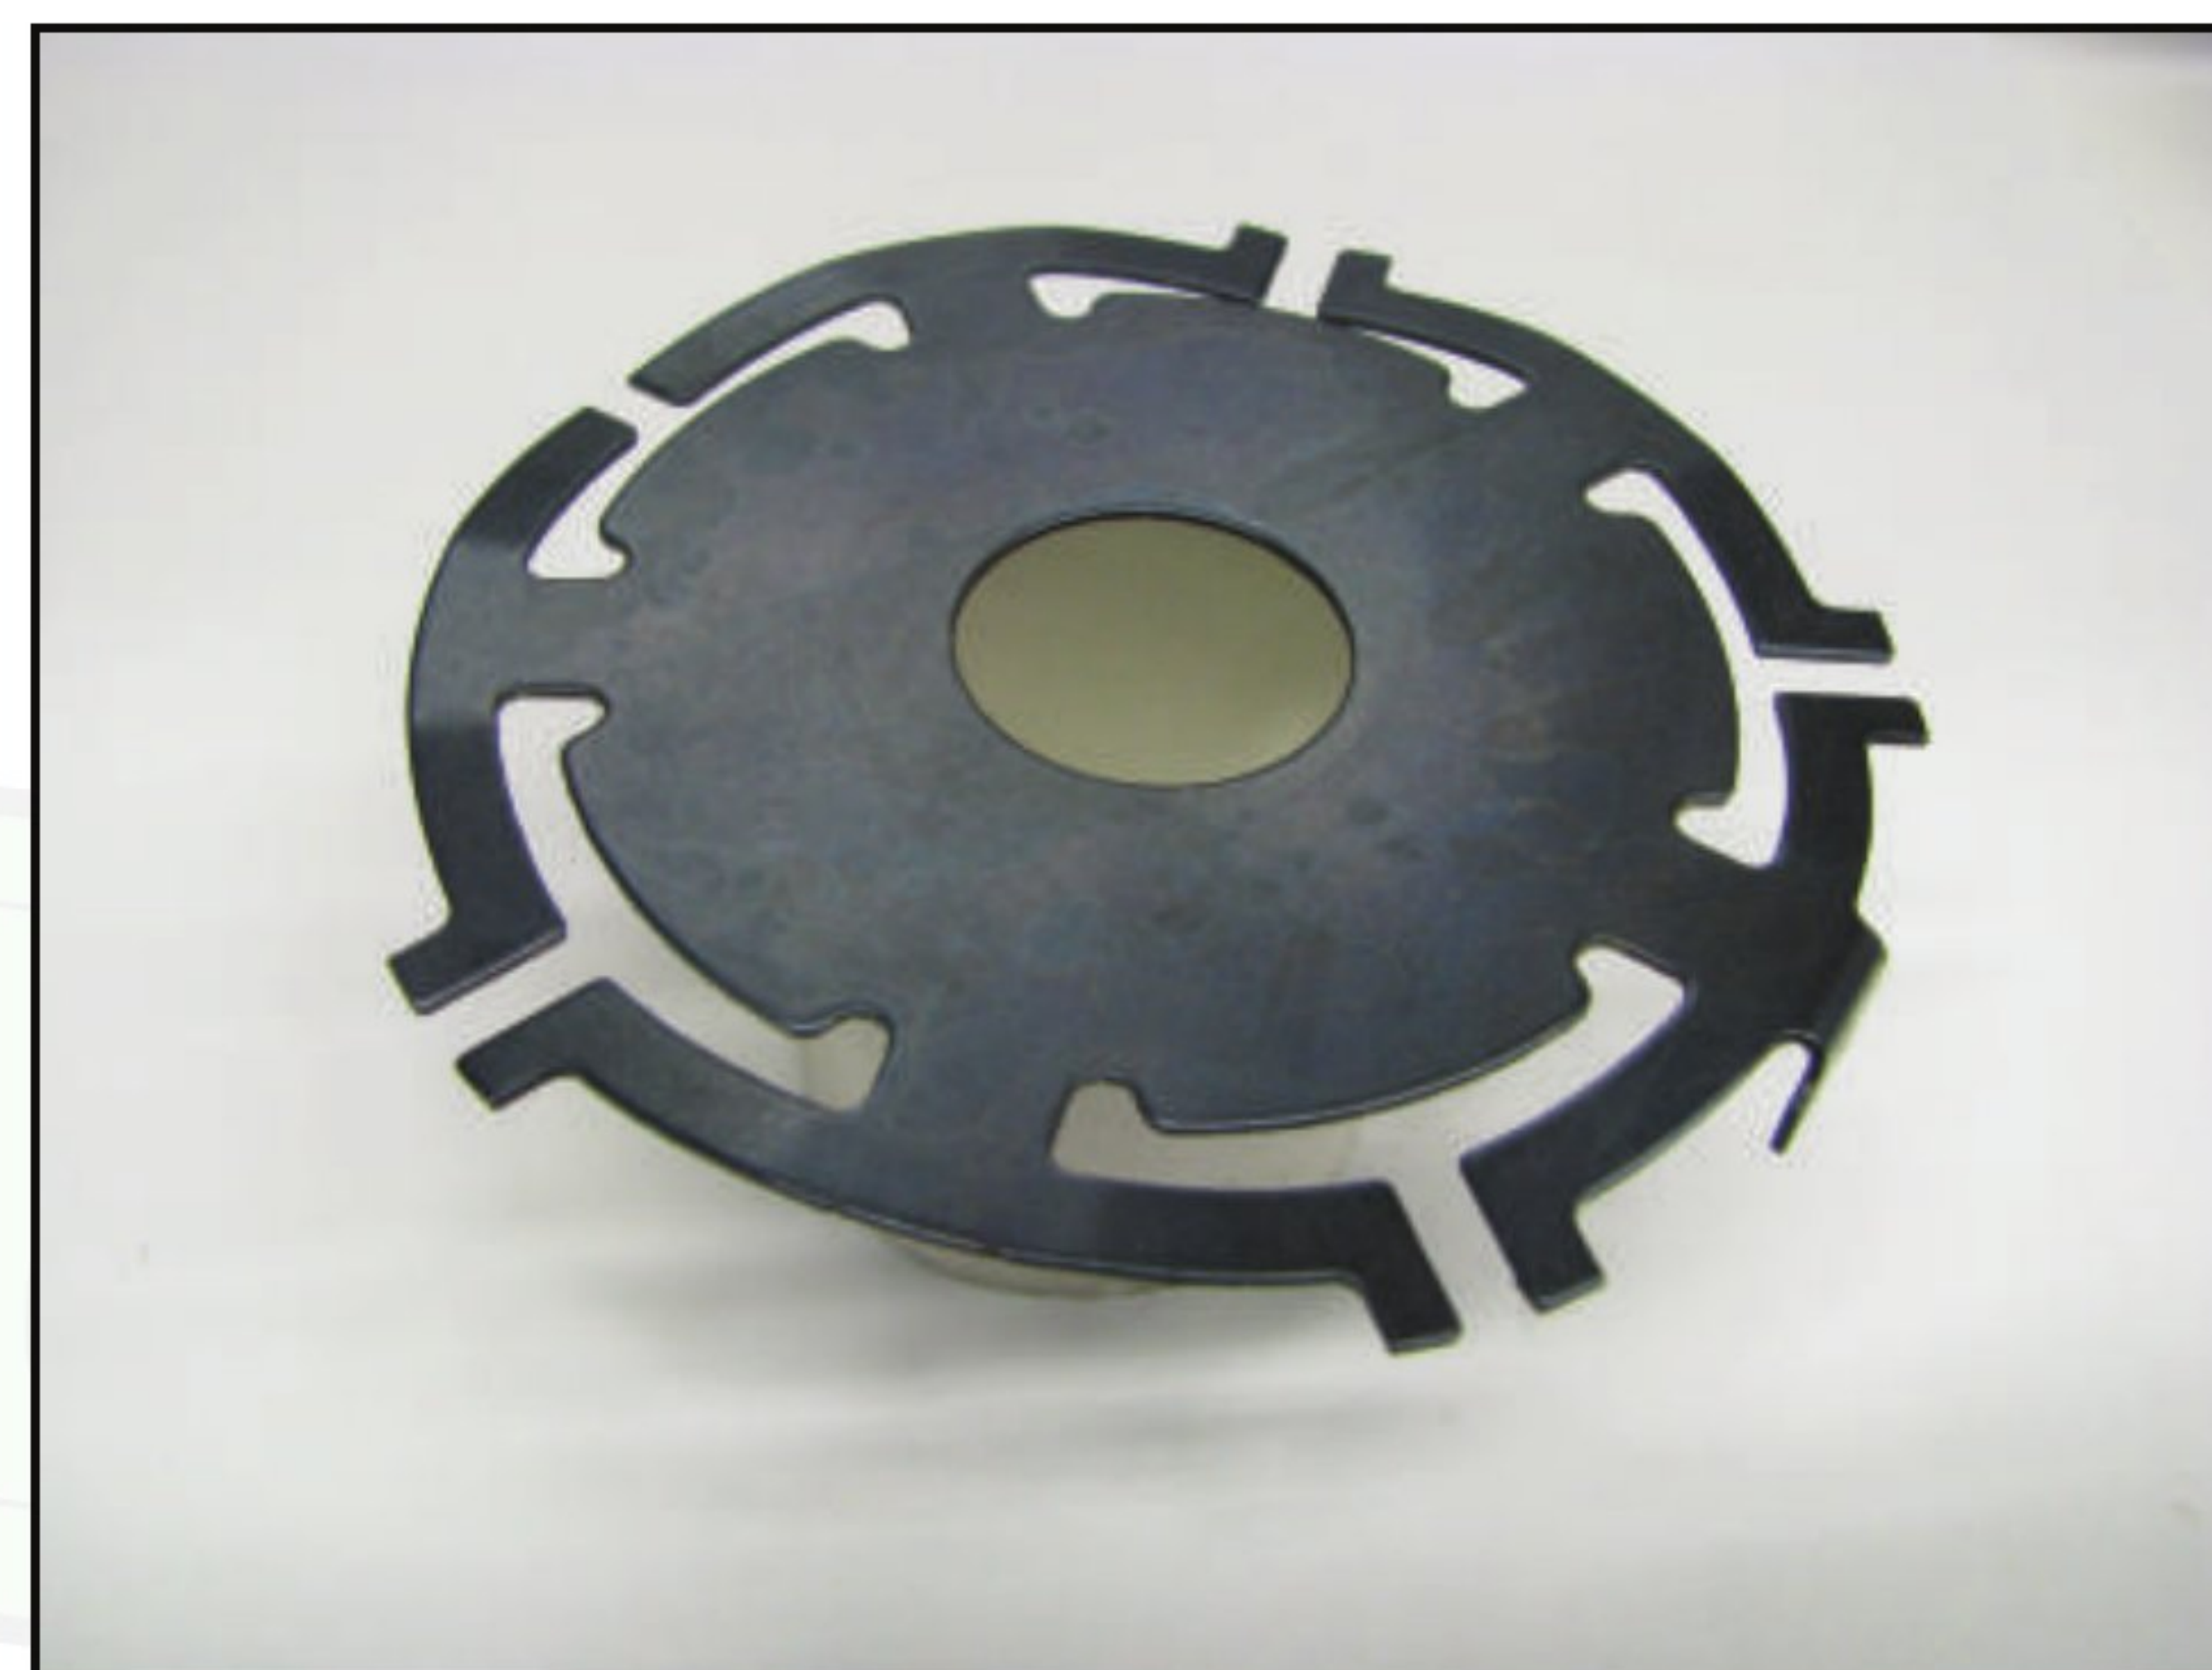
Figure 12 – This odd shaped spring plate is a key part of the PA90S slip disk shock absorber.

The odd shaped spring plate, or **slip disk shock absorber** that was mentioned earlier is there to absorb some of the impact that is created at the moment the pinion engages the stationary ring gear. to soften the blow to the pinion that comes with each crank cycle. But it also reduces the strain placed on the other parts of the starter's power train – all the way back to the armature's gear.

When the pinion grabs the ring gear, the helical splines on the shaft create backwards pressure on the drive clutch, which also holds the planetary gears. You may remember that the stationary gear fits loosely in the drive end housing for a reason. It must be free to move too. The spring plate rests between the loosely fitting stationary gear track and the tightly fixed cover plate. Backward movement is limited to about 1mm. That may not seem like very much, but it is enough to reduce pinion wear over thousands of crank cycles. The needle bearing in the drive clutch which seemed redundant is there to allow the clutch to move toward the armature which does not move back. Remember that it is held in place by its drive end ball bearing. All of these components must work together.

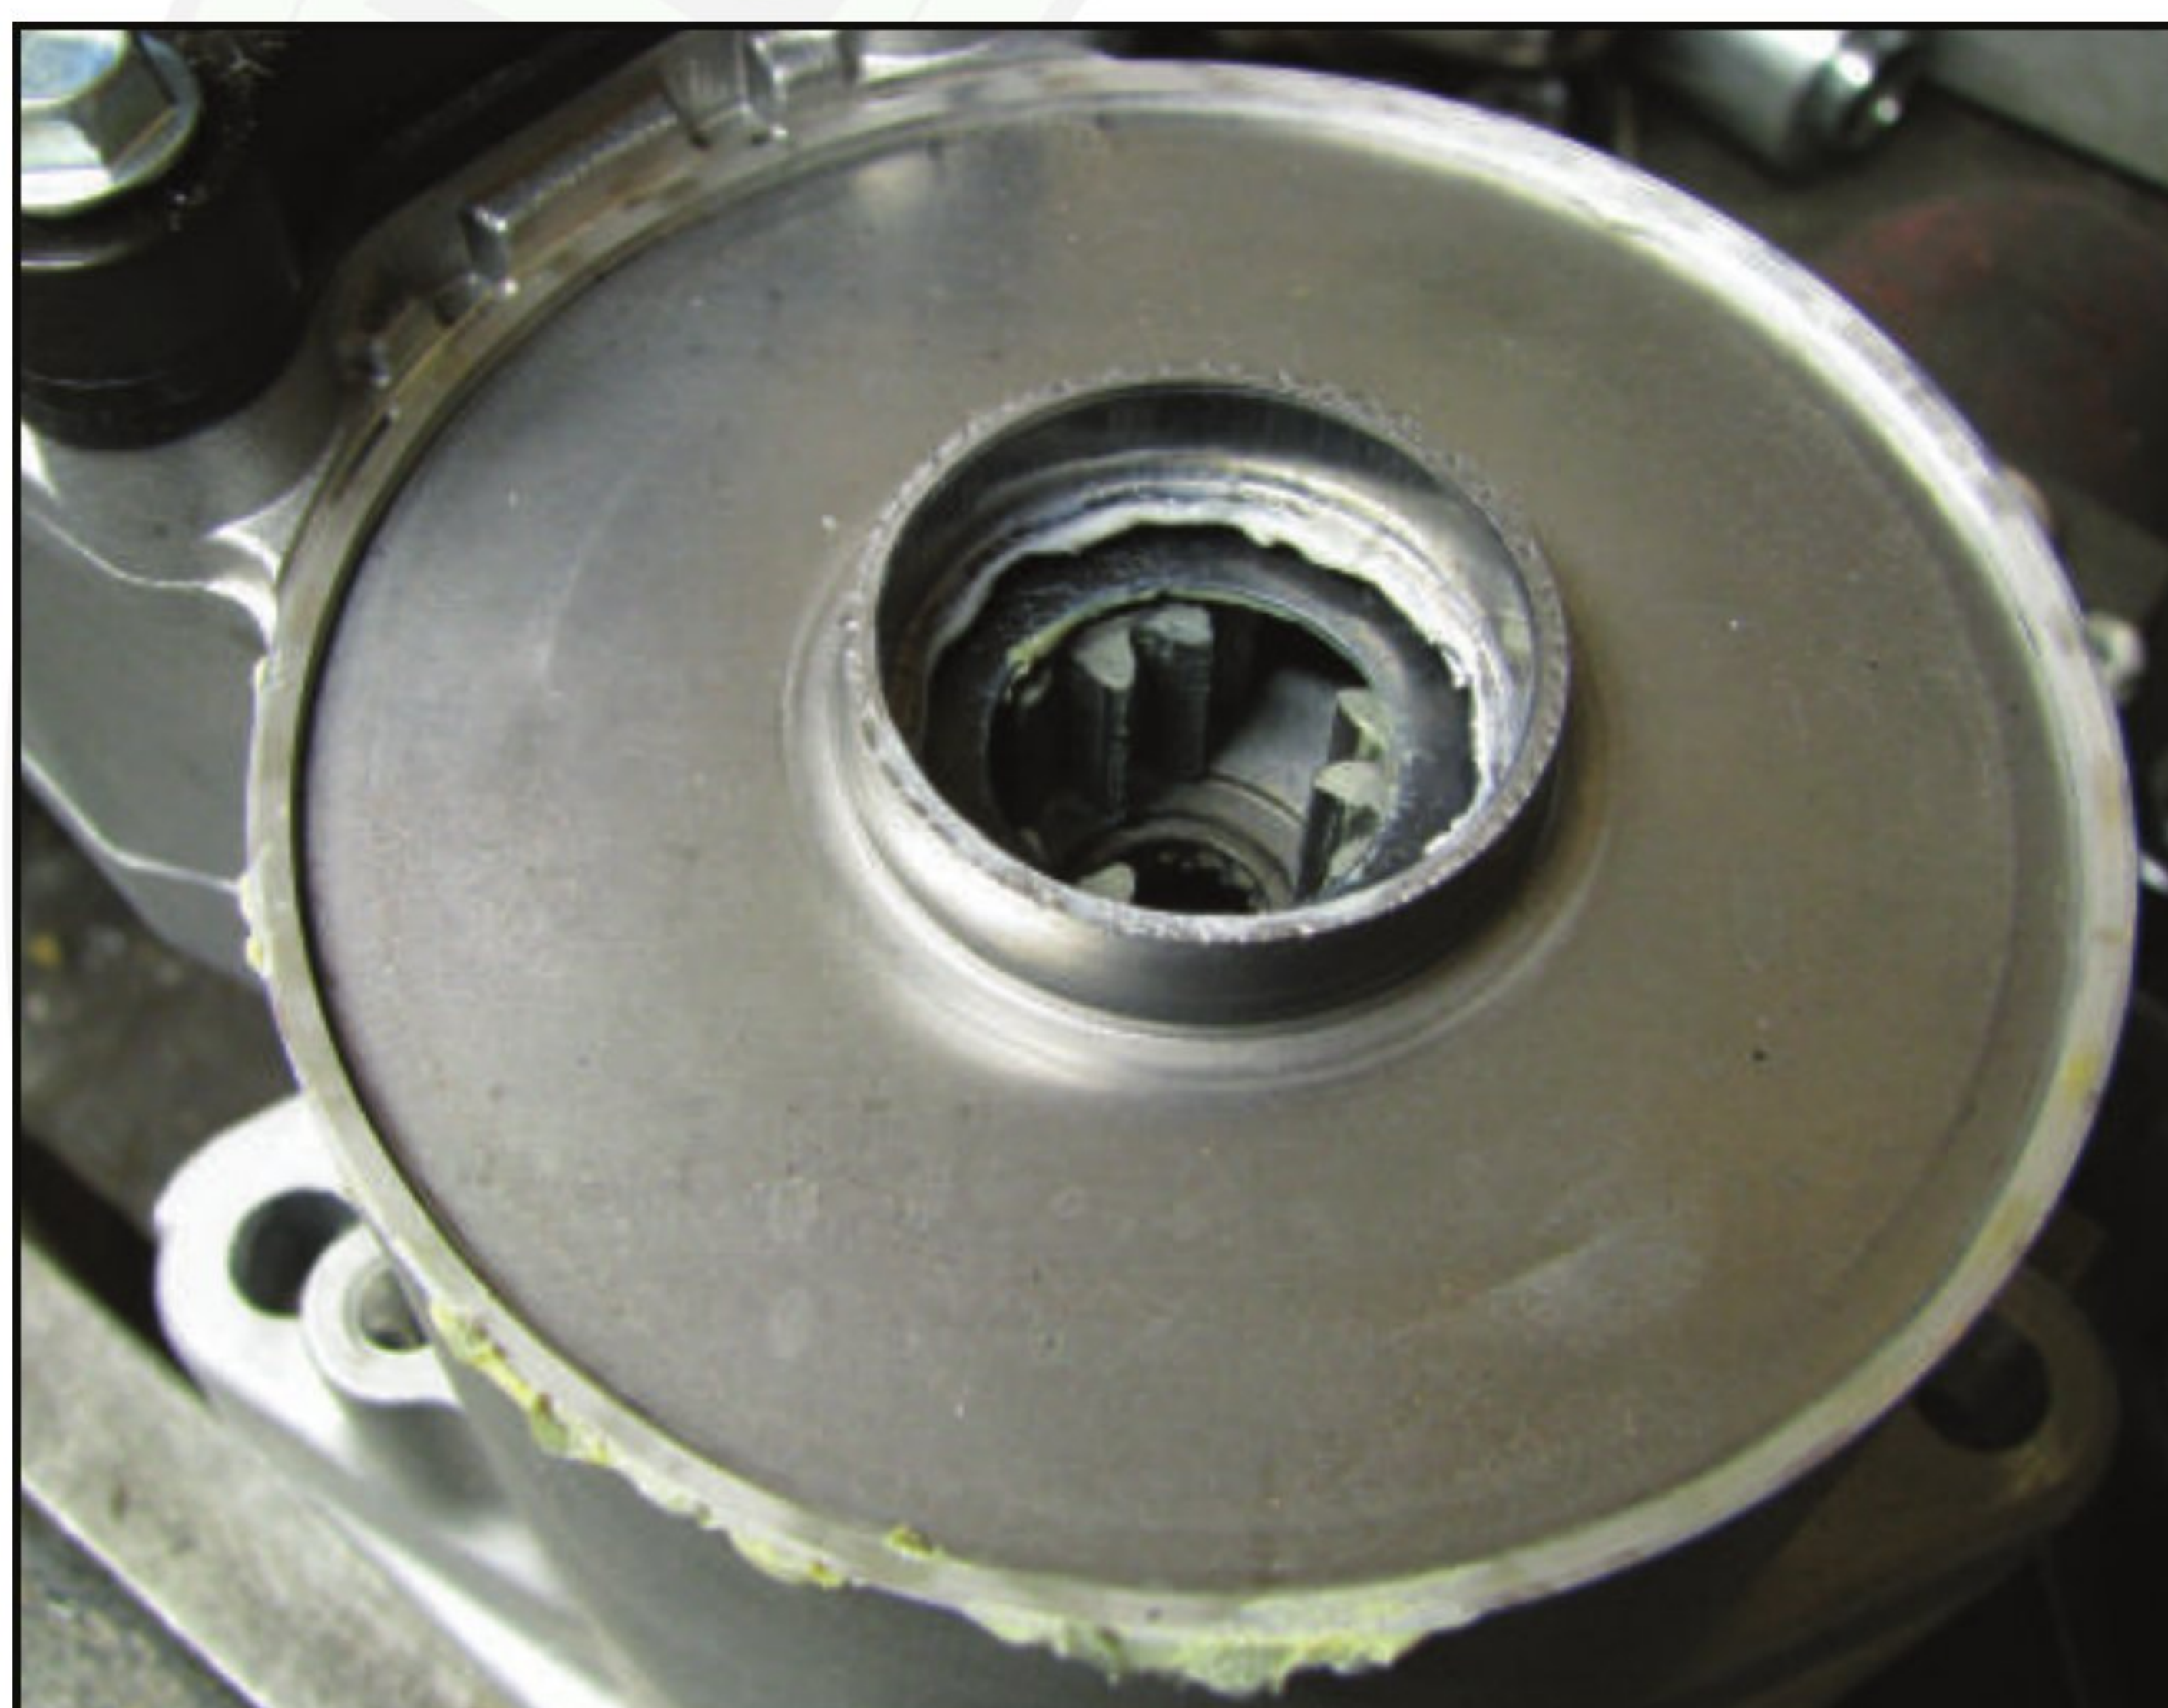
Figure 10 – View of the planetary gear's cover plate once the field case and armature have been removed.

Once the field case and armature are out of the way, you can get to the planetary gear assembly. When you remove the cover plate which also supports the armature's recessed bearing (see Figure 10), there is a good chance that a large strangely-shaped spring washer will stick to its back side. It is very easy to miss it. This is what Denso calls a slip disk shock absorber (see Figures 11 and 12). More about it later as well. But when removing this part, remember to make a note of its orientation, which is easy to forget when it comes out stuck to the bottom of the cover plate. Then remove the planet gears to expose the drive clutch.
