# DENSO PA90S STARTER — Completely Different But Strangely Familiar

BY BOB THOMAS

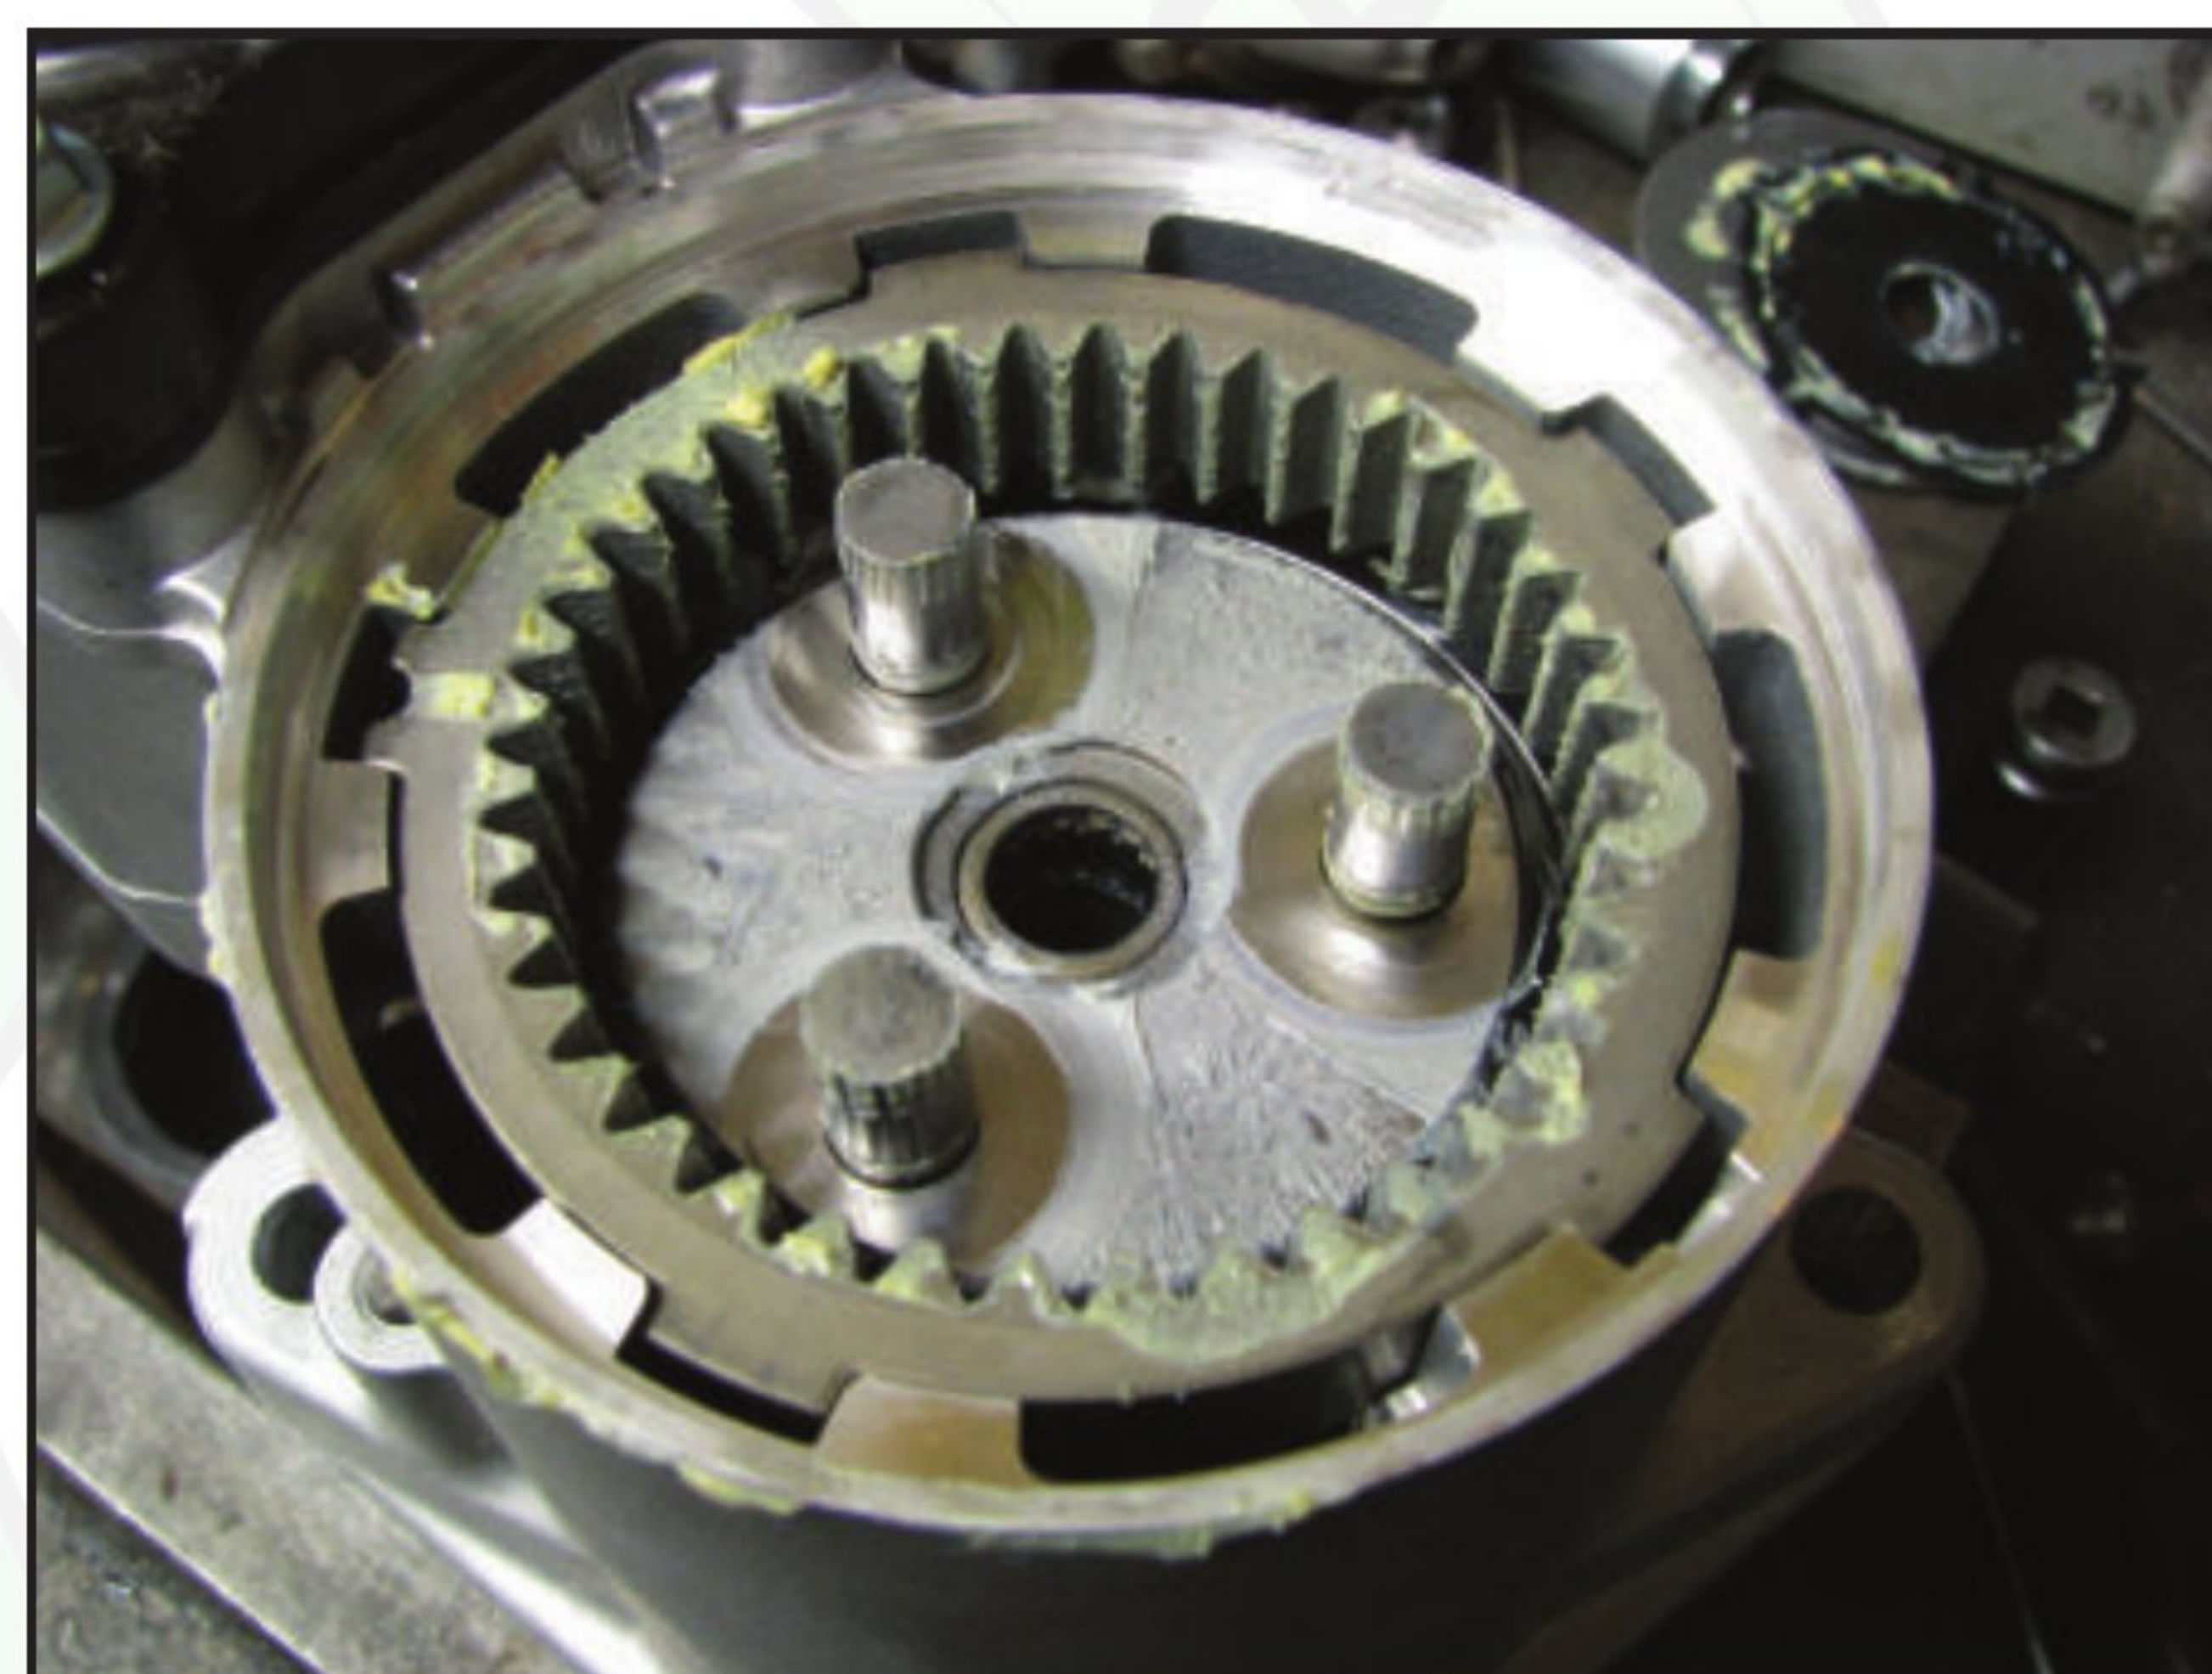
Figure 13 – View of the stationary gear in the housing with drive clutch below it.

The back side of the clutch carries the planet gears. You will note that there is a needle bearing in the clutch housing for the end of the armature's shaft (see Figure 13). That bearing may seem to be redundant given the ball bearing already supporting the armature's shaft, but it is there for a reason. At this point you can remove what will seem like a very loose fitting stationary gear. Do not mistake its sloppy fit in the housing as an indication of excessive wear. It is designed to be loose.

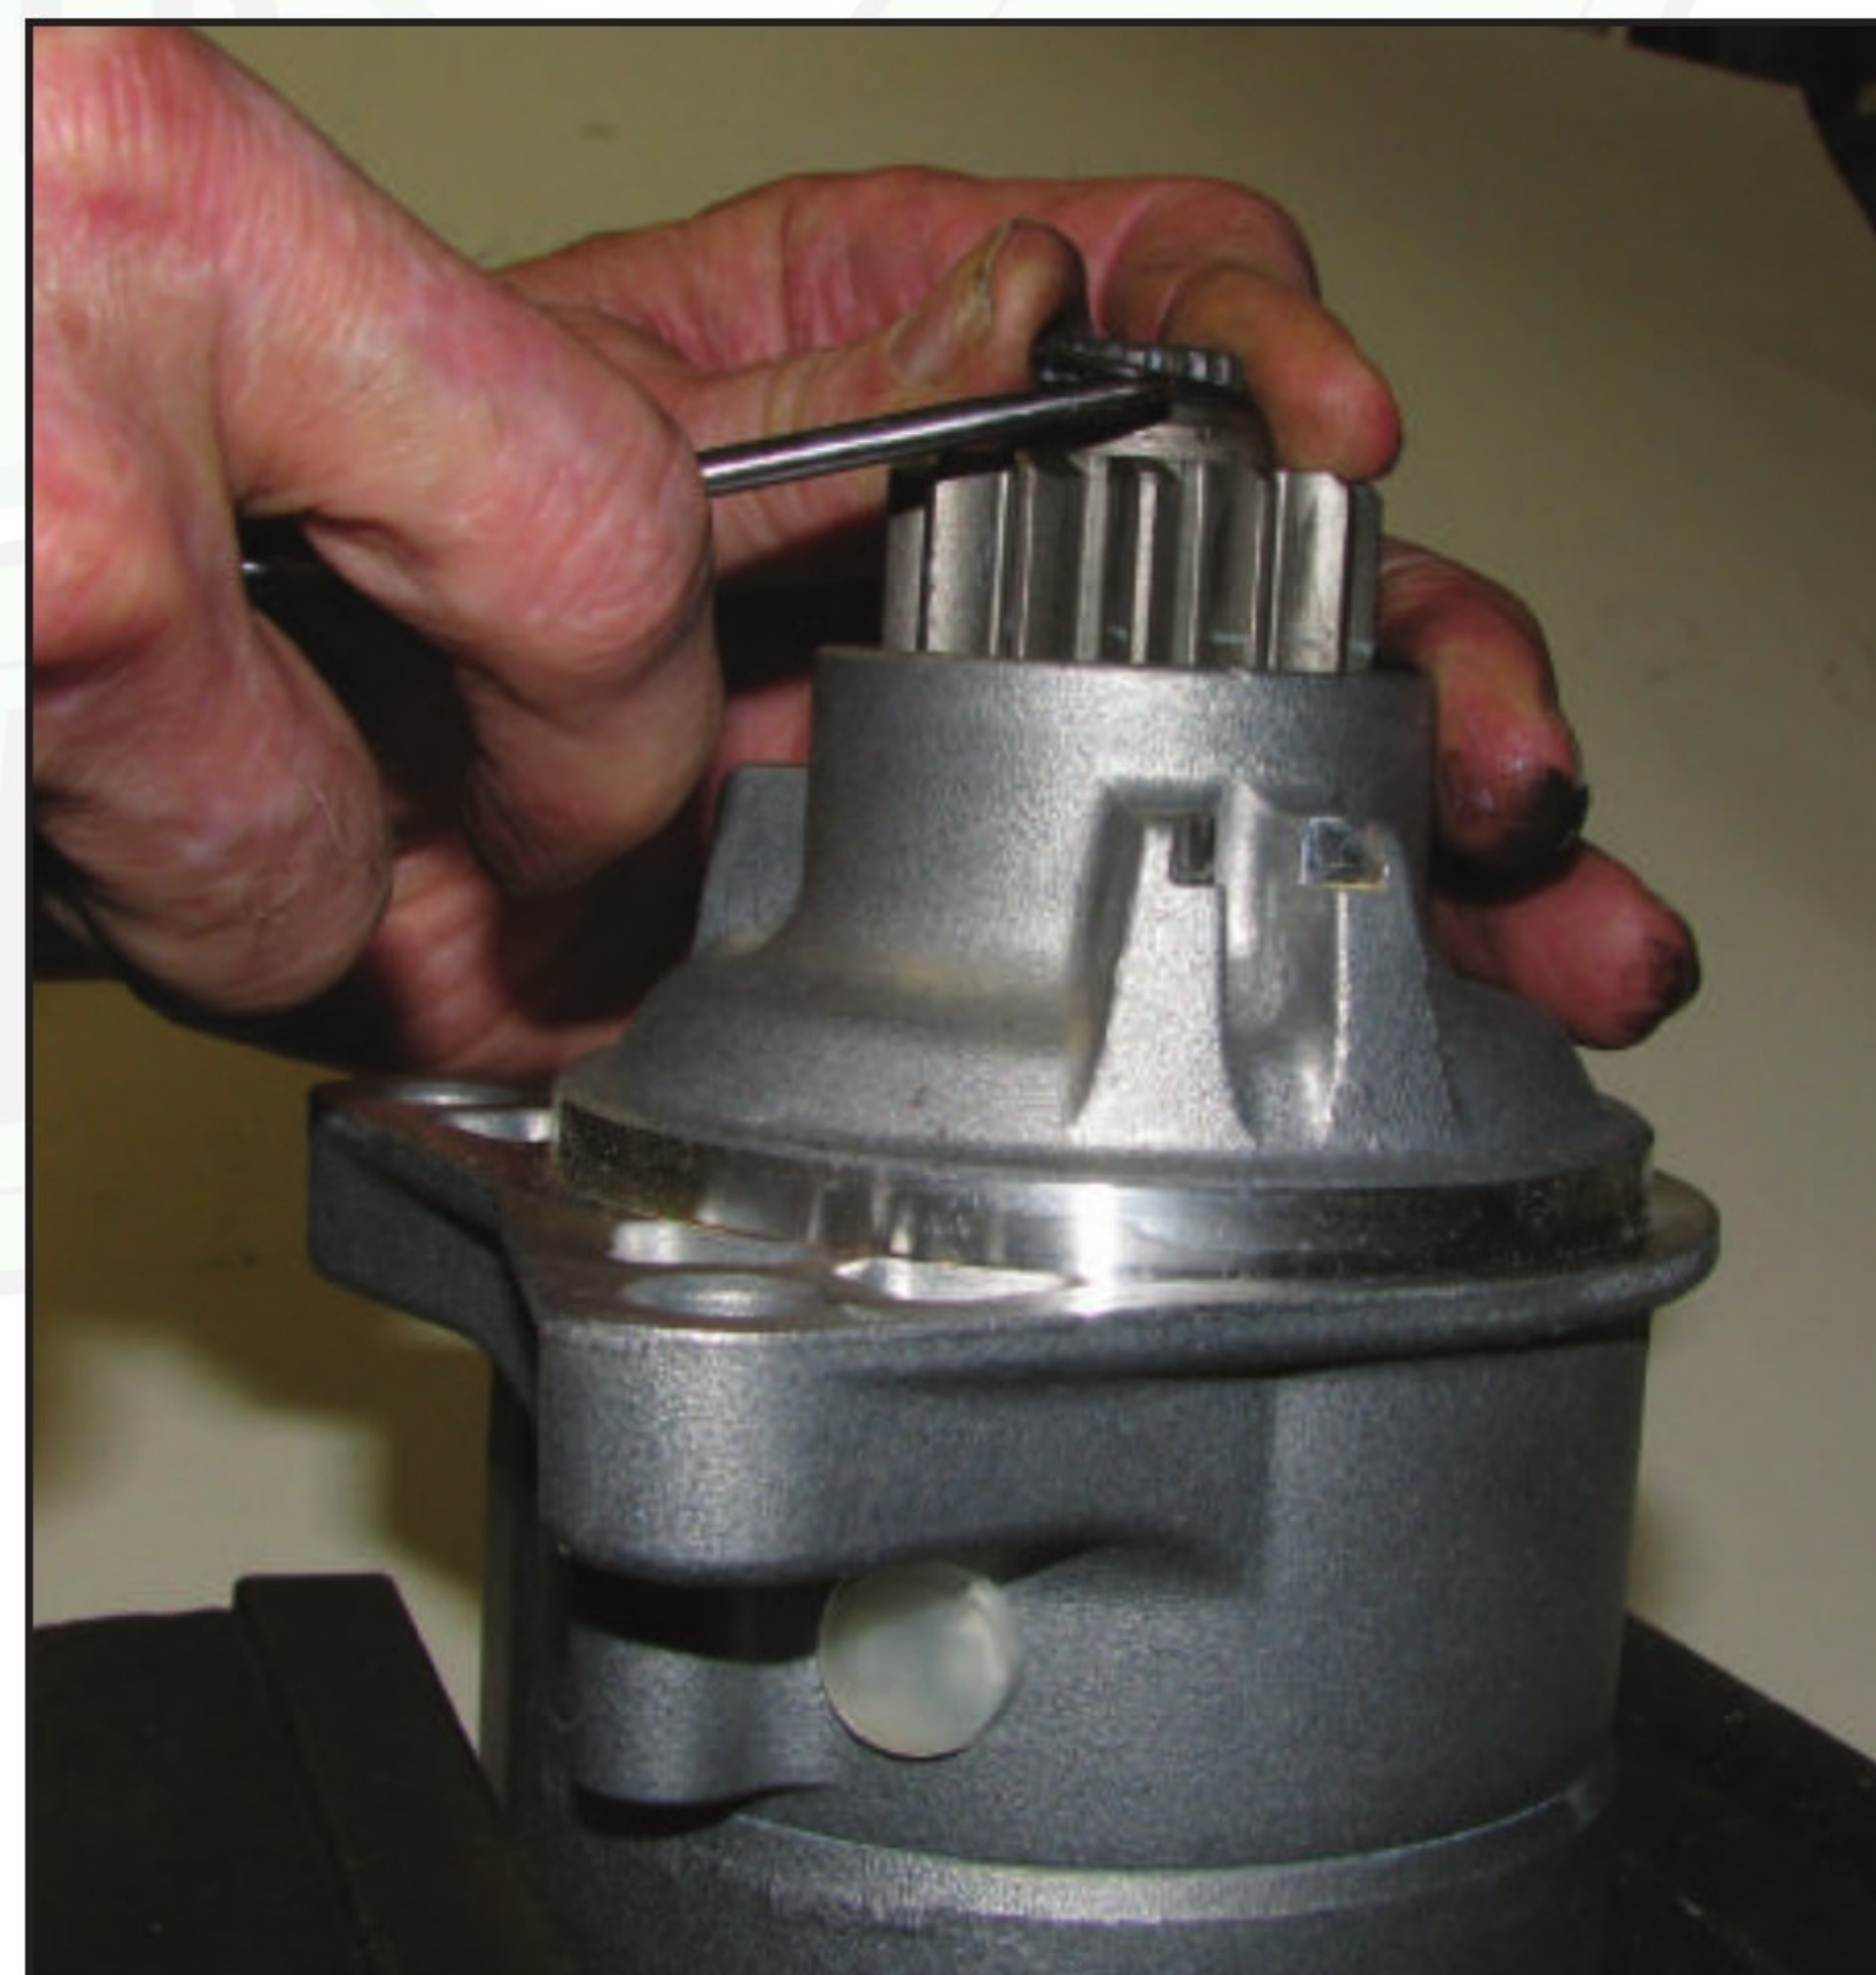
Figure 14 – Snap ring removal is not difficult once the shaft is held extended by a pin punch.

The pinion gear must be removed next. I used a 1/4-inch pin punch, carefully placed through the needle bearing to push the drive shaft to the extended position. It can be held that way by clamping the housing in a vise with the punch supported on the vise's screw box. This starter's snap ring is fairly easy to remove (see Figure 14). Once the pinion and indexing spring are out of the way, remove the two small bolts that are holding the drive end housing to the solenoid housing (see Figure 15) and separate the two housings. That will expose the plunger and shift lever (see Figure 16).

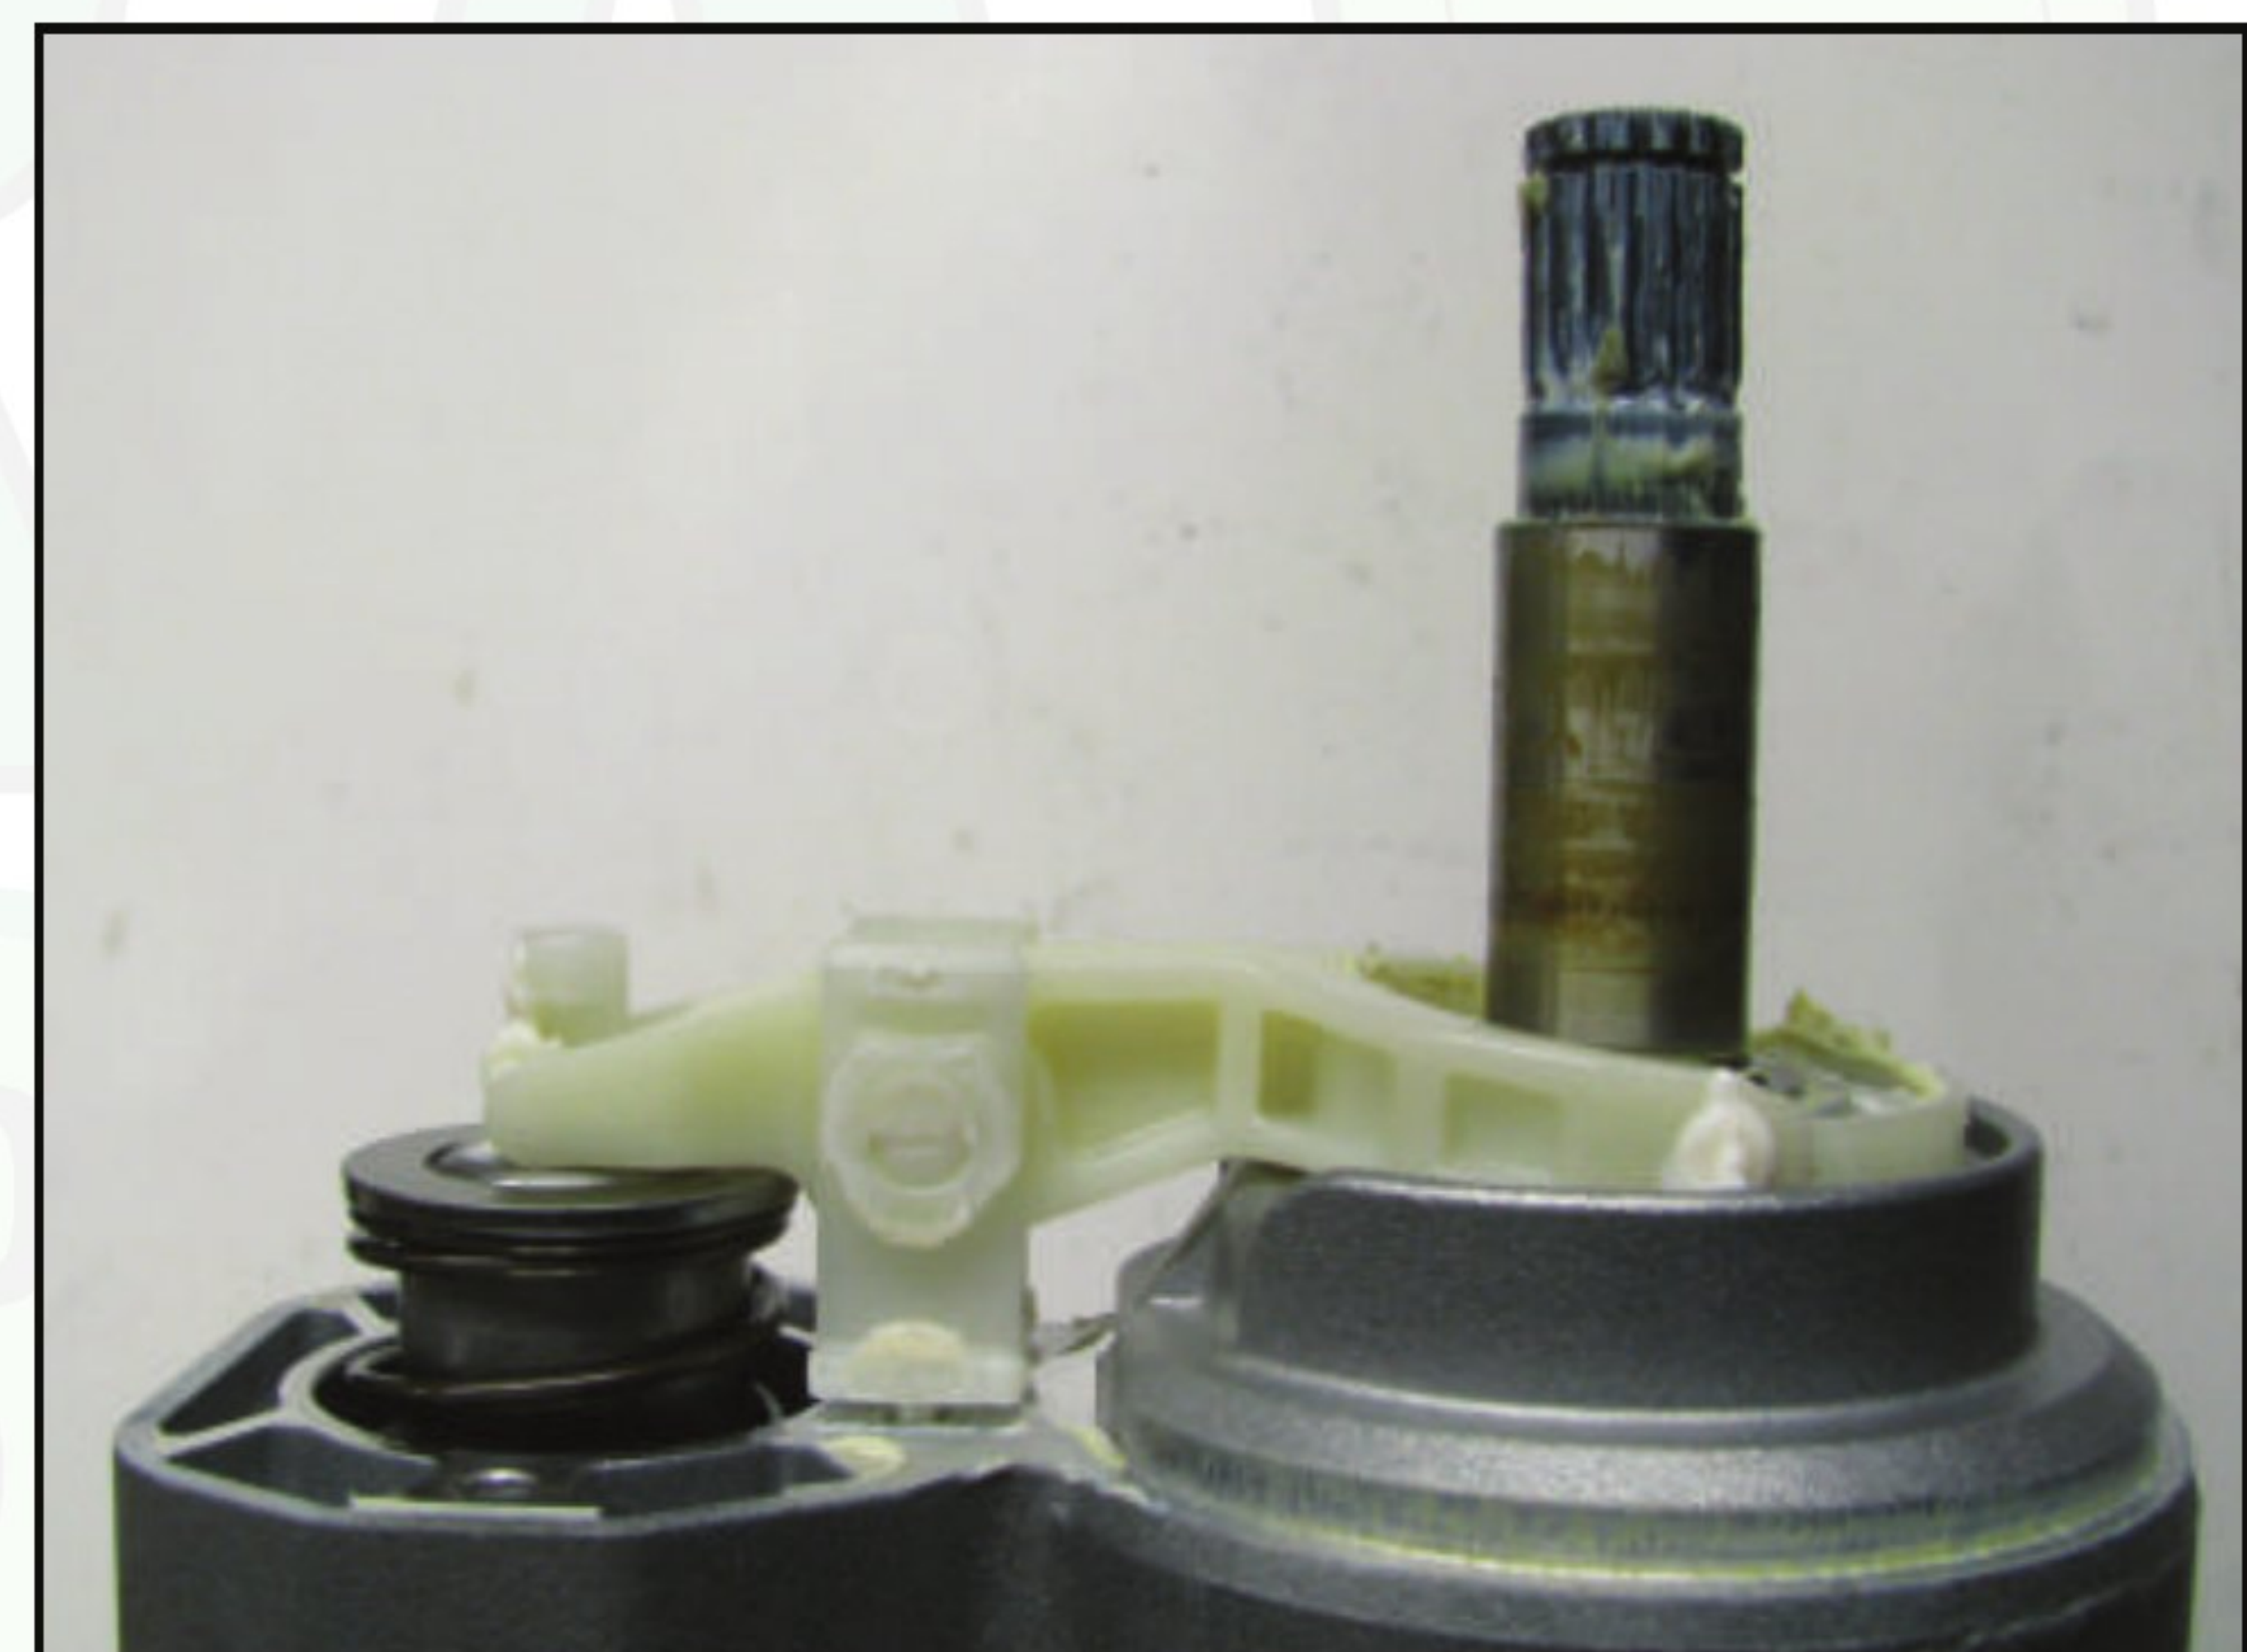
Figure 16 – View of plunger, shift lever and pinion shaft once the DE housing has been removed.

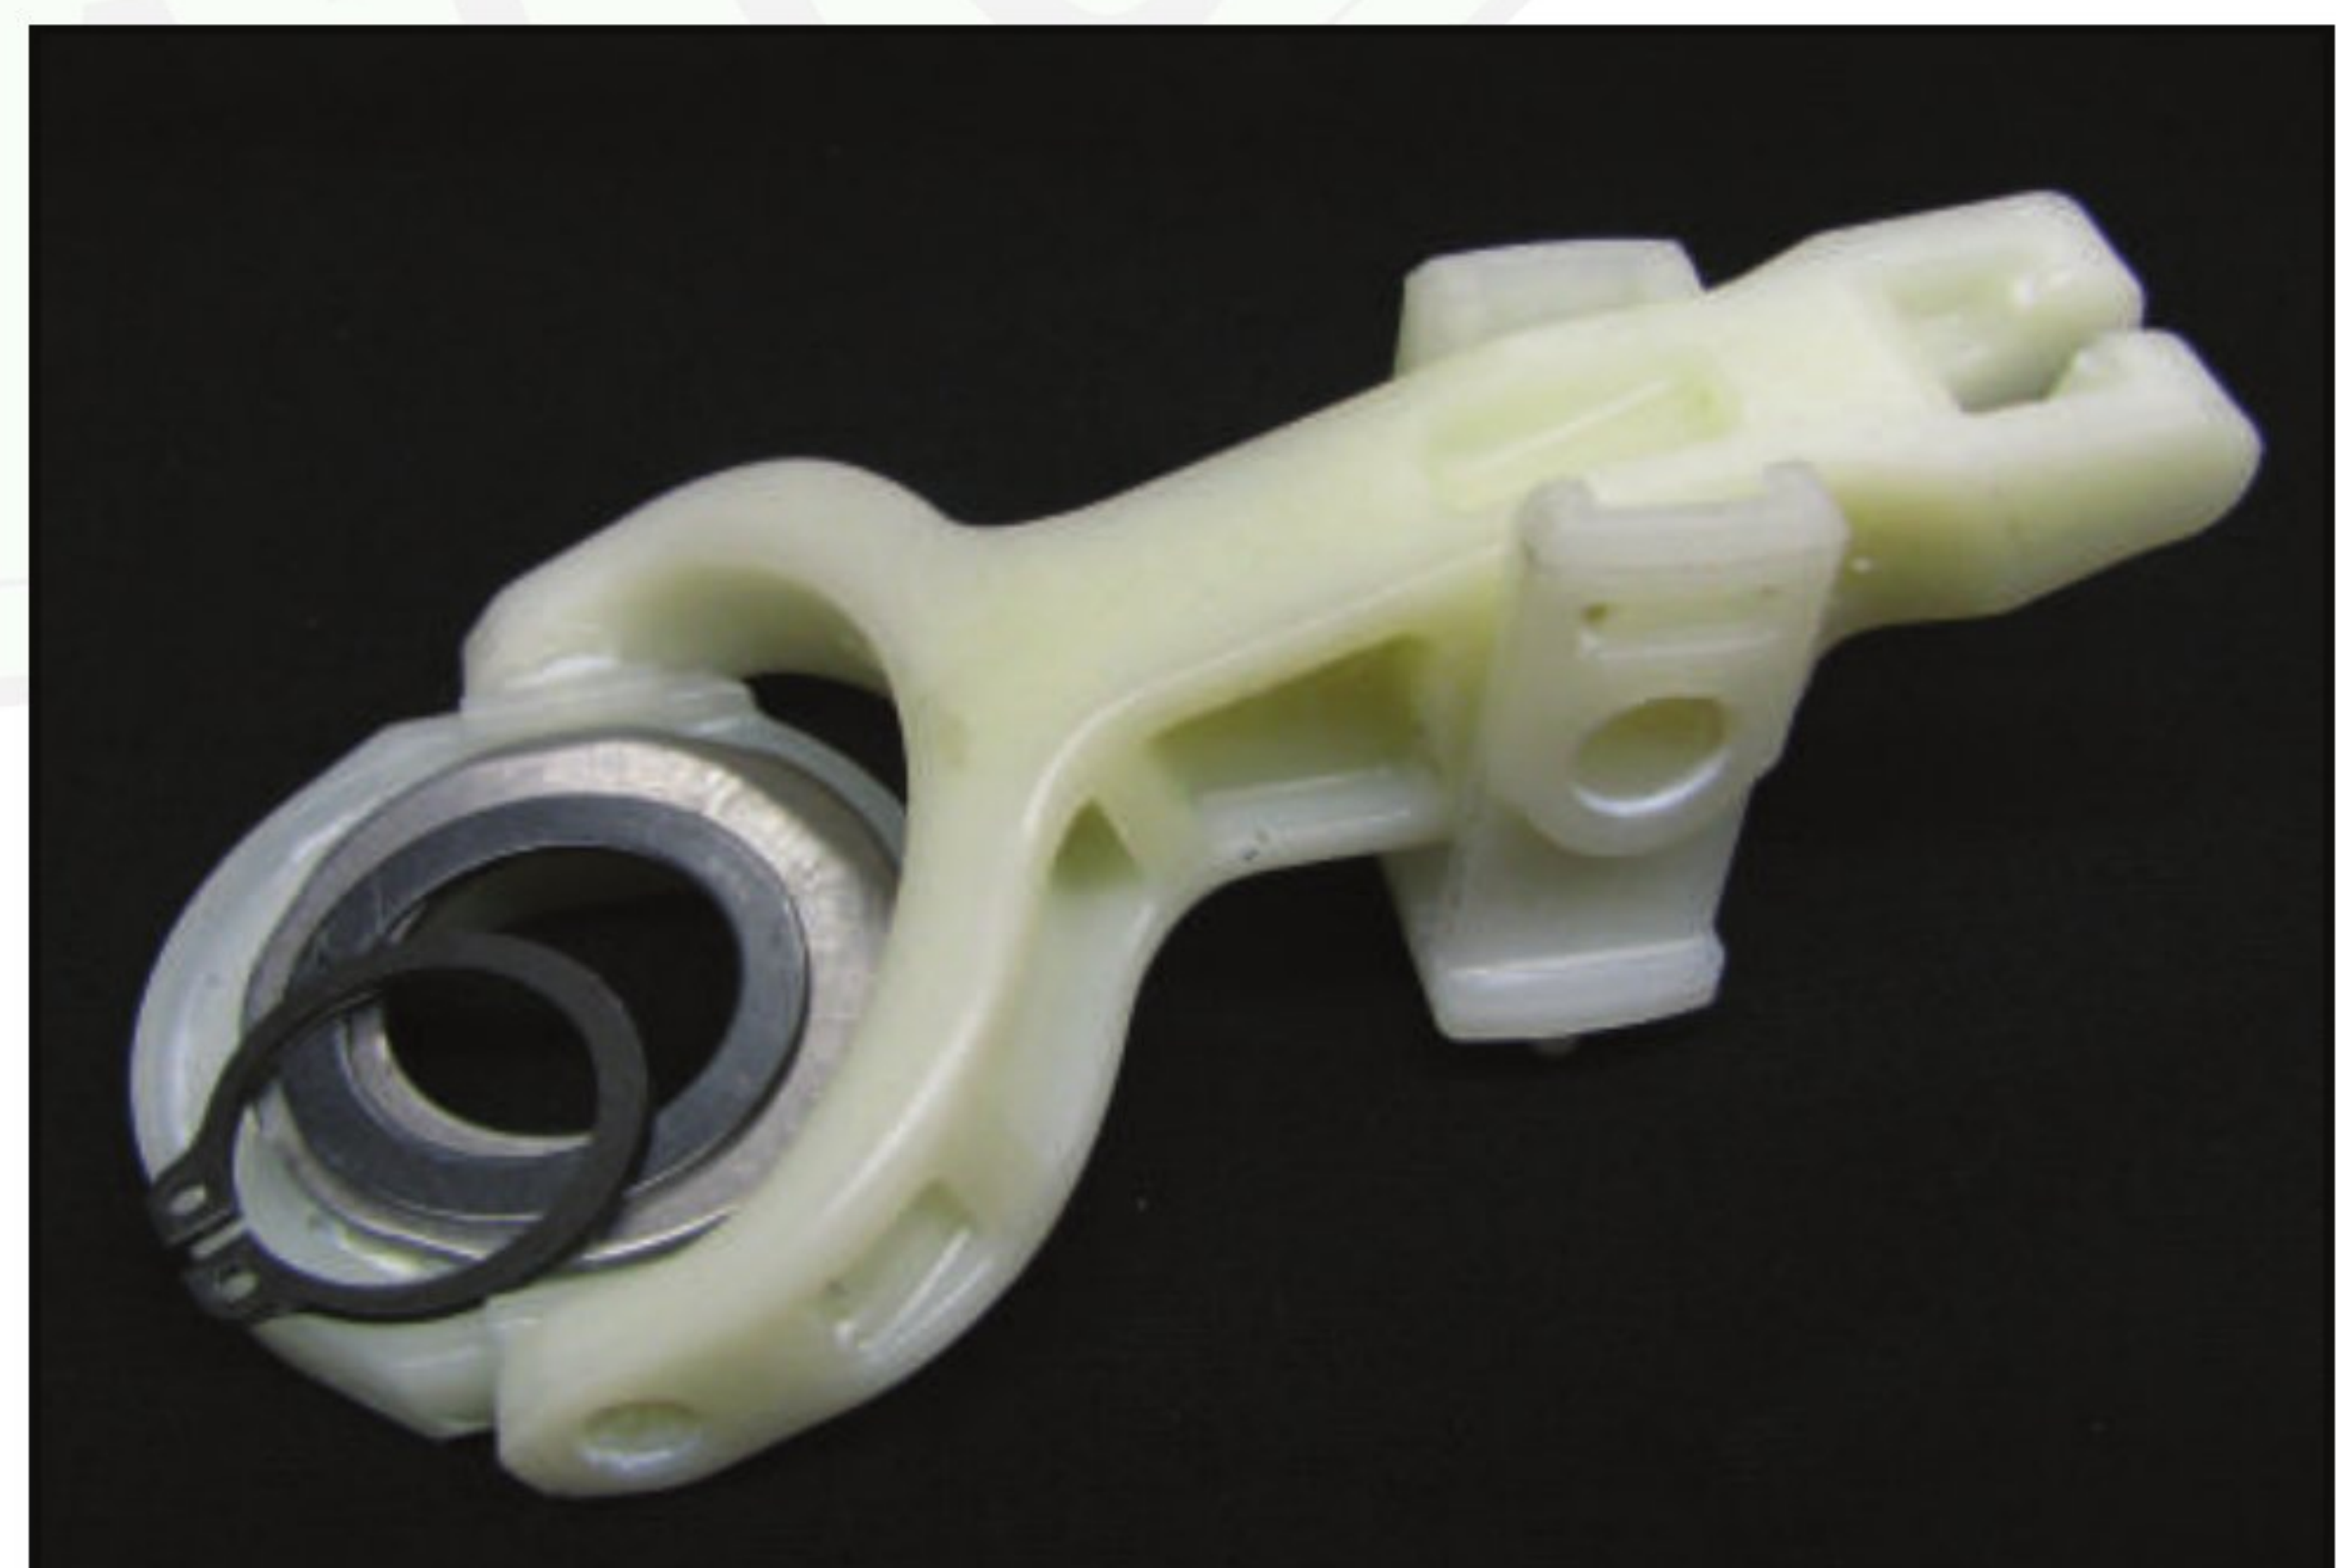
Figure 17 – A close view of the shift lever with washers and retaining ring shown in correct order.

You will need snap ring pliers to get the shift lever off the drive shaft. Once the shaft's retaining ring has been removed, the drive assembly will probably fall out. Be ready for that. Note that two steel washers rest below the retaining ring that holds the shift lever on the shaft. (see Figure 17). This drive clutch itself is nearly identical to the older OSGR drive clutches. The shaft and inner clutch race are two pieces that easily fall apart once they are out of the clutch. Simply rotate the shaft clockwise and pull it to remove the shaft and race from the clutch (see Figure 18 and 19). If you rebuild this clutch, you should use a synthetic drive clutch grease similar to that used by Denso. It is available from Vensel Enterprises in small tubes under their part number P209-0033-OZ.

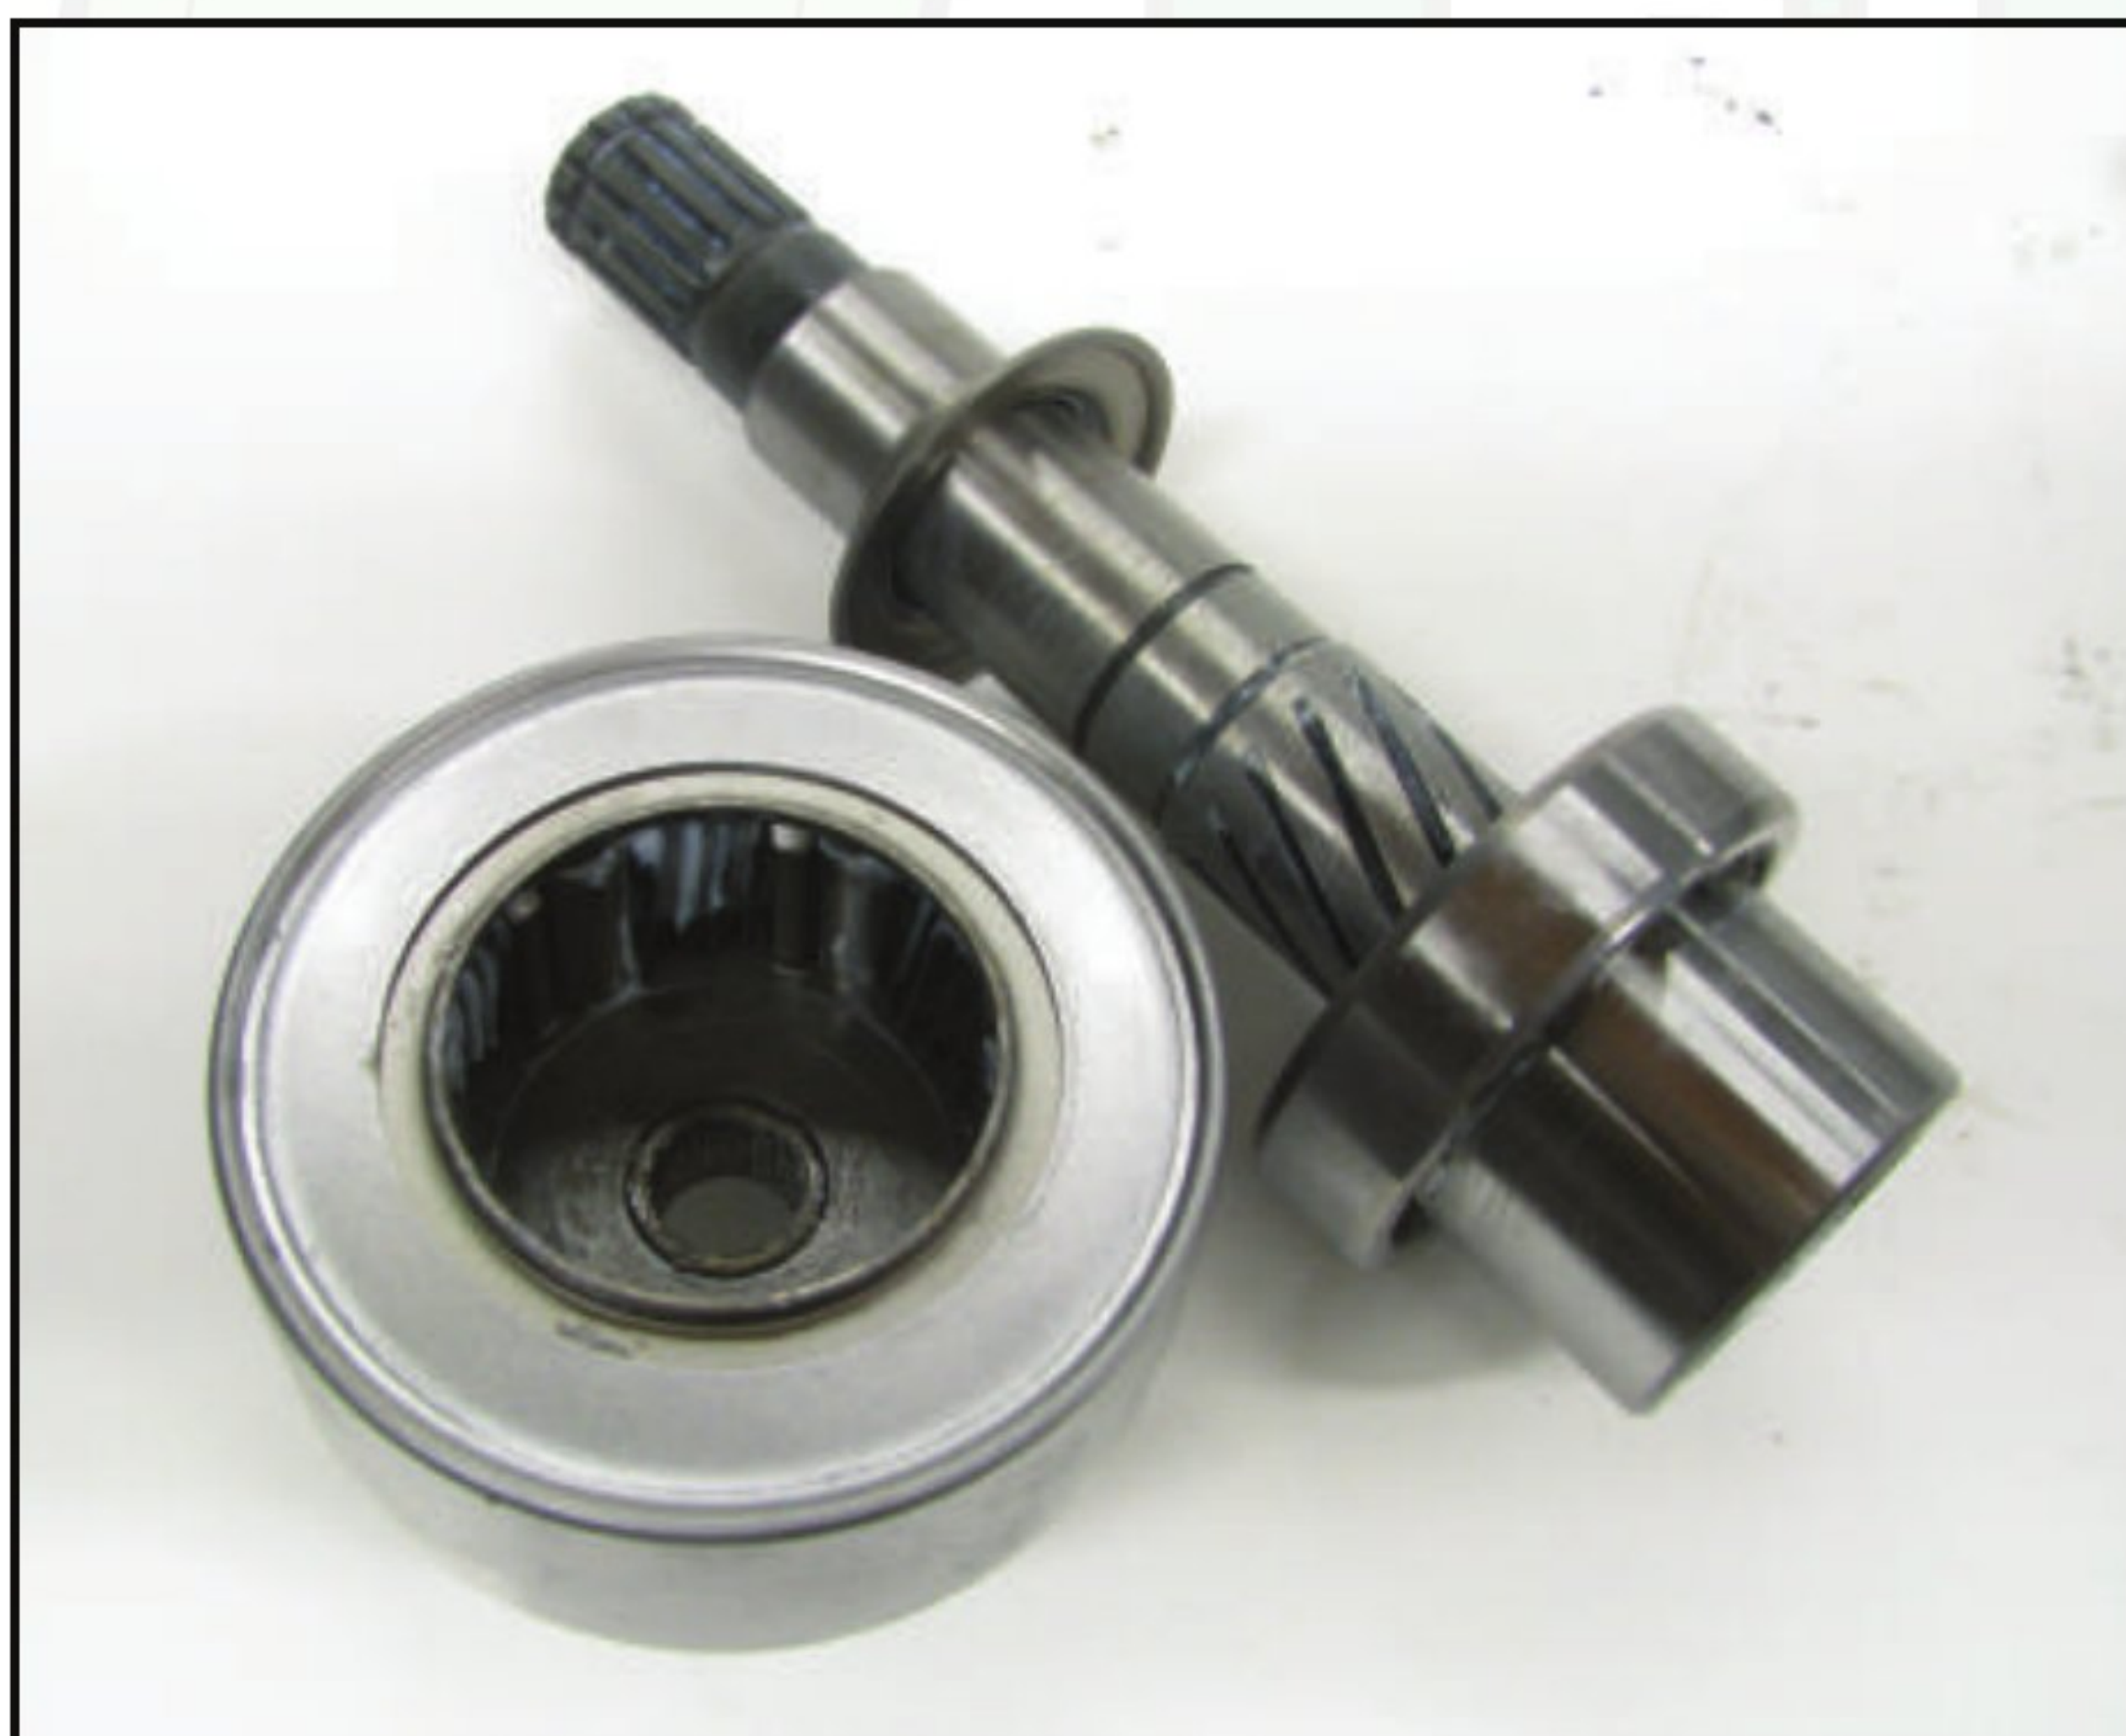
Figure 18 – View of the roller clutch, inner race and shaft.

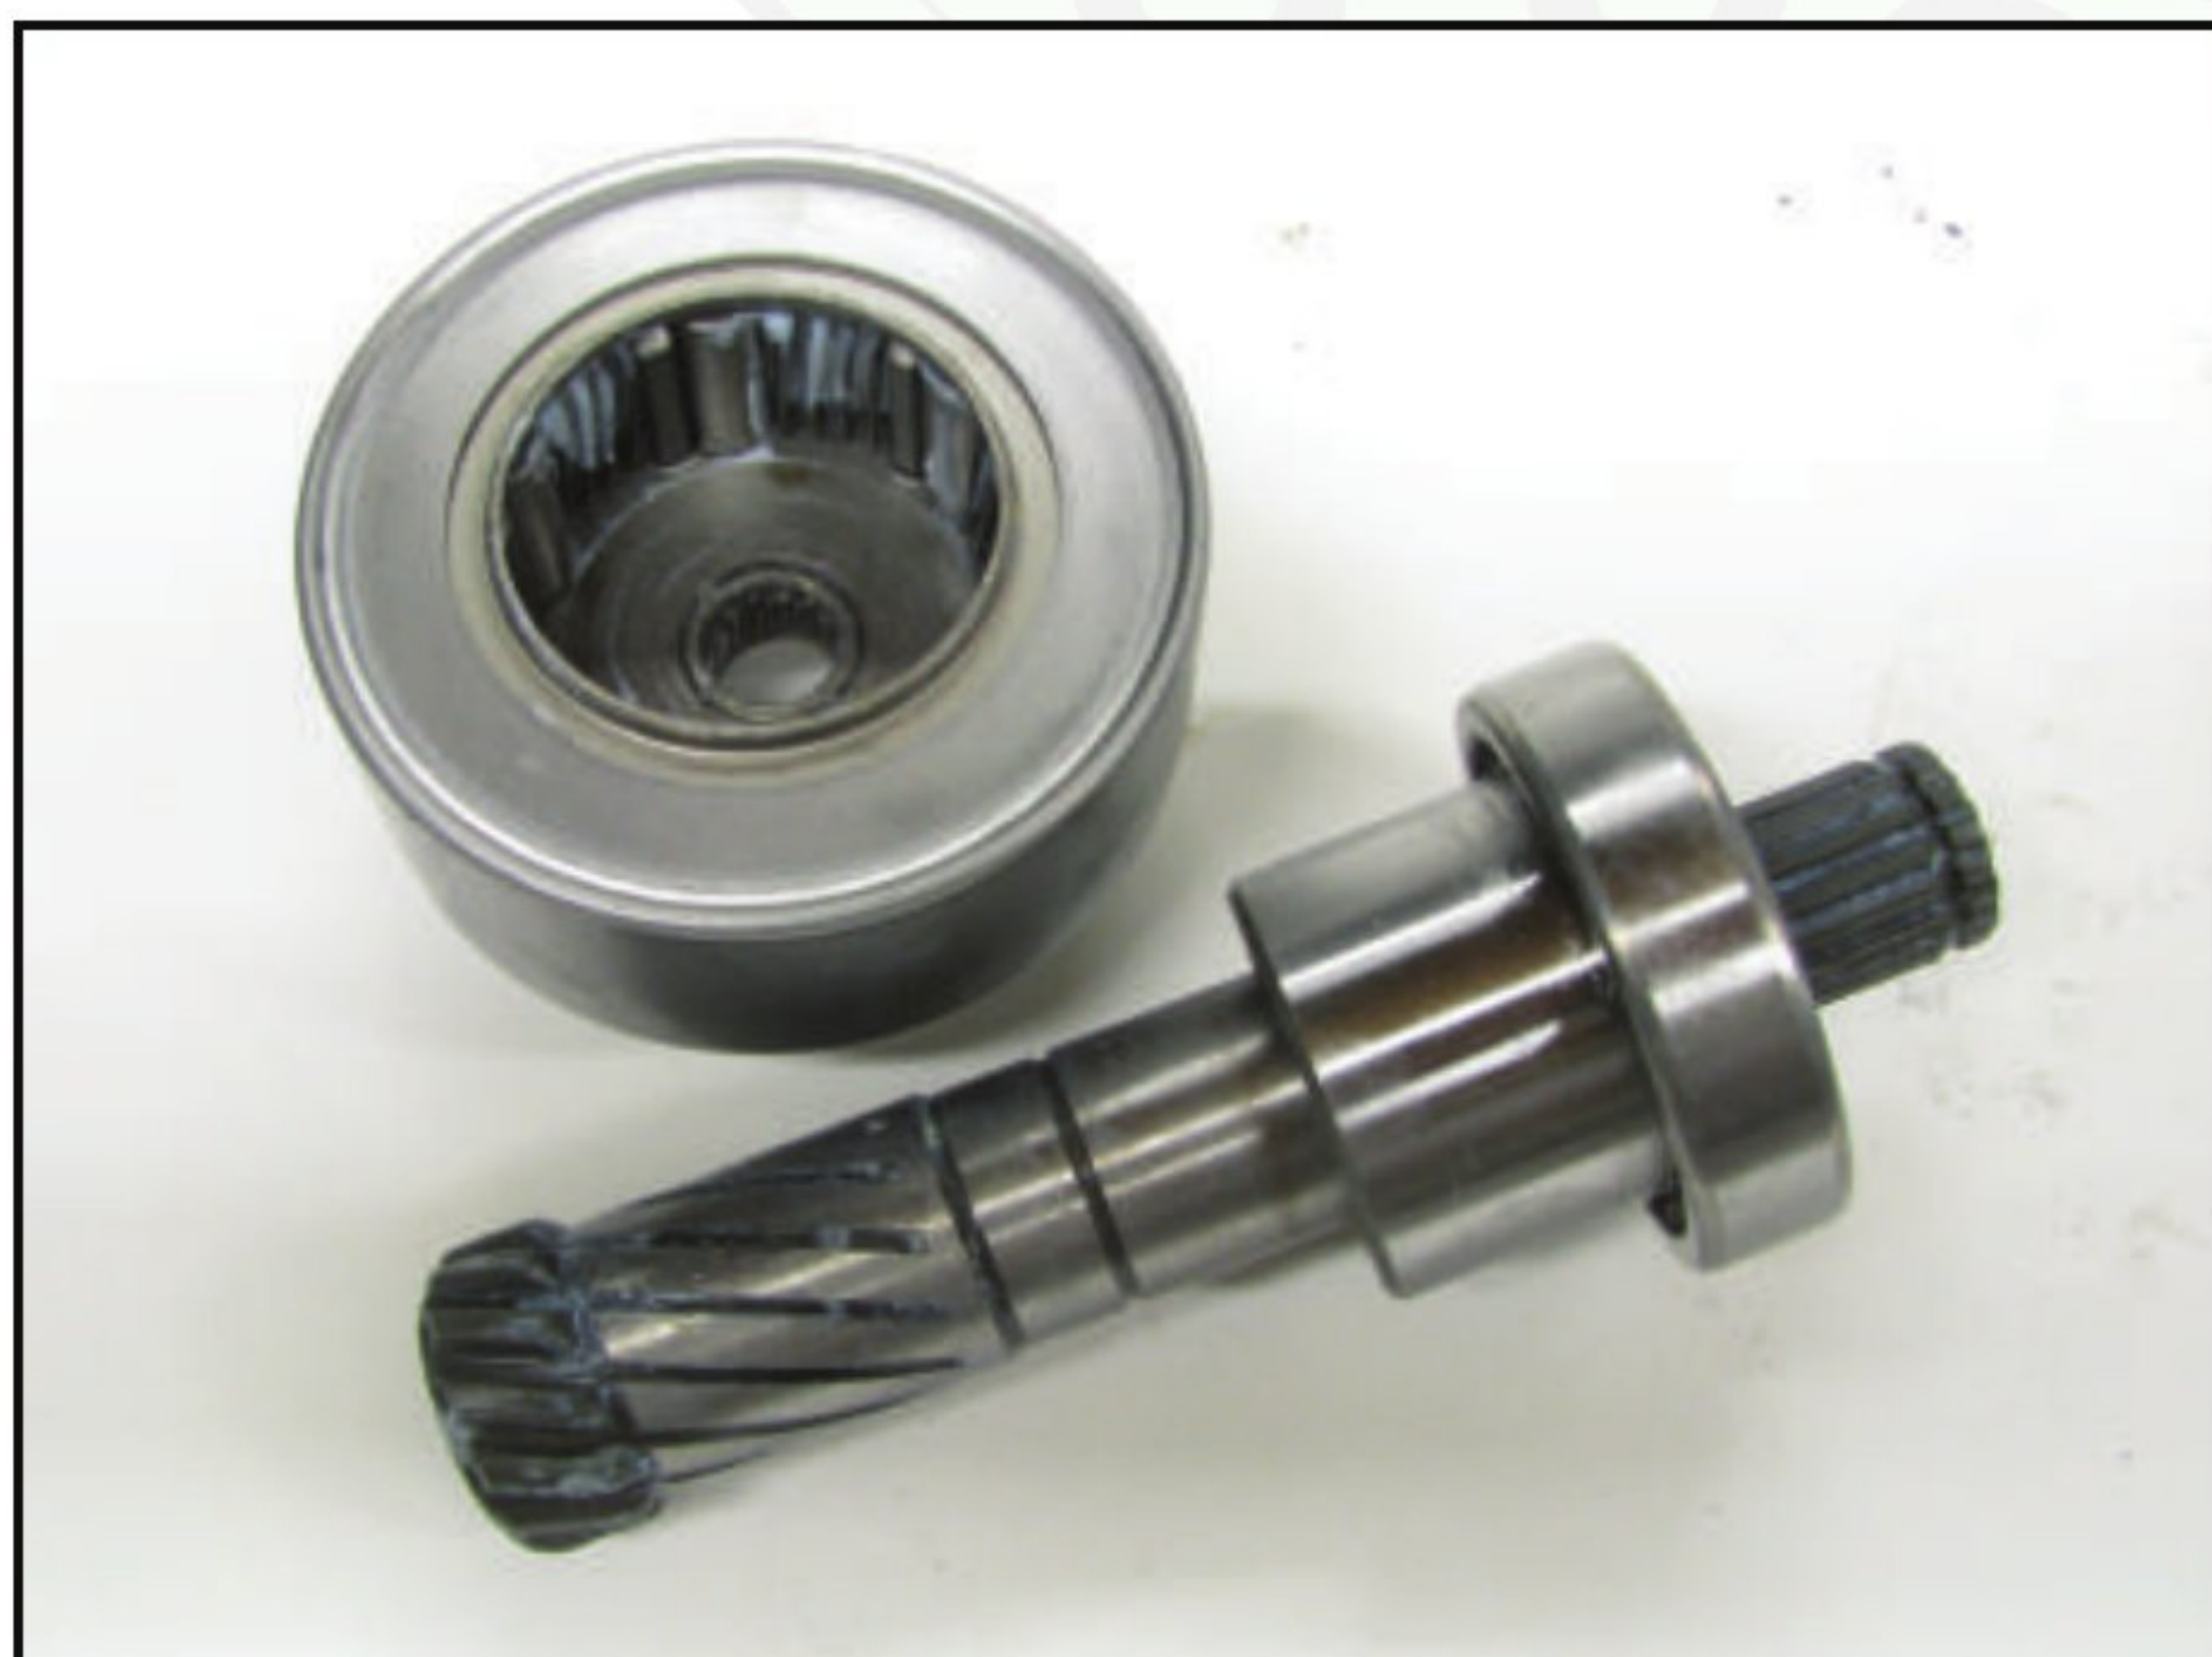
Figure 19 – The clutch's rollers and springs are similar to those on OSGR Denso starters.
