# DENSO PA90S STARTER — Completely Different But Strangely Familiar

BY BOB THOMAS

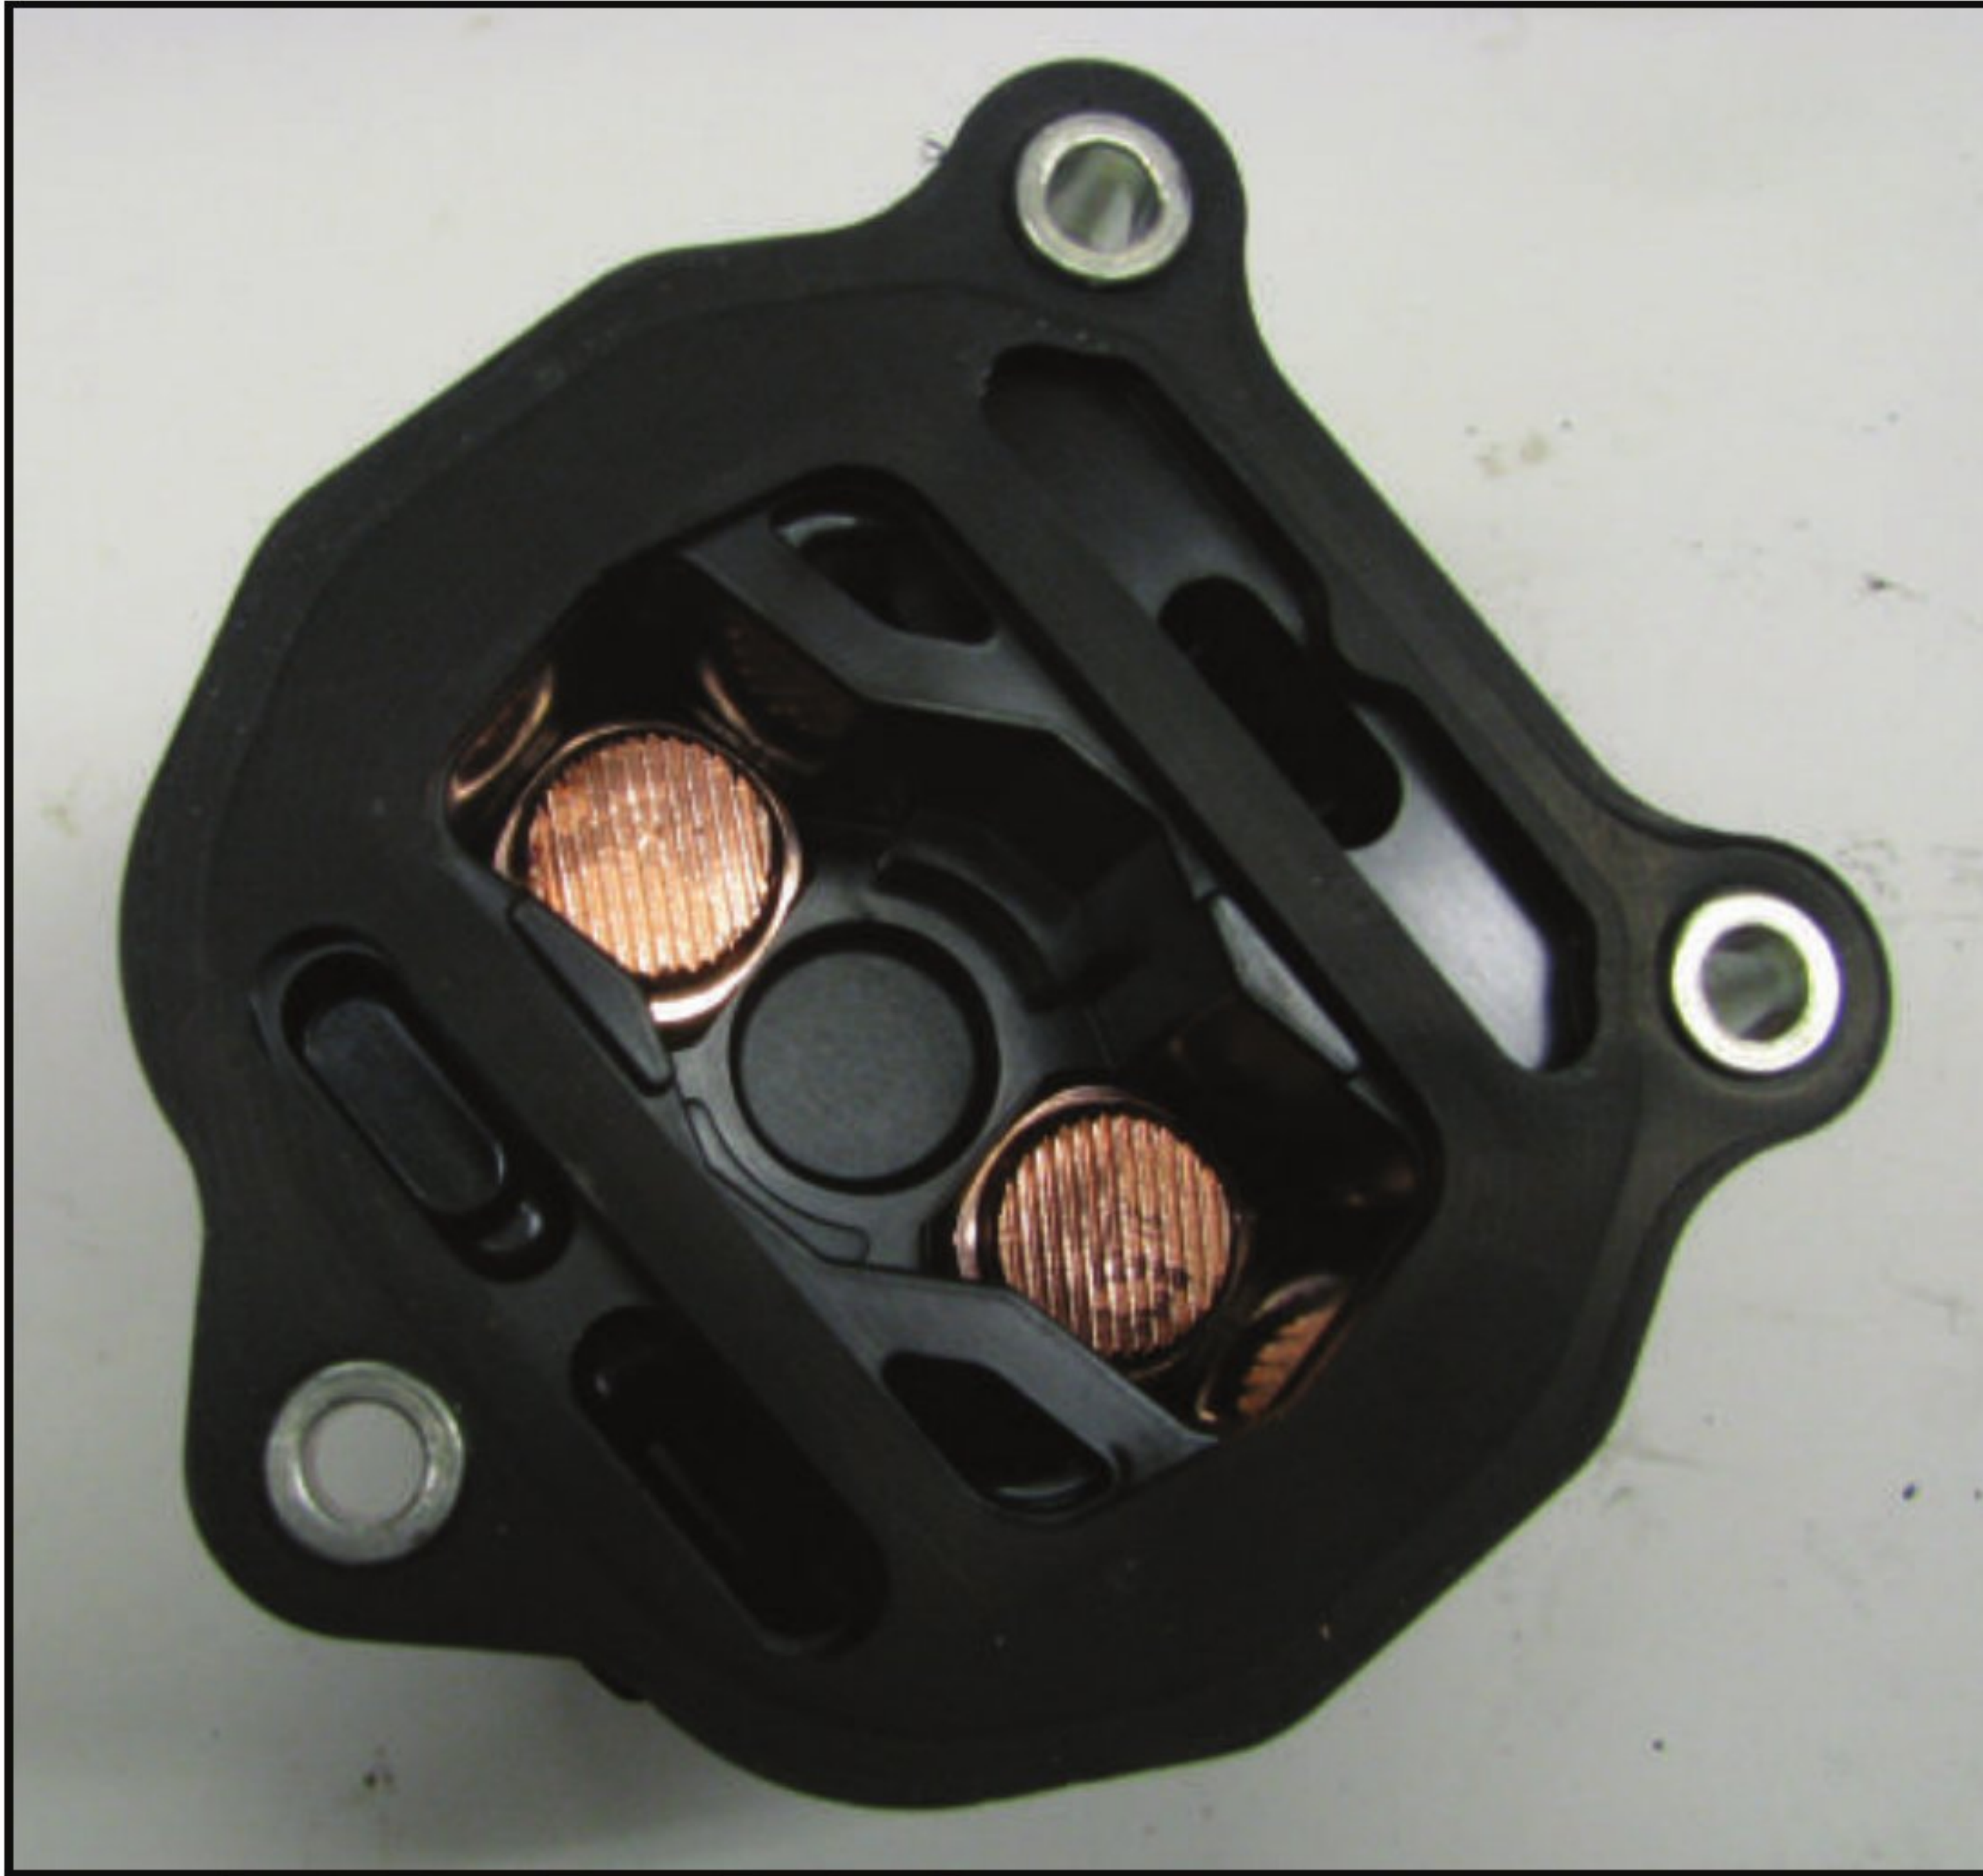
Figure 22 – A view looking inside the solenoid cap.

With the cap off, you can inspect the contacts (see Figures 22 and 23). As you can see, the moving contact was not designed to be serviceable. It is permanently affixed to the shaft end of the plunger. I suspect that the aftermarket will come up with a plunger kit with a detachable moving contact. Otherwise, the entire solenoid case would have to be replaced over a worn moving contact. Denso's parts list shows the loaded solenoid case as one part with no further breakdown. You can see that the plunger has a plastic pin that pulls the plastic shift lever (see Figure 24). Replacing a PA90S solenoid coil will be a little more difficult than on OSGR units because they are staked in four places (see Figure 25).

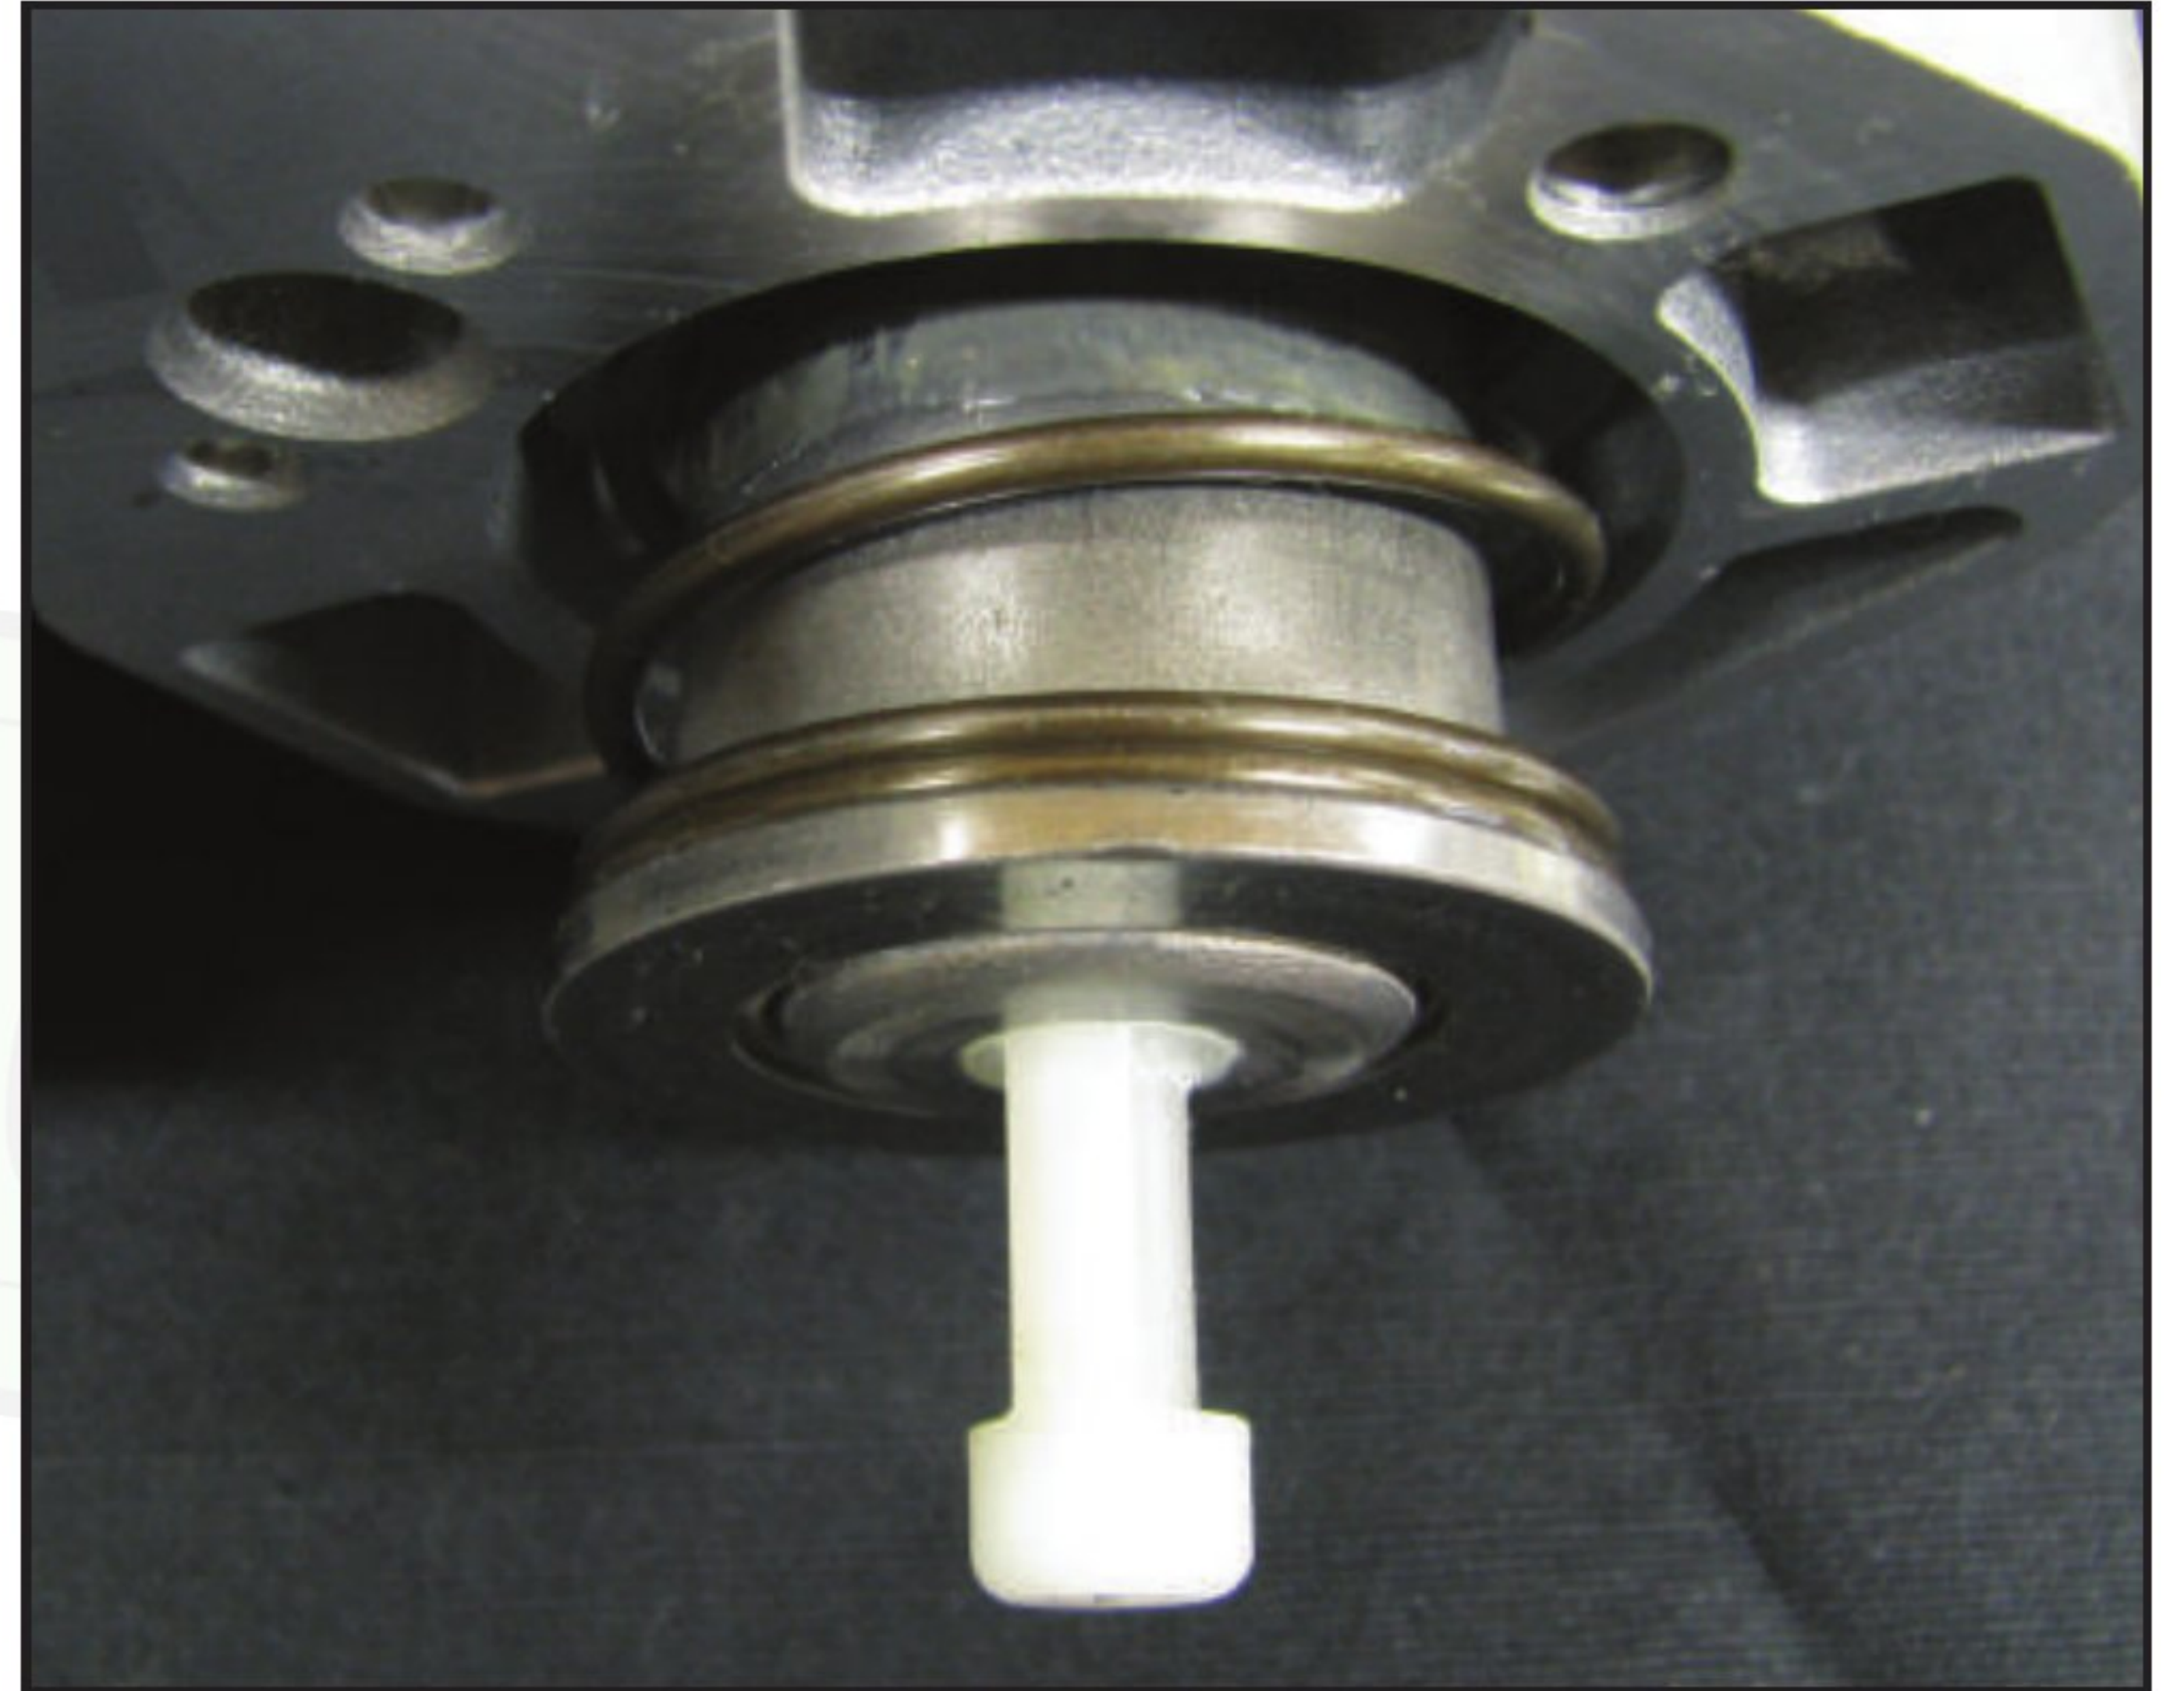
Figure 24 – PA90S plunger in its at rest position.

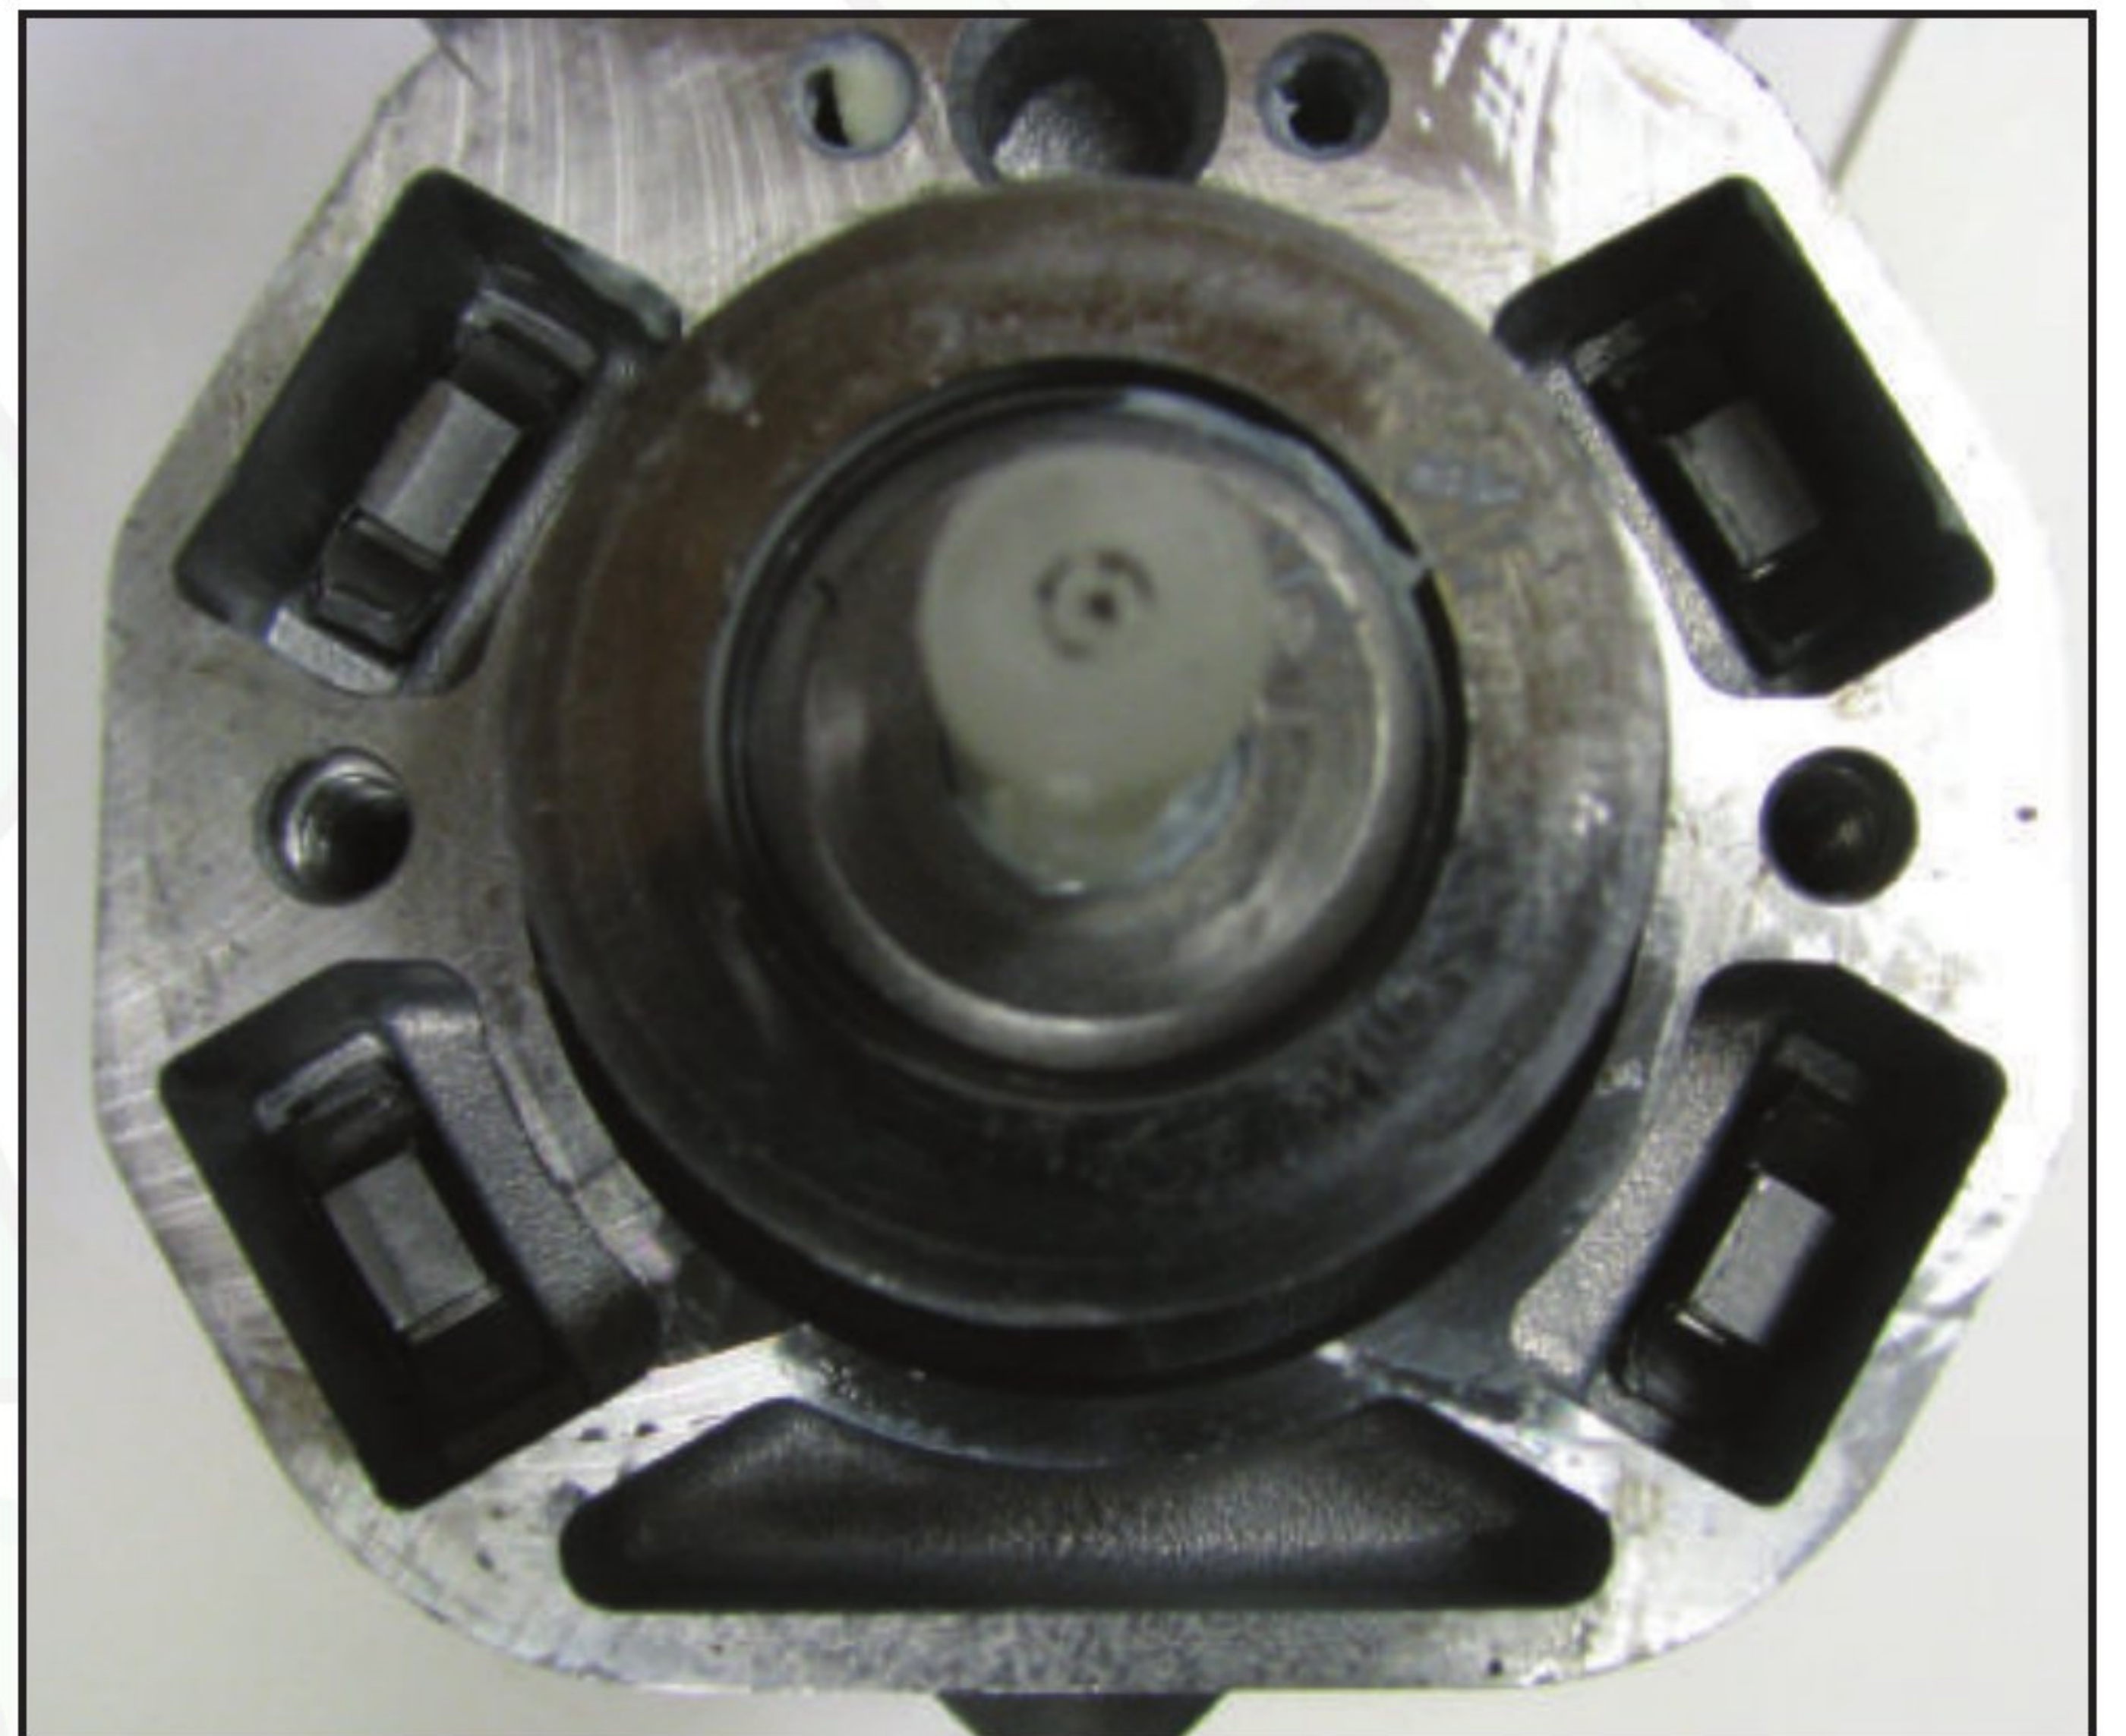
Figure 25 – PA90S solenoid coils are staked in four places for improved reliability.
