## Ford PMGR Update

However, Ford has made so many changes to these starters that we need another one to update you on the most recent developments.

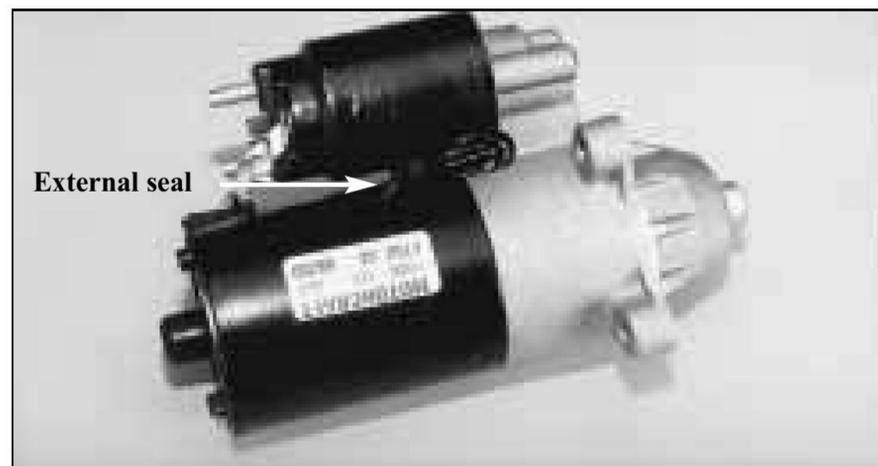
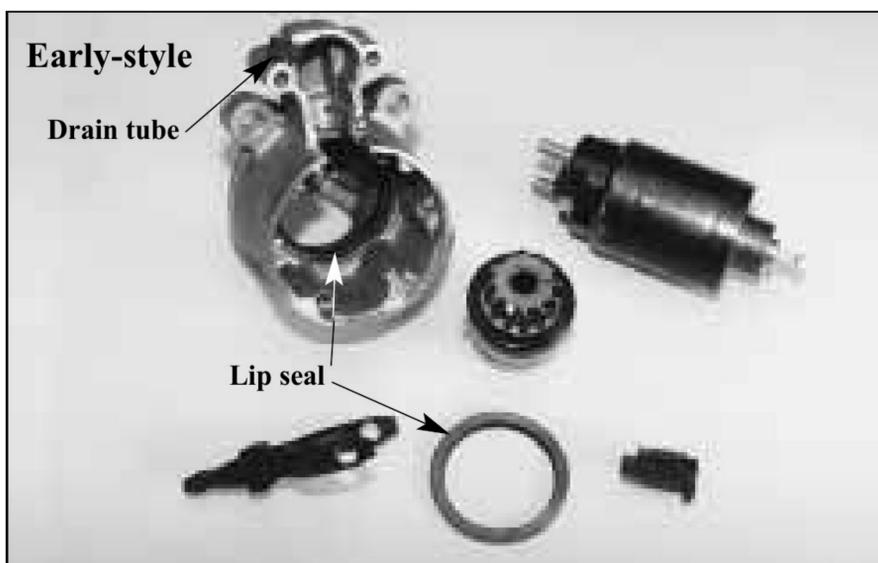
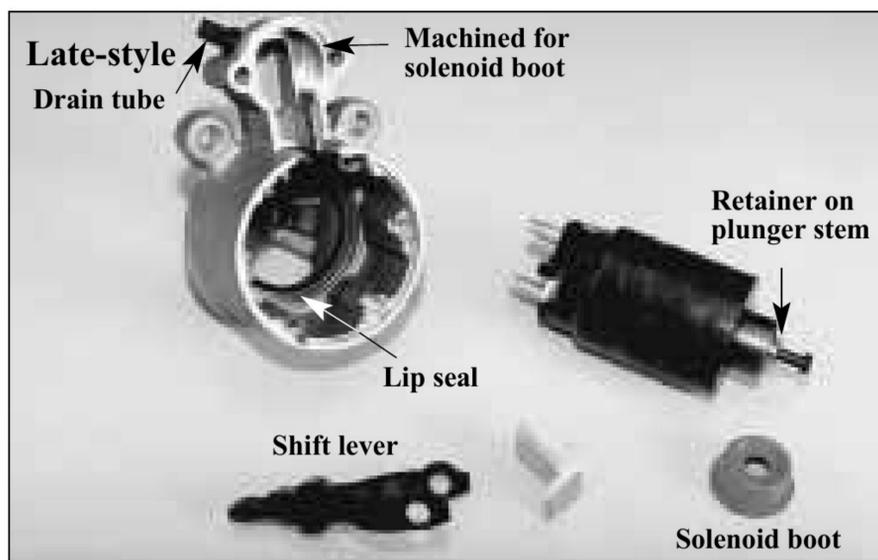
**Figure 1. Top:** To prevent moisture from entering the solenoid, Ford added an external silicone seal. **Middle:** The early-style lip seal. **Bottom:** The latest configuration, using a boot on the solenoid, a retainer on the plunger stem and different shift lever, in addition to the lip seal.

As we discussed on page 2 of *Technical Update 13*, Ford PMGR starters used on 1992 and 1993 Lincoln, Ford and Mercury with 4.6 L V8 engines had a problem with moisture entering the solenoid area.\* Because moisture in the solenoid has continued to be a problem, Ford has made several changes to try to remedy it, as follows:

1. Further modifications to the D.E. frame
2. New solenoid shift-lever seal
3. Boot added to the solenoid plunger.

To allow for the boot on the plunger, Ford made several changes to the starter. First, they moved the drain tube inward away from the machined edge of the D.E. frame and machined the solenoid-attaching area to accommodate the boot. In addition, they needed to add a retainer on the plunger stem so that this area would also be sealed. Now they are using this plunger with the retainer in all their solenoids, even if the solenoids don't have the boot. However, because this retainer interferes with the early shift lever, Ford has introduced a new shift lever, which can also replace the early-style shift lever (*Figure 1*).

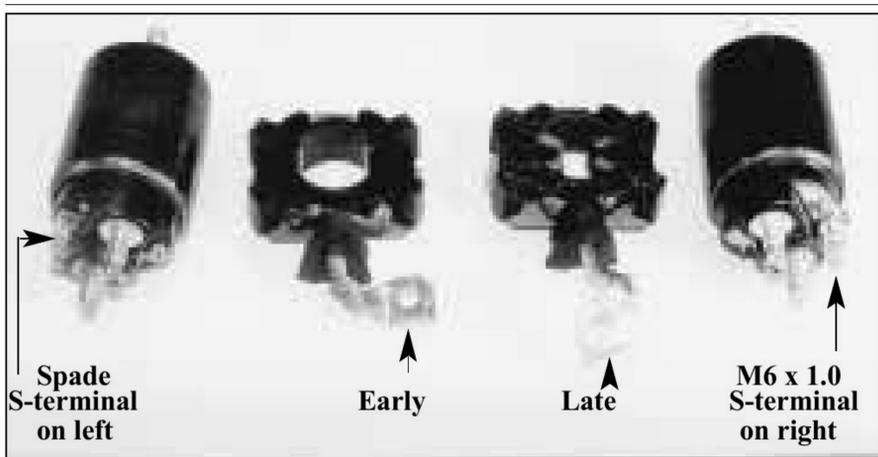
**Figure 2.** Left: Early solenoid with spade S-terminal and early brush holder. Right: Later solenoid with M6 x 1.0 S-terminal and late-style brush holder. Note change in position of flag on brush holder leads.

Ford PMGR starters initially used a solenoid with a spade-type S-terminal. This spade terminal was on the left side of the solenoid, with the motor terminal at the bottom. This configuration allowed the motor lead on the brush holder to bolt onto the solenoid's motor terminal without interfering with the S-terminal (Figure 2).

Then in 1995 Ford introduced a number of starters that use a solenoid with an M6 x 1.0 S-terminal located on the right side. This design is used on applications that have the vehicle wiring coming in on that side. However, because of the position of this S-terminal, Ford also had to put a different flag on the brush holder's motor lead, so the lead could bolt on without interfering with the S-terminal. In Figure 2, note where the flag is attached to the motor lead. This brush holder, using the late-design motor-lead configuration, can replace the early-style brush holder, as well.

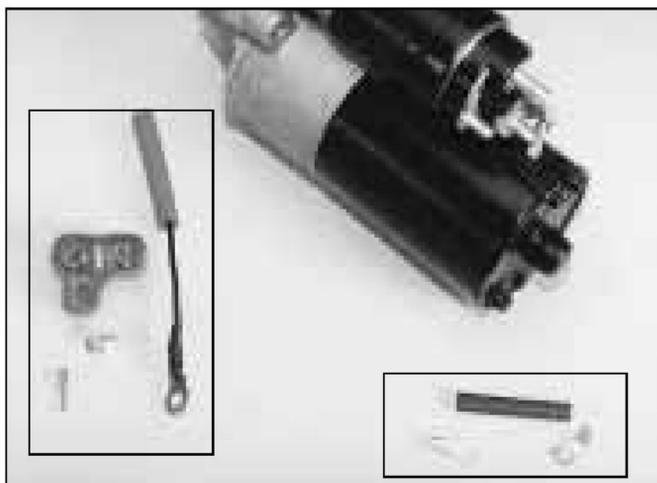
**Figure 3.** Ford conversion kit is on the left. WAI kit is on the right.

Because of this tendency for the spade-type S-terminal to corrode, Ford developed a terminal-conversion kit that they provide with retrofit units. This kit allows the installer to convert the wiring of the vehicle from a spade-type to an eyelet-type S-terminal. The part number for the kit is WT-5673-B or F6VY-14A411-AA (Figure 3).

WAI also offers a conversion kit (79-2503), which gives the installer two options: They can convert the wiring on these units to the stud-type terminal or bolt on an angle male-spade terminal to the M6 x1.0 S-terminal, and use the original female spade connector. However, in our opinion, if the installer continues to use the spade connector, rebuilders will see a higher rate of returns (Figure 3).

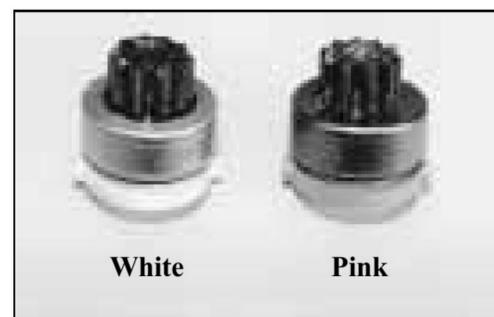
**Figure 4.** 10-tooth drive on the left, with white plastic ring, is not interchangeable with 10-tooth drive on the right, with pink plastic ring.

The most popular drive for Ford PMGR starters has 10 teeth, a white plastic ring and a gear OD of 28mm (54-212). But be careful! The 1995-1997 Contours and Mystiques with a 4-cylinder, 2 L engine also use a 10-tooth drive (54-216) -- but the gear OD on this drive is only 27mm and the plastic ring is pink. If the wrong drive is installed, this one-millimeter difference will cause the starter to either be very noisy or to not crank at all (Figure 4).

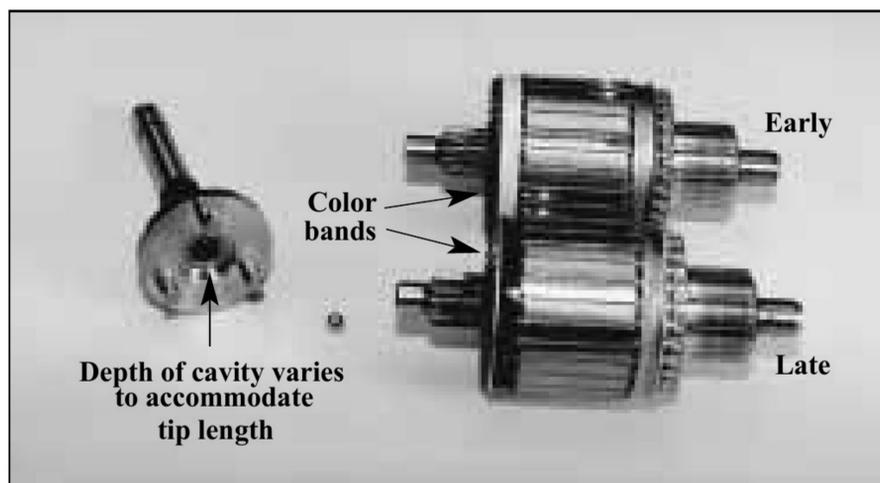
Figure 5. The tip of the later armature is 2mm shorter than the tip of the early one.

Ford made a running change in the armature shaft used in PMGR starters. The tip of the armature has been shortened by 2mm and the depth of the bore

in the drive shaft has been decreased by 2mm to accommodate the shorter tip on the armature (Figure 5). The trick is to determine which armature and drive shaft you have. The chart below Figure 5 shows the differences between these two armatures.

<b>Armature</b>		
Short tip (new)	61-211	127mm length
Long tip (old)	61-210	129mm length
<b>Drive shaft</b>		
New drive shaft	76-2822	16mm cavity
Old drive shaft	76-2809	18mm cavity
<b>Bushing</b>		
New bushing	62-2301	8.5mm long
Old bushing	62-2300	10mm long

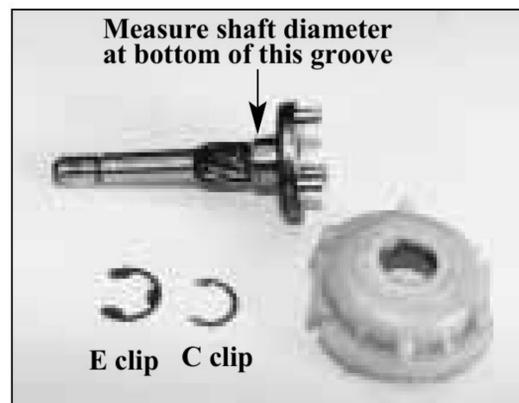
Figure 6. The E clip on left fits shafts that have a 16mm diameter, measured at the bottom of the groove. The C clip on right fits shafts that have a 17mm diameter, measured at the bottom of the groove.

You should also note that Ford changed the depth of the groove for the clip that retains the tracking gear on the drive shaft. This change is almost impossible to detect visually, but can be easily determined by measuring the diameter of the shaft at the bottom of the groove. On early versions, the diameter of the shaft, measured at the bottom of the groove, was 16mm and required an "E" clip (76-2808). The diameter of the shaft at the bottom of the groove for the later version is 17mm and requires a "C" clip (76-2819). To determine which clip you need, fabricate a simple "Go / No Go" gauge to check the shaft diameter (Figures 6 and 7).

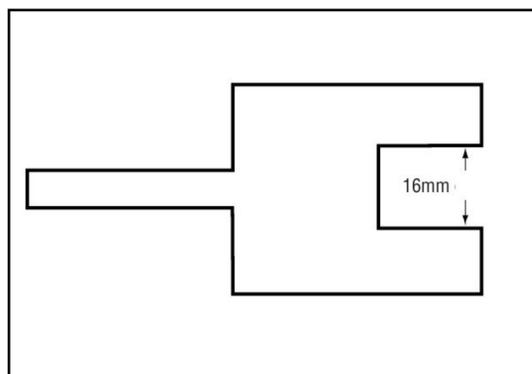
Figure 7. Make this simple Go/No Go gauge to determine whether you need an E clip or C clip.

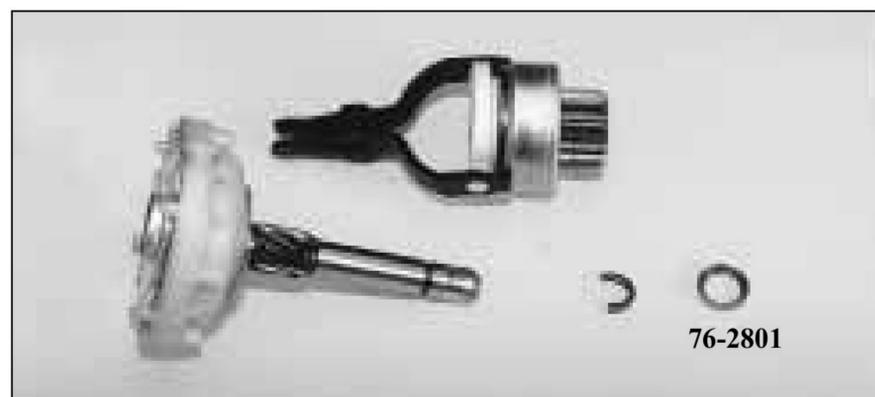
Figure 8. Stop collar on the right (76-2801) is no longer needed on Ford PMGR starters.

Ford is no longer installing the stop collar (WAI #76-2801) over the drive-retaining clip on PMGR starters. This is possible because the thrust movement

of the drive shaft is controlled by the tracking ring and the E or C retaining clip (described above). This cup was needed in non-PMGR Ford starters so the thrust of the armature shaft into the D.E. frame would not destroy the D.E. frame or dislodge the drive-retaining clip (Figure 8).

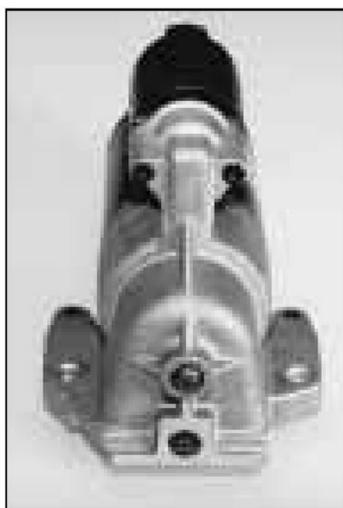
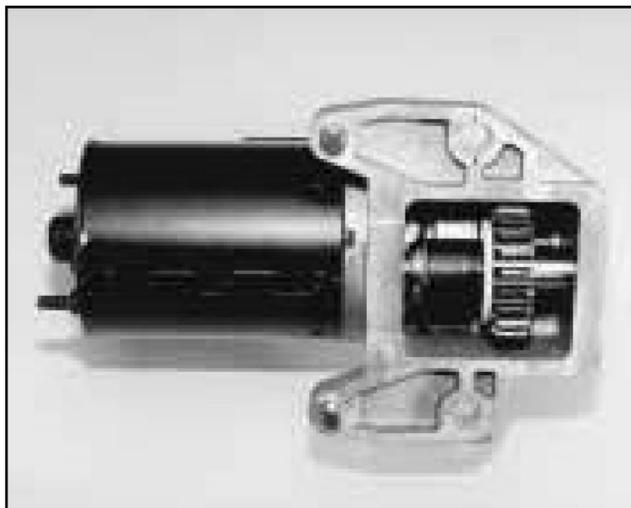
Figure 9. Side-mounted PMGR starters are a little tricky to disassemble.

Here are a few interesting things you need to be aware of on side-mounted Ford PMGR starters (Figure 9).

When you are disassembling these units, in order to remove the idler-gear shaft, you must first remove a small retaining pin. However, this pin may be hard to see because it is usually covered with dirt and grease. Also note that in the idler gear itself there is a small ridge that prevents the bushings from being

pressed straight through. The bushings must be extracted, each from its own end.

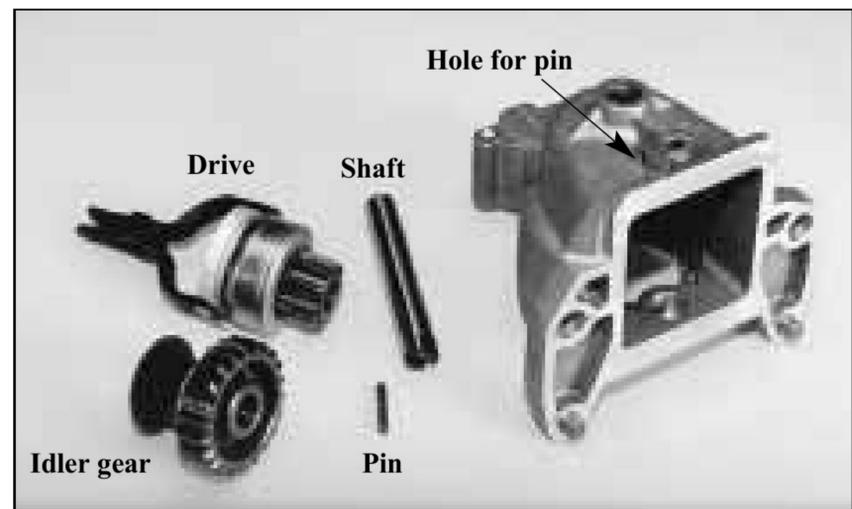
Figure 10. The thickness of the starter drive body is critical on side-mounted PMGR starters.

The thickness of the starter-drive body on these side-mounted starters is critical because it must fit into the groove of the idler gear. If the body of the drive is too wide, the starter may crank slowly or may not crank at all. If it is too narrow, the idler gear will engage the flywheel late, possibly causing a milling condition – or the idler gear may be slow to exit the flywheel, thus staying engaged (Figure 10).
