# Dealing with Cheap Battery Terminals

By Paul Rupp

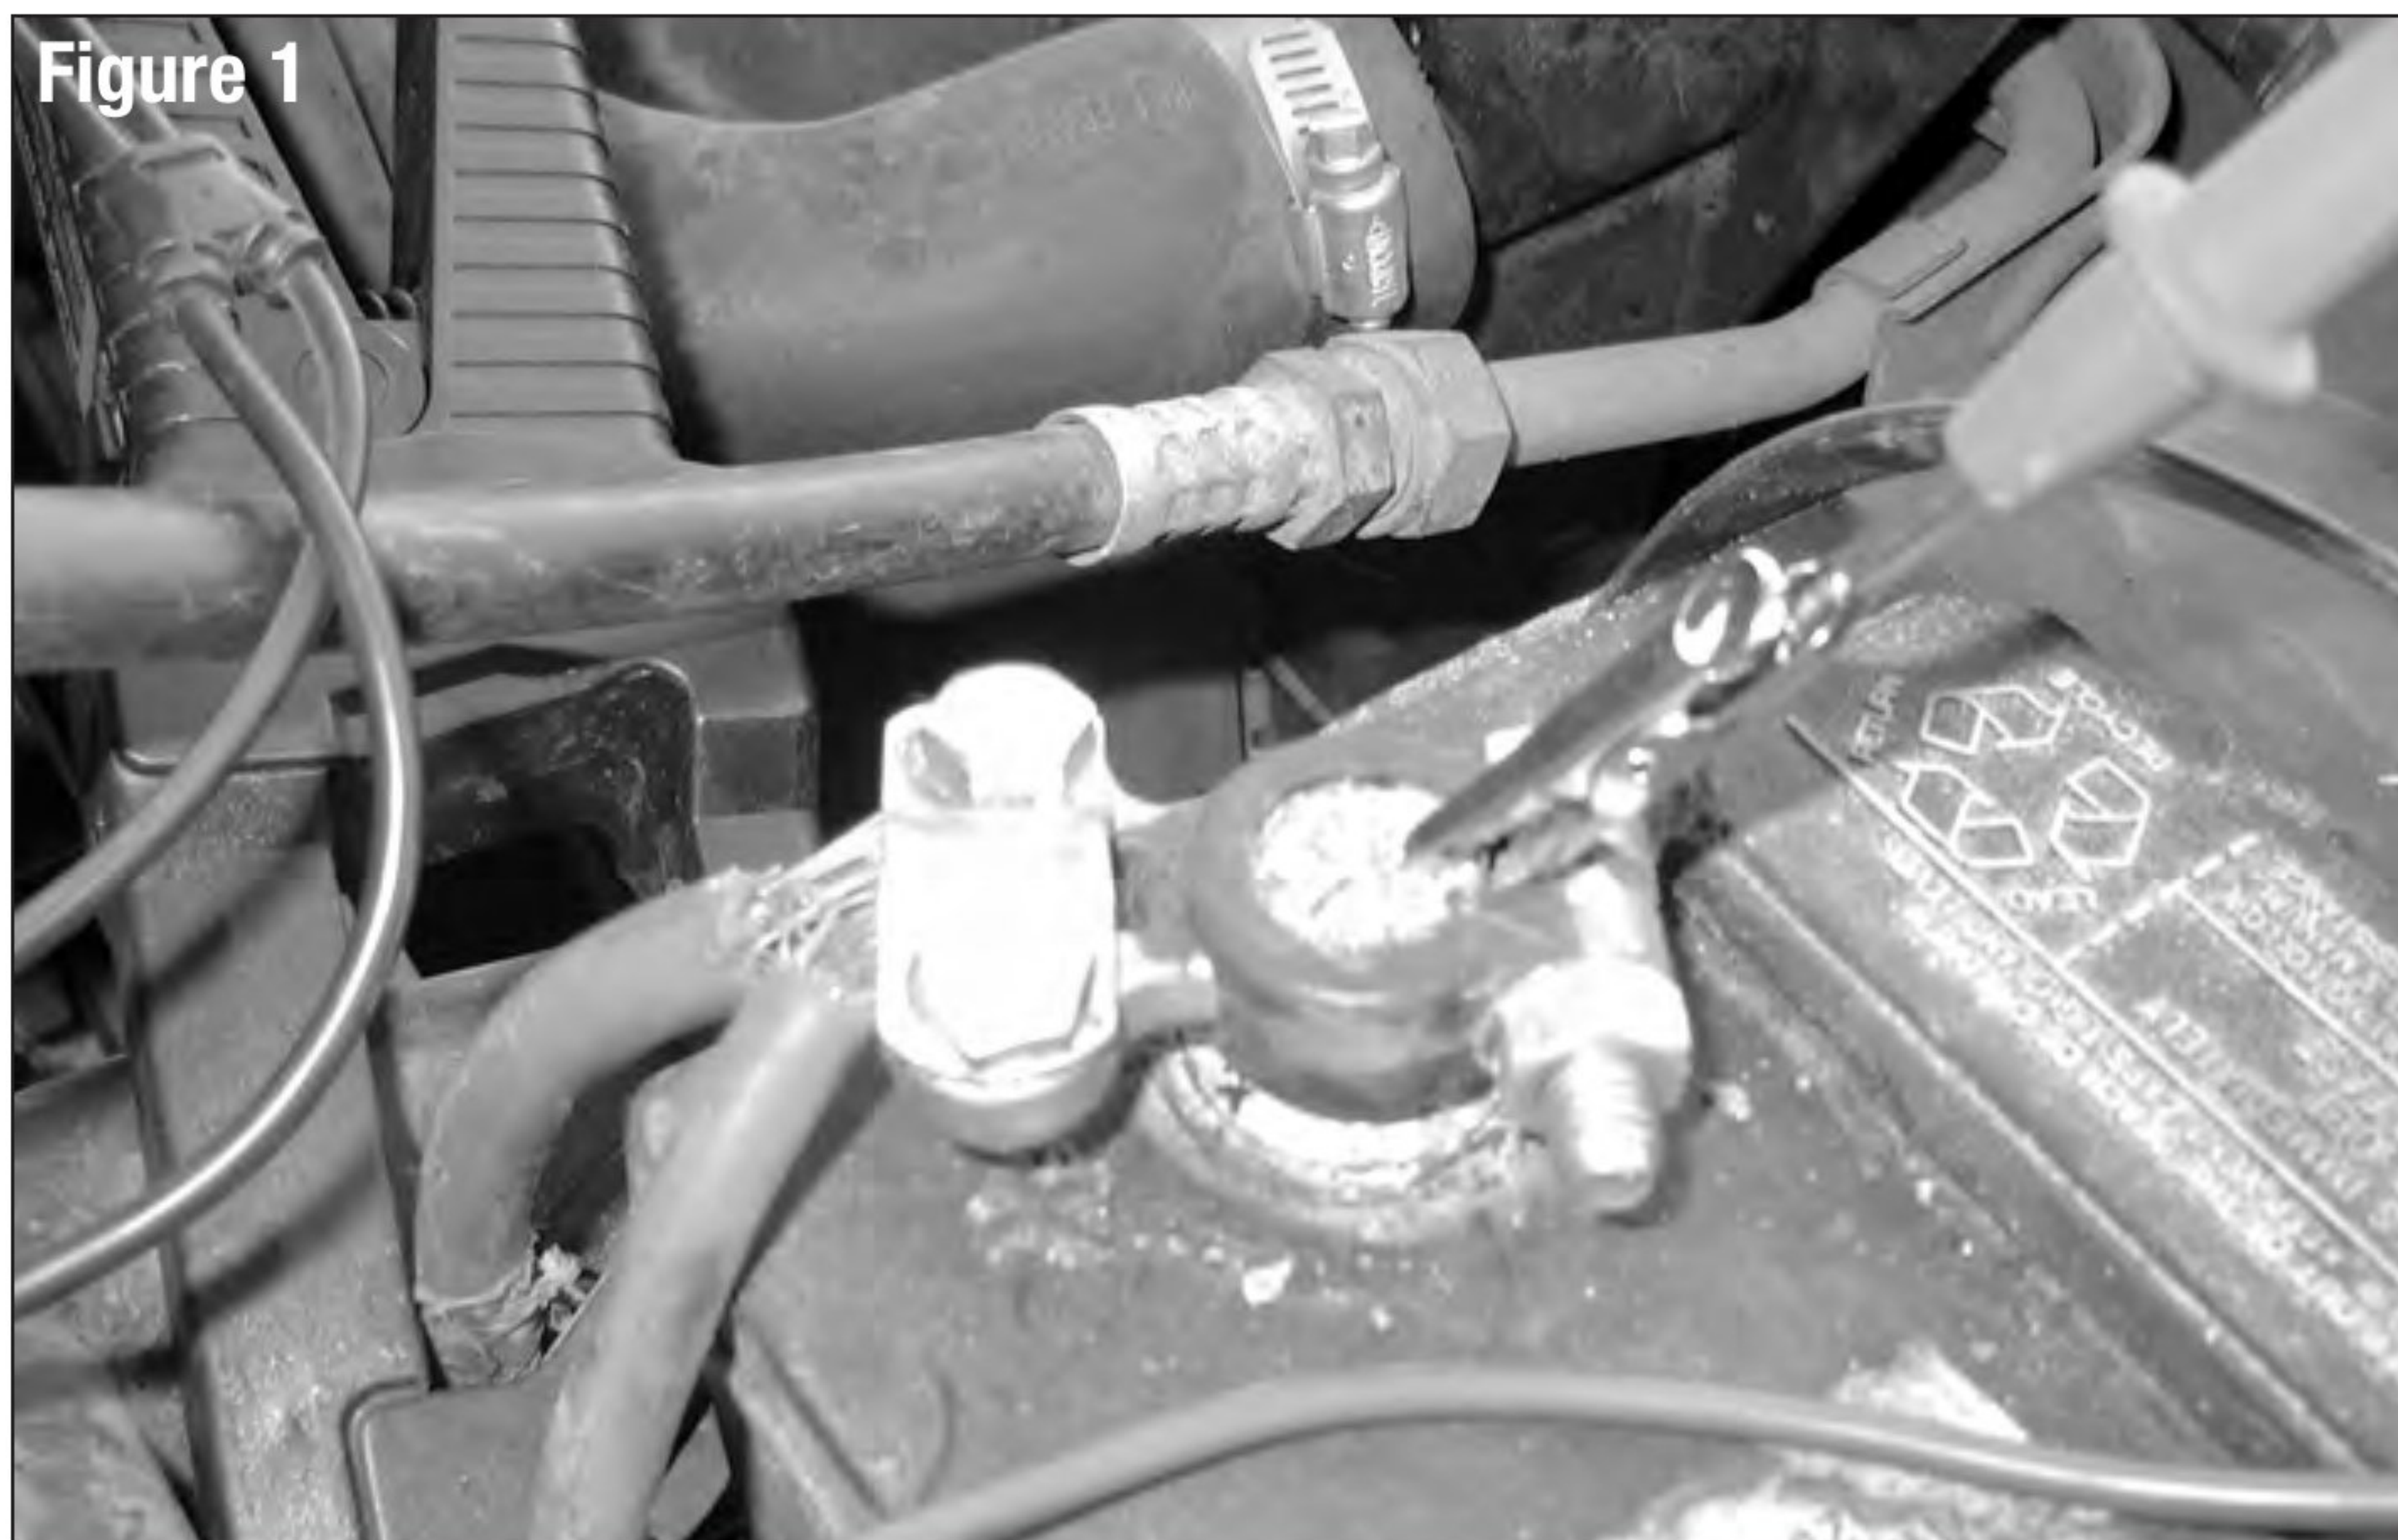
Figure 2 shows the test setup with the meter on the left reading amps and the meter on the right reading volts. Notice I connected the voltmeter pos lead directly to the battery post to catch any resistance from the post to the terminal as well as from the terminal to the cable. The neg meter lead is connected to the starter big lug.

seconds and took the readings. The test showed 0.45 volt drop from the pos post to the starter big lug. Next I moved the pos lead to the terminal itself and found the same 0.45 volt drop. I next moved my lead from the terminal to the exposed copper wiring in the big cable. The voltage drop was near zero. This info tells me the exact location of the resistance and voltage drop is where the terminal connects to the cable. The right meter showed the starter drawing 152 amps constant crank, which is pretty normal.

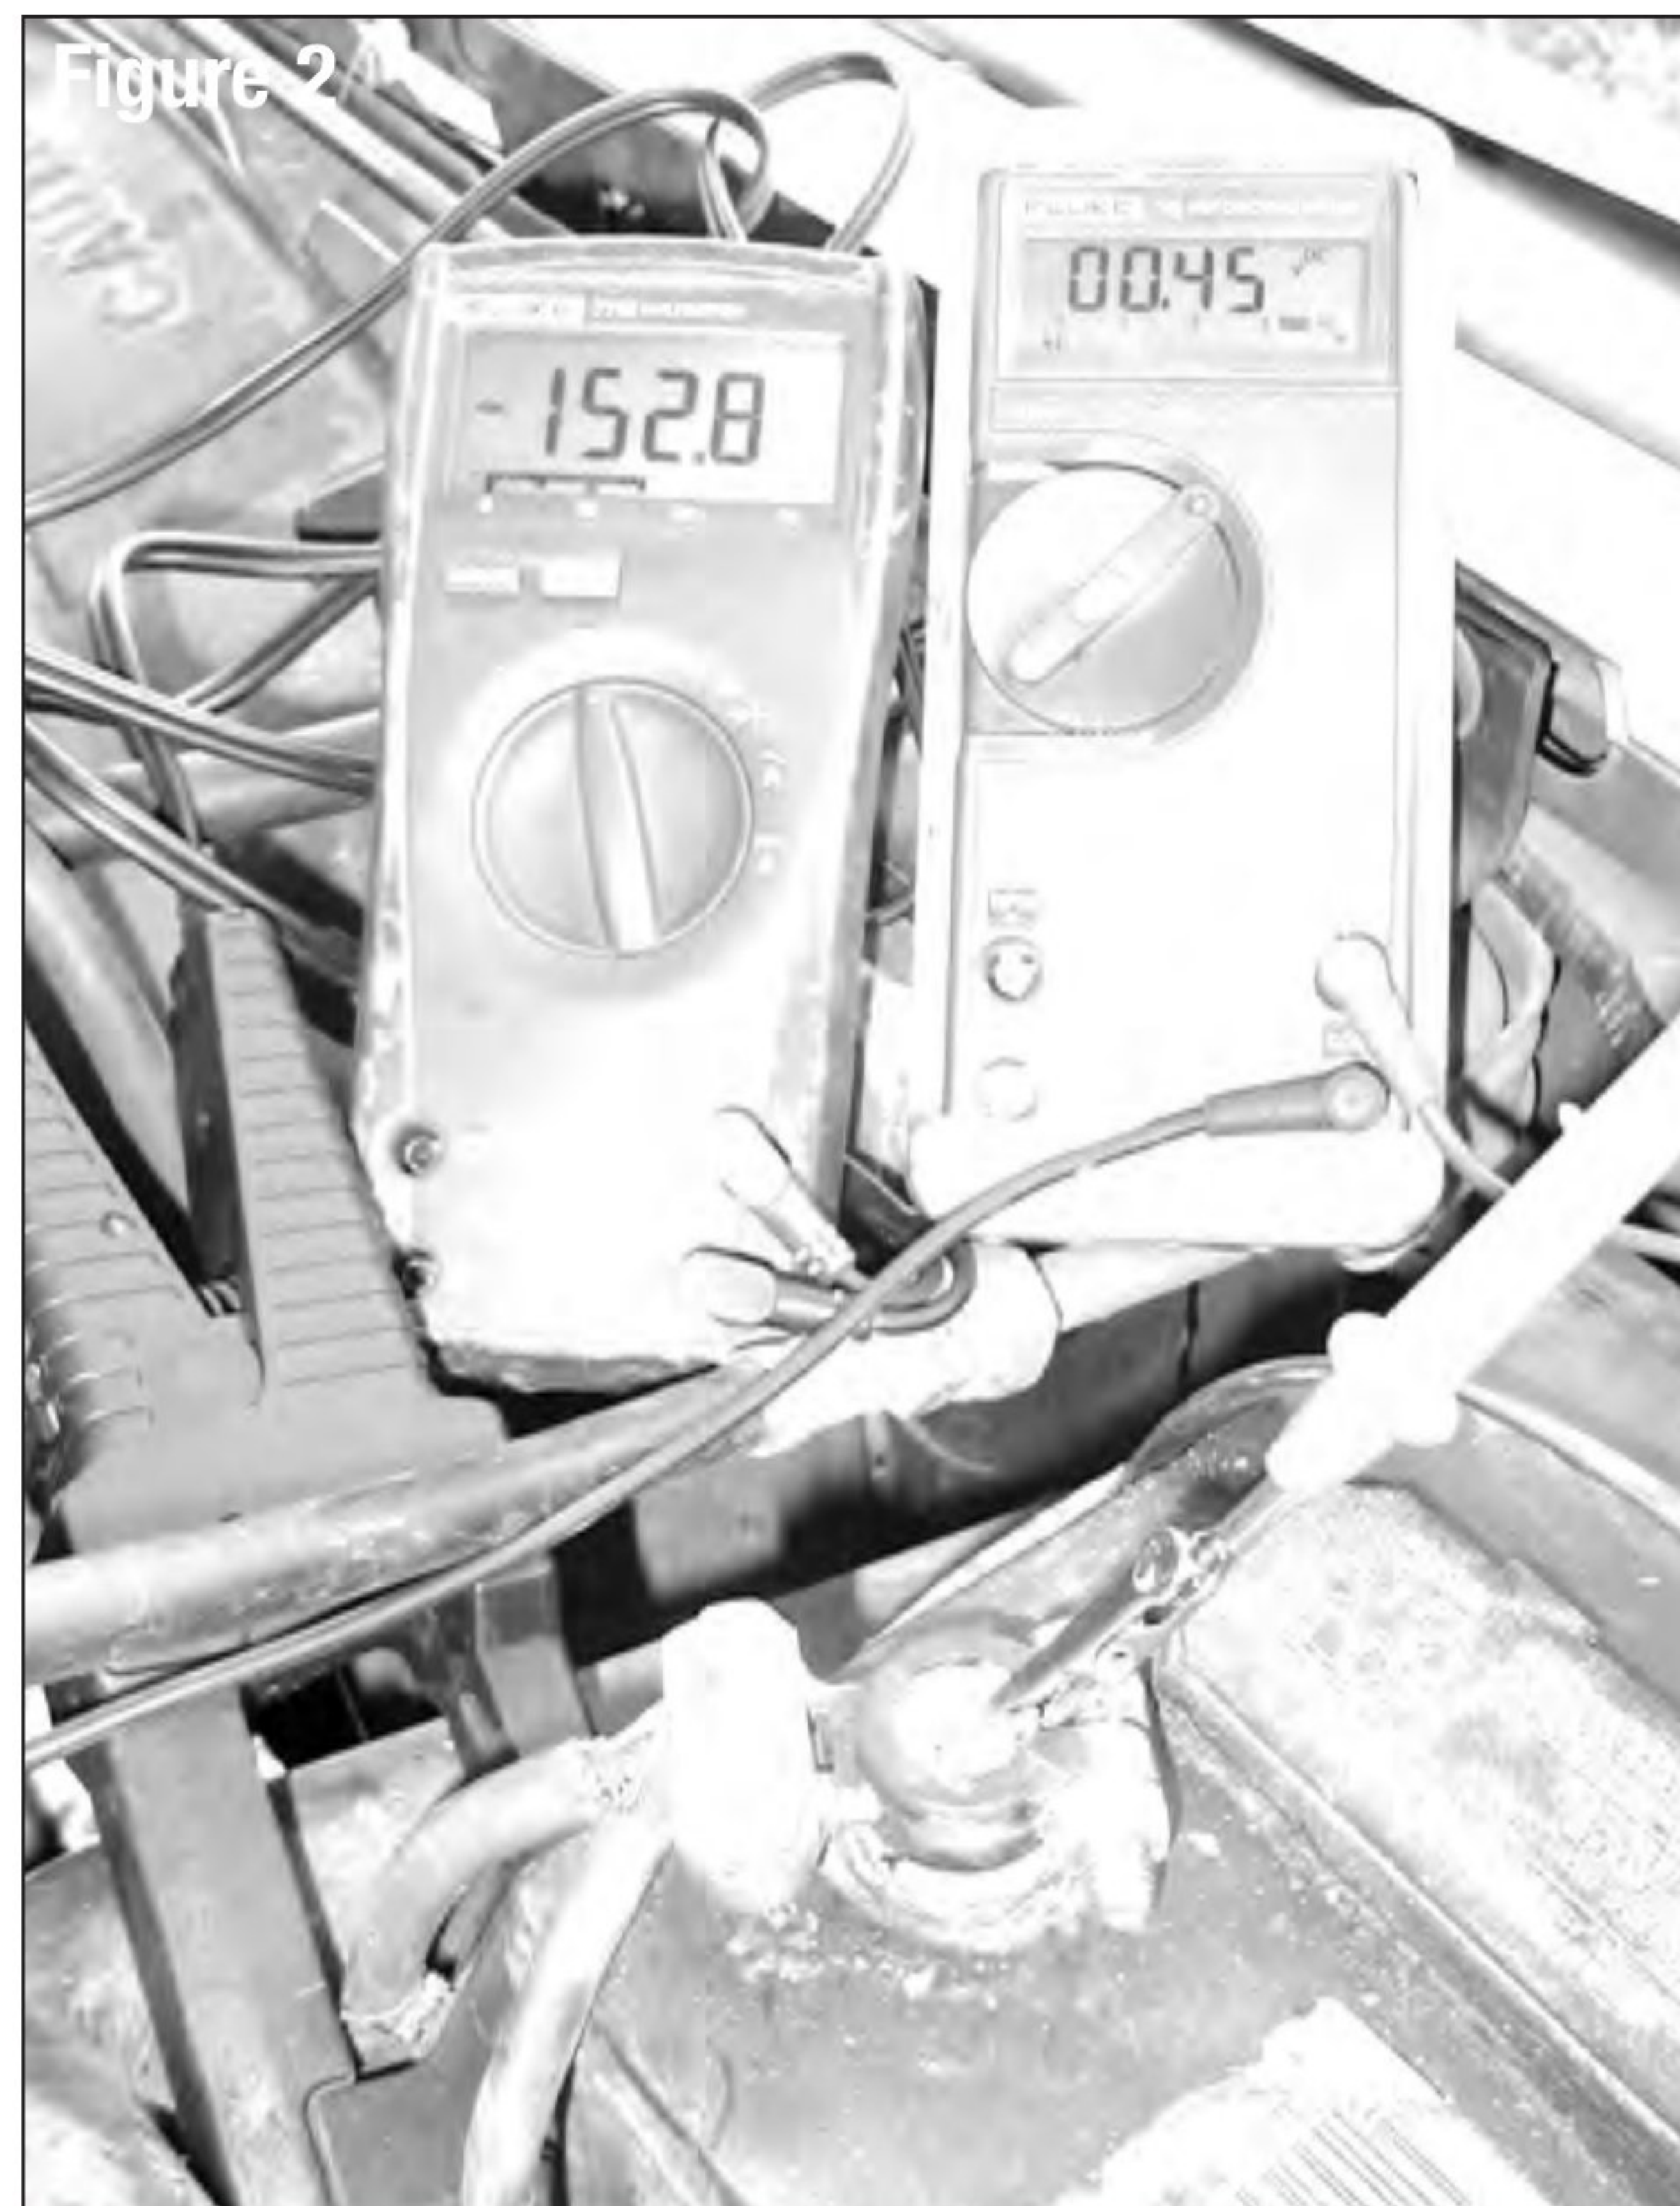
It was a beautiful fall day outside with a cool temp of around 70 degrees F and I decided to verify the problem another way. Figure 3 shows the infrared temp gun reading of the problem resistance point at 95 degrees F. Five seconds earlier, before cranking,

it was all 70 degrees F. Therefore, when I suspect a significant voltage drop problem on a starting circuit, to save time, I quickly measure the temp of the circuit just after cranking. Sure enough  $V = IR$  holds true every time and I will find a “hot spot” sometimes even under the insulation in a nice looking starter cable. Most commonly the connection points are the problem or acid from a previously leaking battery has seeped into the cable insulation and slowly corroded over time.

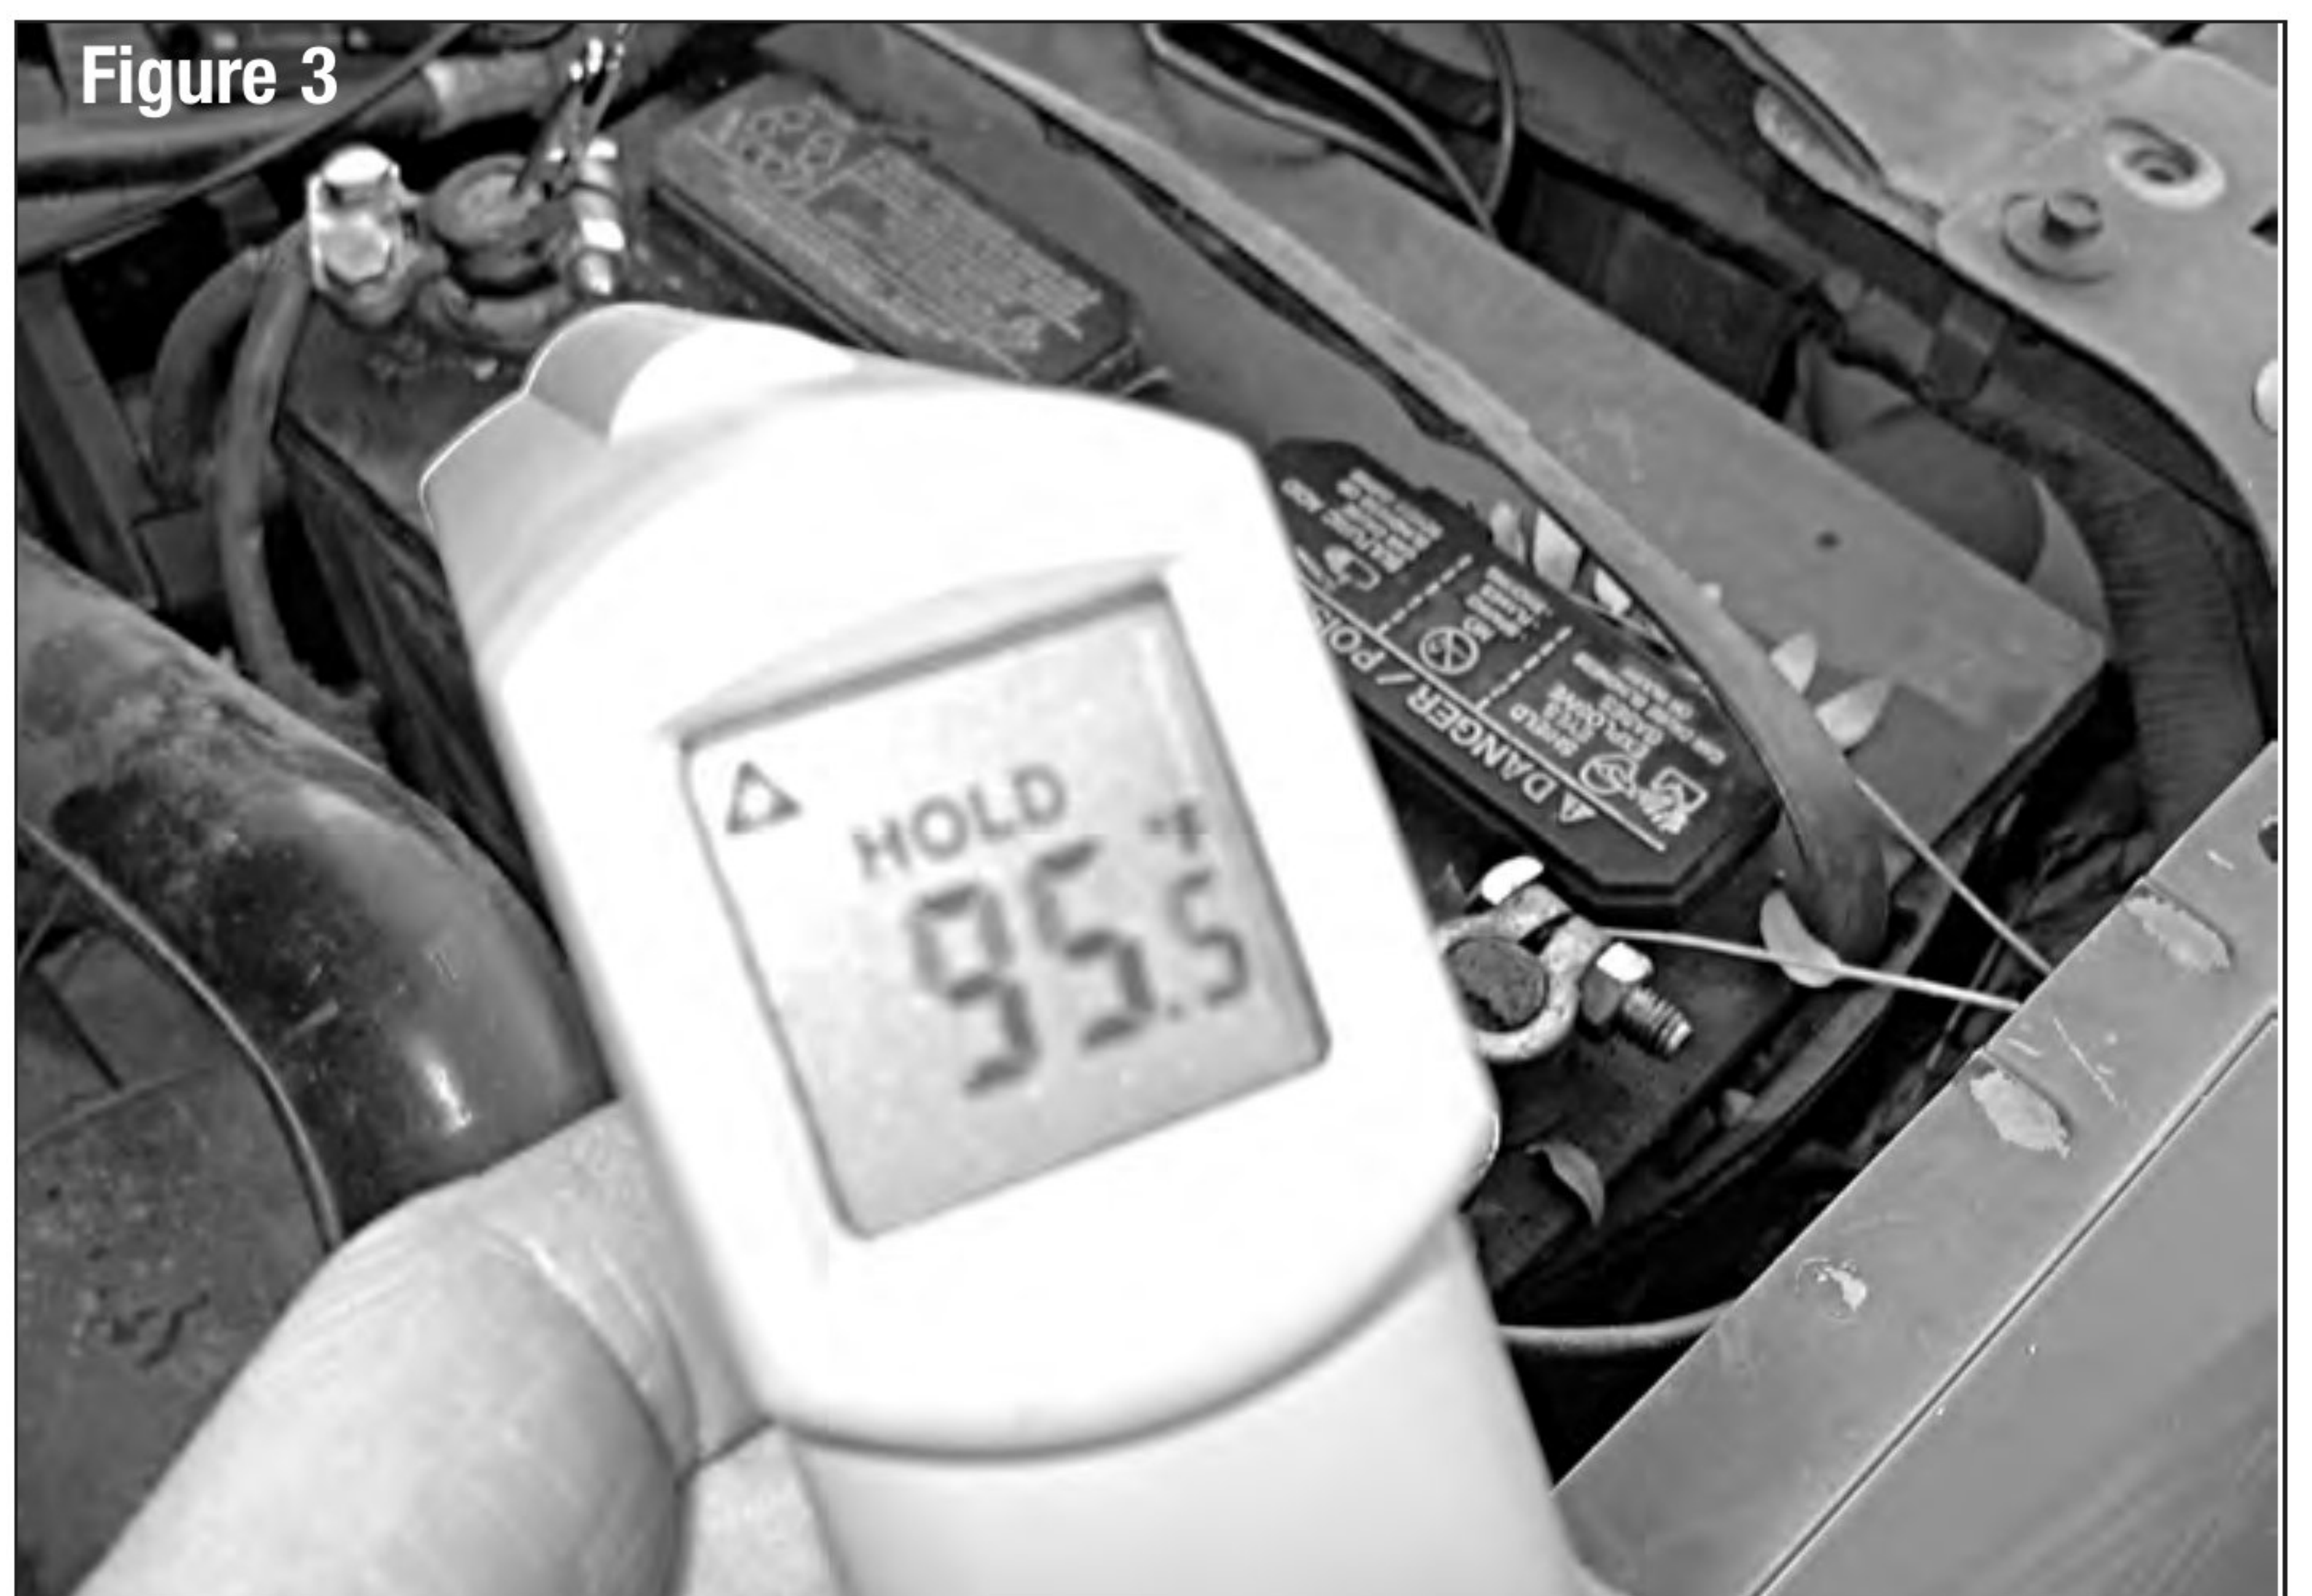
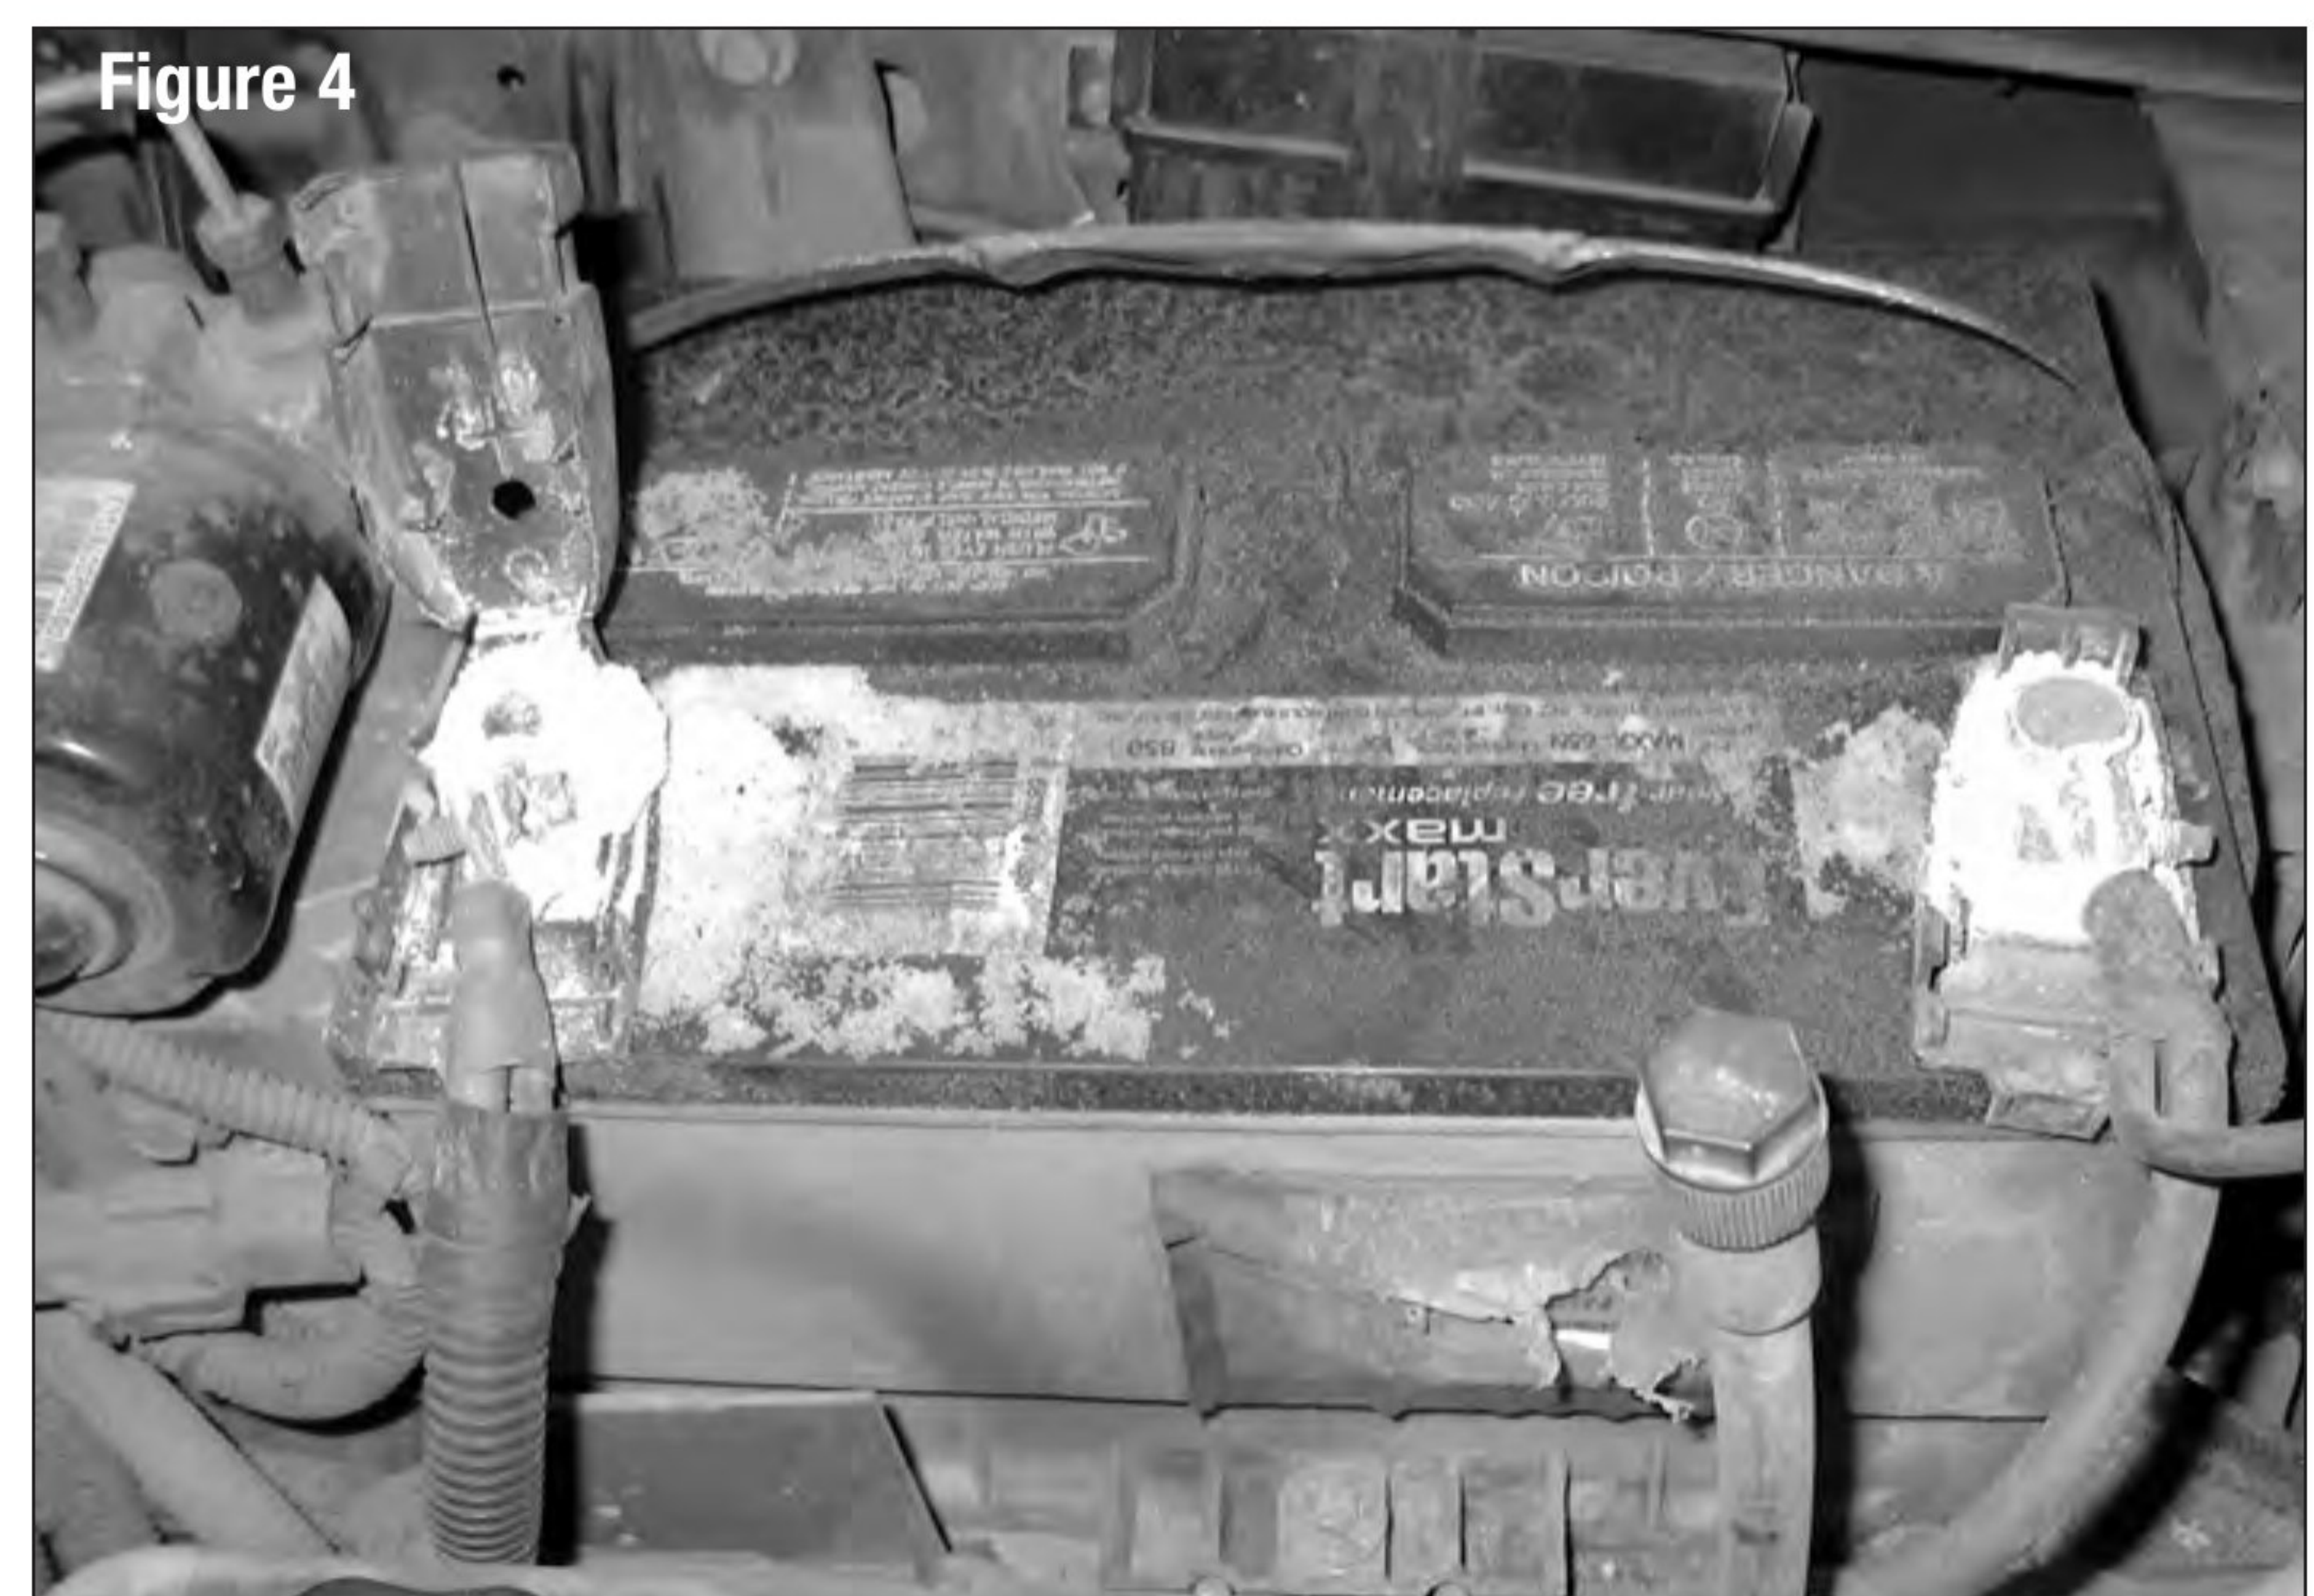
For fun, Figure 4 got the “OE battery terminals of the month” award at NCAS. I could not pass up the photo-op. This vehicle cranked just fine with the acid seeping battery and the original terminals. I mentioned this condition to the customer who truthfully responded with, “Well, the engine starts just fine.”
