# Benchmarks: Looking at mechanical woes

COLUMN BY JOEY CLINE

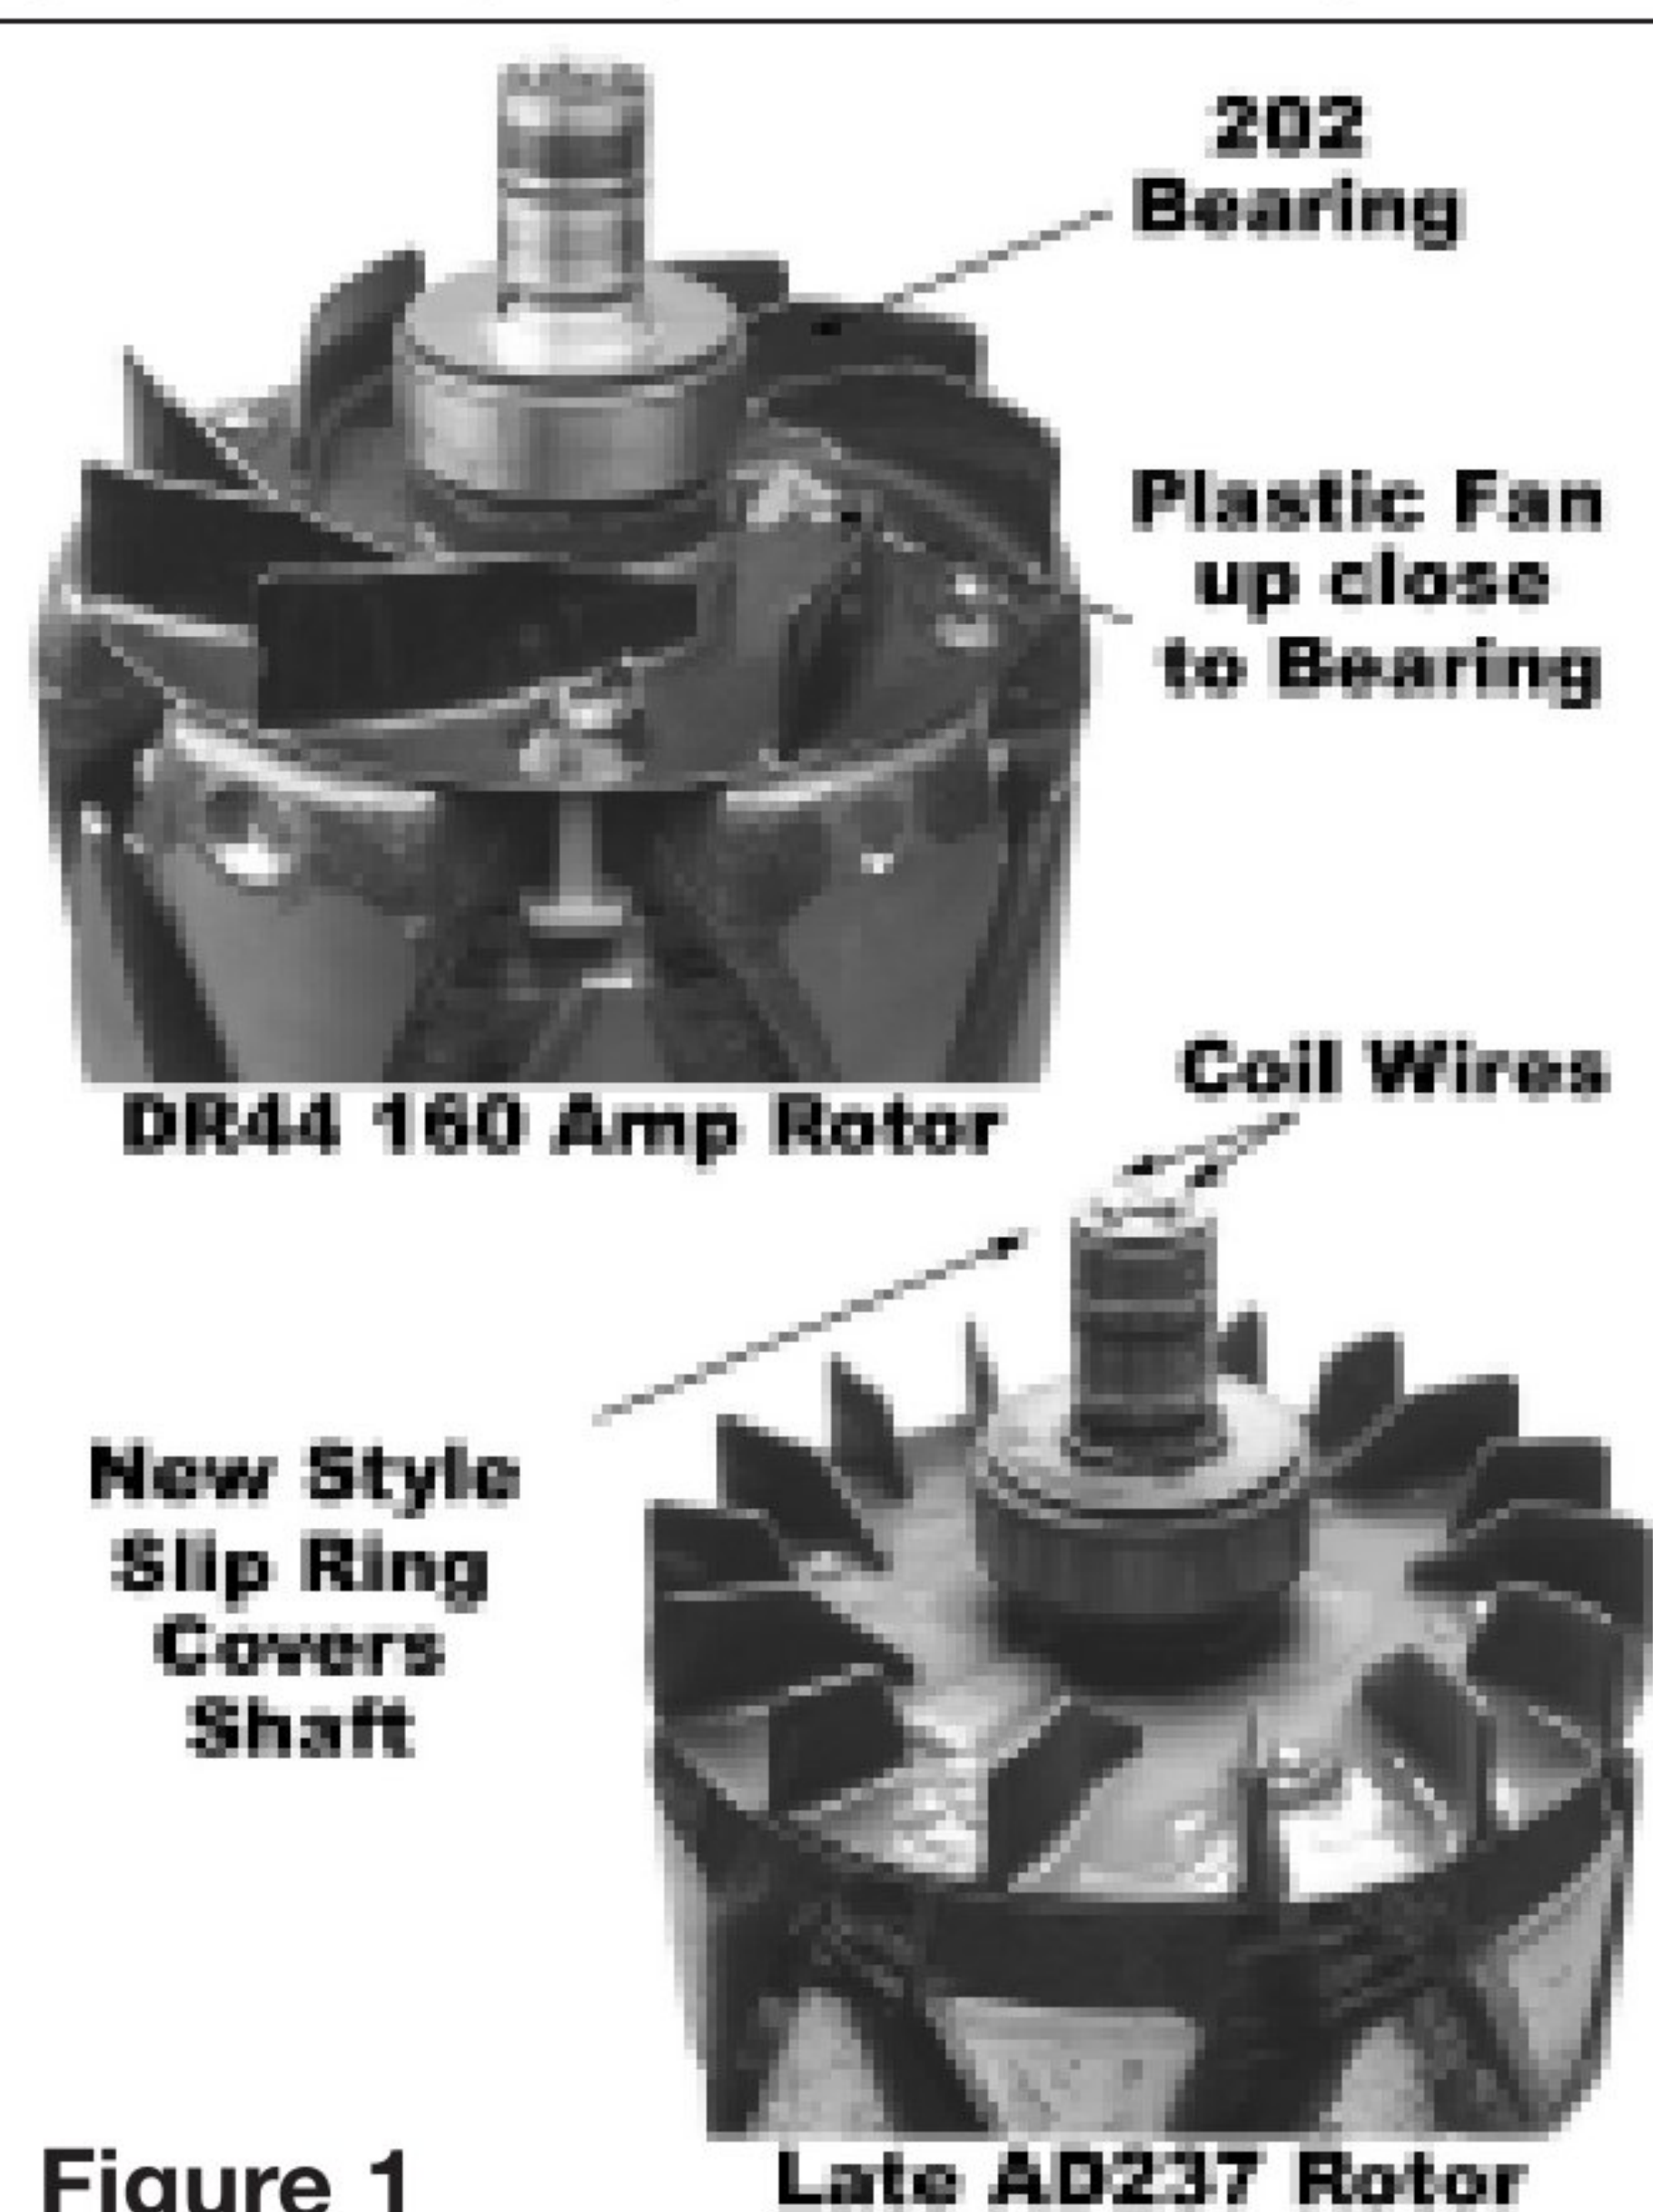
Looking at the bottom half of Figure 1 you can see that there is room for a puller under the bearing but nothing to push against. The new-style slip ring is very similar in size as the CS130D slip ring. The biggest difference in the two is that the latest-style slip ring has the rotor coil wires soldered on top. These wires are now located in the very area that a puller would contact, resulting in damage to the slip ring and/or coil wires. To complete this unit in a timely manner I used an older-style AD rotor, made similar to that of a CS130D. The original AD rotor, with the new-style slip ring, was put to the side for later consideration of how to remove the bearing.

in Figure 1 is from the DR44 family which uses the new-style slip ring and has the similar problems of the Delco 24SI rotor regarding the plastic fan being close to the bearing. The rotor in Figure 2 is from the Denso hairpin family which uses a SRE bearing with the same OD as the 202 but is a little wider. The problem with removing the bearing on this rotor is that the metal fan forms a shroud around the bearing making it difficult, if not impossible, to use any known puller on the market today. Late Delphi AD, DR44, DR44G, Delco 24SI, Denso hairpin and possibly other alternators with this bearing removal problem make up millions of units that are in use today and showing up in the rebuild shop.

Looking back at Figures 1 and 2 you will see two more rotors that have the same bearing removal problem. The rotor

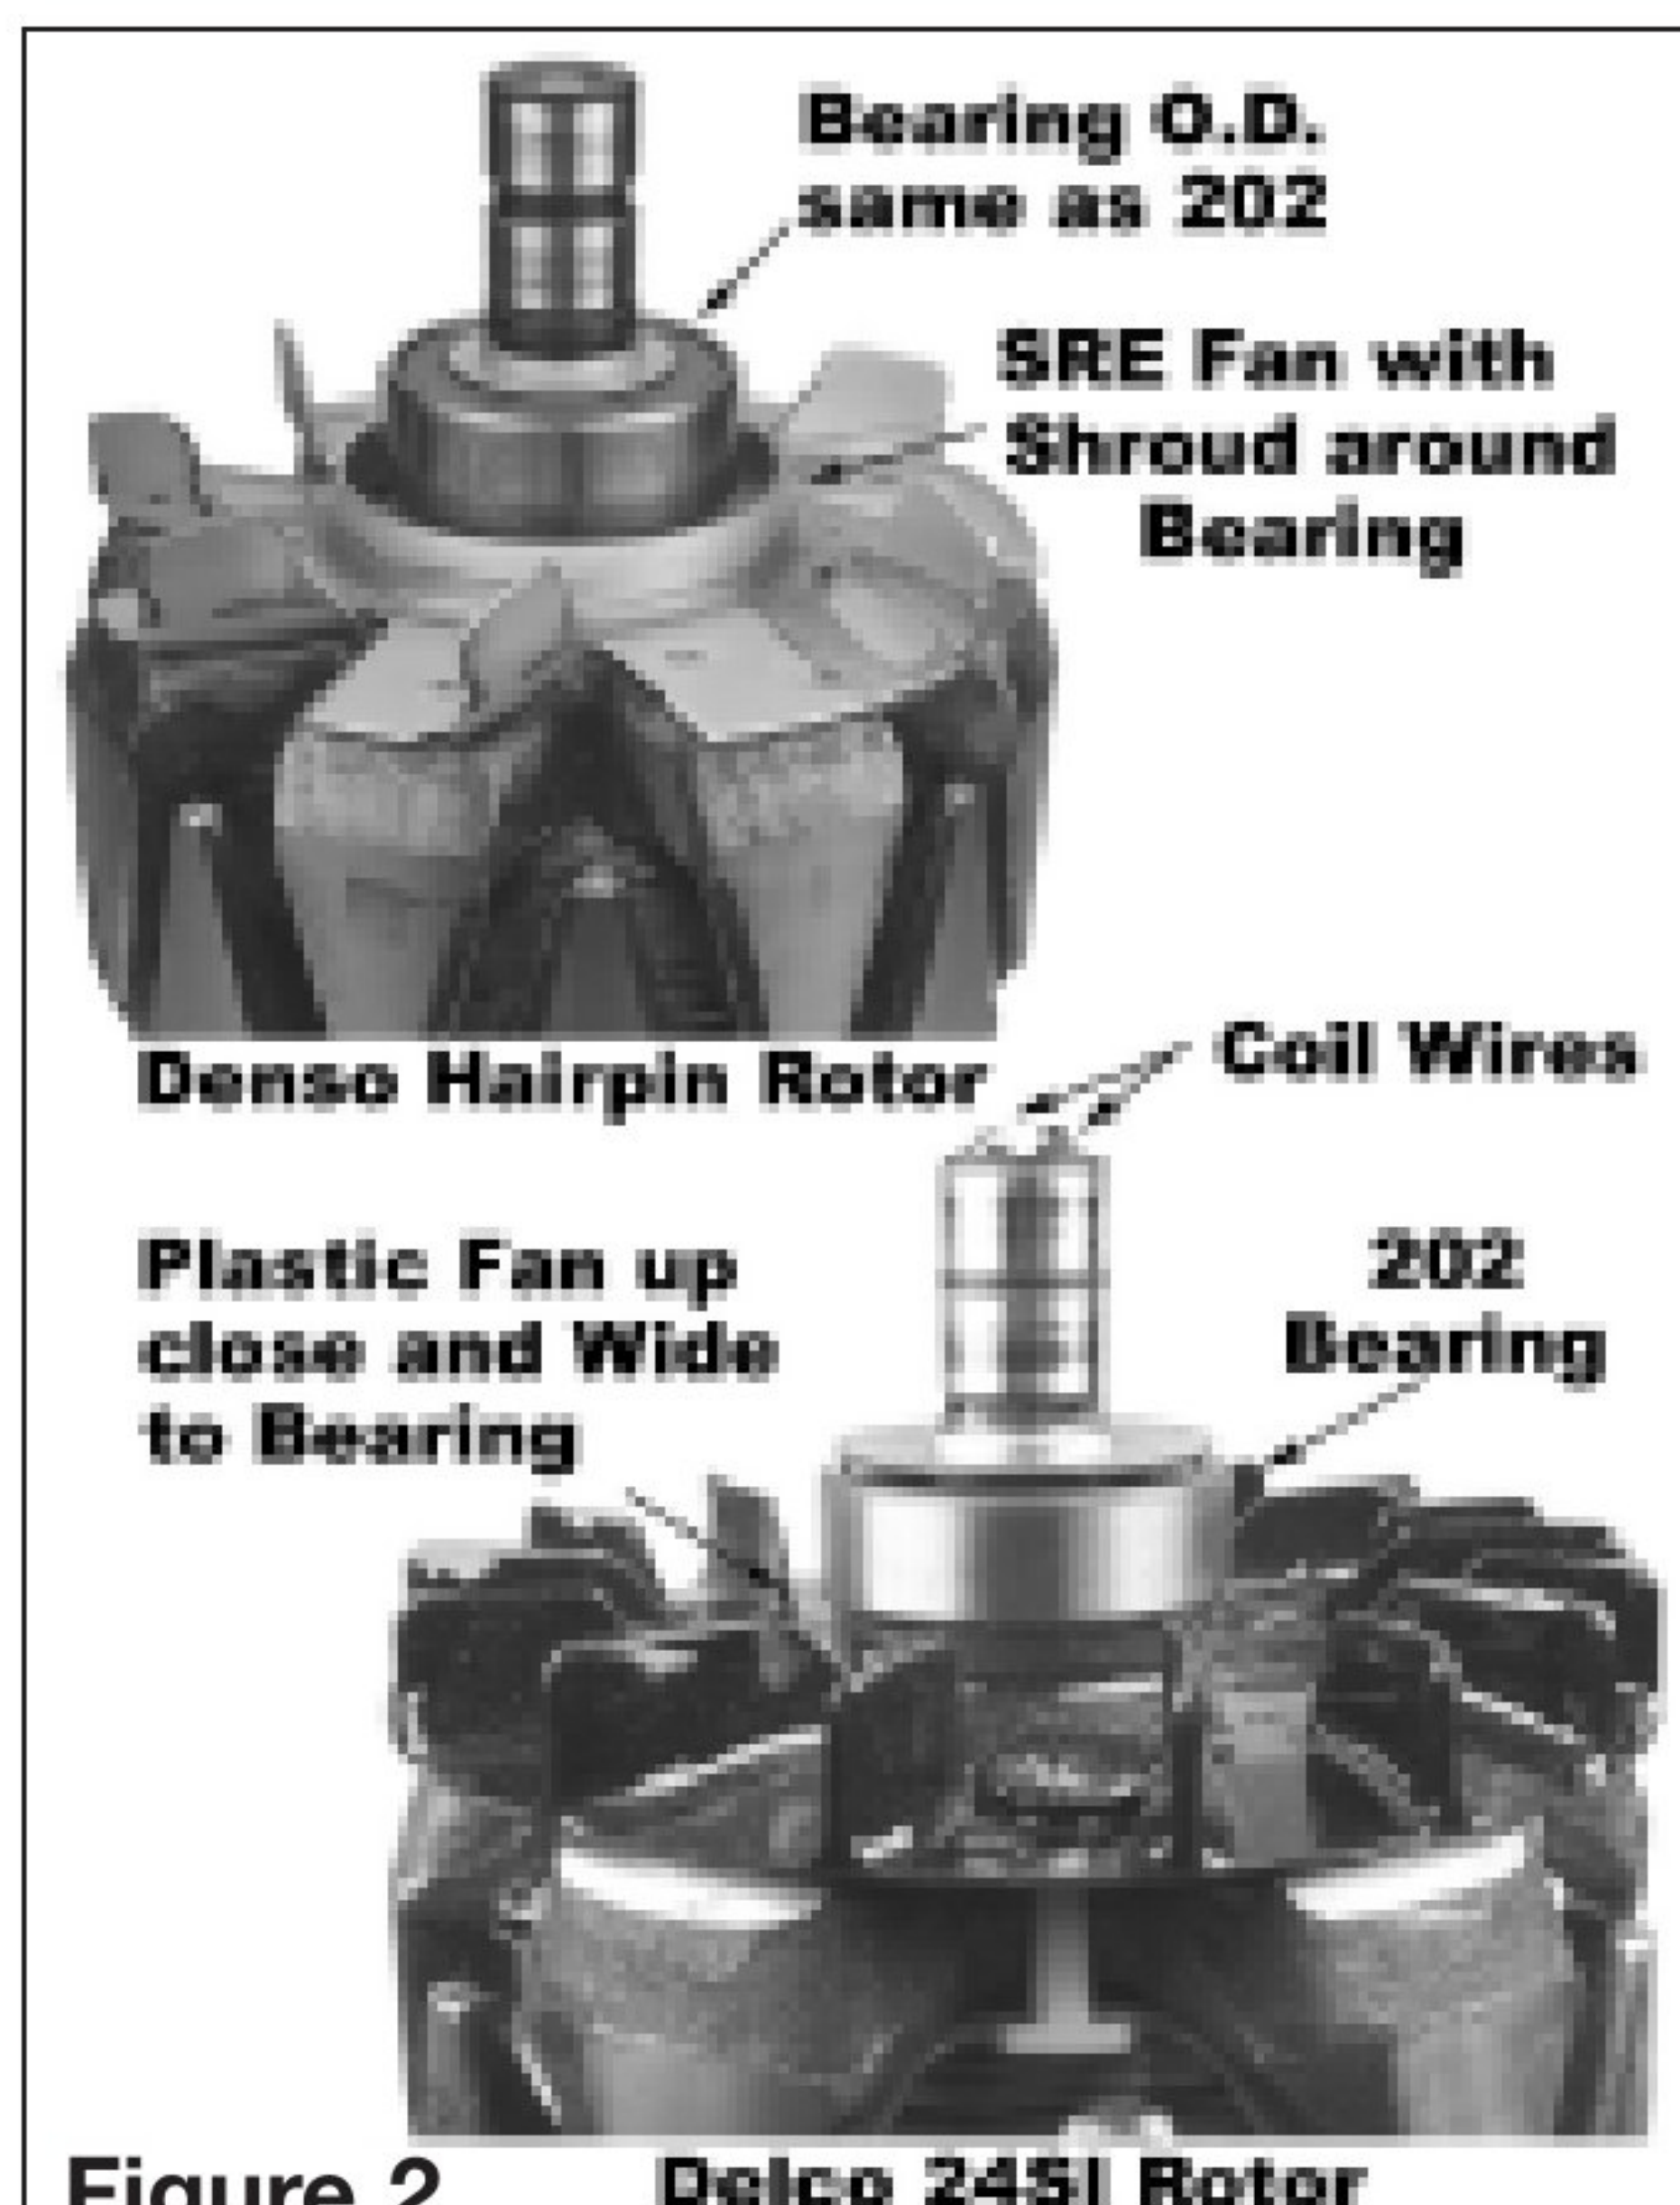
Figure 2

we would have them ready in a couple days. Upon disassembly of the units the new-style slip ring was observed yet again. With no spare rotors to grab to bail me out of this situation, I was forced to come up with a way to remove these bearings. The lower half of Figure 2, page 18, shows the Delco 24SI rotor.
