ERA EXCHANGE

August 2016 $12.95

CONTACT RESISTANCE
It All Adds Up

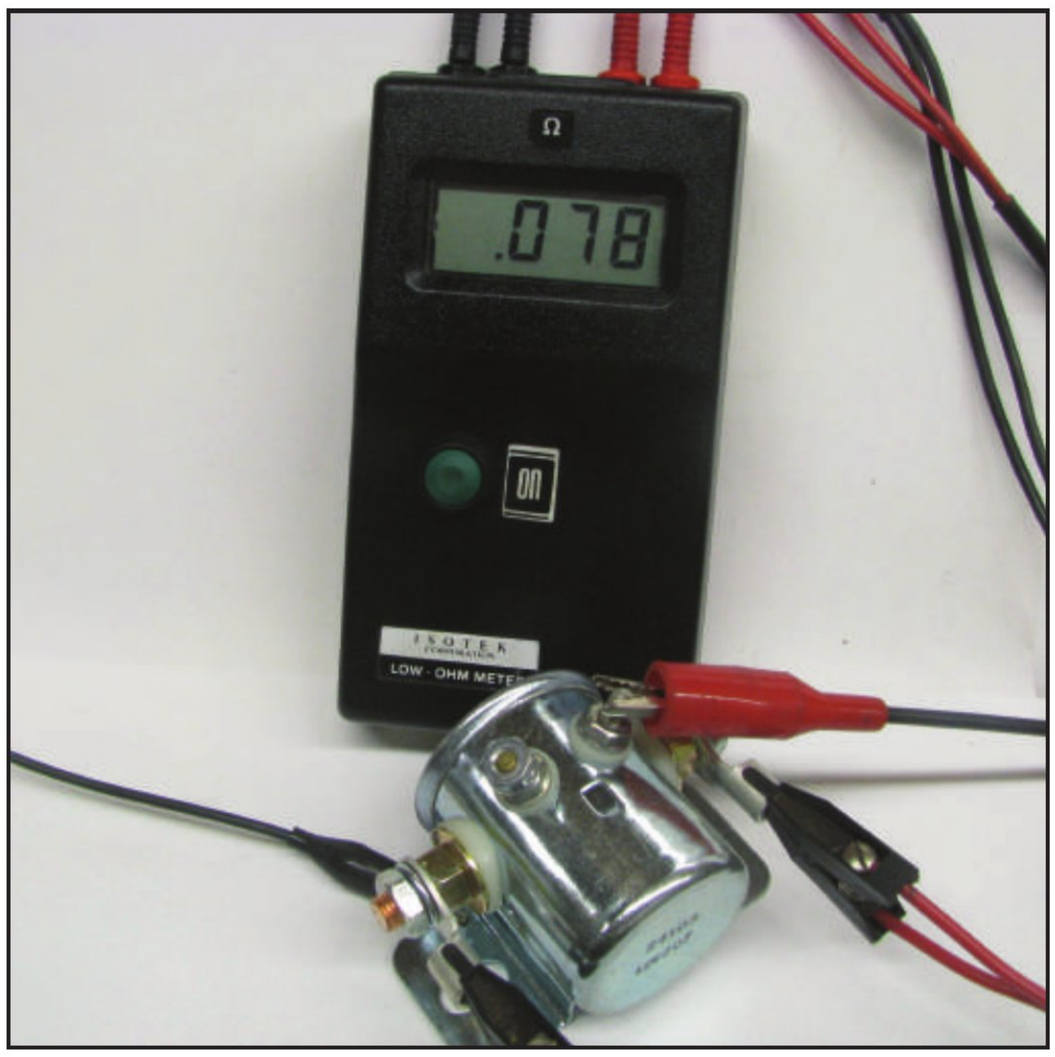
Figure 1 – Using a low ohm meter here, we are testing contact resistance of an external start relay.

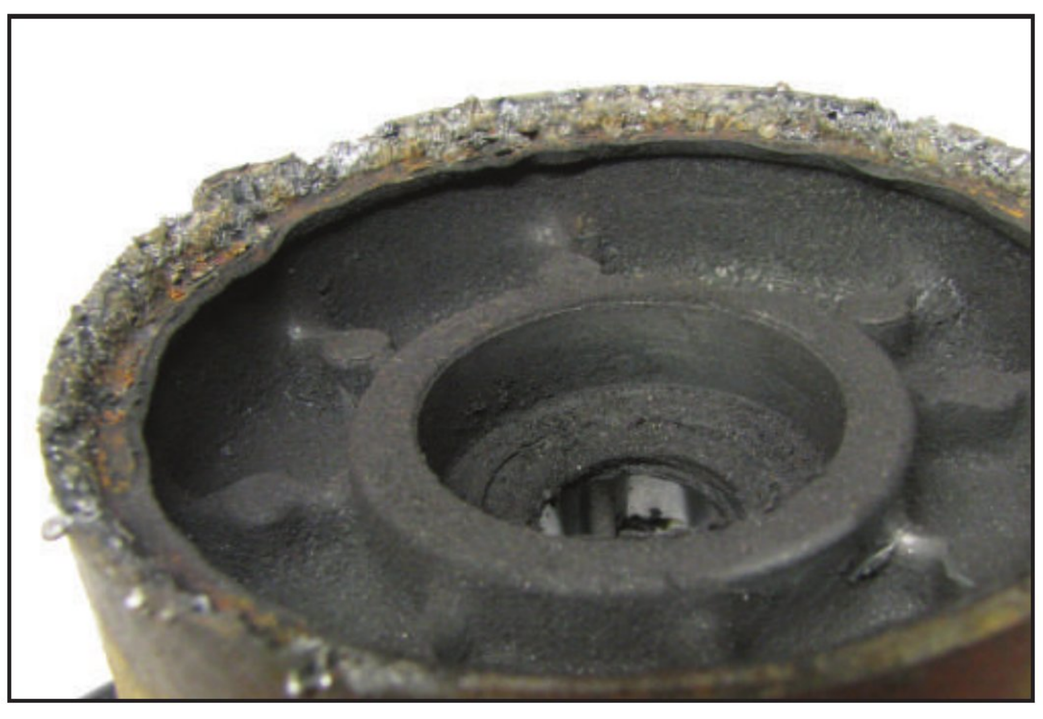
you can see in the other photos (*see Figures 5 and 6*), the aluminum melted from extreme heat, that was generated by heavy current flow across an electrical connection that had high contact resistance. Aluminum melts at over 1,200 degrees Fahrenheit. While much of the visible damage in the photos is melted aluminum, it was caused by a contact surface that had been previously eroded by galvanic corrosion.

Figure 5 – Once apart, I could see that the intermediate housing was severely eroded where it had been in contact with steel.

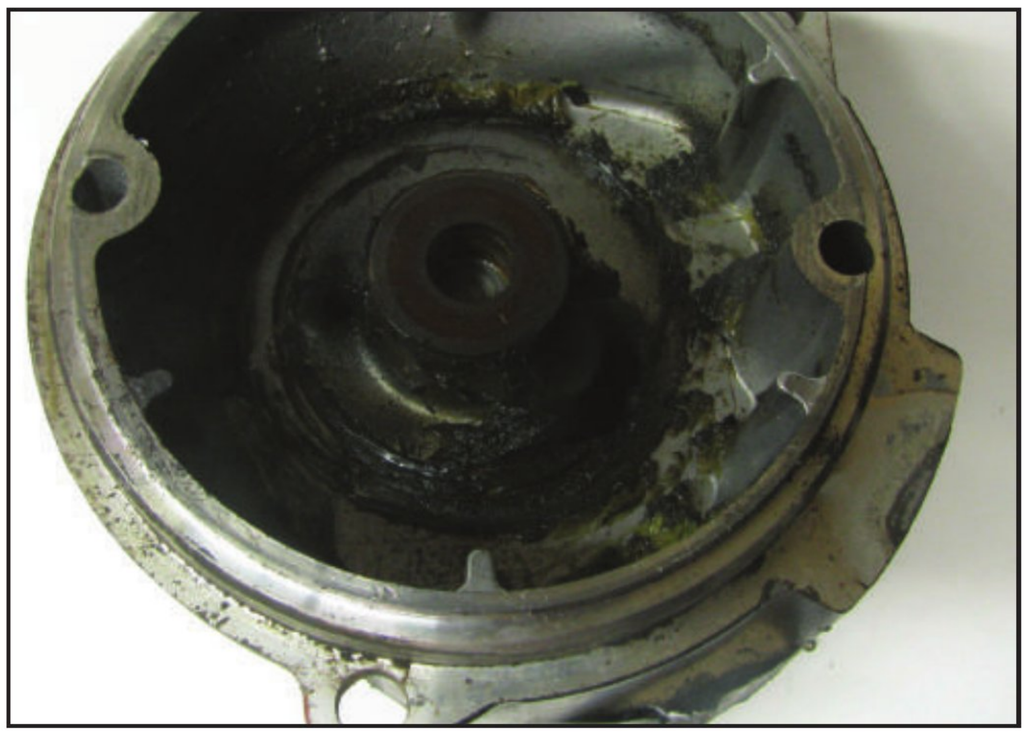
Note that there is no sign of corrosion on the other side of the intermediate housing (*see Figure 7*). That surface mates with the aluminum drive end housing – a same metal connection. Even though it was exposed to the same moisture and the same current, it is in absolutely perfect condition. As with the Jeep starter, it was an aluminum to steel dissimilar metal connection that caused the failure.

Figure 7 – The other side of the intermediate housing that was in contact with the aluminum drive end housing was in perfect condition.

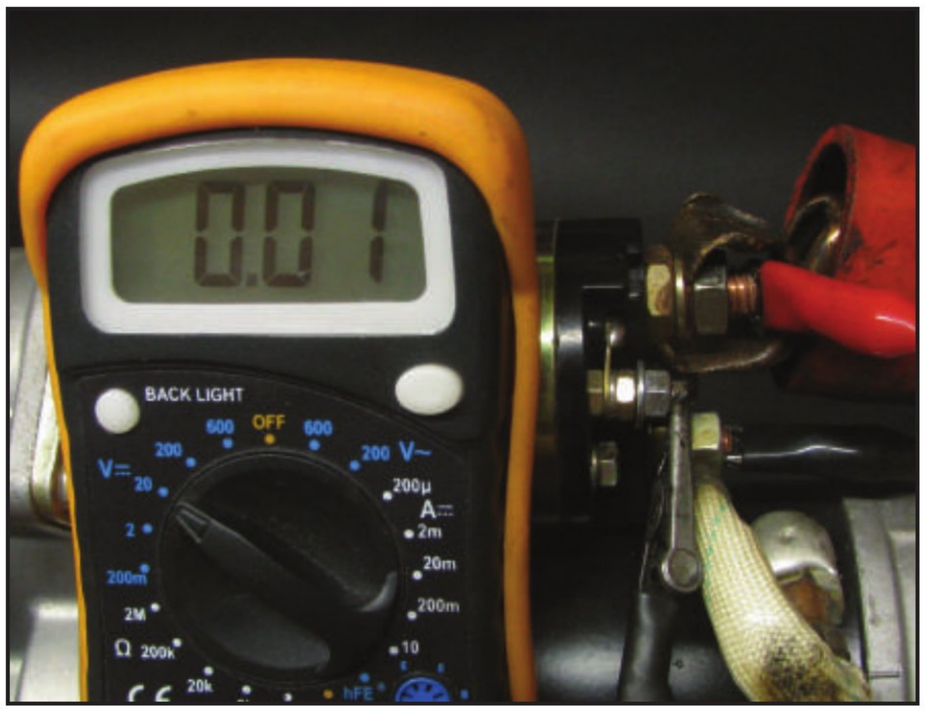
Figure 9 – Here we test a 28MT solenoid's contacts for voltage loss using the same test.

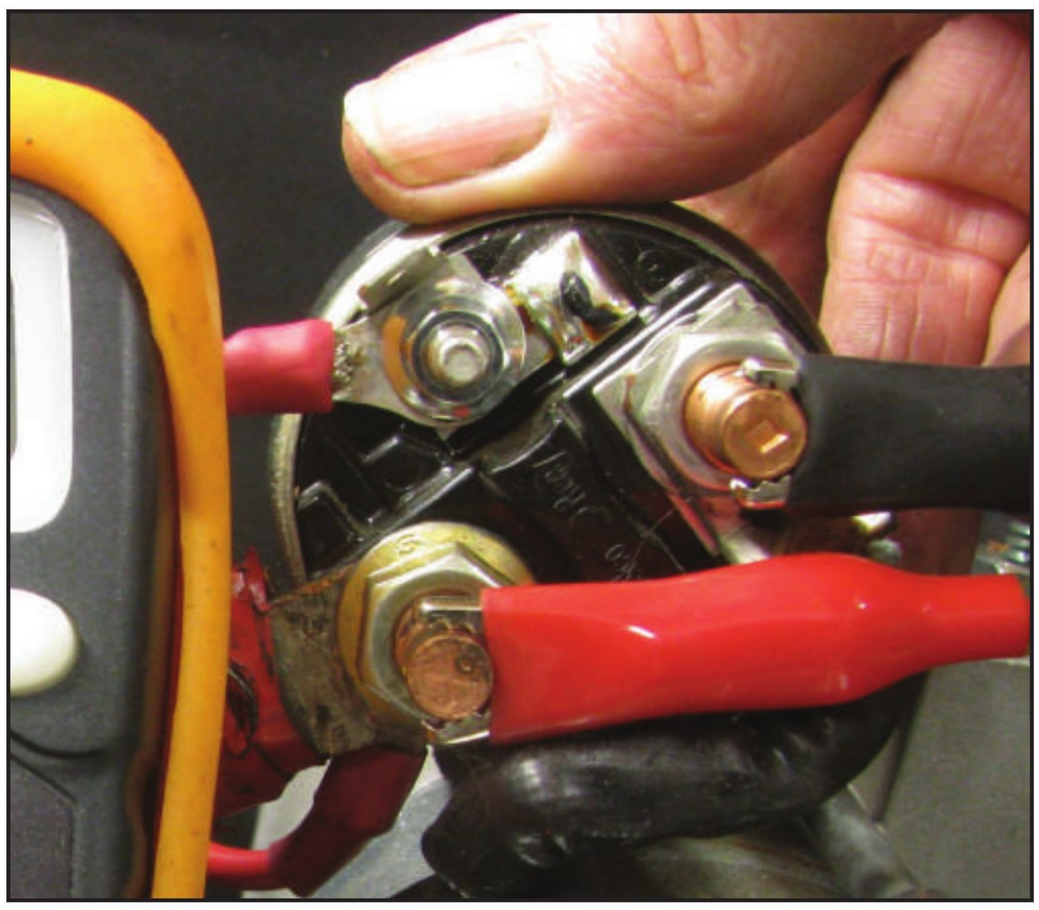
Figure 8– To test a starter solenoid for contact resistance during a free spin or loaded test, simply connect a voltmeter to the battery and motor studs.

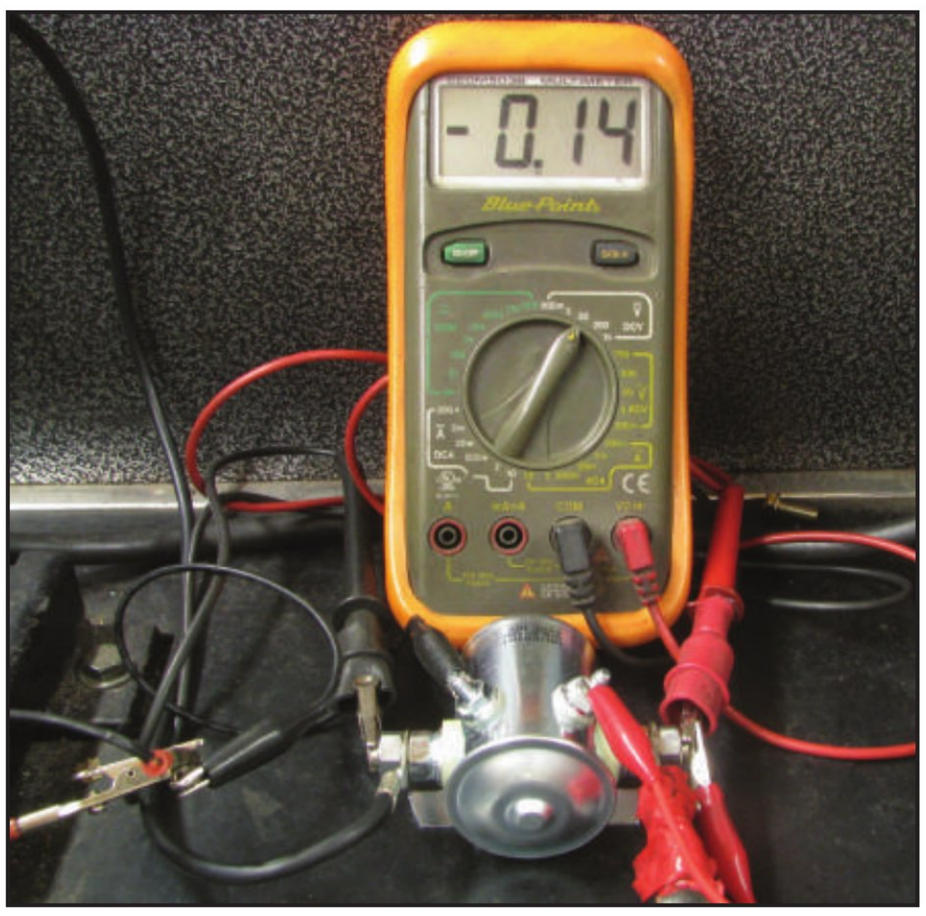
You can test external starter solenoids and continuous duty relays in a similar manner by connecting it in series with an alternator on your test bench (*see Figure 10*). B+ is connected to one side of the relay and the alternator's output terminal is connected to the other side. This will allow you to pass the alternator's output current through the relay's contacts at a known amperage that should not exceed the relay's rating. Simply control output to a predetermined value and measure the drop across the solenoid's contacts. Then use Ohm's Law to calculate the contact resistance across the contacts. In the last photo, the alternator was charging at 50 amps when the voltage drop was 0.14 volts. Voltage = Amperage X Resistance. Therefore, resistance across the contacts was 0.0028 ohms.

Figure 10 – Here we are testing a 12 volt continuous duty solenoid for voltage drop while running current through it from an operating alternator.

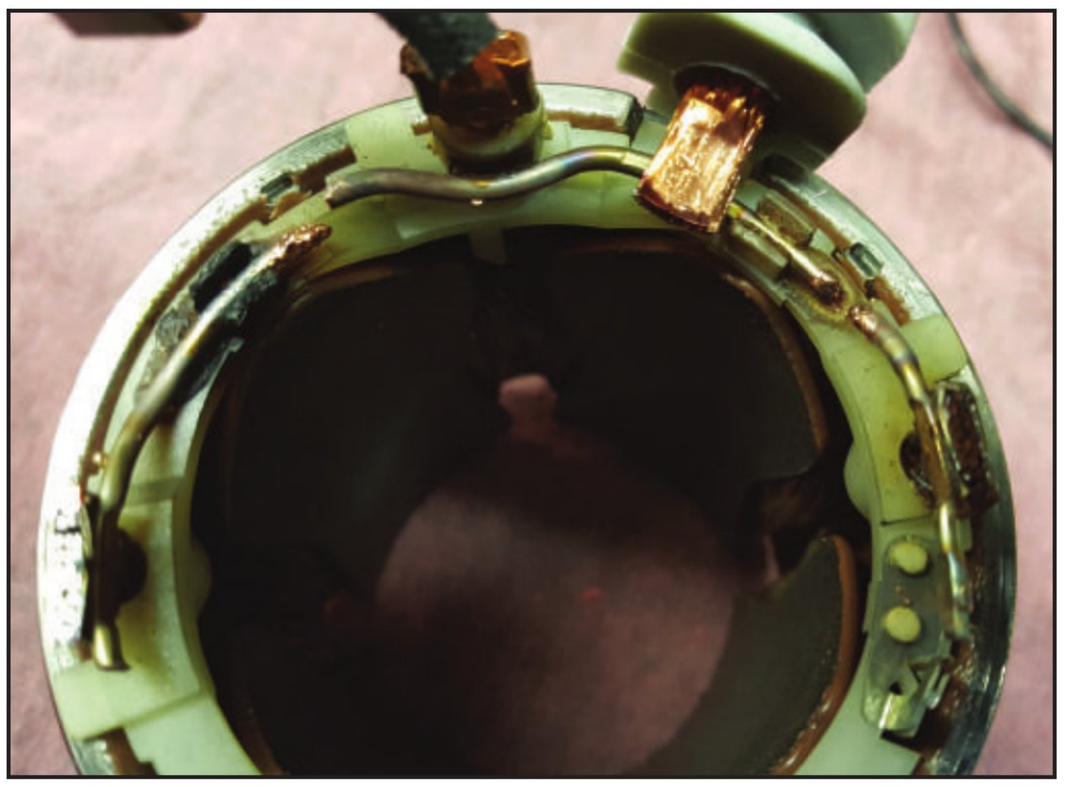
Recently, a Denso 2kW planetary gear starter came in with what appeared to be burned out connection wires between the main field case lead and the coils (*see Figures 1 and 2*). There was absolutely no sign that the armature, brushes or field coils had been overheated. In fact, the brushes were not even completely broken in and the rest of this starter was in "like new" condition. This starter's Denso part number is 228000-4593. It fits a many Kubota compact tractor and small equipment applications from the late 90's through 2009.

Figure 1 – This is the 2kW Denso field case with burned field coil lead wires.

Figure 2 – Here you can see where they burned open on both sides of the field case lead.

We decided that the burned connection bar was most likely a fuse wire and could be easily repaired. Denso has fused the field coils in several different series starters going back into the late 1990's to protect them from over-cranking. You could look at that as a potential problem area for the over-zealous and under-educated operator. But at the same time, it presents an opportunity to rebuilders.

To begin the repair we first cut away the damaged wire. Then we measured an undamaged section of the original wire (*see Figure 3*) to confirm the wire size. As you can see from the chart that we found using a web search (*see Figure 4*), the 2 mm wire size is rated at 100 amps, meaning it should be able to withstand 100 amps for extended periods without burning. Fuse wire can

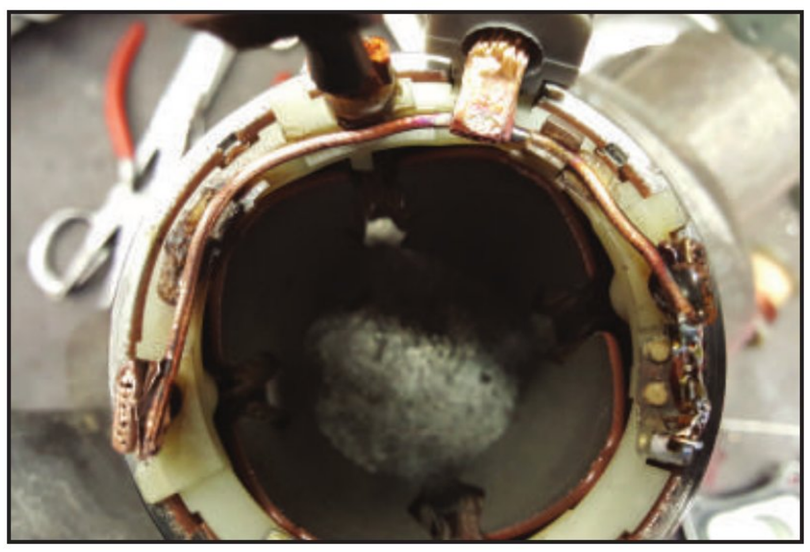
Figure 5 – Here is a view of the repaired field case.

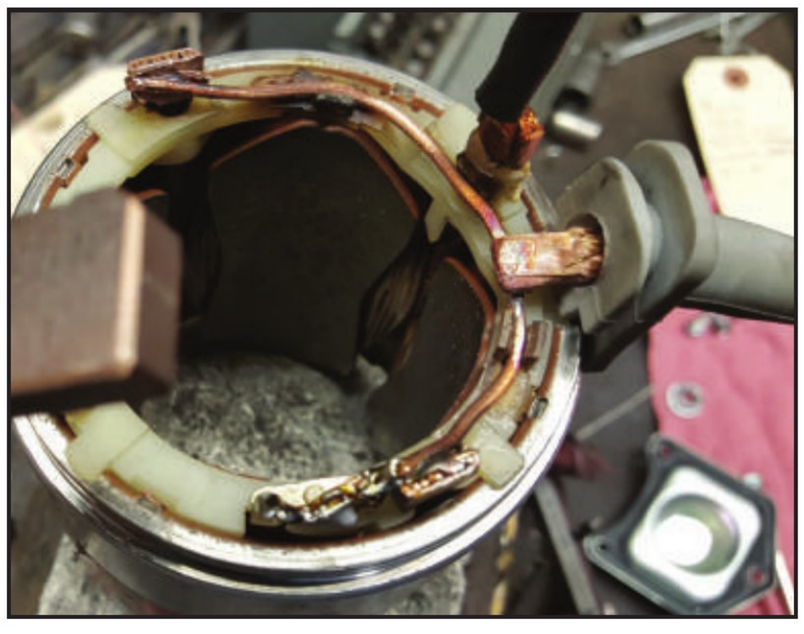
Figure 6 – Another view here. Note the shunt coil connection on the bottom of this photo.
