FAIRBANKS-MORSE

MAGNETO *Service* INFORMATION

BULLETIN FM194

NEW END CAP FOR TYPE FM-XV4C73 VERTICAL MAGNETO

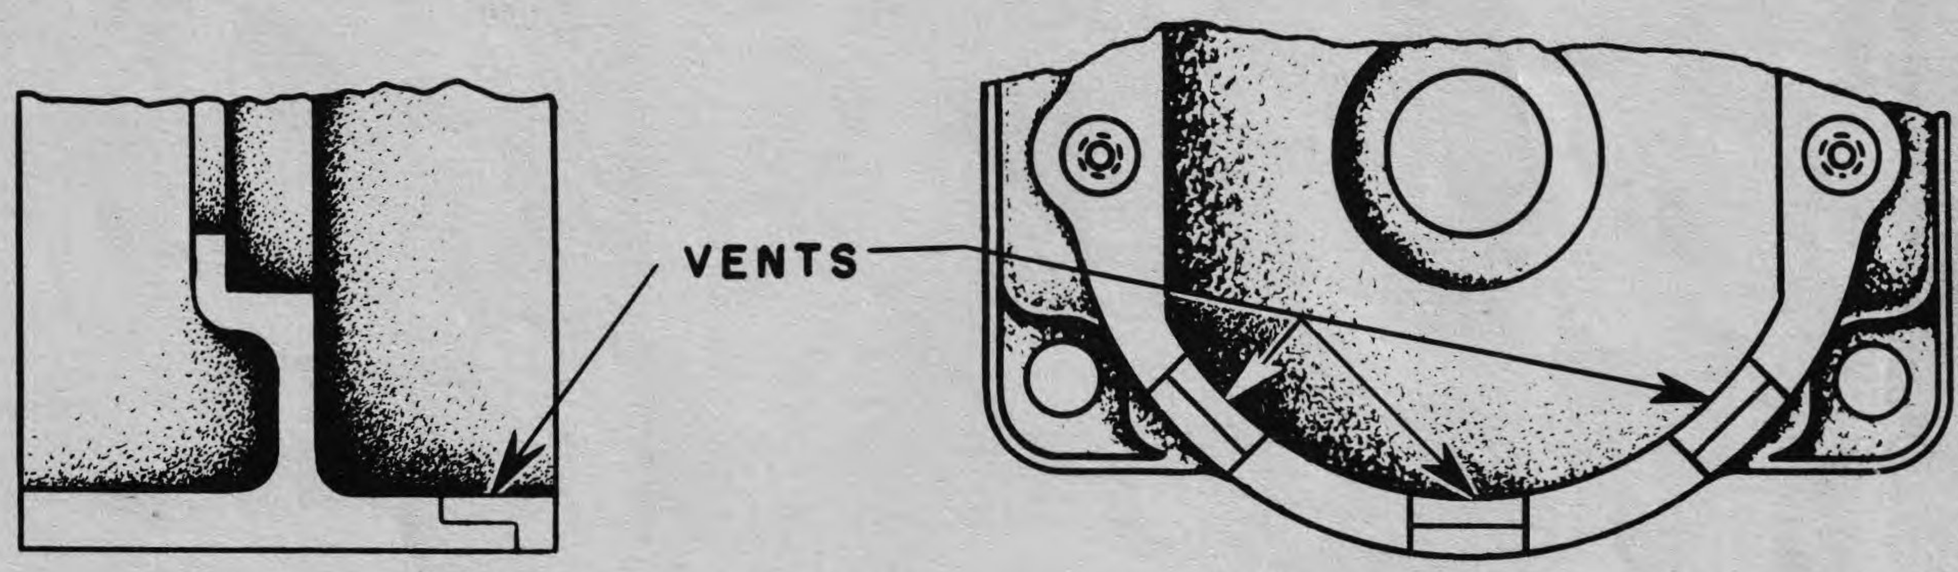
GX2430 End Cap

Reports from the field indicate that during rain difficulty has been experienced with the FM-XV4C73 vertical magneto due to water getting into the end cap through the present vent holes.

End cap GX2430 originally used on this magneto should be replaced, no charge, by end cap identified as LY2430 on all FM-XV4C73 magnetos. If the magneto has not been used, the GX2430 end cap removed may be returned for credit.
