# AUTO ELECTRIC CORNER — Drive Doctor, Corrosion Issues and HID Headlights

## Drives...and Ford Diesel Starters...!

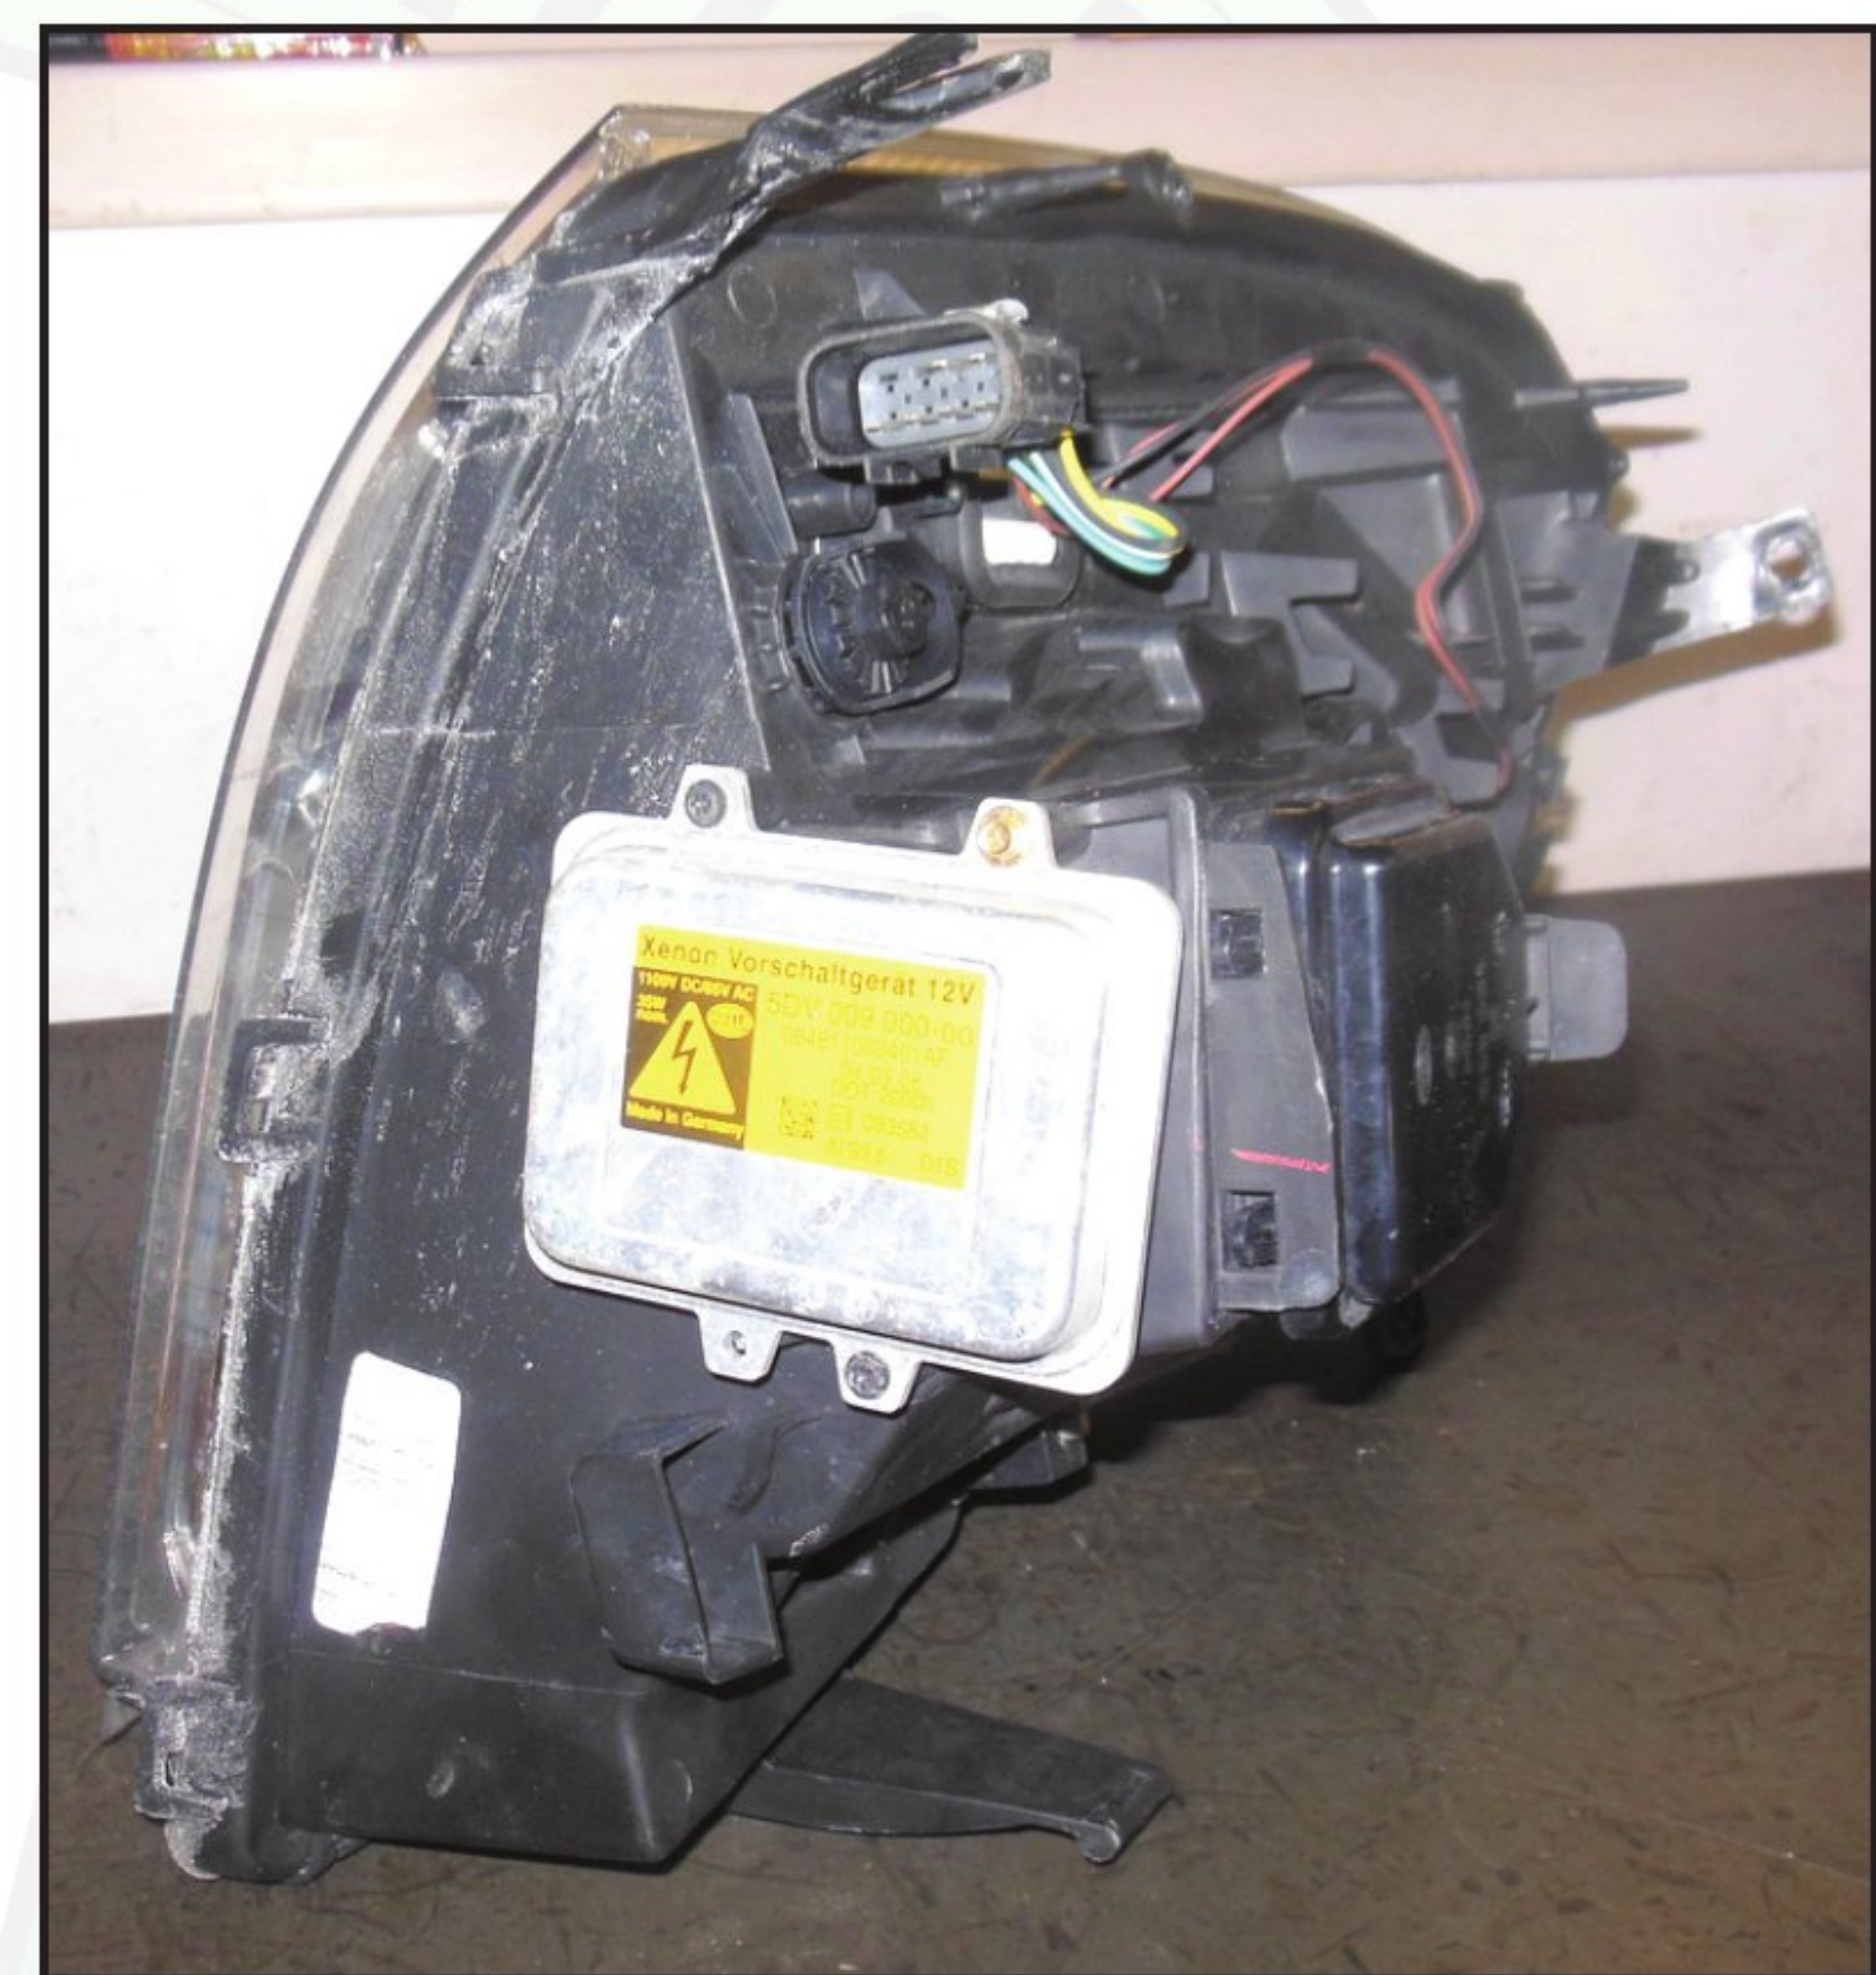
The HID (High Intensity Discharge) headlights use a ballast, much like your florescent shop-light to fire a strong arc across two electrodes inside of an enclosed capsule filled with a metallic vapor. Once the arc starts between the two electrodes, the metallic vapor reacts and releases energy in the form of light. Figure-5 shows the complete headlight assembly of a 2009 Cadillac Escalade with Xenon (HID) lighting, and Figure-6 shows the ballast.

Figure 5 – The Xenon HID headlight assembly for 2009 Cadillac Escalade

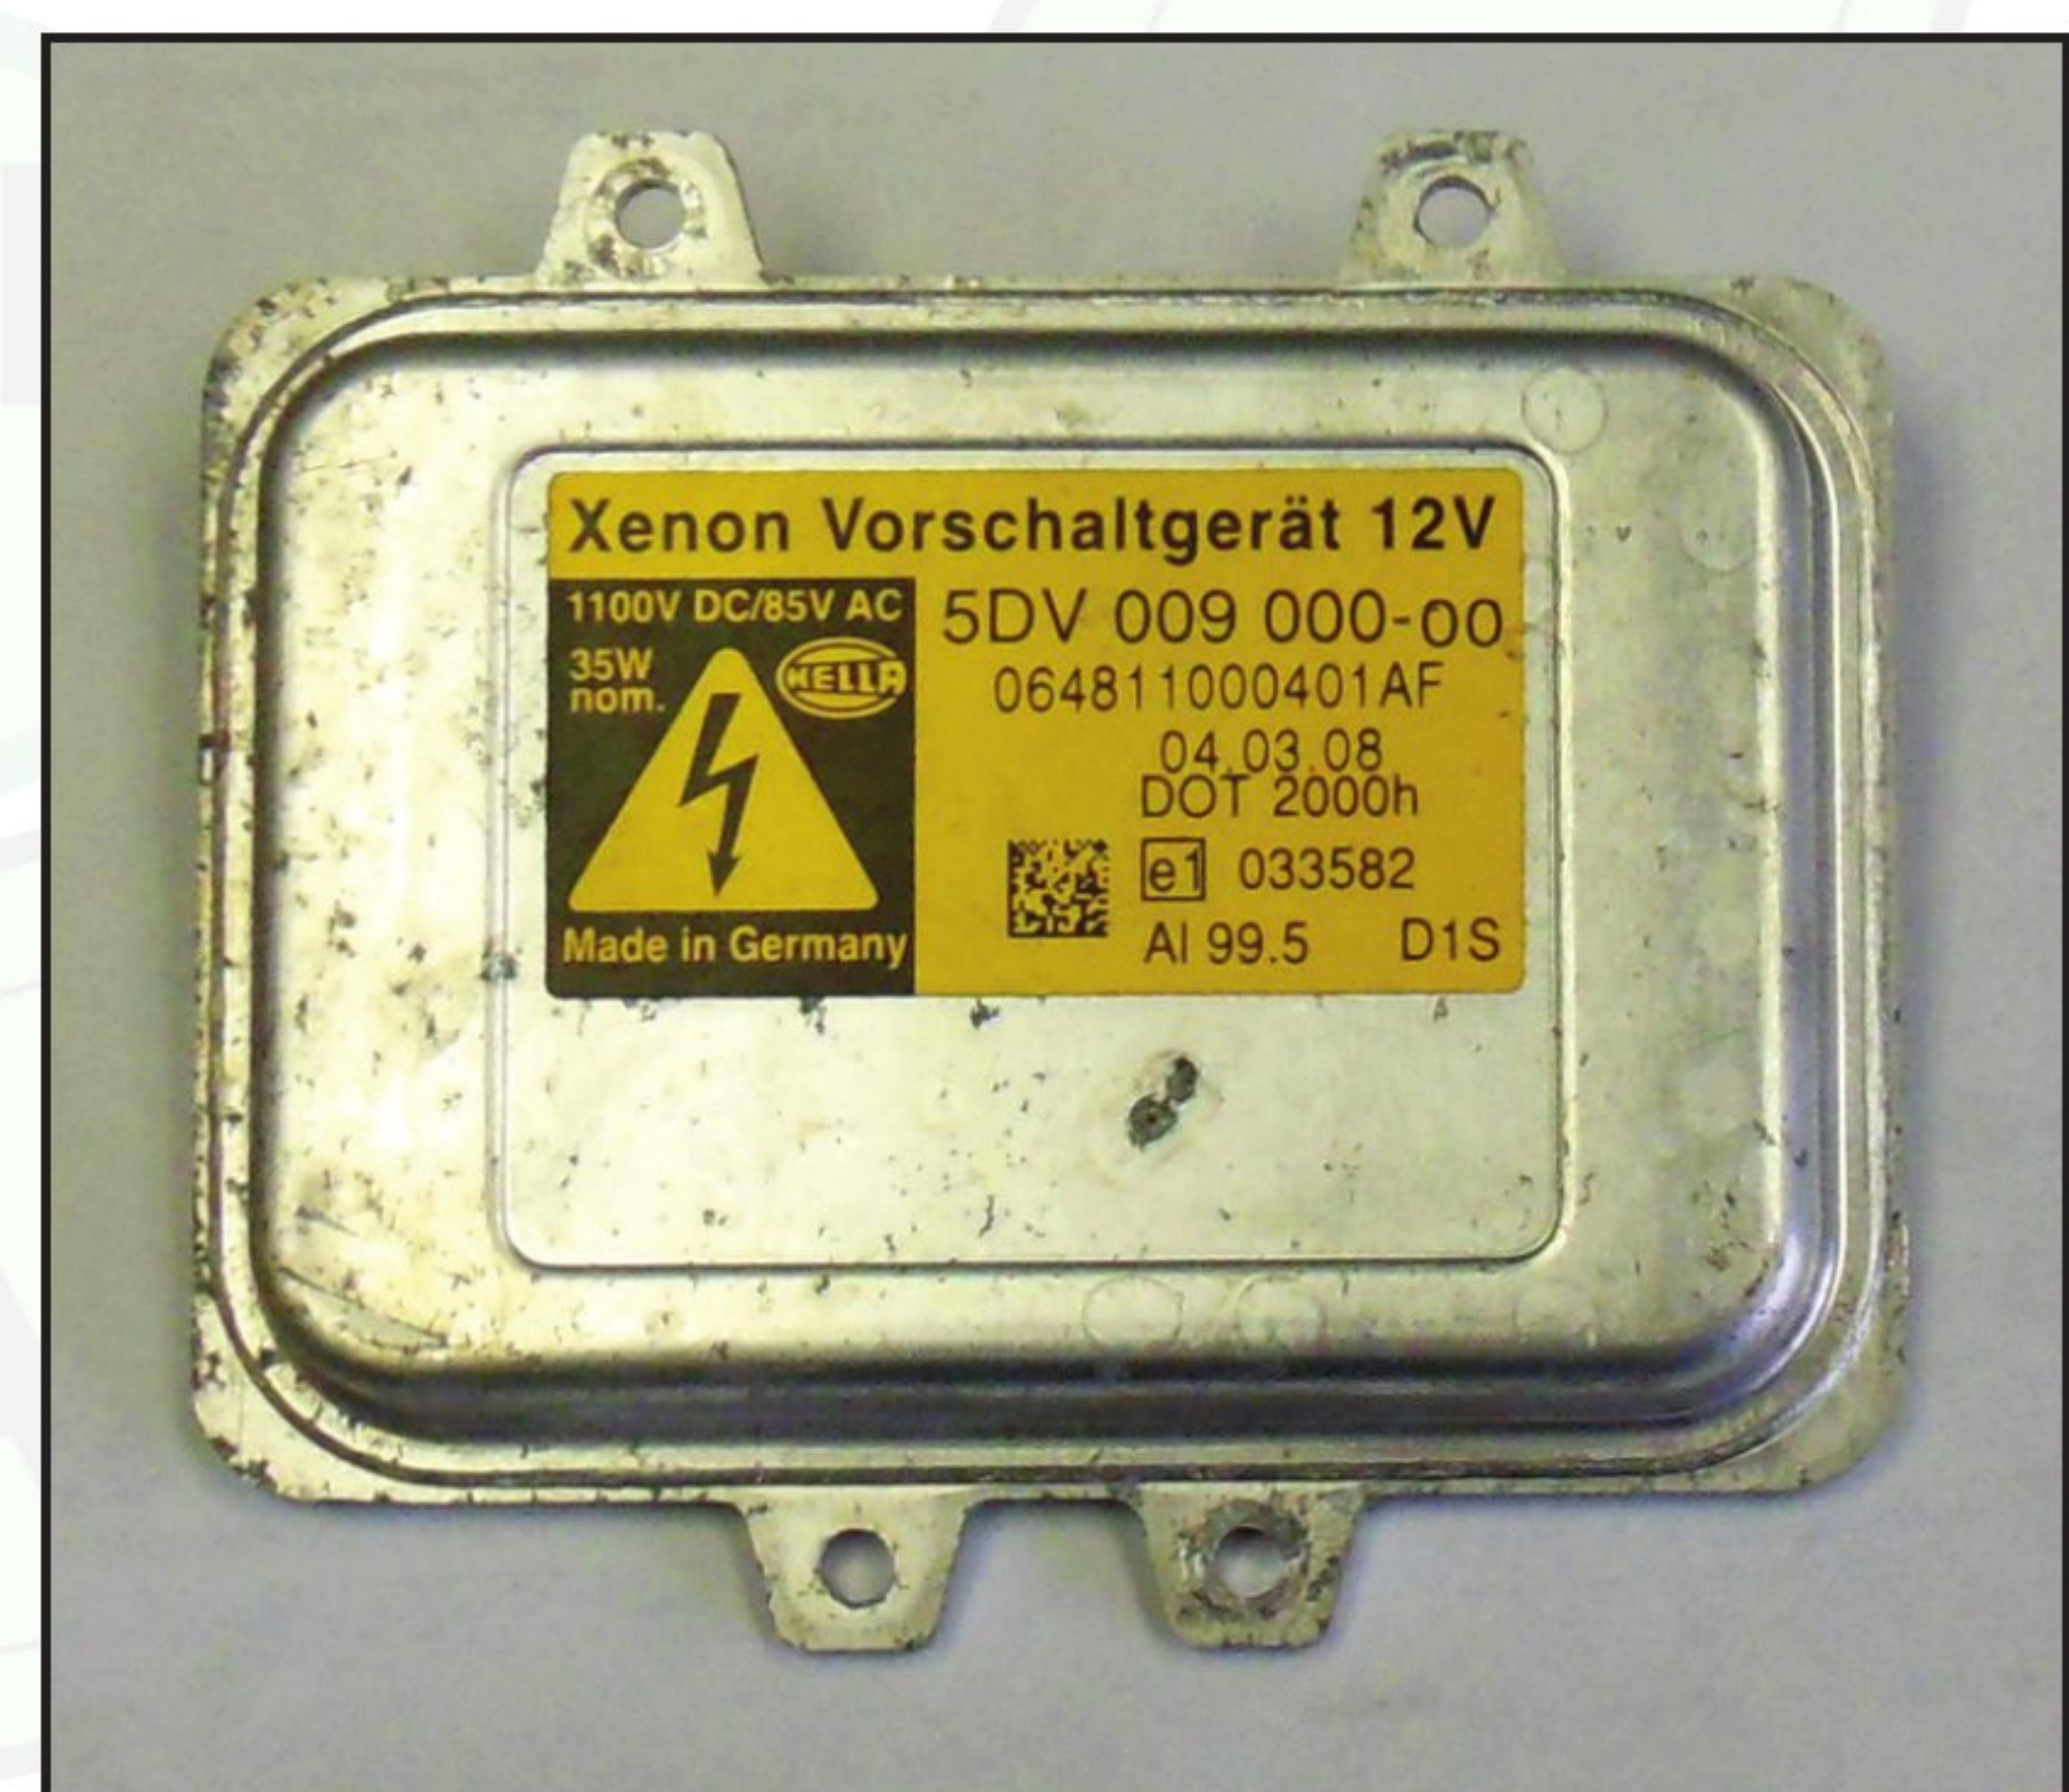
Figure 6 – The HID ballast made by Hella in Germany
