# TECH TIPS

**Applications:** Various Coach Applications

# WHY MOTORCOACHES MAY BURN

(A MECHANICAL ANALYSIS)

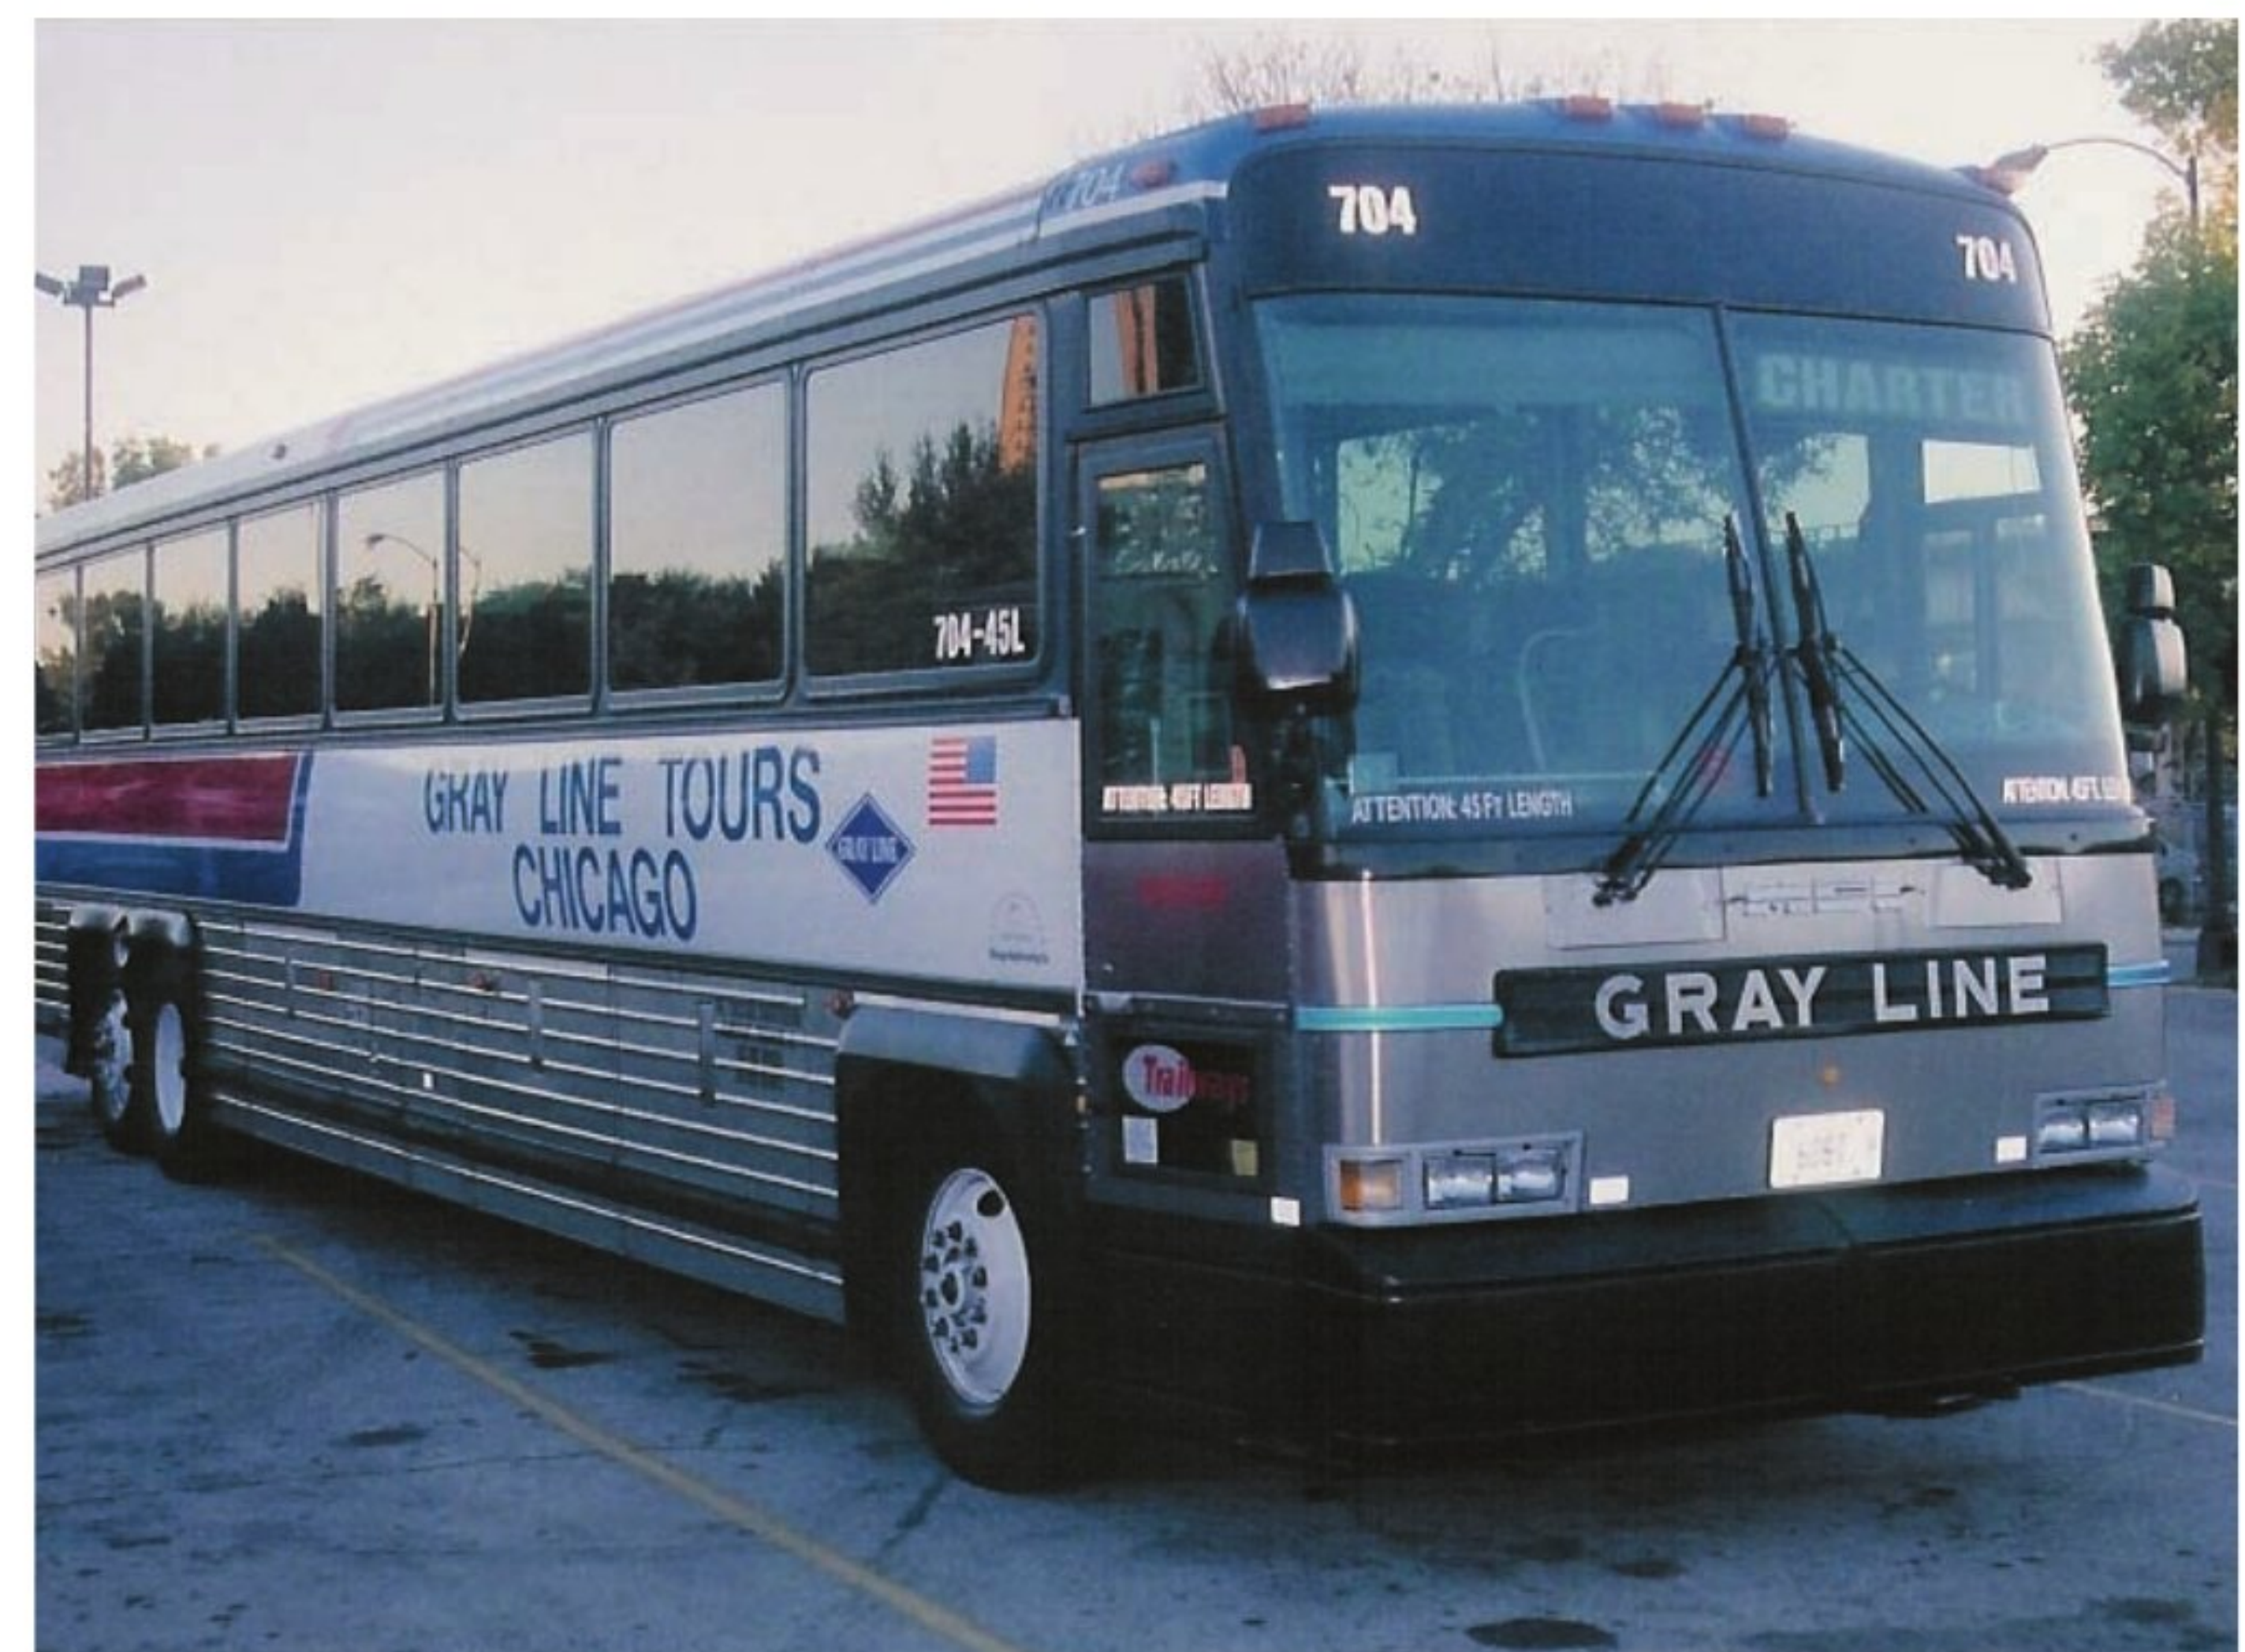
Photo 2: MCI DL-3

**Temperature Mapping:** Temperature mapping is a technique used to determine the surface temperature of various components on the motorcoach. By using a non-contact laser thermometer, a map of component surface temperatures can be established for any particular vehicle. For this study an MCI DL-3 was used (Photo 2).

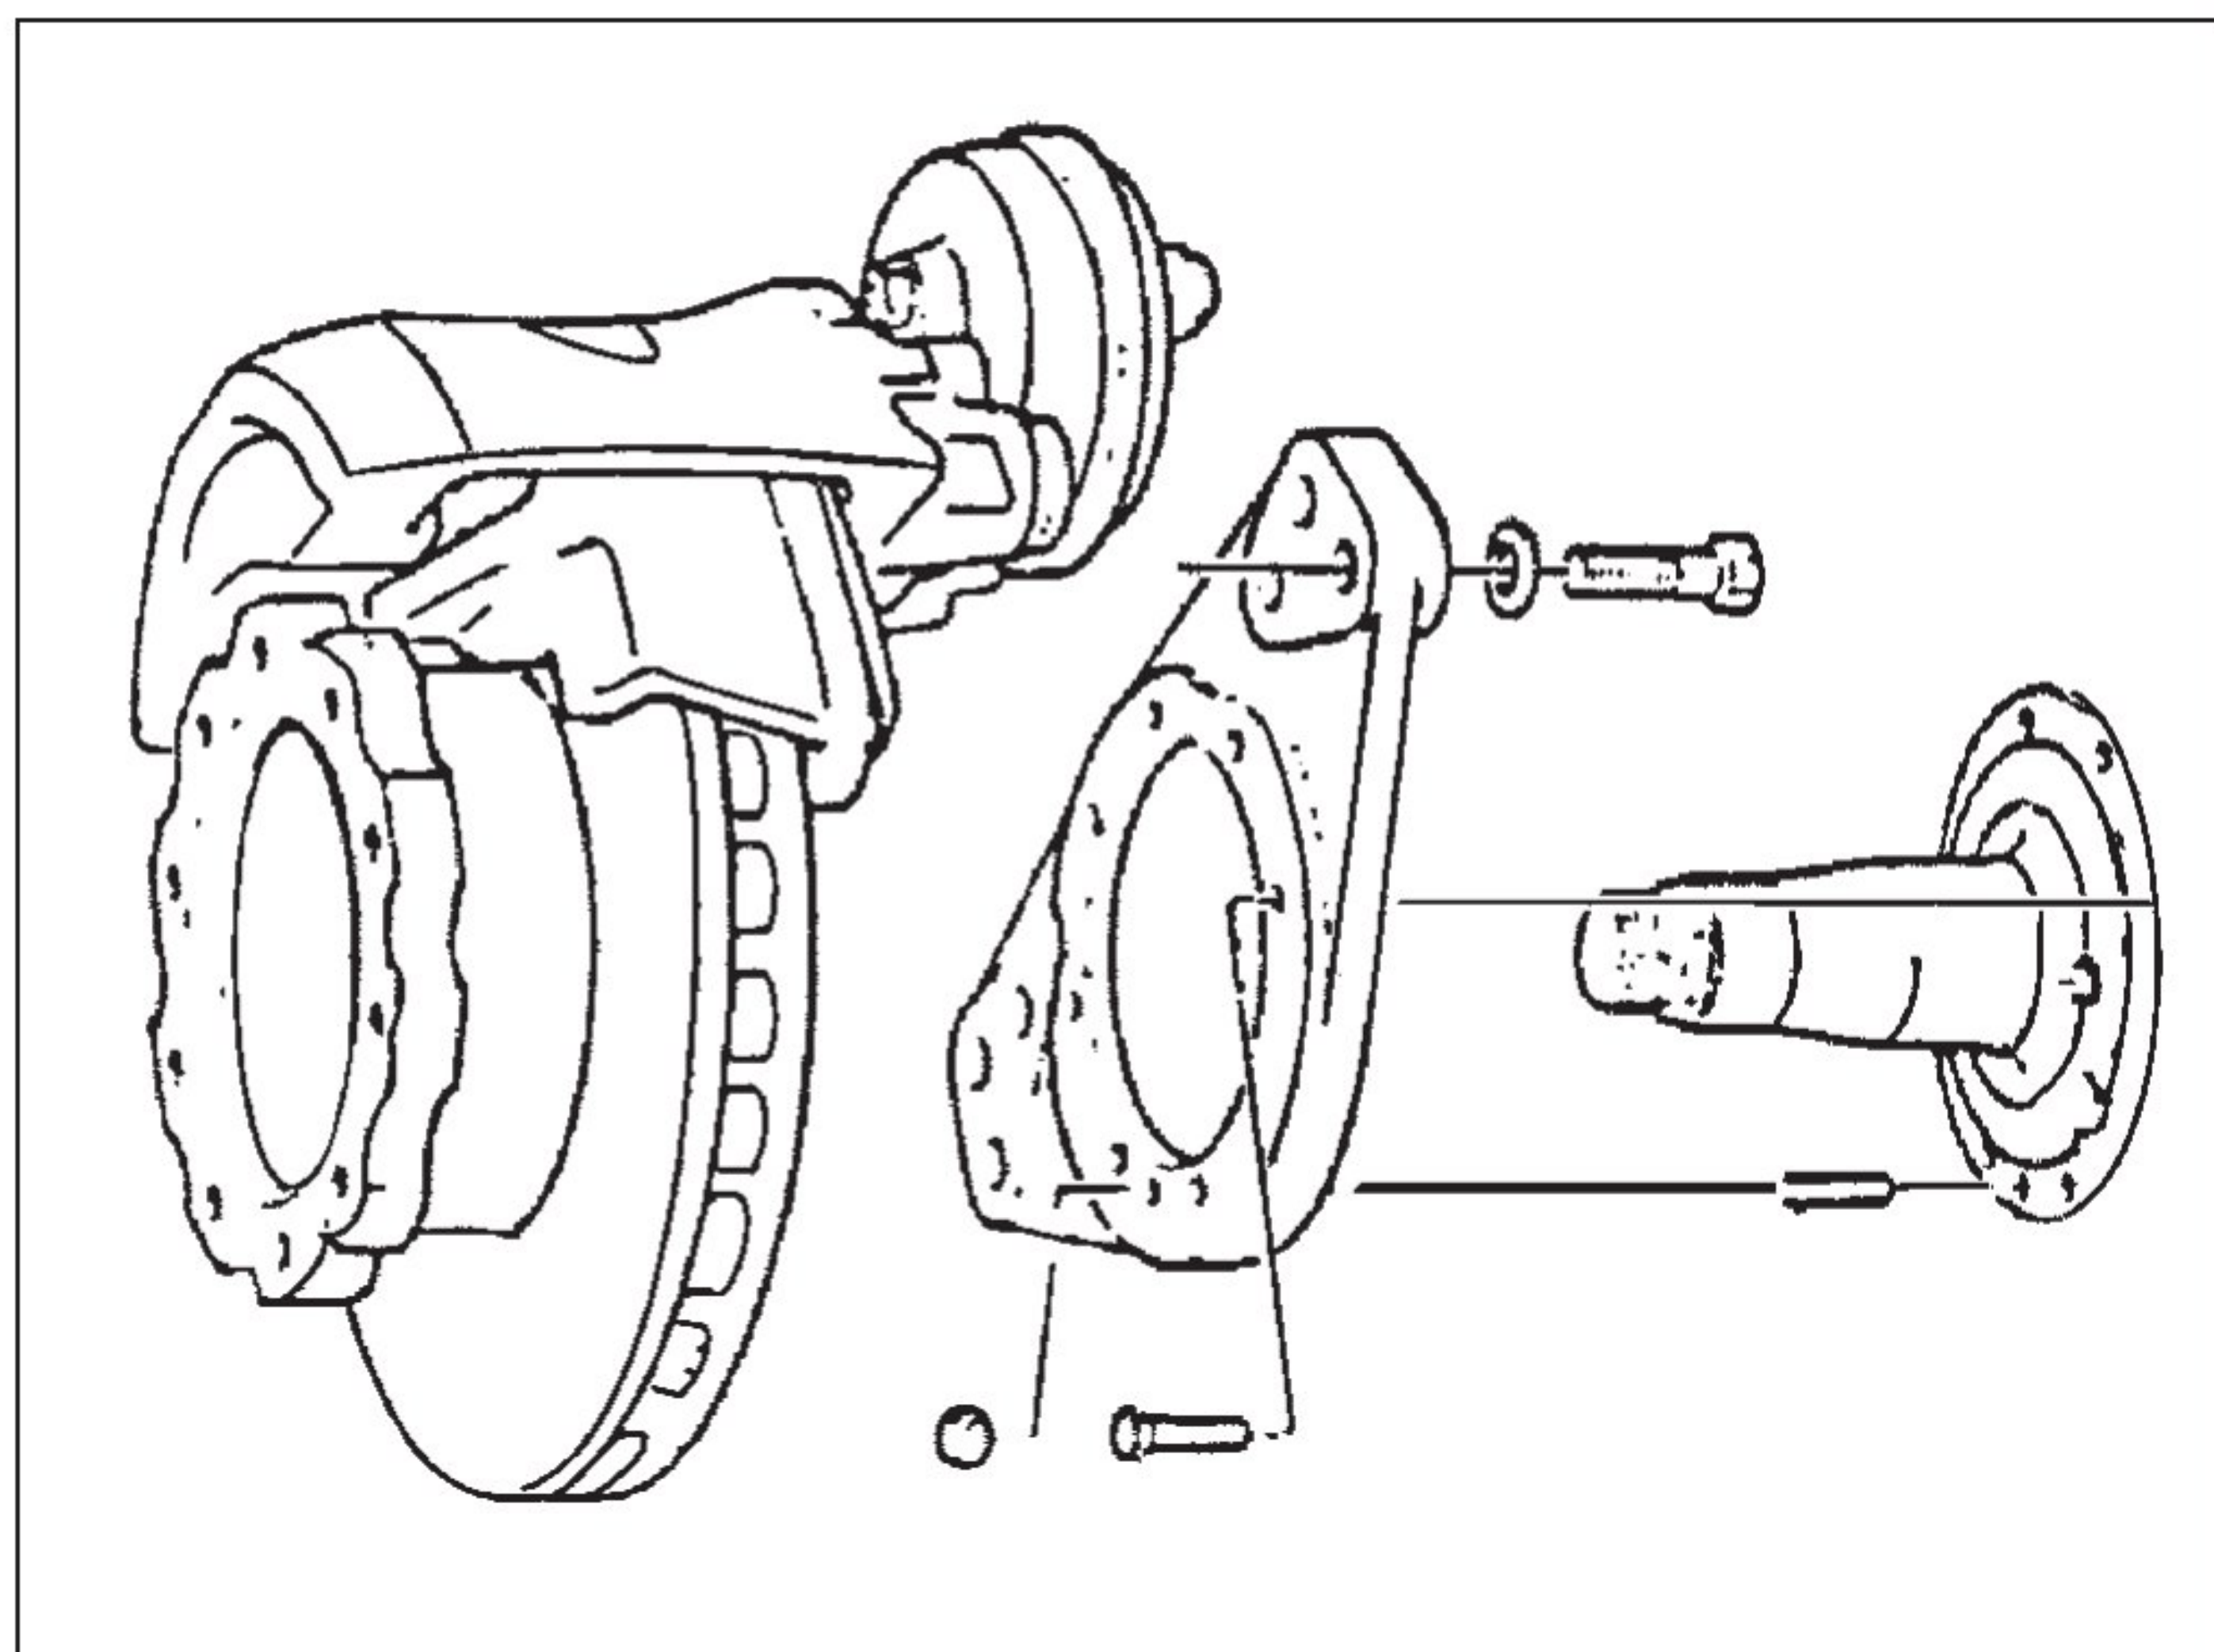
Figure 4: Disc Brake, Caliper, Spider & Spindle

An additional risk exists, with disc brake applications, during a wheel bearing/hub failure. That is, as the outer bearing begins to fail, the hub load is transferred from the outer bearing to the brake caliper, brake pads and rotor. Once the outer bearing has failed completely, no longer able to support the hub load, the caliper, brake pads and rotor are then supporting that particular wheel end (Photos 9 & 10).

This is due to the fact that the caliper rides in the caliper carrier which is attached to the spider which is mounted to the axle tube/spindle (Fig. 4).

Once the brake caliper begins carrying the load, at that particular wheel end, the surface temperature of the brake pads and rotor (or drum) rise well above the auto-ignition temperature of the surrounding combustibles (due to friction) and eventually igniting them. The combustible material typically ignited by this failure mode is the tire(s). Tires generally revert (melt) at approximately 250°F and catch fire over the 600°F mark. It is common, although not mandatory, for the tire fire to occur when the vehicle comes to a stop. This is the condition with the least amount of air flow circulating around the brake rotors, brake drums and tires. Without air flow around these items, their temperature rises rapidly and is transmitted to the tire—subsequently igniting it. This concept of brake caliper/pad/rotor supporting the hub load can typically be seen by a thinner more worn outside brake pad as compared to the inner pad. This is due to the hub moving outward, away from the spindle. As a result of this temporary load support from the caliper, the

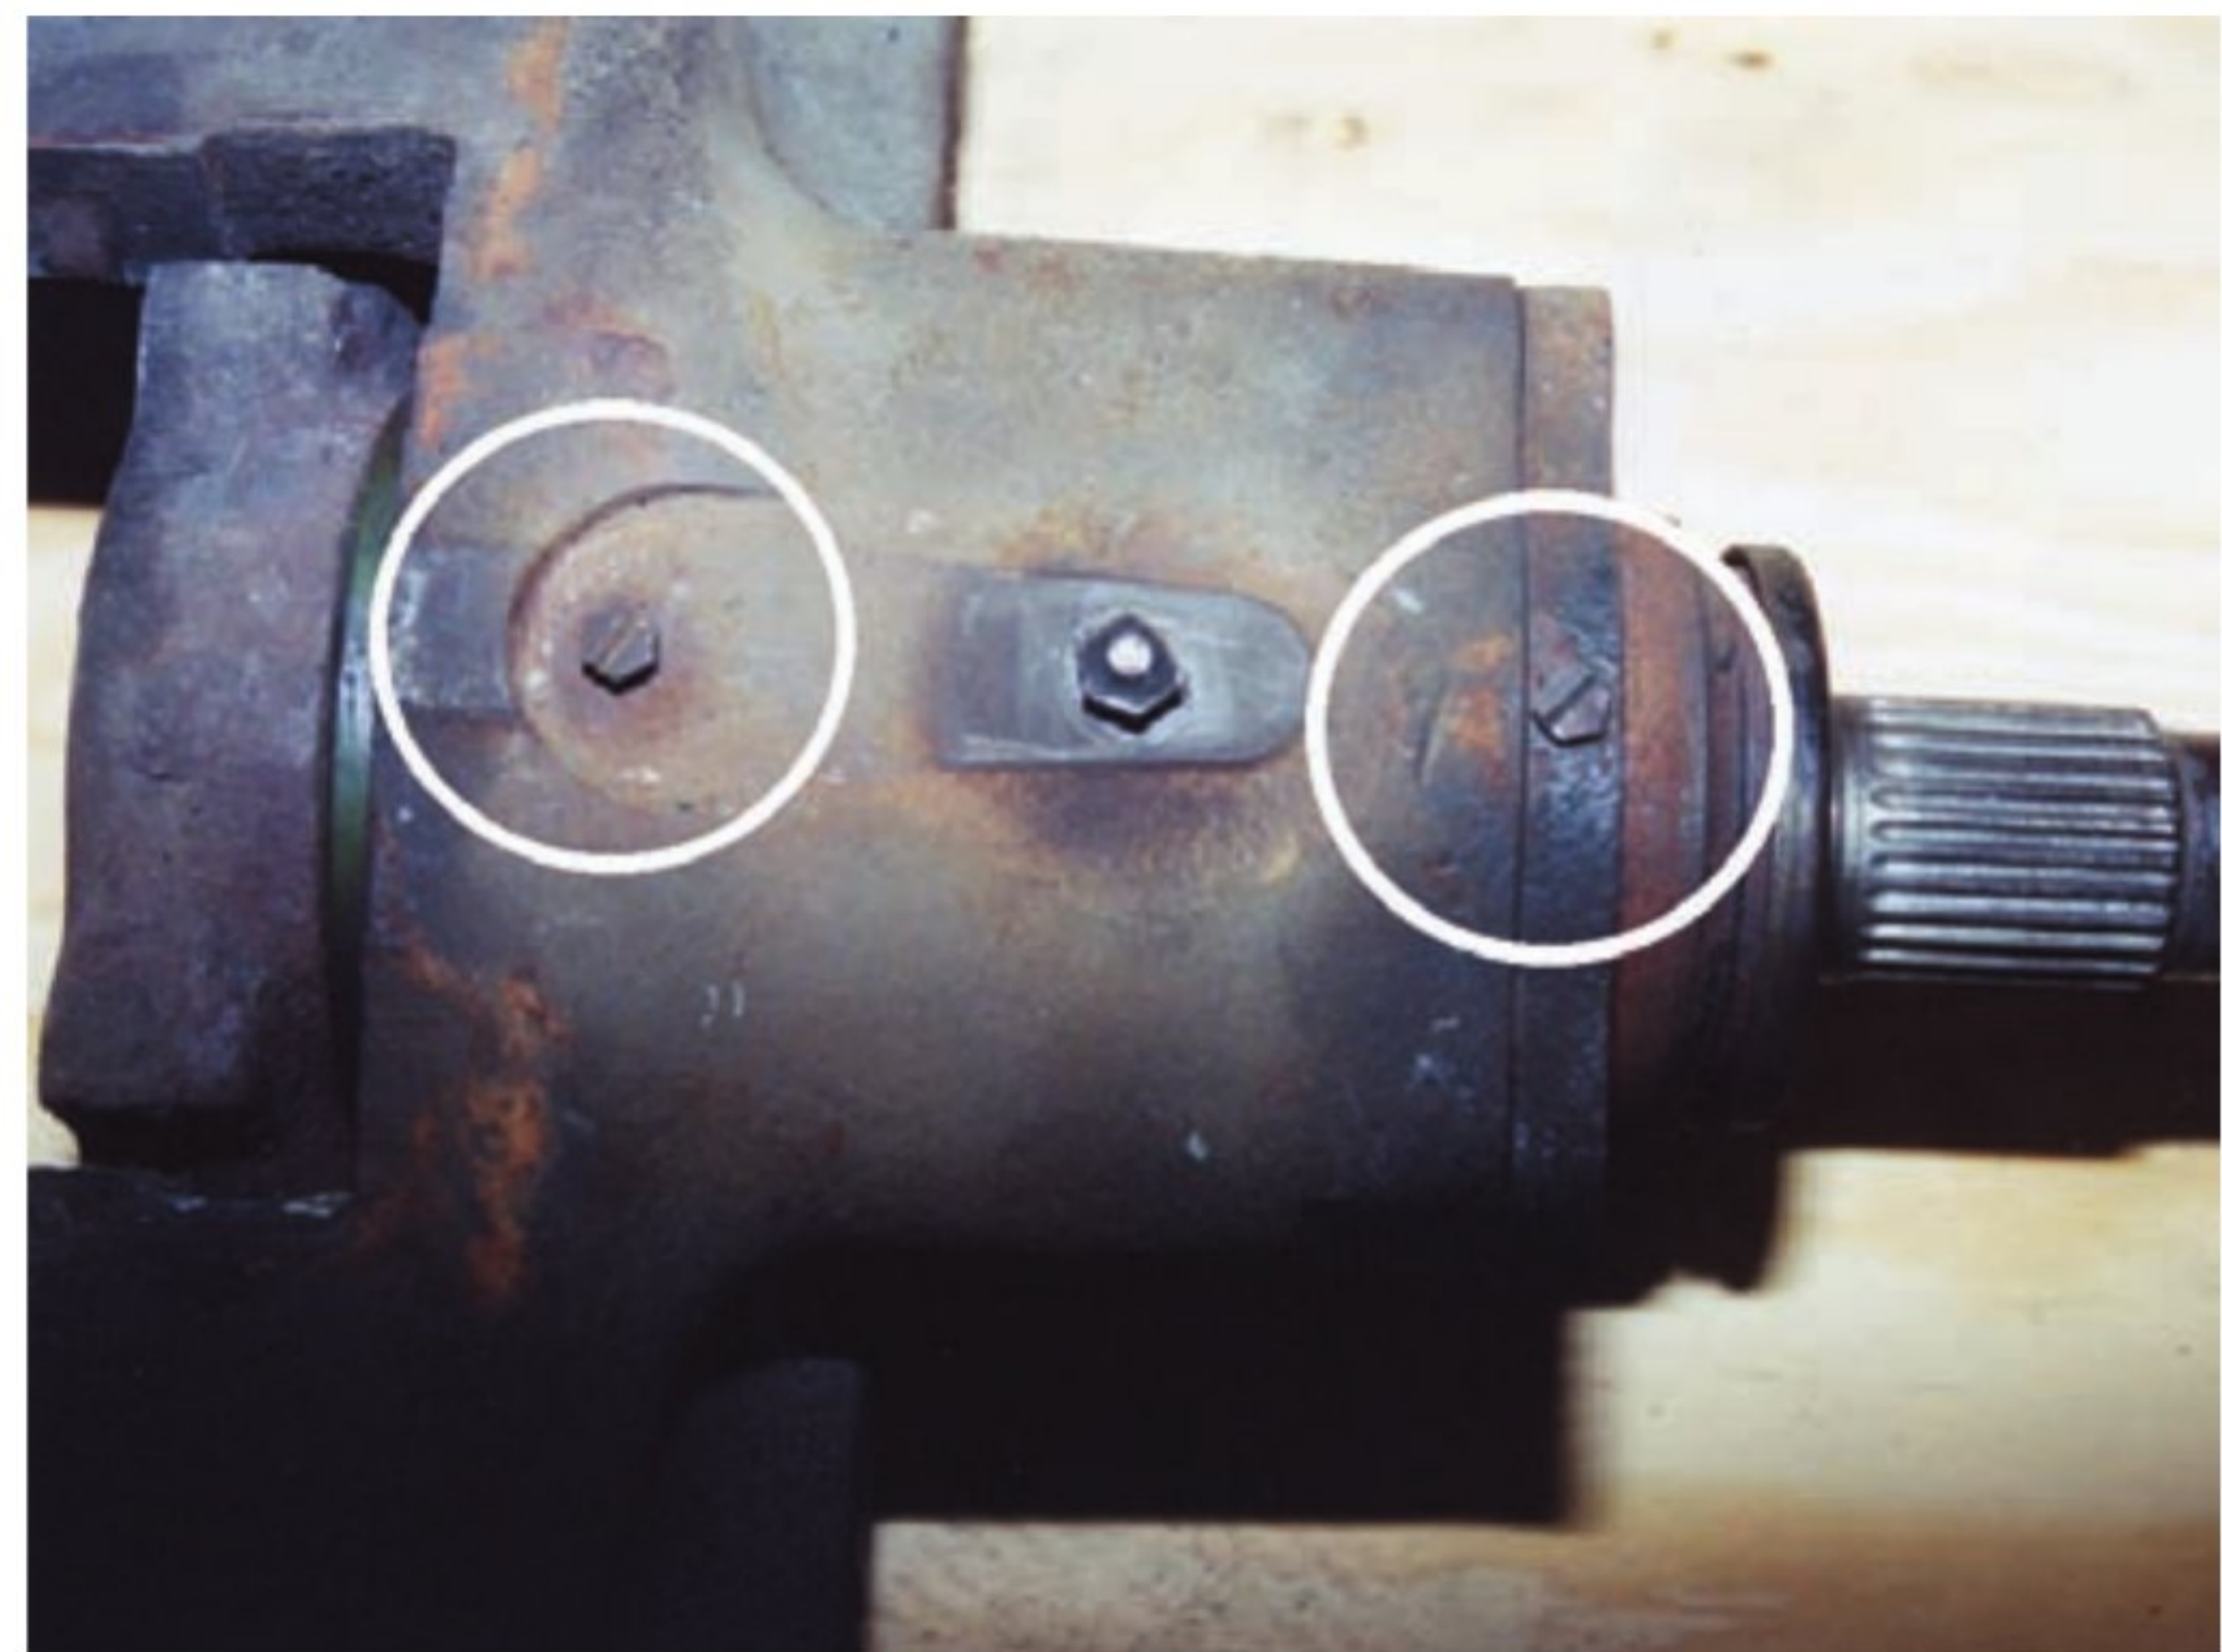
**Disc Brakes:** A “frozen” disc brake caliper can generate enough heat to ignite the surrounding combustible materials and sustain a fire. Proper inspection and lubrication intervals should be adhered to along with a periodic activation and release sequence confirming that the calipers are releasing and allowing the rotor to turn freely. This scenario applies to both air and hydraulic disc brakes. A simple method to determine the proper action of the calipers is to insert a feeler gauge (.002” - .004”) between the brake pad and rotor. By applying the service brakes a technician can feel if the gauge goes into this space, remains there upon brake application and is then released upon release of the service brakes. In some early applications, Rockwell disc brakes were used which in some instances were not supplied with grease fittings in the calipers\* (Photo 11, Fig. 5). This very point leads to a “frozen” caliper scenario which, in the author’s direct experience, results in a fire at that wheel end.

Photo 11: Rockwell Caliper ADB-1560

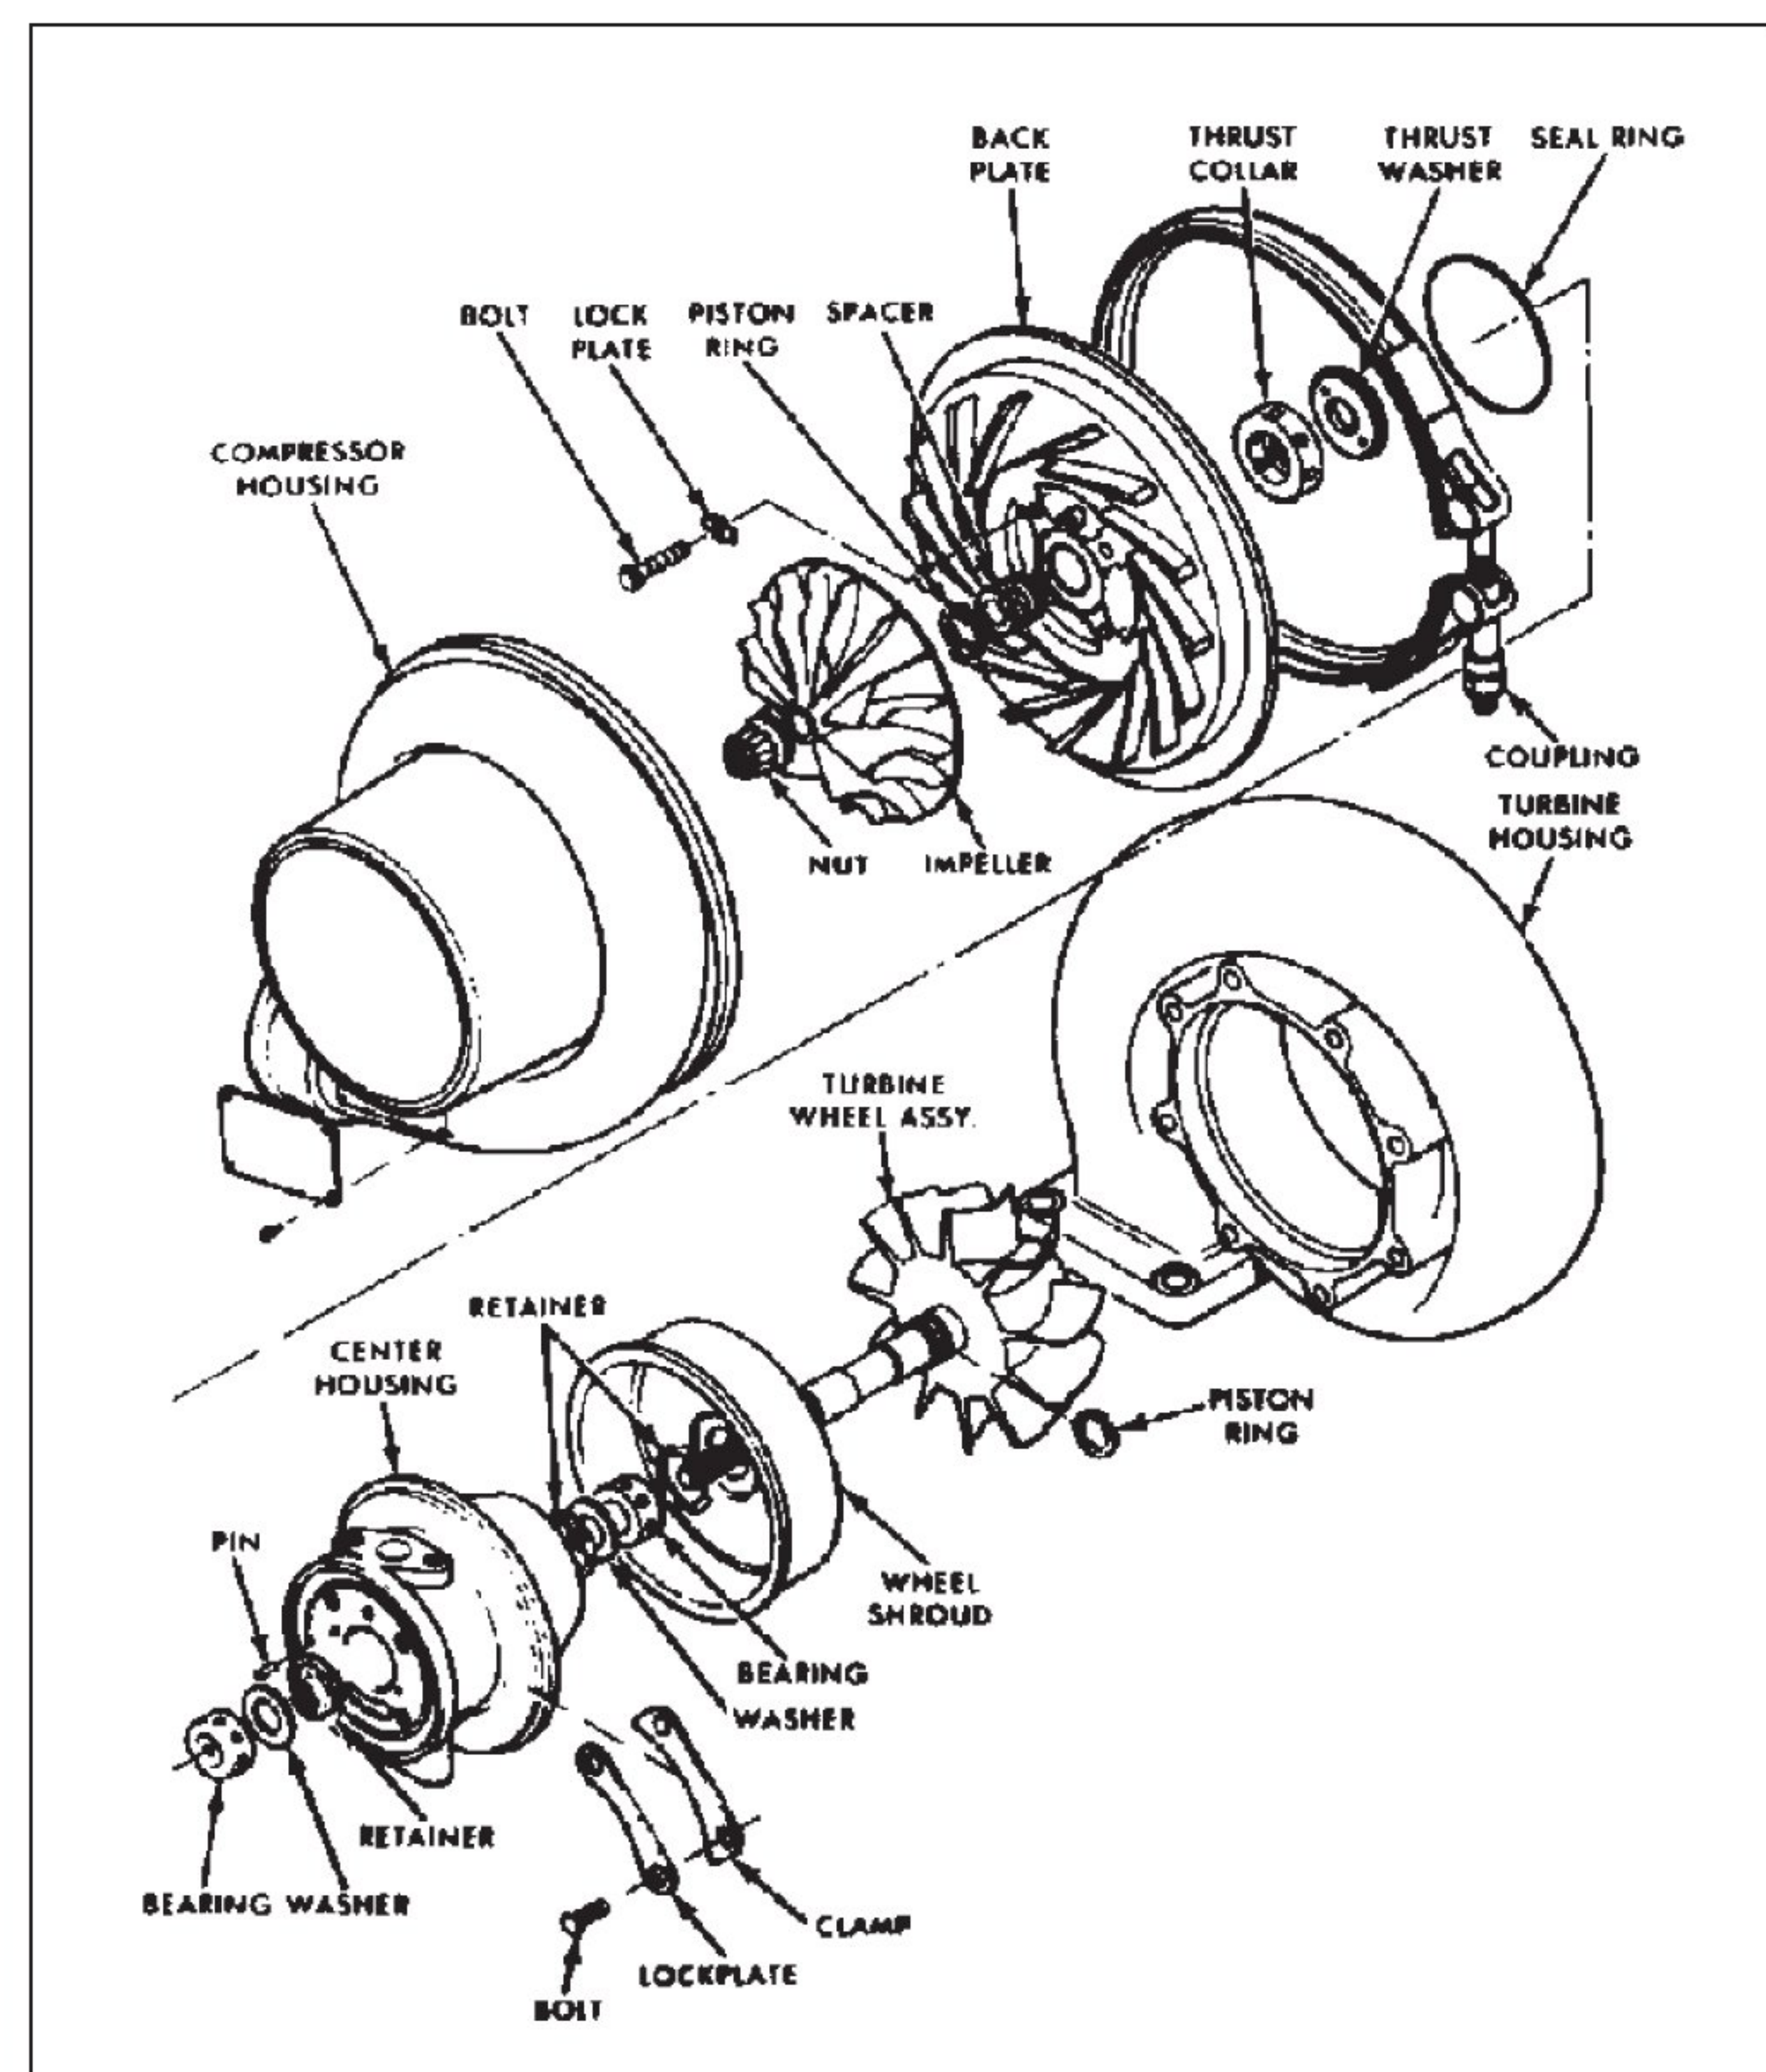
**Turbocharger:** Turbochargers are a dual threat as an ignition component. First, since they are typically very hot, on the surface, they can act as an auto-ignition source. Second, upon their own internal failure, they can become an ignition source by virtue of their own internal lubrication oil. The typical turbocharger supports the shaft of the compressor and turbine with a non-conventional bearing. This is unlike the typical roller bearing. Instead the shaft is supported by

two bearing collars which are supported by the boundary lubrication layer (Fig. 7).

Figure 7: Turbocharger Detail

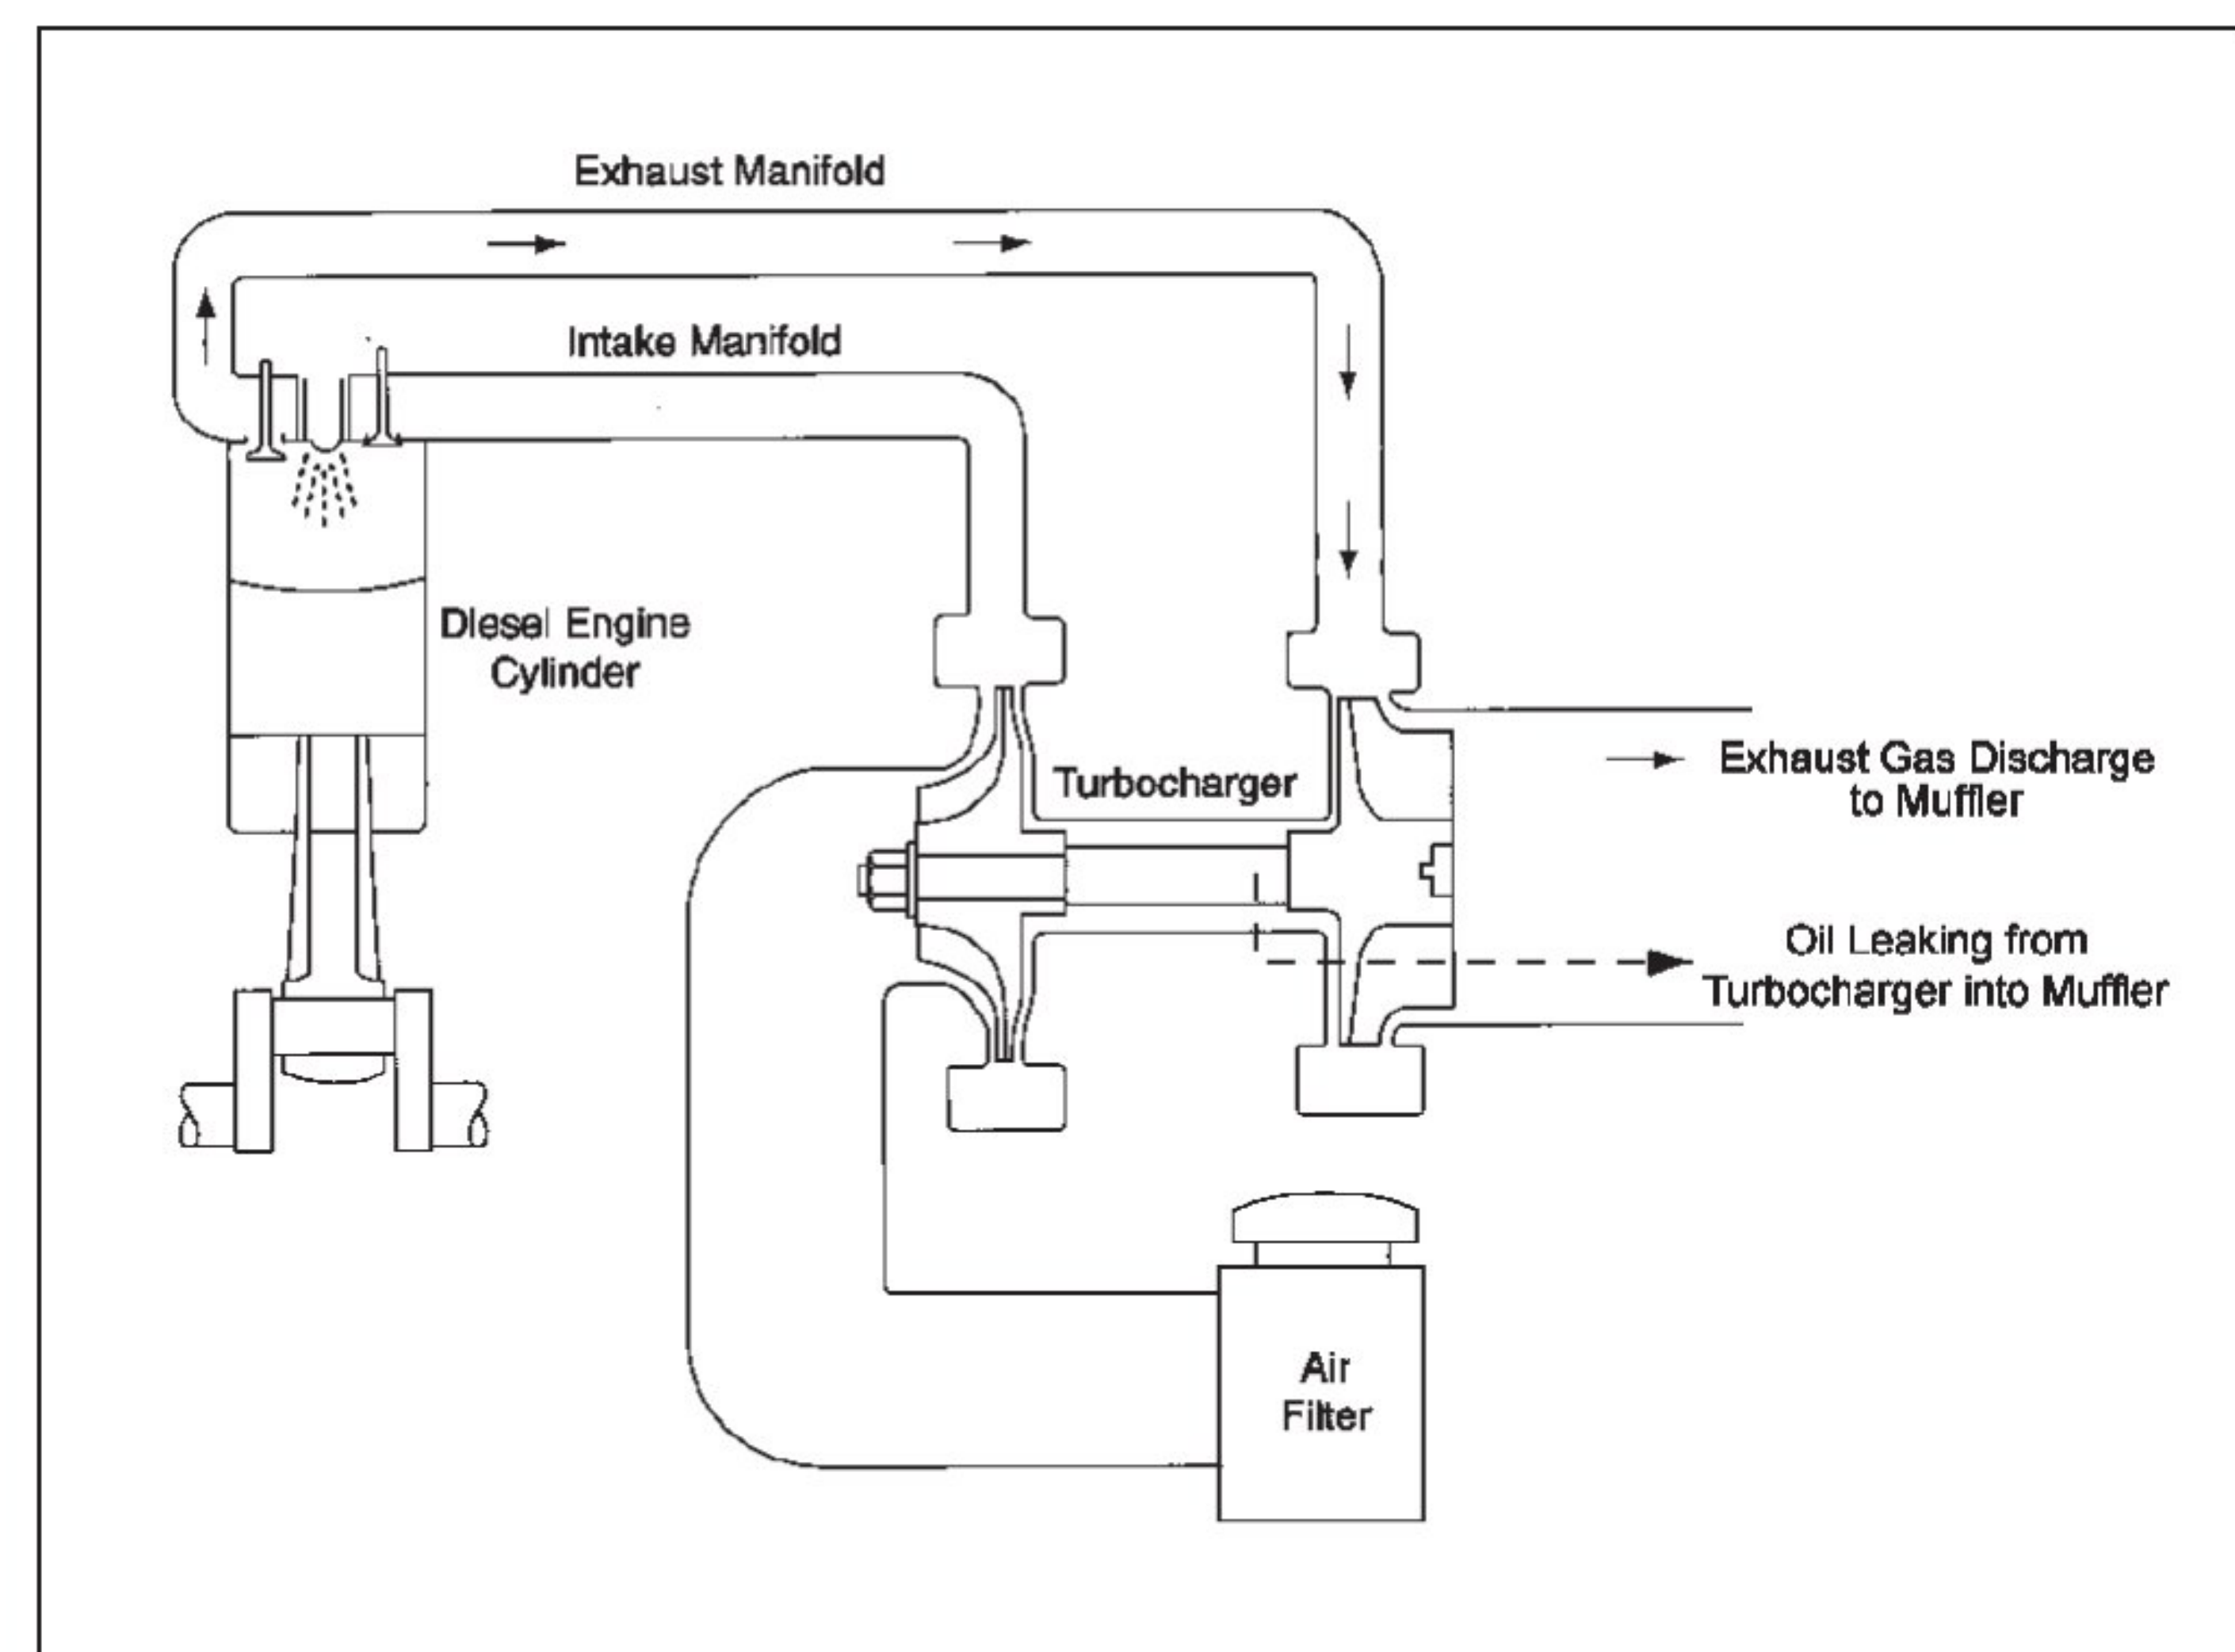
Once the shaft has been re-oriented as a result of any one of the aforementioned failure modes, the shaft seal(s), which controls the lubrication oil within the bearing cavity, subsequently fails allowing oil to enter directly into the hot side (turbine) of the housing and then directly into the exhaust system (Fig. 8). This can create and auto-ignition fire within the turbocharger itself or exhaust system.

Figure 8: Typical Turbocharger/Intake/Exhaust Schematic
