# TECH TIPS

**Applications:** Various Coach Applications

# WHY MOTORCOACHES MAY BURN

(A MECHANICAL ANALYSIS)

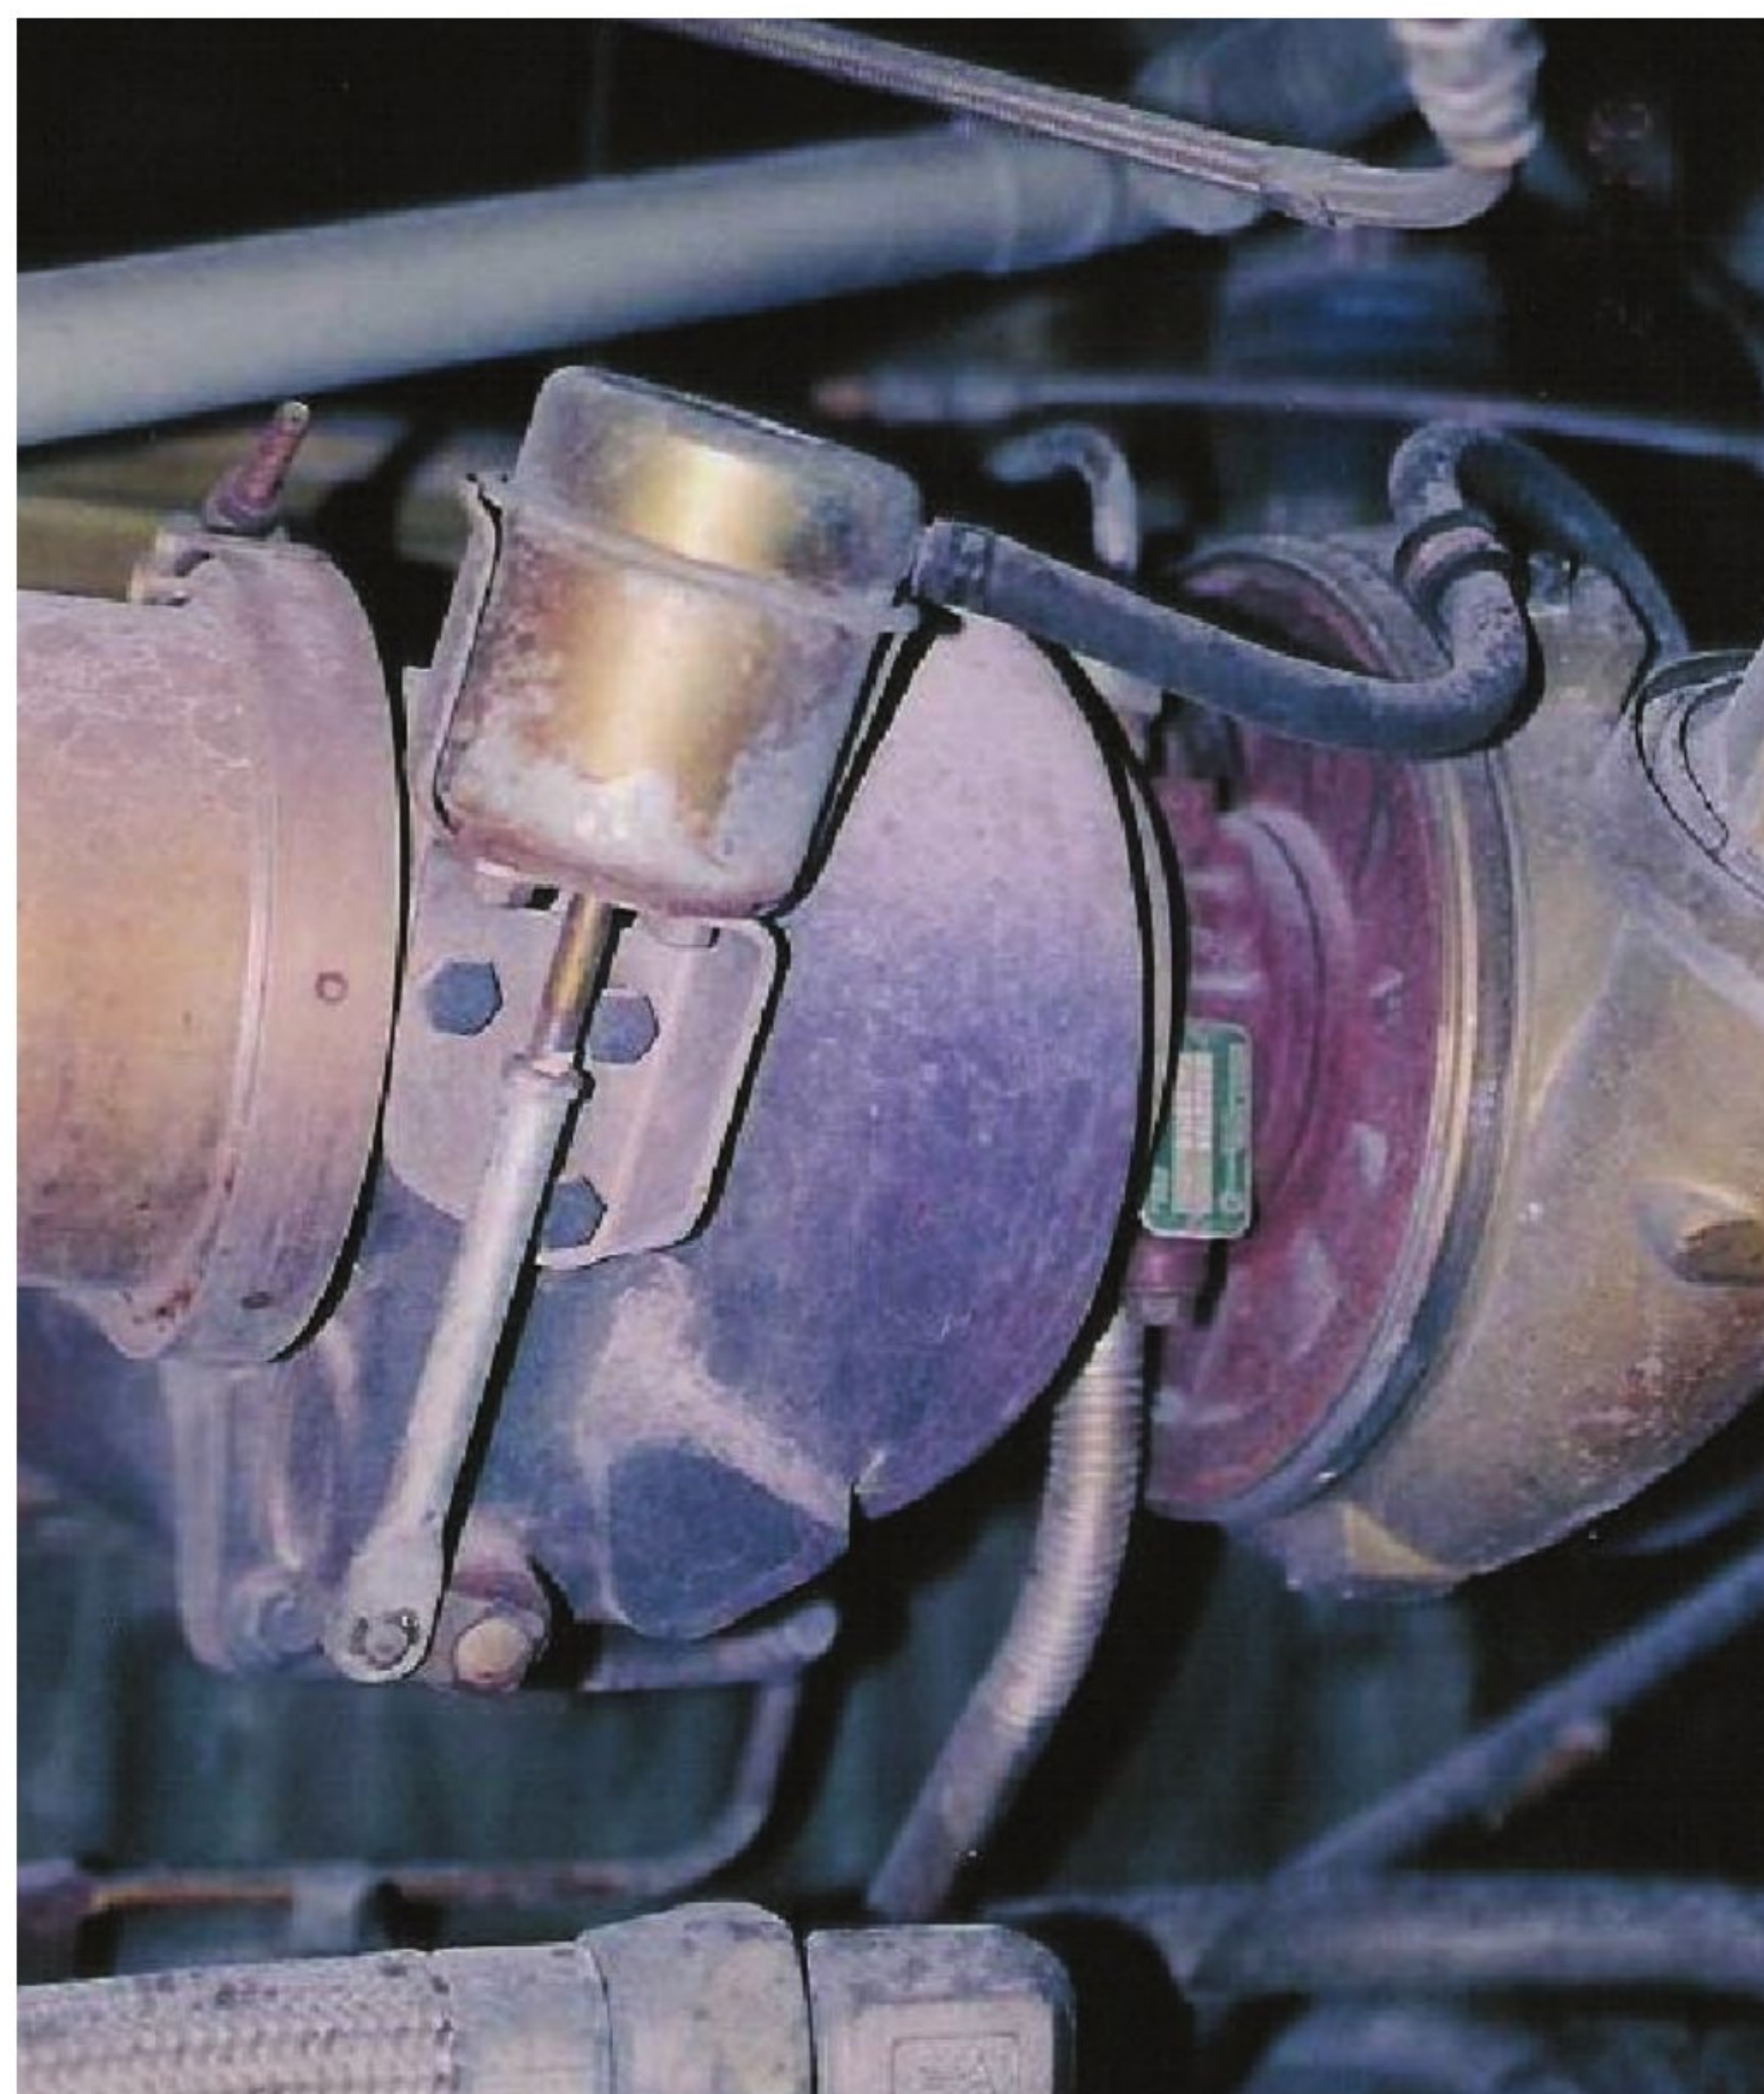
Photo 15: Waste Gate, Series 60

bocharger it should be removed from service and the exhaust system should be thoroughly cleaned. To assist in preventing this failure mode; the turbocharger waste gate or variable geometry function (V.G.T.) must be confirmed. Additionally, the shaft free play, both axially and radially, must be inspected by a mechanic.

To confirm the function of the waste gate (Photo 15), apply regulated air pressure to the boost line (20-30 psi) to exercise the waste gate slave cylinder. To confirm the V.G.T. function (Photo 16), turn on the vehicles' ignition to "on" and observe the slave cylinder motion.

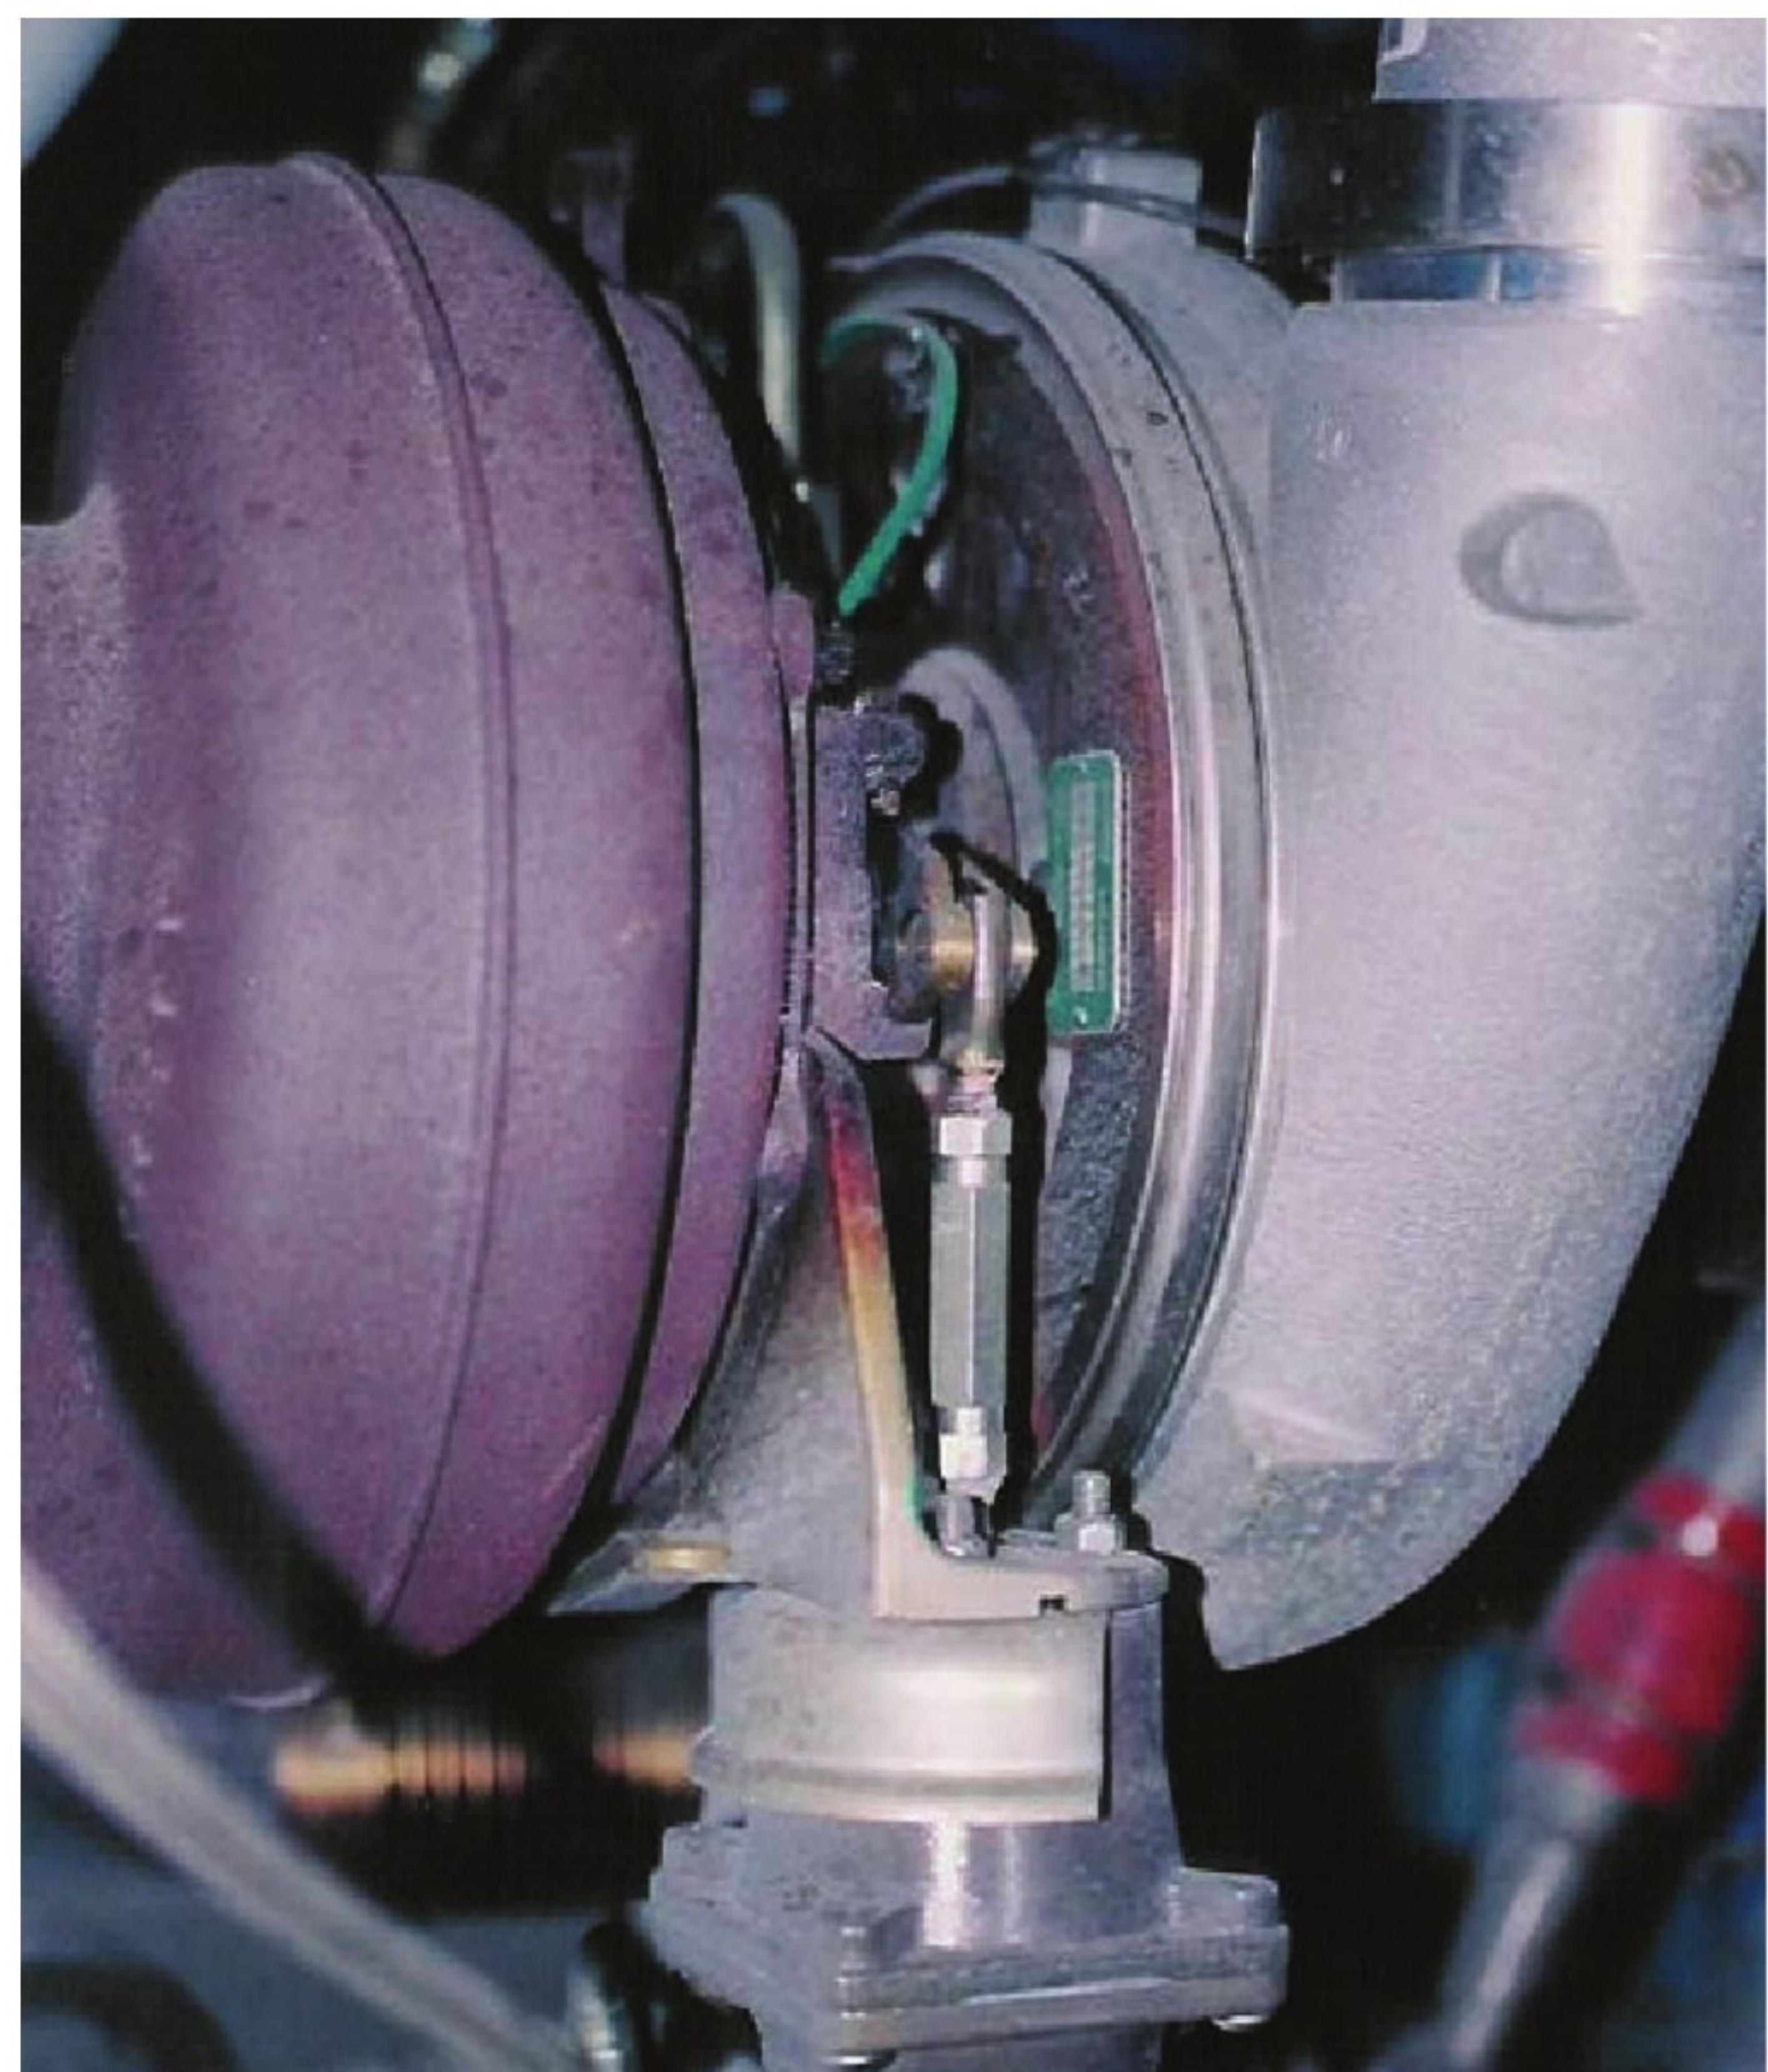
Photo 16: V.G.T., Series 60

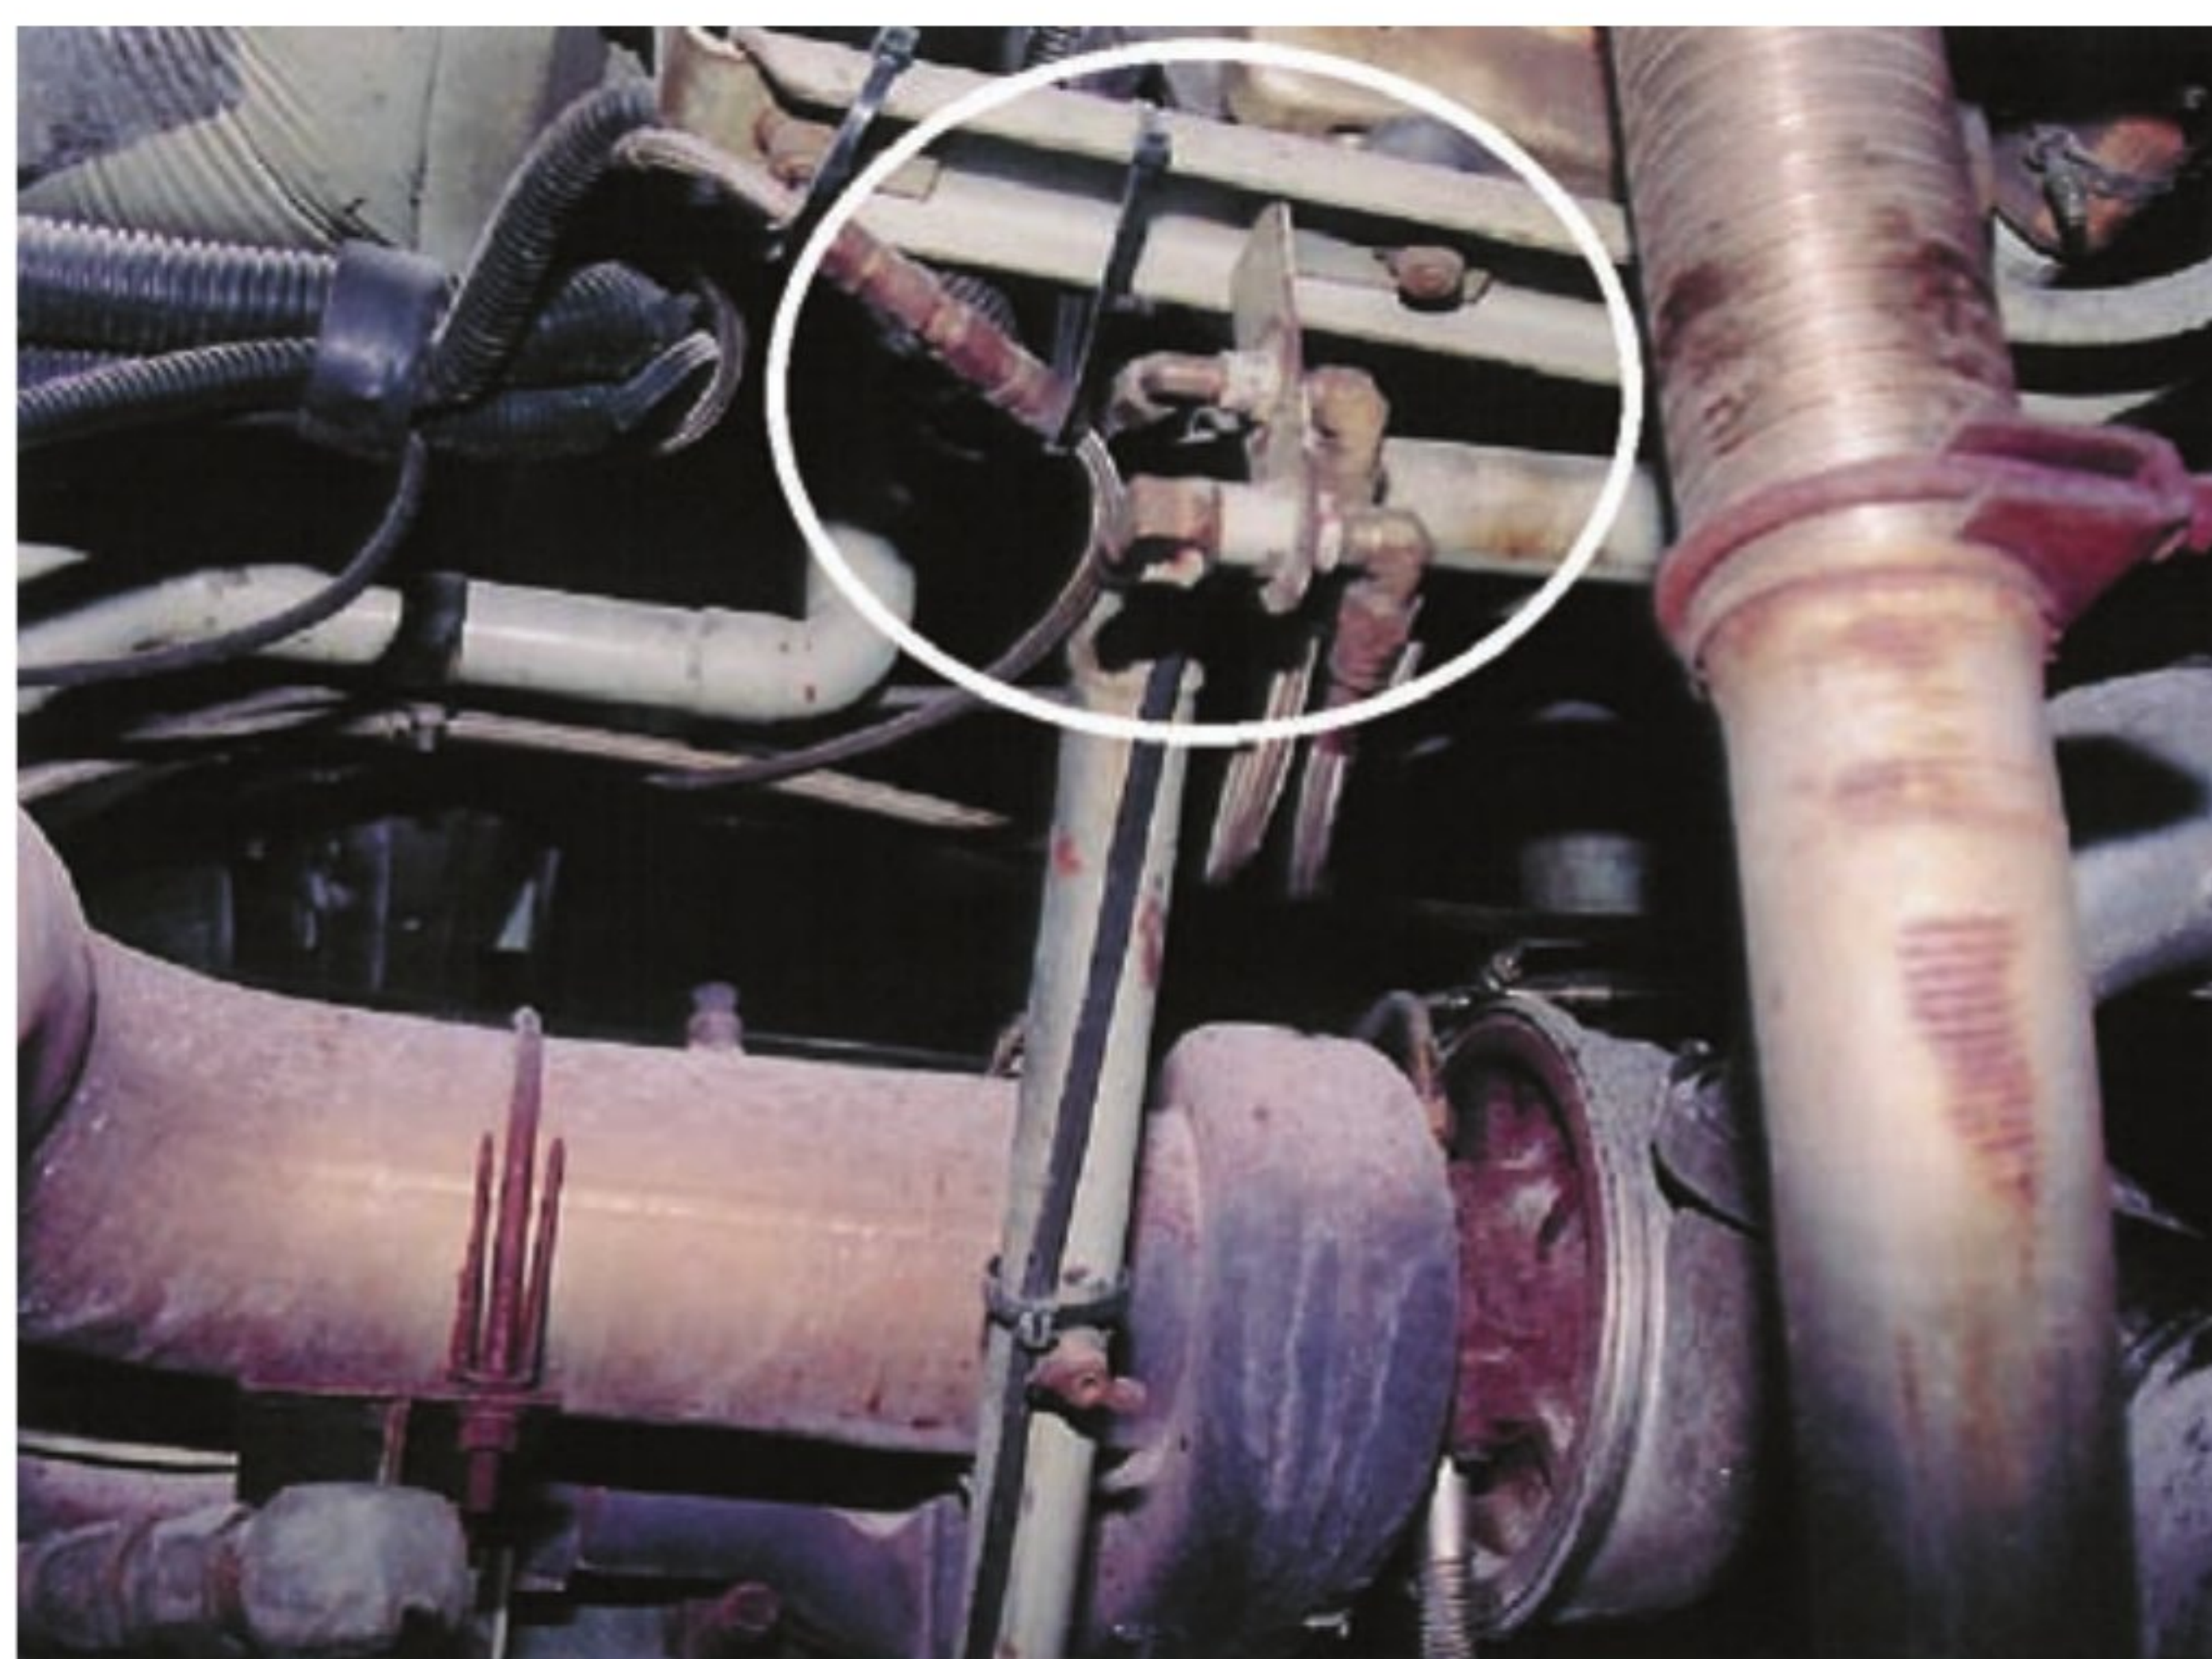
Photo 19: Looped Fuel Lines, Auxiliary Heater

**Auxiliary Heaters:** Also known as diesel furnaces, auxiliary heaters heat the onboard coolant when the engine is not running. However since it is a furnace which burns diesel as fuel it must be periodically inspected for function, control and integrity. Specifically, its cycle time and control must be verified to assure it is functioning when it should be, as well as, turning off when commanded. Additionally, the fuel lines must be inspected to confirm there are no leaks. In fact, in the summer months it is good practice to disconnect the heater function power supply and loop the supply and return fuel lines together (Photo 19). This will assure that fuel does not leak from the furnace itself when not in service. It should be pointed out that the heaters' exhaust pipe (Photo 20), within minutes of heater activation, reaches 375°F and continues to climb approaching the auto-ignition temperature of most of the vehicles fluids. Therefore, it is vital that

any leak, of any fluid in this area, be immediately repaired to minimize high temperature contact and subsequent fire.

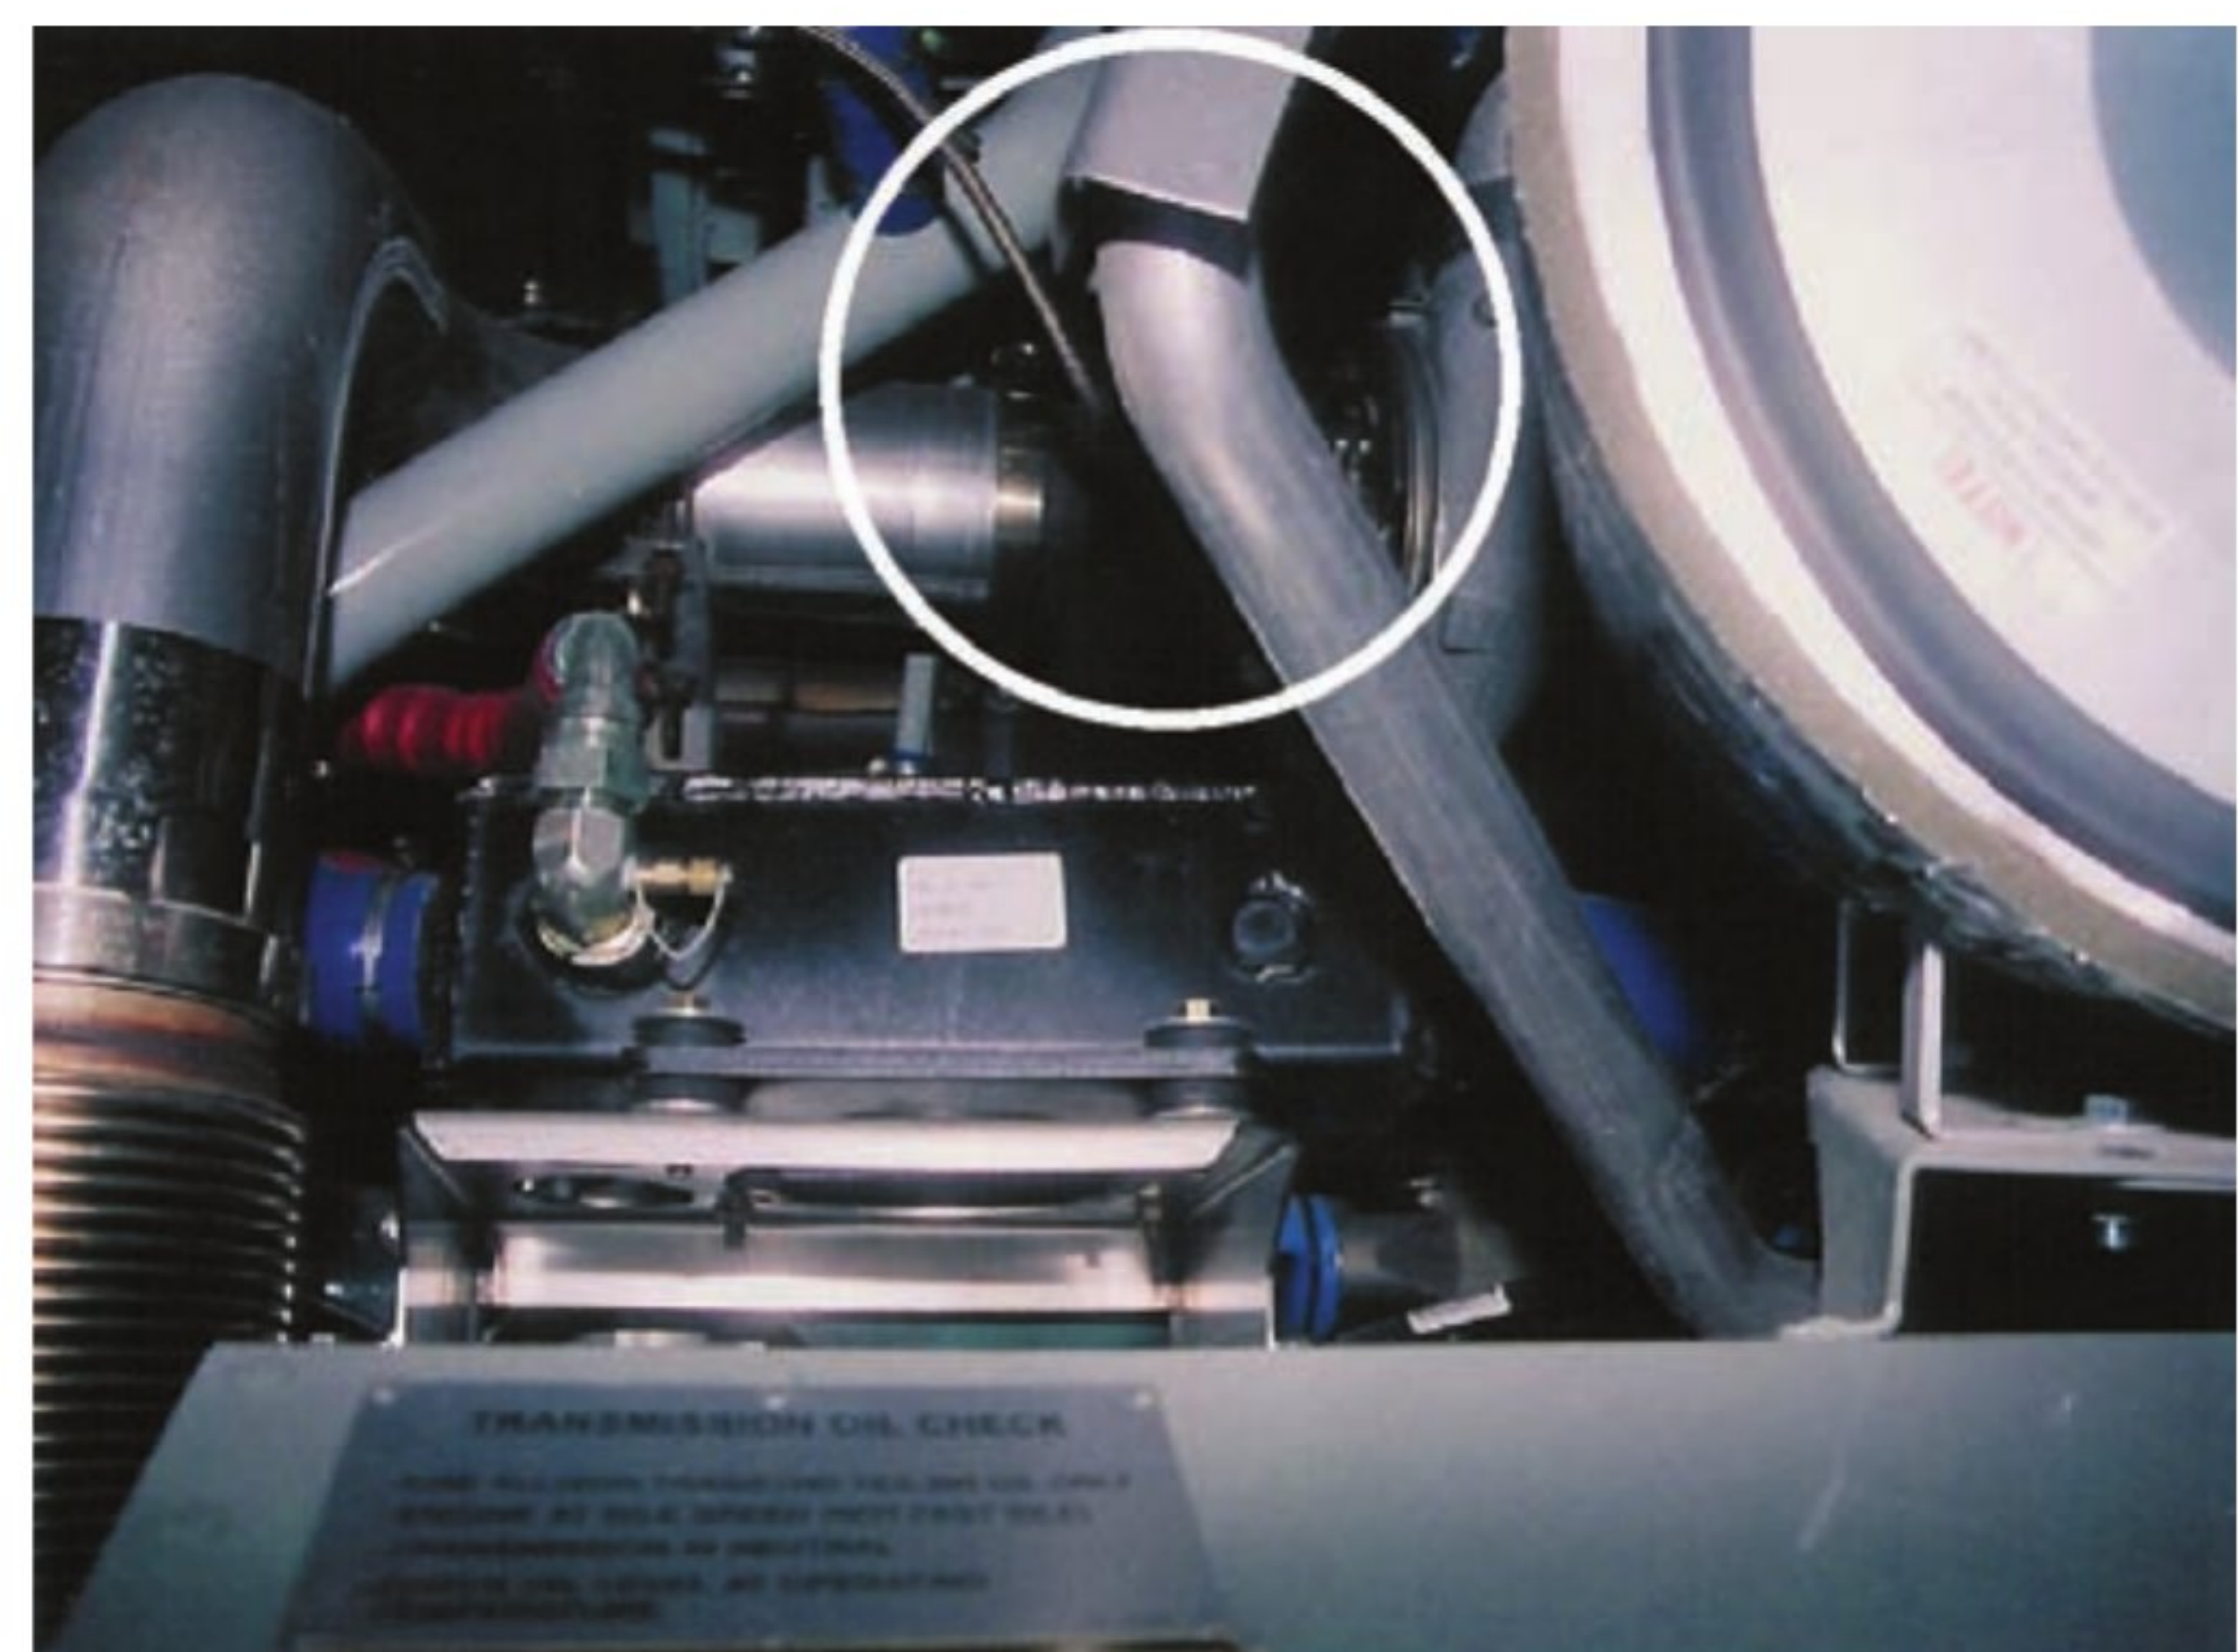
Photo 20: Auxiliary Heater Exhaust Pipe
