## Ford 4G Alternators: An Overview

In 1995, Ford introduced a new series of alternators known as the 4G. The first applications were on the 1995 Lincoln Continental with a 4.6L V8 engine. Then in 1996, 4G-series alternators began appearing on a number of other models. To date, these alternators are all 130-amp.

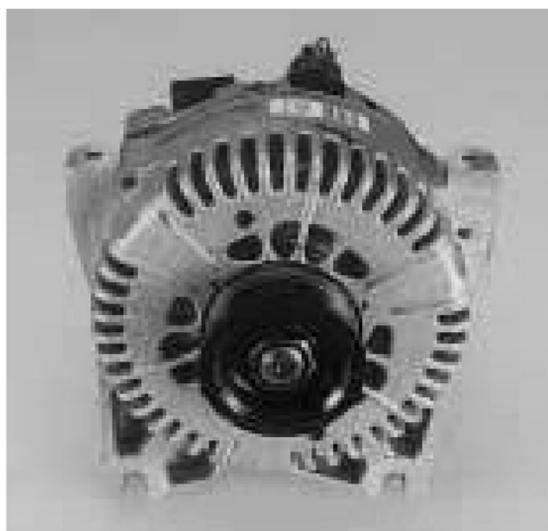
*Figure 1. Saddle-mount units with slotted mounting holes were the second version of the 4G to be introduced.*

The original units in this series, which were used on Lincoln Continental, have a saddle mount (*Figure 1*). At first, these saddle-mount units had round mounting holes (Ford #F5OU-10300-FA). Then Ford changed to the slotted mounting holes shown in *Figure 1*, but kept the same basic part number, changing only the last letter (Ford #F5OU-10300-FB). The WAI number for these saddle-mount units is 1-1904-11FD.

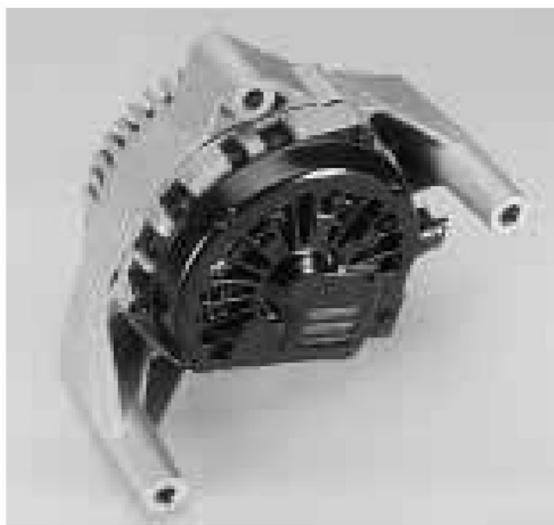
*Figure 2. A version with long-arm mounts was introduced in 1996 on 3L V6 Taurus and Sable.*

In 1996 Ford introduced a unit with unique long-arm mounts (*Figure 2*) that is used on 1996 3.0L V6 Ford Taurus and Mercury Sable (WAI #1-1993-11FD).

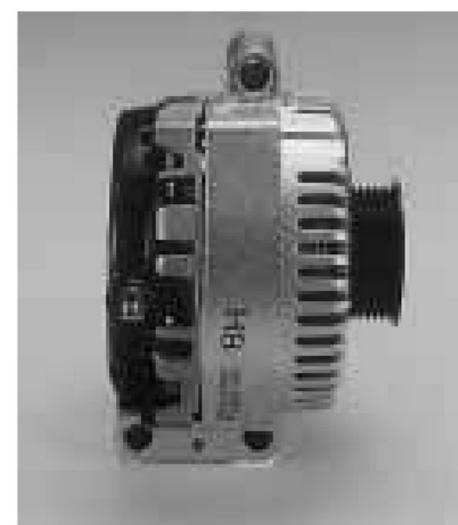
*Figure 3. A side-mount version was used on several 1996 models.*

Also in 1996, Ford began using two side-mount versions of the 4G, one on Windstar with 3.8L engine (WAI #1-2012-21FD) and the other on Explorer with 5.0L V8 engine and F Series pickup with 4.6L V8 (WAI #1-2024-21FD) (*Figure 3*). See the chart on page 2 for complete details on all these units.

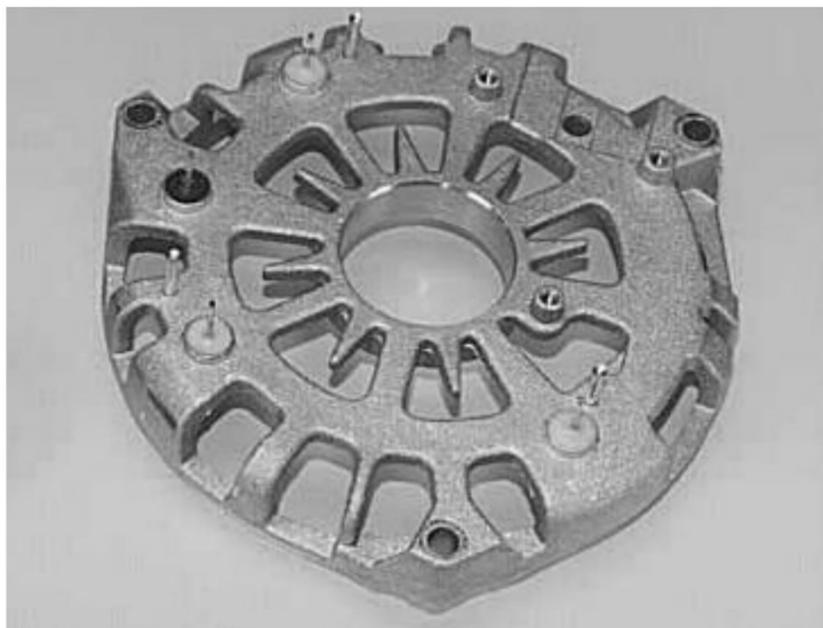
**Figure 6.** The three 50-amp negative diodes have white potting material. The 25-amp negative diode has black potting material.

diodes with white potting material are 50-amp and the one with black potting material is 25-amp (*Figure 6*).

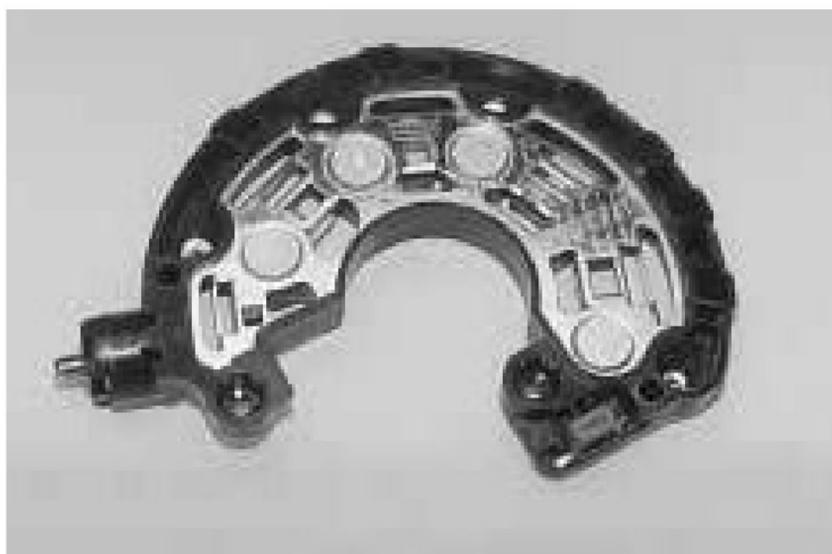
**Figure 7.** Sections of the copper heat sink are cut and bent over for better transfer of heat away from the rectifier.

These units also use three positive 50-amp diodes and one positive 25-amp diode. Both of the 25-amp diodes in this unit have a small “dimple” on the bottom (*Figures 5 & 7*).

molded into the plastic. For cooling, sections of this heat sink are cut and bent over rather than removed. The bent material acts like fins for better transfer of heat away from the rectifier (*Figure 7*).
