# TECH TIPS

**Applications:** 1996 – 1997 Volkswagen Golf (all options)  
1996 – 1997 Volkswagen GTI (all options)  
1996 – 1997 Volkswagen Jetta (all options)

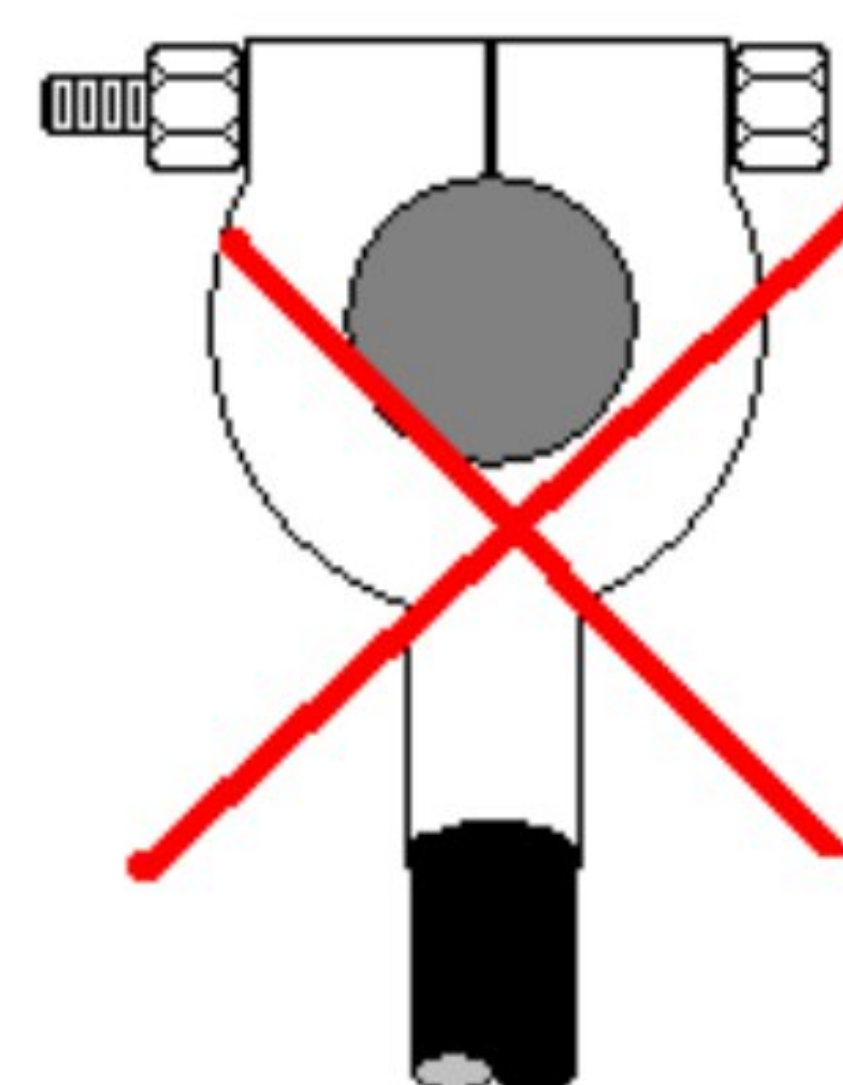
**Cause:** A potential cause for the above conditions is the battery clamps at the battery positive and negative terminals.

No Clearance  
between jaws of  
the battery clamp

**Correction:** Inspect the battery clamps that attach to the battery posts. If there is no clearance between the jaws disconnect the cables and file 1mm of material so that there is a gap as shown in the sketch on the right.

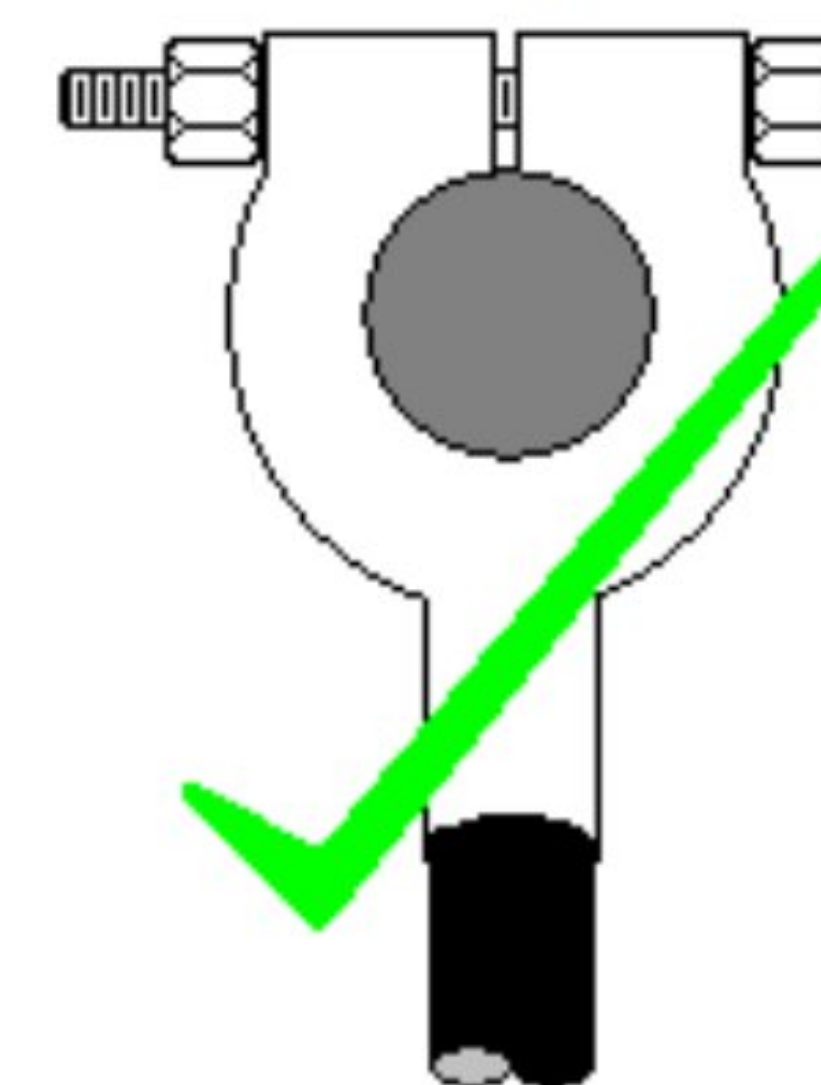
A minimum of 1mm  
clearance between  
the jaws of the  
battery clamp
